ARCHAEOLOGICAL SCHEME OF WORKS REPORT:

LAND OFF MILL LANE, KEELBY, LINCOLNSHIRE

By Allen Archaeology Limited Report Number AAL 2016015

May 2016

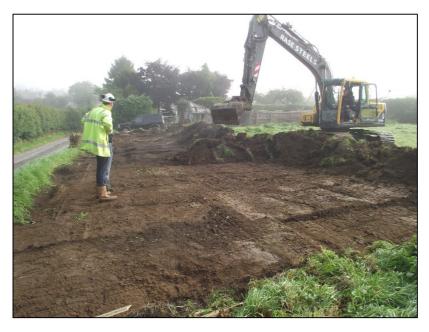
Plate 1: General view of the site during topsoil stripping, looking northeast

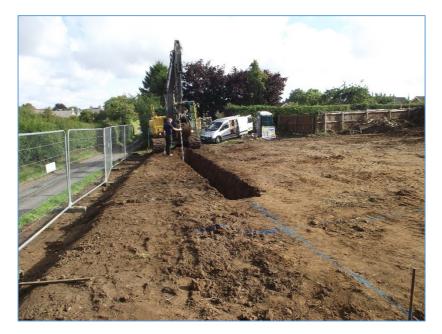
Plate 2: General view of the footings during excavation, looking west

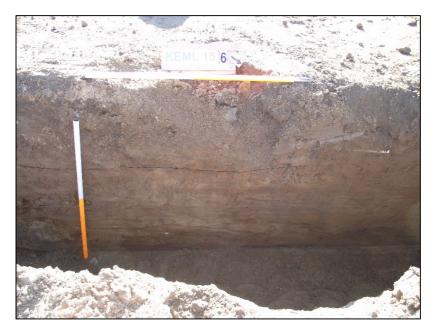
- 6.0 **Results** (Figures 3 and 4)
 - 6.1 The earliest deposit revealed within the footings was a loose, light brown sand and gravel, 004, that represents the underlying superficial geology. This was recorded to a depth of *c*.1m below the existing ground level. Sealing 004 was a 0.2m thick, moderately compact, light brown sandy silt, 002, with occasional pebbles, flint and chalk that has been interpreted as a subsoil (Plate 3).

Plate 3: East-facing section showing subsoil 002 overlying natural sand and gravel 004. Scales 1m

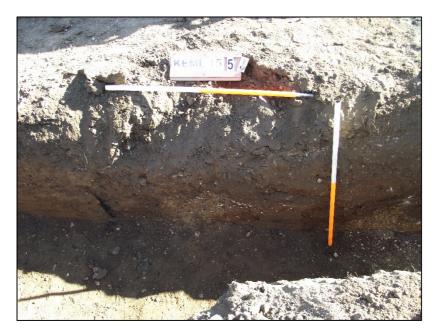
6.2 Cutting the subsoil in the northeast half of the site was a north-south aligned linear feature, [005], with u-shaped sides and a concave base, and a terminus to the northwest. [005] measured at least 3m long by 1.8m wide and 0.7m deep and was filled by a primary deposit comprising a thin lens of coal dust, 006, sealed by a loose, mixed sand and silt backfill, 007, interpreted as redeposited natural (Plate 4).

Plate 4: North-facing section of ditch/gully [005]. Scales 1m

7.1 The monitoring revealed a modern brick built structure, [008], that was likely to have been a small outhouse. A number of small outbuildings are apparent on later 20th century mapping, but nothing that corresponds with the location of this structure, and as such its precise date and function are unclear. Likewise, a pit or linear feature was recorded [005], but produced no dating evidence, thus limiting its interpretive potential.

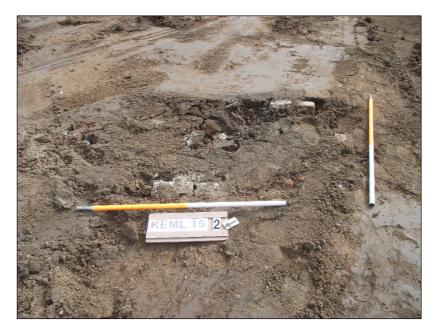
6.3 The foundations of a brick, mortar bonded structure, [008], were recorded in plan in the southwest half of the footings. Rectangular and aligned northwest-southeast this probable outbuilding measured 2m x 1m and had a wall extending from the northeast corner for a further c.2m

Plate 5: View of brick structure [008], looking southeast. Scales 1m

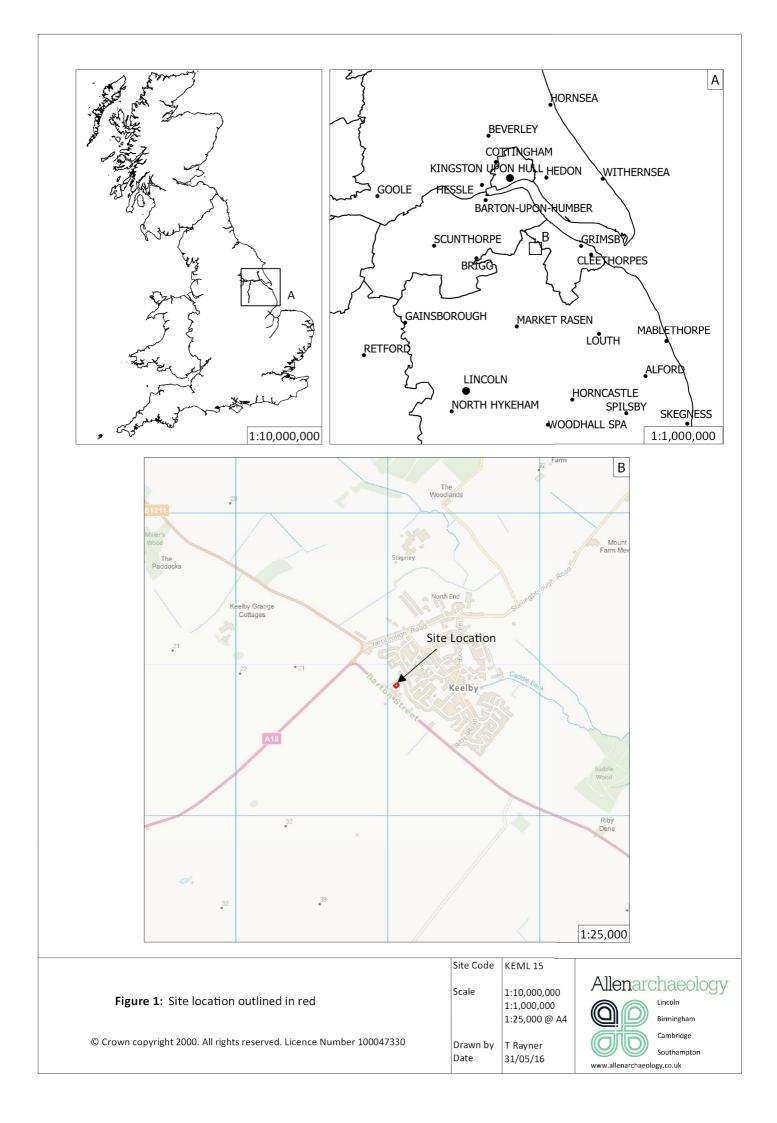
Figure 1: Site location outlined in red	11
Figure 2: Detailed site location (in red)	12
Figure 3: Plan of features within footings and section locations	13
Figure 4: Sections, located on Figure 3.	14
