ARCHAEOLOGICAL EVALUATION REPORT:

**TRIAL TRENCHING ON LAND AT CHRISTCHURCH MEMORIAL HALL, 11 CHURCH ROAD AND LAND
SOUTHEAST OF THE PADDOCKS, GREEN LANE, CHRISTCHURCH, CAMBRIDGESHIRE**

Allen Archaeology Limited
Report Number AAL 2016056

April 2016

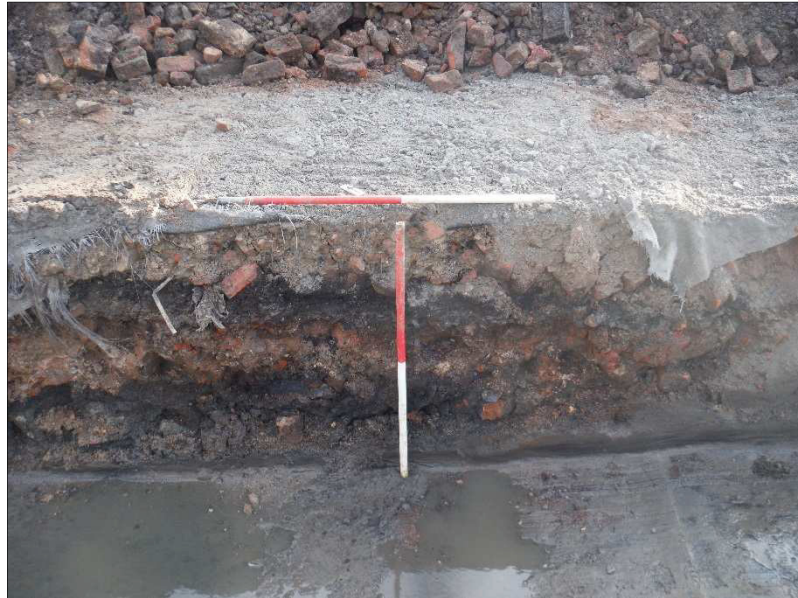
- 6.4 Trench 2 was located towards the centre of the site and was aligned roughly north to south, measuring 30m long by 1.6m wide. It contained a 0.44m thick layer of made ground comprising loose grey gravel, 200, overlying loose yellow rubble and aggregate, 201.
- 6.5 At the north end of the trench, layer 201 sealed a tarmac layer, 202, which in turn overlay a 13m long spread of loose light yellow rubble which was 0.25m thick, 203. This deposit then sealed a 0.33m thick layer of loose, very dark grey, silty sand with frequent brick fragments and occasional fragments of mortar, 204, and a 0.1m thick layer of soft, dark grey sand with very occasional brick fragments, 205. These layers have been interpreted as dumped deposits of demolition rubble, associated with the clearance of the previous buildings from the site, and a

series of levelling deposits. These deposits sealed a 0.2m thick layer of mid grey sand, 217, interpreted as the natural geology (Plate 1).

Plate 1: Southeast-facing section showing made ground layers in Trench 2, scales 2 x 1m

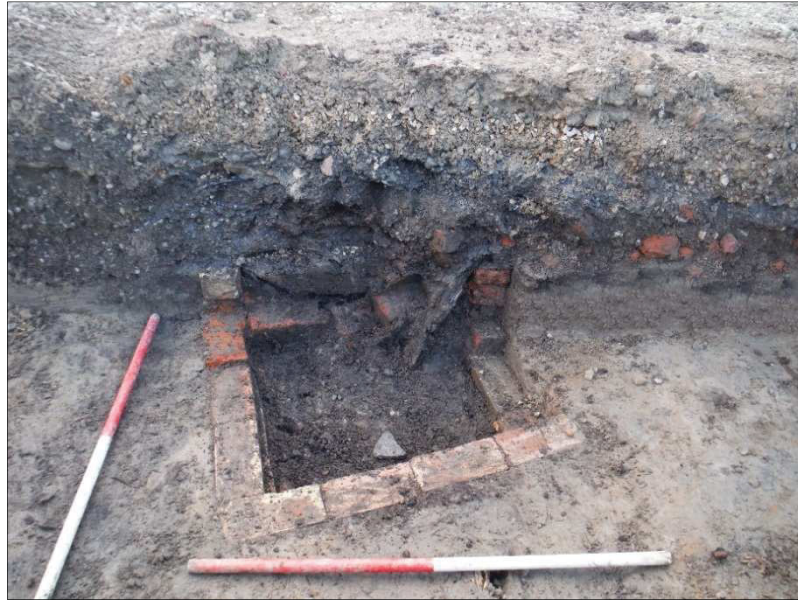
- 6.6 In the centre and south end of this trench layer 201 sealed a 0.2m thick layer of loose, mid orange brown, medium sized gravel, 221, which sealed modern postholes, [208] and [210], and square brick structures, 212 and 215, which were located towards the centre of the trench.
- 6.7 Posthole [208] measured 0.25m long x 0.18m wide and [210] measured 0.3m long x 0.18m wide. Both contained degraded wooden posts, 207 and 209.
- 6.8 Square, brick structure, 212, was four courses high and a single course wide. It measured 0.8m wide x 0.91m long and was constructed of hard red bricks bonded with cement, with each brick measuring approximately 0.25m long x 0.11m wide x 0.1m high. The structure was filled by a loose, dark grey brown, silty sand with occasional brick fragments, 211, and was situated within construction cut [213], which measured 0.8m wide x 0.91m long (Plate 2).

Plate 2: Northwest-facing section of structure, 212, scales 2 x 1m

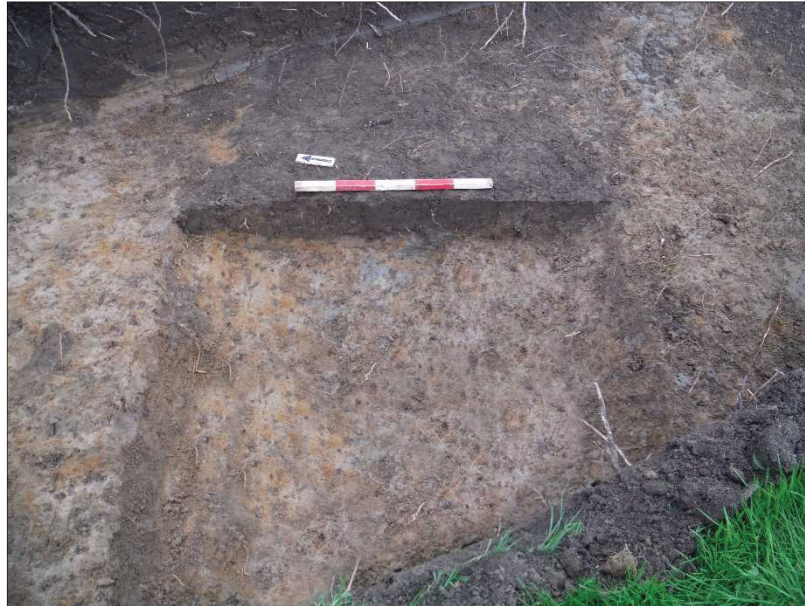
- 7.2 Trench 1 was located at the northeast end of the site, and was aligned roughly northwest to southeast, running parallel to Green Lane. It contained two broadly east-west oriented linear features, [103] and [105].
- 7.3 Towards the northwest end of the trench, linear feature [103] measured 1.12m wide x 0.12m deep and contained a single fill of dark brown silty sand, 104. To the centre of the trench, linear feature [105] measured 1.18m wide x 0.22m deep and contained a single fill of dark brown silty sand, 106. No dating evidence was recovered from either of these features and based on their wide, shallow profile they have been interpreted as the remains of possible furrows.

Plate 3: Northwest-facing section of linear feature [103], scale 0.5m

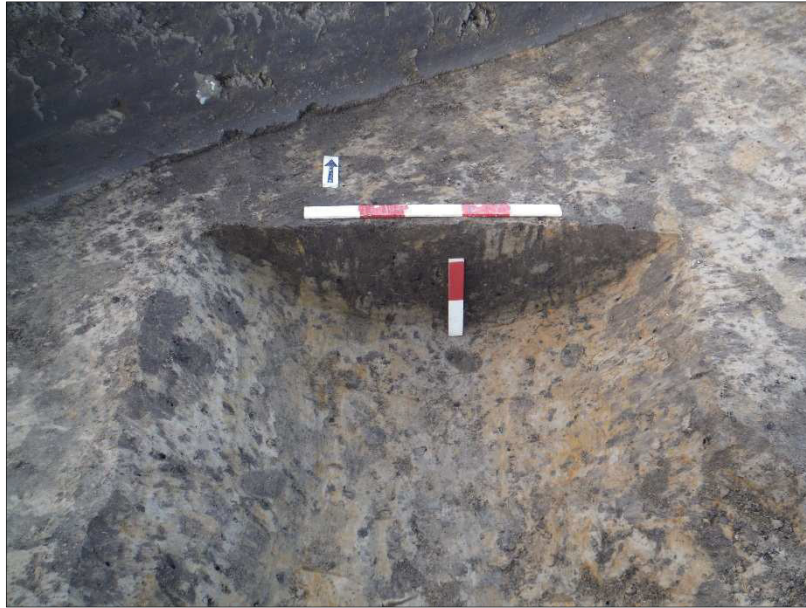
- 7.4 Trench 2 was located in the northwest part of the site, and was aligned roughly northeast to southwest. Three undated linear features were recorded in this trench.
- 7.5 In the northeast half of the trench was a northwest to southeast oriented gully, [203] which measured 0.52m wide x 0.33m deep and contained a single undated fill of dark brown silty sand, 204.
- 7.6 In the centre of the trench was a northeast to southwest orientated gully, [205], which measured 0.5m wide x 0.12m deep and contained a single undated fill of dark brown silty sand, 206.
- 7.7 At the southwest end of the trench was a north-south oriented curvilinear ditch, [207], which measured 0.92m wide x 0.28m deep and contained a single undated fill of dark brown silty sand, 208 (Plate 4).

Plate 4: South-facing section of ditch [207], scales 0.4m and 0.2m

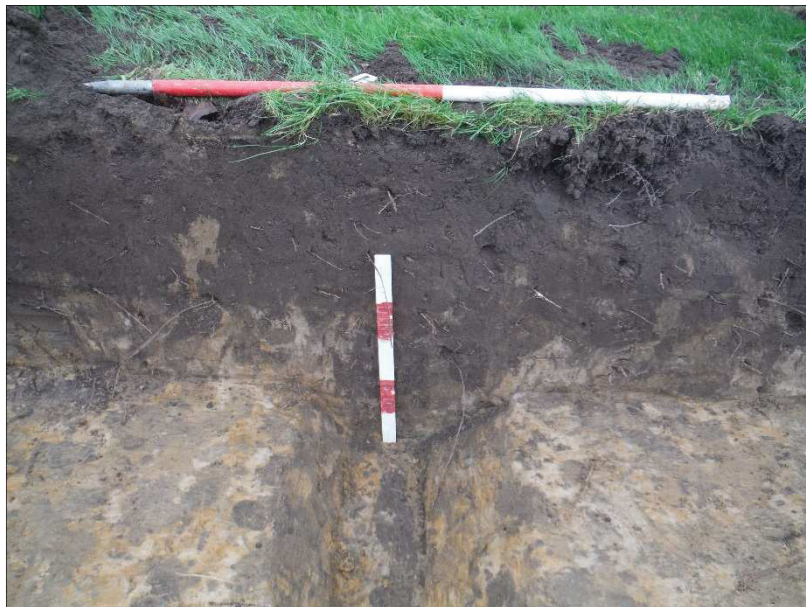
7.9 Trench 3 was located in the southeastern half of the site and was aligned roughly northeast to southwest. It contained a single northwest to southeast oriented steep sided gully, [303] which measured 0.54m wide x 0.22m deep and contained a single fill of dark brown silty sand, 304, from which no dating evidence was recovered. Its profile is suggestive of the cut for a ceramic land drain, although no ceramic pipe was recovered from the feature.

Plate 5: Northwest-facing section of gully [303], scales 1m and 0.4m

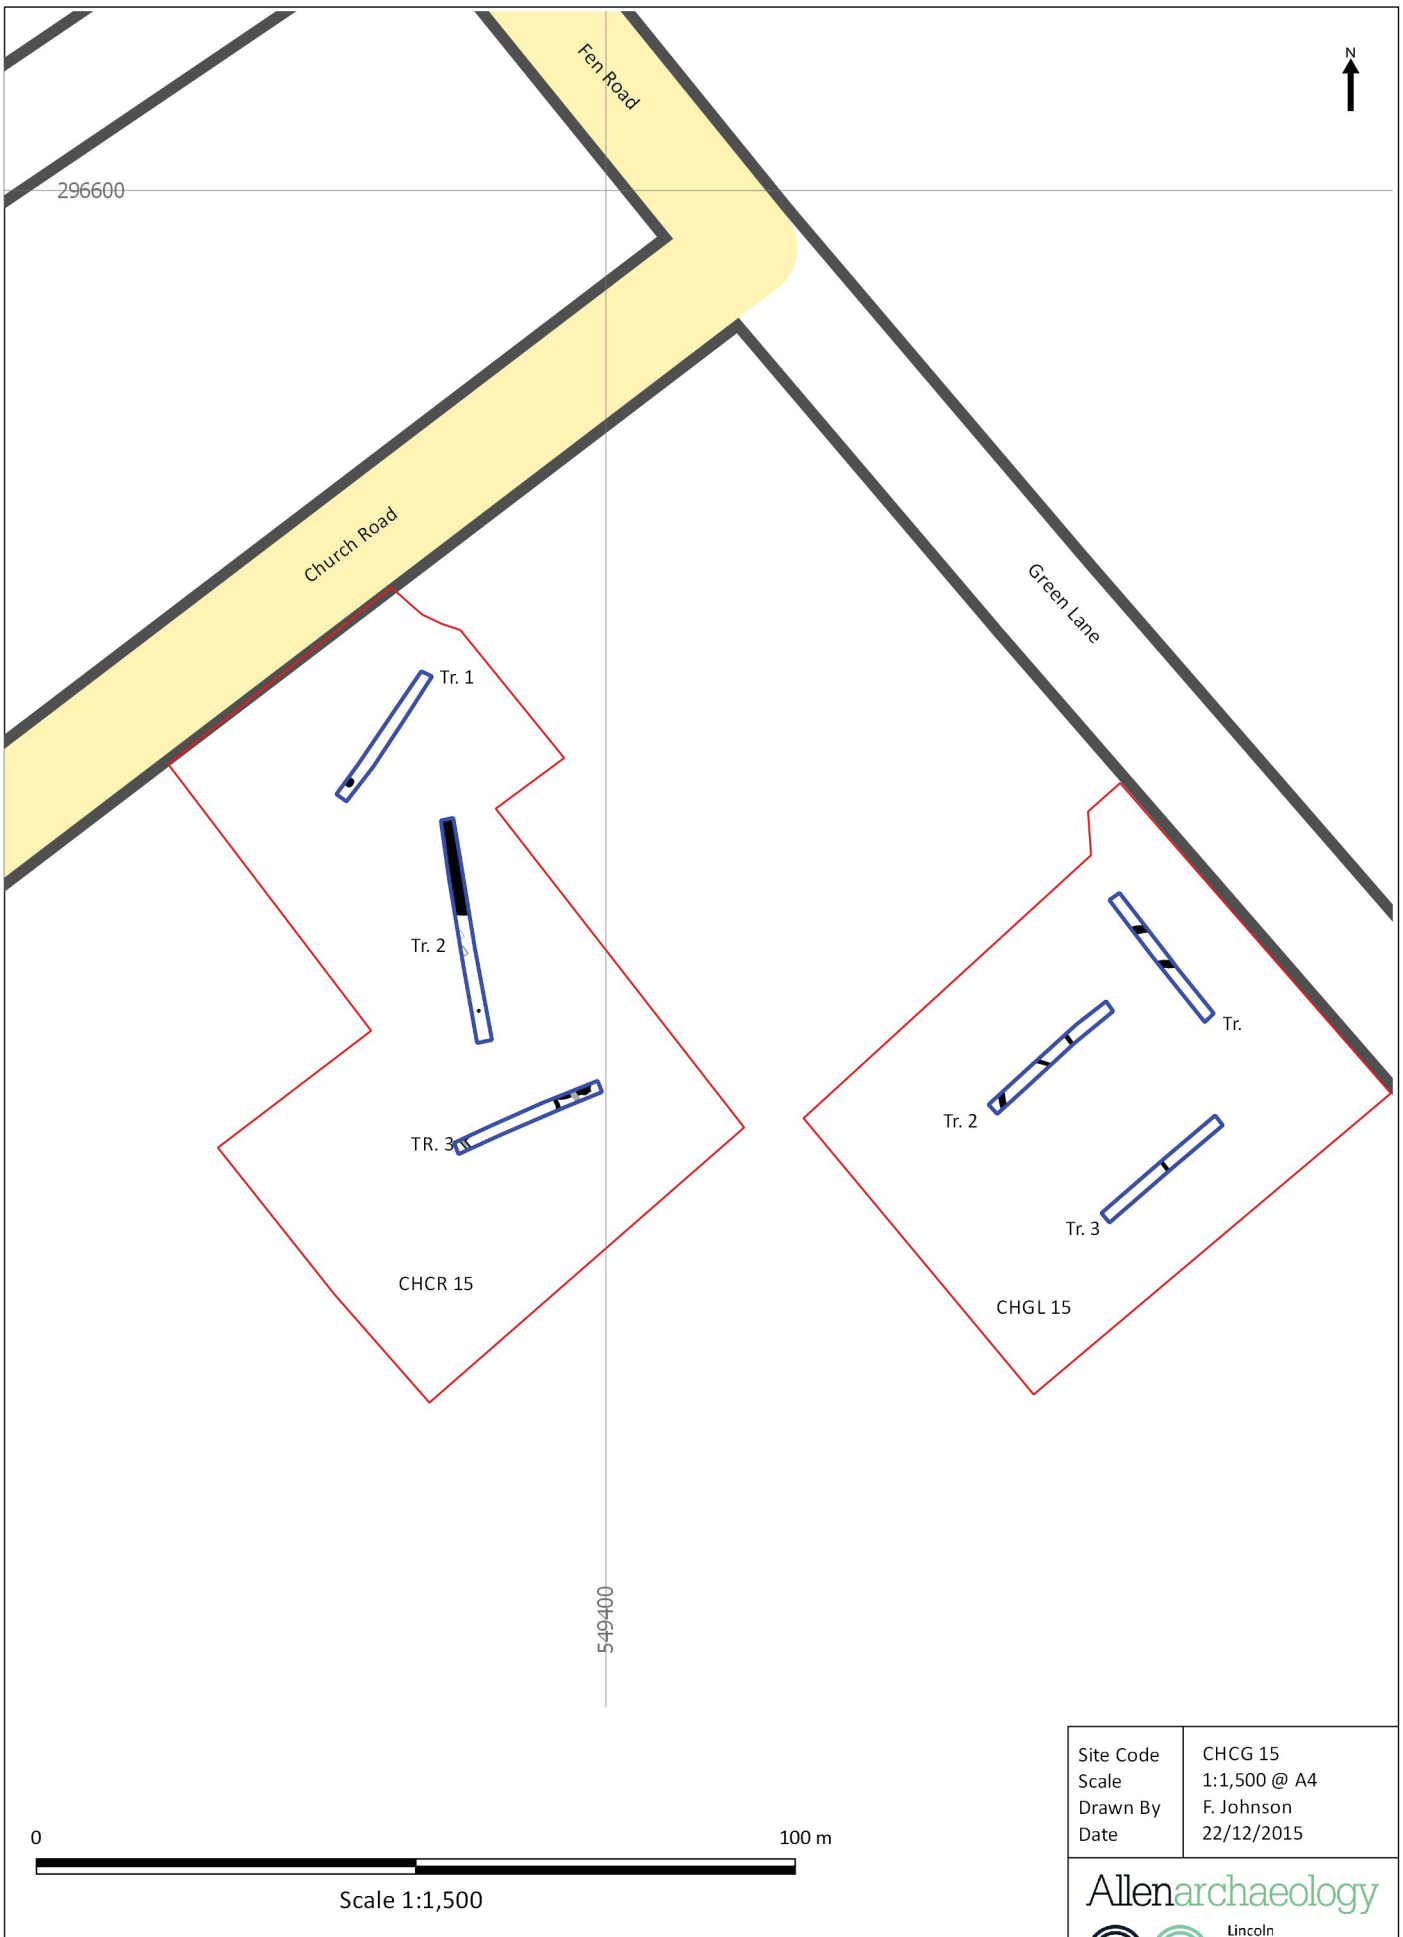
Figure 2: Trench locations (TR) in blue with archaeological features in black and modern masonry in grey. Sites outlined in red

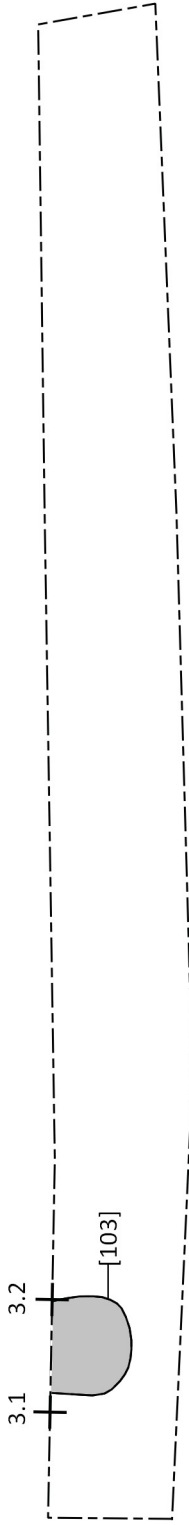
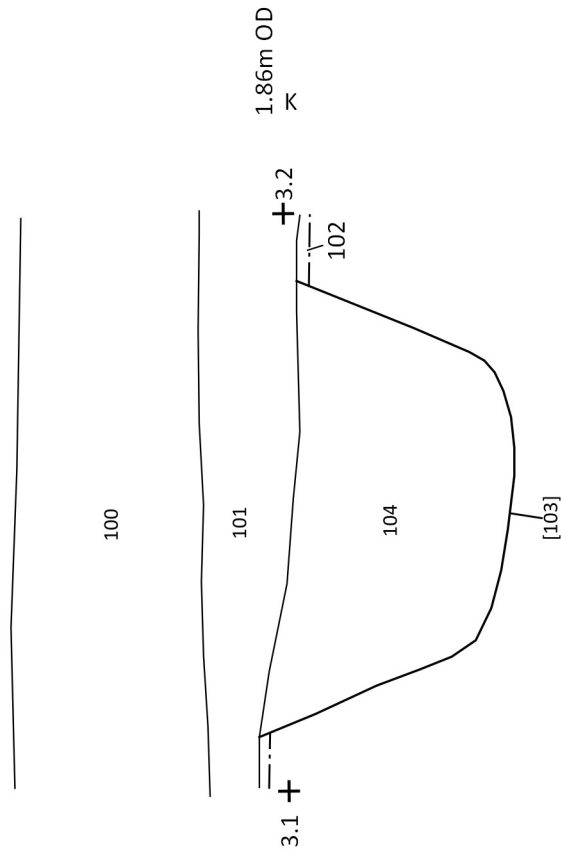
Figure 3: Plan and section of Trench 1 CHCR15

- 6.2 Trench 1 was located to the northeast of site, aligned roughly northeast to southwest, and measured 20m by 1.6m. It contained a 0.44m thick layer of made ground comprising loose grey gravel, loose yellow rubble, aggregate and building rubble, 100, overlying a layer of compact grey sand, 101, into which pit [103] was cut. Layer 101 has been interpreted as a possible subsoil layer and in turn overlay a compact yellowish grey sand, 102, which represents the natural geology of the site.

- 6.3 At the southwest end of this trench there was a sub-circular pit, [103] which measured 1.4m wide x 1m long x 0.33m deep and extended beyond the limit of excavation to the west. It contained a single fill of dark grey silty sand, 104, which contained occasional fragments of ceramic building material which were too small to provide further information on date. This feature was truncated to the southwest by a northeast to southwest aligned modern land drain.
