**HISTORIC BUILDING SURVEY REPORT:
BRENTRY HOUSE, AMPFIELD, HAMPSHIRE**

Planning Reference: 15/2377/FULLS
NGR: SU 3803 2352
AAL Site Code: AMBH 16
OASIS Reference Number: allenarc1-248234

By
Allen Archaeology Limited
Report Number AAL2016072

May 2016

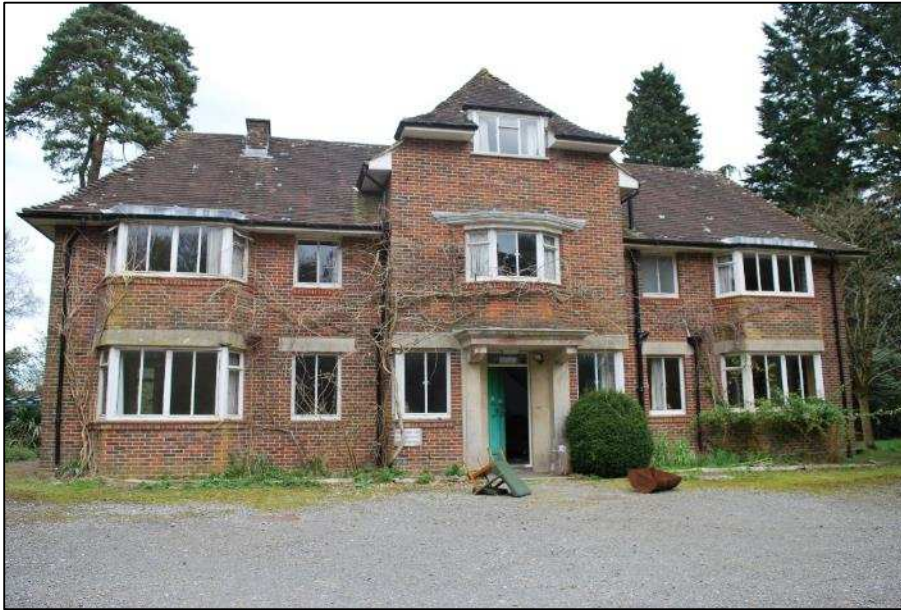
Plate 1 (Shot 71): Brentry House from the front, looking northeast

- 6.2 Brentry House (Plate 1) is located within the Registered Park and Garden: Sir Harold Hillier Gardens and Arboretum. It is a brick building with a clay tile combination pitched roof that was constructed sometime between 1938 and 1940, based on Ordnance Survey mapping. The building is accessed via a track from Jermyns Lane and is surrounded by the arboretum in an area known as Brentry Woods (Plate 2).
- 6.3 The front elevation (Elevation A: Plate 1) is to the southwest and presents as an entrance porch in a protruding central bay, which projects forward from two wings to the northwest and southeast. The

- 6.6 The wings to either side of the entrance are nearly identical (Plate 1). To either side of the entrance the elevation is broken by two light casement windows at ground floor and first floor level, and canted bay windows of six lights. The ground floor windows are all slightly longer than those at first floor level. The bay windows at first floor level are sealed in with lead where they project through the roof line (Plate 6). These again feature on 1953 photo and therefore are likely to have been original, as is the chimney which is present on the north-western wing (Plate 6).

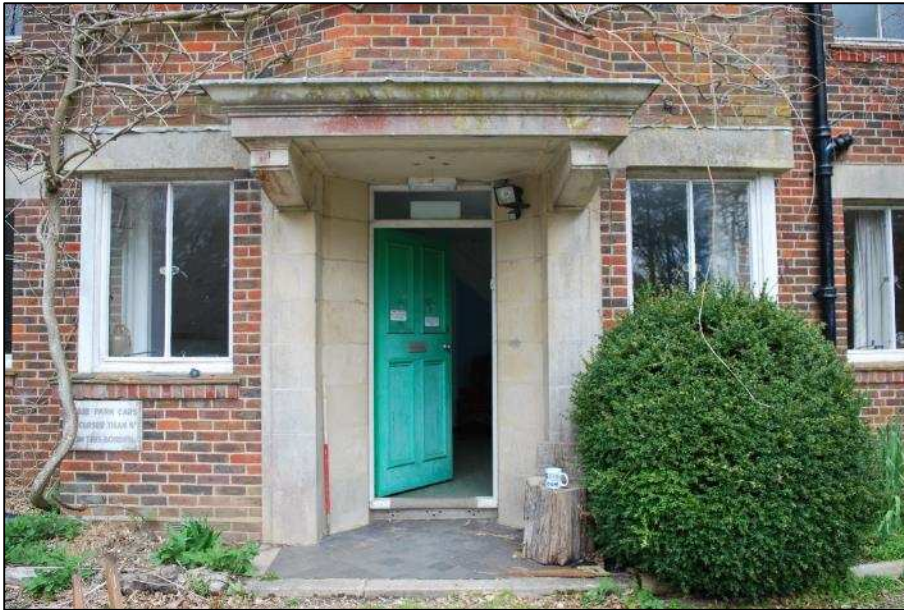
Plate 3 (Shot 79): Entrance porch, looking northeast, 1m scale

entrance consists of a flat canopy porch in a classical style supported by pilasters (Plate 3), all of ashlar stonework that is somewhat at odds with the brick building. The same ashlar is used across the rest of the ground floor as lintels. The porch is sealed to the main building by lead flashing.

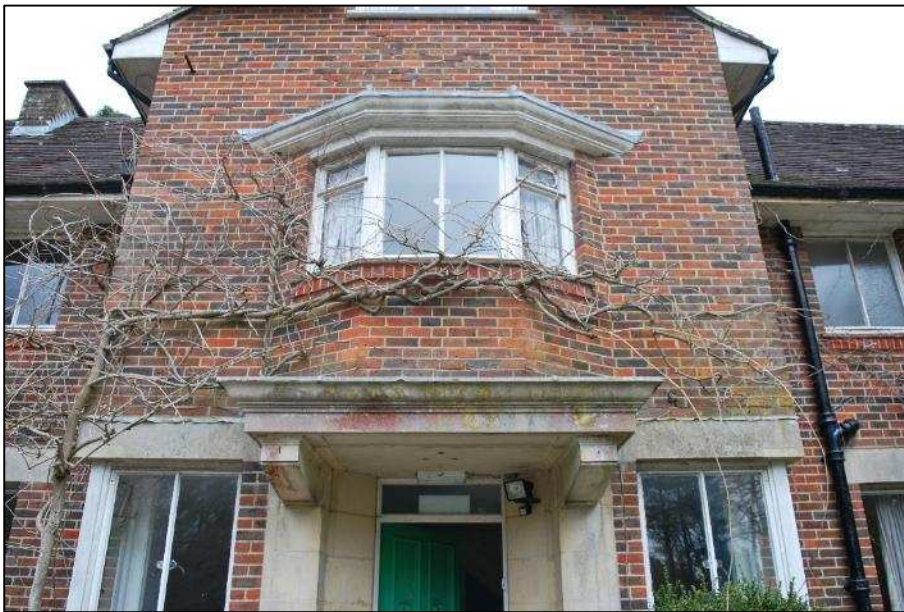
Plate 4 (Shot 80): Bay window above entrance porch, looking northeast

- 6.5 Directly above the entrance a bay window is present at first floor level, again sealed in with lead flashing (Plate 4). The support for the window springs from the porch, below. Above the bay window is a dormer window, which appears to have been inserted through the overhang of the roof (Plate 5), although it is present on a photo taken in 1953 suggesting that it might be an original feature.

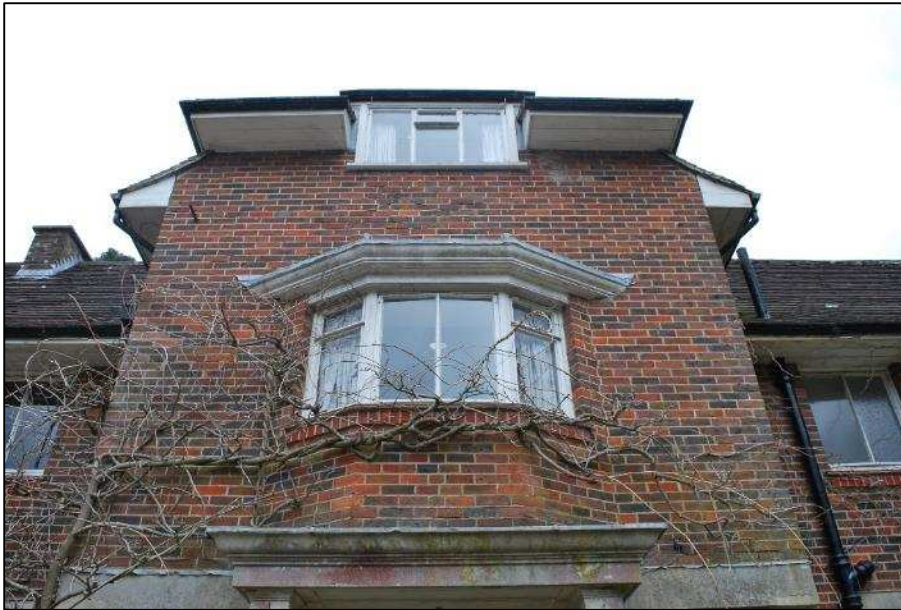
Plate 5 (Shot 81): Dormer window at second floor level which is placed through the roofline, looking northeast

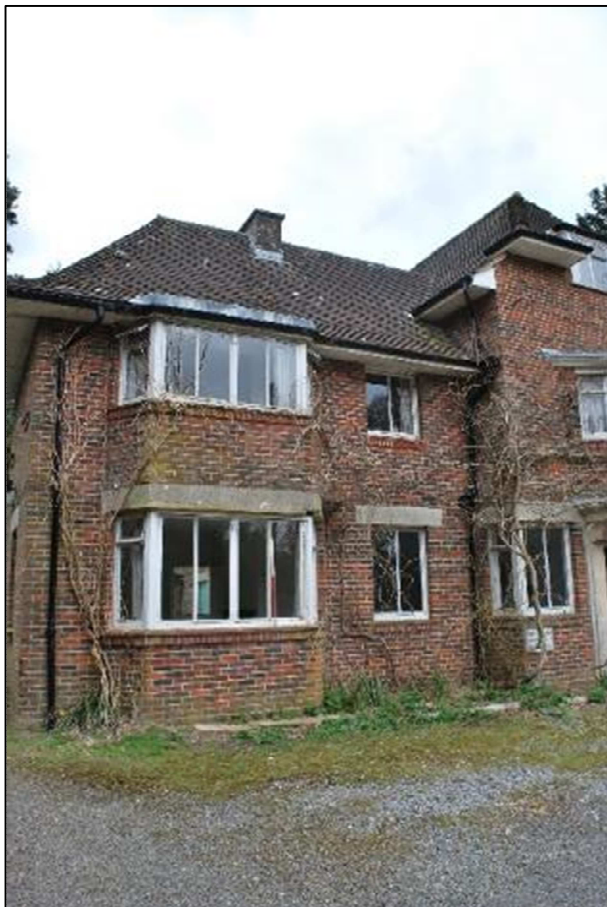
Plate 6 (Shot 88): North-western wing of Elevation A, looking east (1m scale)

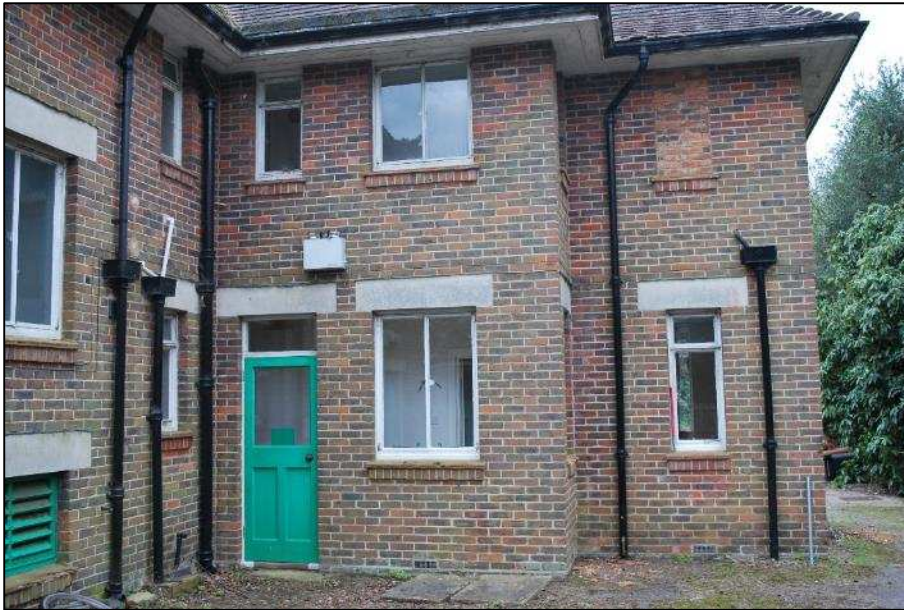
Plate 9 (Shot 5): Elevation C, looking southwest, 1m scale

- 6.10 Elevation C (Plate 9) is the north-eastern elevation of the buildings north-western wing, and consists of two sections. To the north the elevation is set back and is broken by a single window at ground floor level, directly above another window has been bricked up. A cast iron down pipe runs from the roof to the ground and a second decorated downpipe runs from first floor level down. To the south the elevation has a two light casement window and a fire exit with a transom above on the ground floor. At first floor level a single casement with top opener casement above is located above the doorway and a second two light casement window is placed above the one at ground floor level.

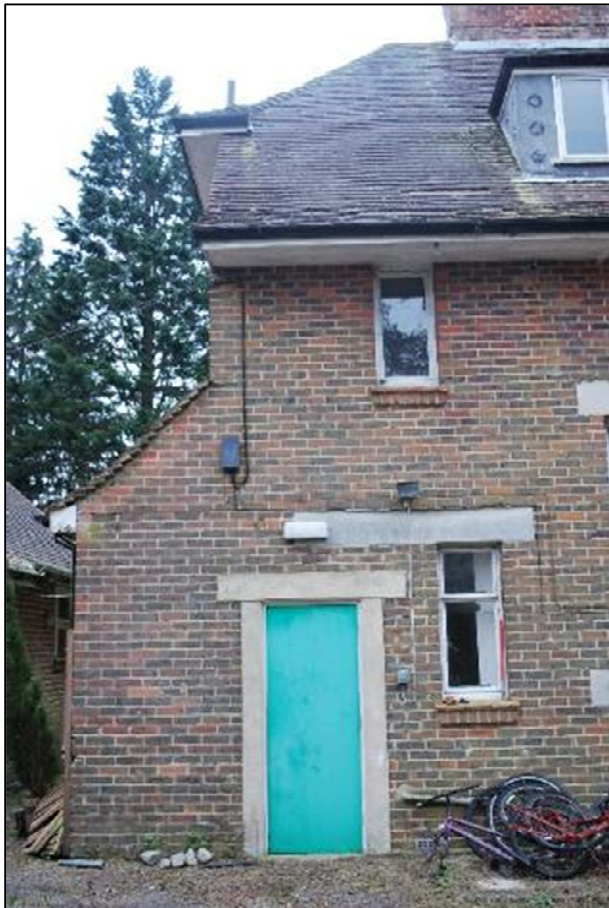
Plate 10 (Shot 28): Northern extent of Elevation D, looking southeast, 1m scale

- 6.11 Elevation D faces northeast. At the north-eastern extent of the elevation is a single storey lean-to store. The brickwork is tied in and therefore it is not an extension, but is contemporary with the rest of the building (Plate 10). At ground floor level are a fire exit and two single casement windows with top openers. The window to the northeast has an extended lintel, however, there is no suggestion in the brickwork that the layout of doors and windows in this part of the building has been altered and as such the reason for this extended lintel is unclear (Plate 10 and Plate 11).

- 6.13 There are two further single light casement windows at first floor level; the window to the southwest has a top opener above it (Plate 10 and Plate 11). A dormer window has been inserted into the roof, creating a second floor (Plate 11). It is unclear whether this contemporary with the rest of the building, however, it is not constructed of the same red brick and therefore is likely to be a later addition.

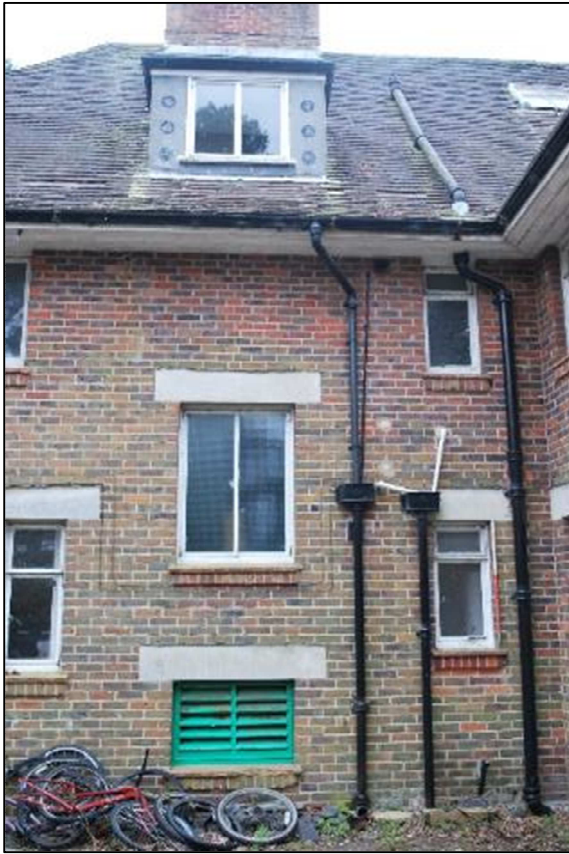
Plate 11 (Shot 20): Southern extent of Elevation D, looking southeast 1m scale

- 6.12 An internal staircase is present at the centre of the elevation, meaning that a two light casement window at this point sits between ground and first floor level. Directly below a green painted vent services the staircase to the basement (Plate 11).

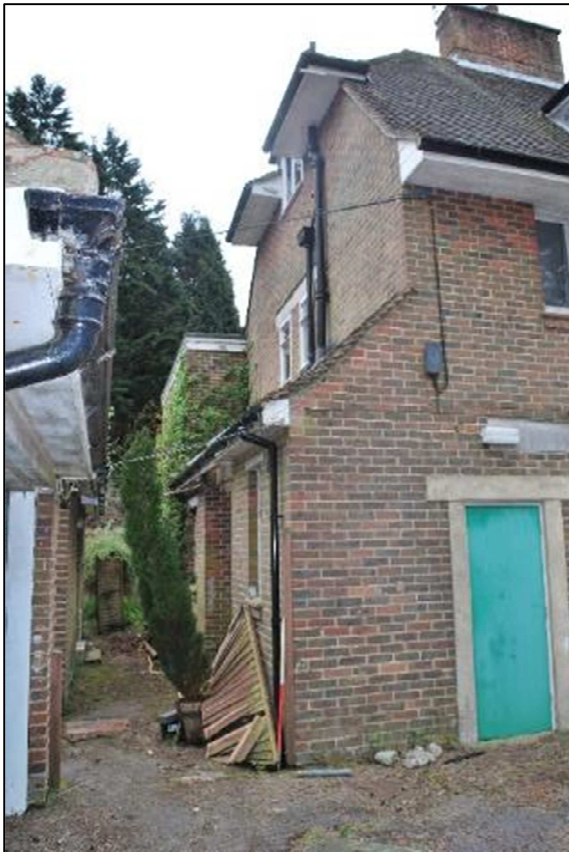
Plate 12 (Shot 32): Gap between Elevation E and the Garage and Bungalow, looking southeast 1m scale

- 6.14 Elevation E faces northeast towards the adjacent bungalow and garage (Plate 12). To the northern extent of the elevation the ground floor level is set forward with a mono-pitched lean-to roof. This houses a wood store which is only accessible from the exterior (Plate 13) and is lit by a single light window with a top opening casement above. It does not have the concrete lintels and brickwork cills seen elsewhere in the building but instead has a narrower white painted lintel and a red tile cill (Plate 14).

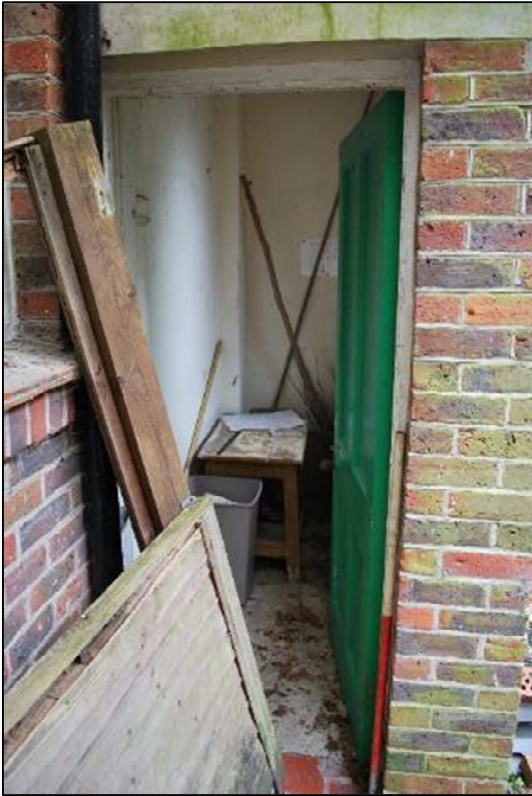
Plate 13 (Shot 36): Wood store in Elevation E, looking northwest, 1m scale

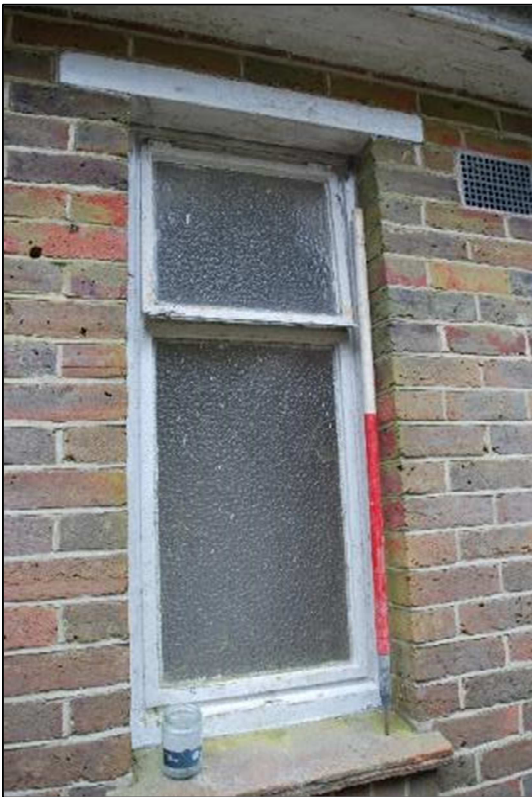
Plate 14 (Shot 33): Window into the wood store, looking southwest 1m scale

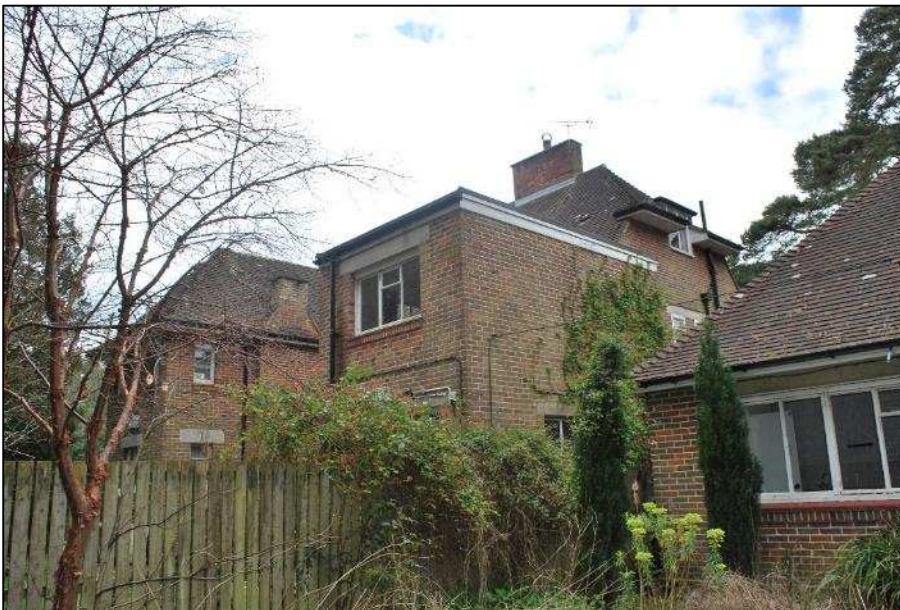
Plate 16 (Shot 372): South-eastern part of Elevation E, looking west

- 6.16 Towards the southeast end of the elevation are two, two light casement windows at ground floor level.
- 6.17 At first floor level two single light casement windows with top opening casements above are located in the centre of the gable end. The south-eastern extent of the elevation has a flat roof and is blank at first floor level (Plate 16).

- 6.18 The roof is half hipped to the north of the elevation and at the peak of the gable end, before the roof pitches back a dormer window is placed at second storey level. Unlike the dormer window on Elevation D this fits into the line of the roof (Plate 16).

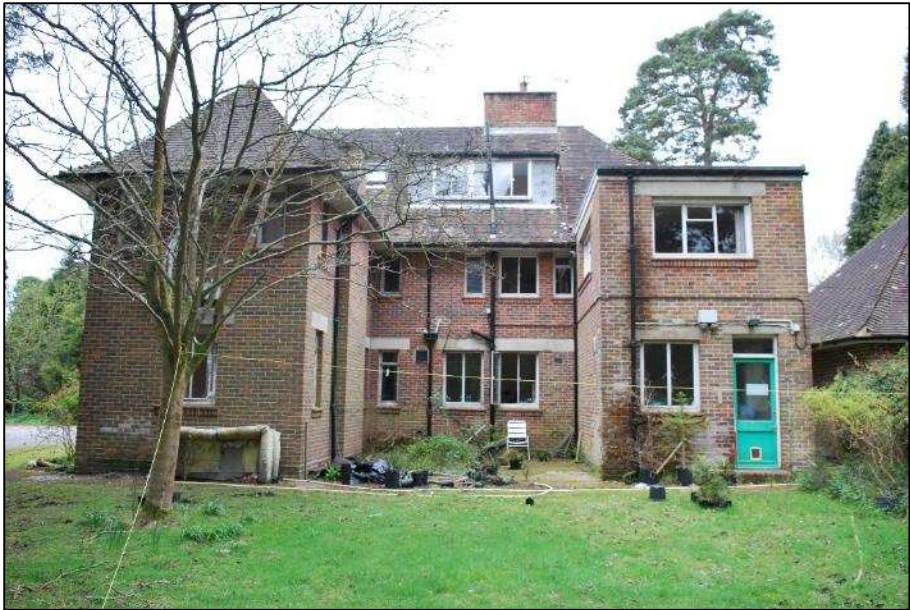
Plate 17 (Shot 46): Elevation F, looking northwest 1m scale

- 6.19 Elevation F faces southeast and is made up of two wings projecting southeast. The north-eastern wing is flat roofed and has a door with transom window above and a two light casement window at ground floor level. At first floor level a four light window with a small top opening occupies the middle of the elevation (Plate 17).

- 6.20 The southwestern wing has a combination pitched roof which is not broken up by any windows. Below it at first floor level there are two single light windows with top opening casements, and at ground floor level a two light casement window is positioned at the centre of the elevation (Plate 17).

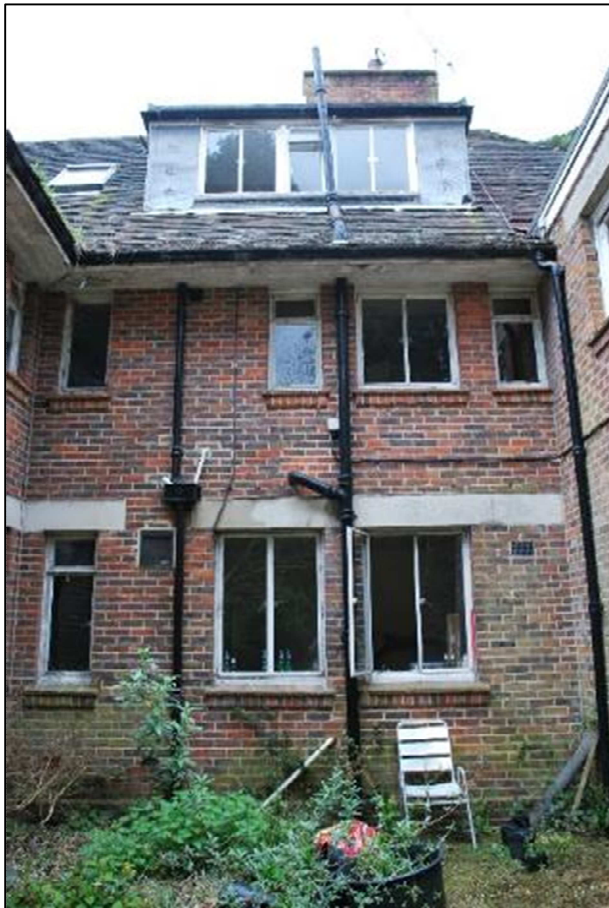
Plate 18 (Shot 54): Central section of Elevation F, looking northwest 1m scale

- 6.21 Between the two protruding wings the elevation is set back behind a courtyard/patio area. Seven windows are unevenly distributed across this elevation. At ground floor level two light casement windows share a lintel, which spreads beyond the windows to the northeast, suggesting that another window or door was planned for this corner. To the southwest a single light window with a top opening casement has its own lintel (Plate 18).

- 6.22 Above are three single light windows, one with a top opener, and a two light casement (Plate 18).
- 6.23 Above this elevation, the roofline is broken by a flat roofed six light dormer window and a skylight, both facing southeast (Plate 18).

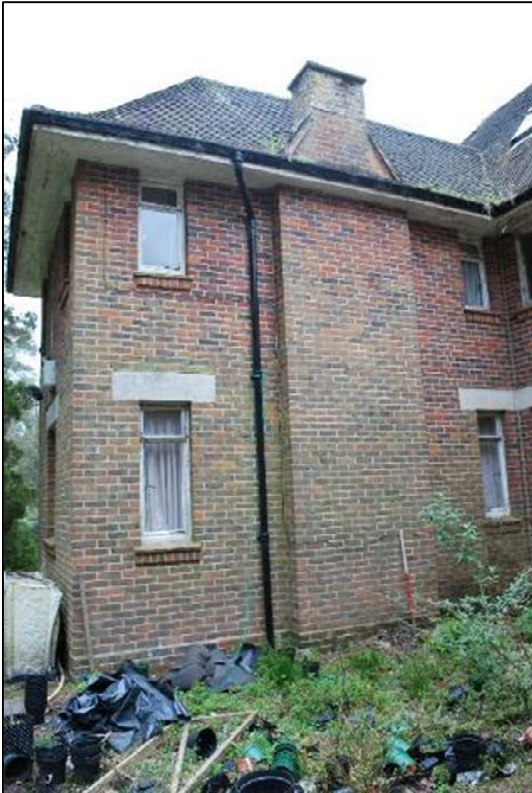
Plate 20 (Shot 62): Elevation H, looking west 1m scale

- 6.25 Elevation H faces northeast, opposite Elevation G. A chimney stack occupies the central third of the elevation and projects into the courtyard. To either side of it are single light casement windows with top opening casements above at both ground and first floor. The chimney stack projects through the roofline but there are no other features at second floor level (Plate 20).

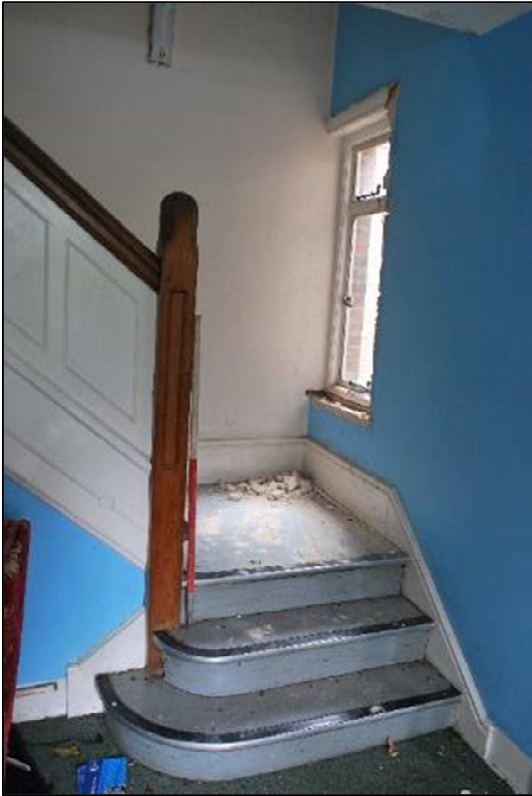
Plate 29 (Shot 210): Staircase in the entrance lobby, looking east, 1m scale

- 6.29 The principal staircase is located in the entrance lobby, it is L-shaped with a flat 90° turn close to the bottom (Plate 29). A second stairwell is located towards the rear of the building and provides access to the cellar, first and second floors (Plate 30).

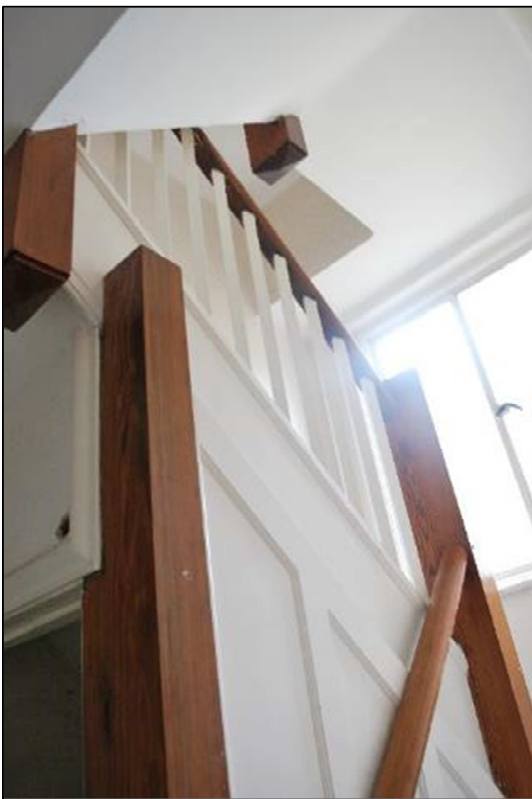
Plate 30 (Shot 209): Stairwell that provides access to the cellar, first and second floor, looking west

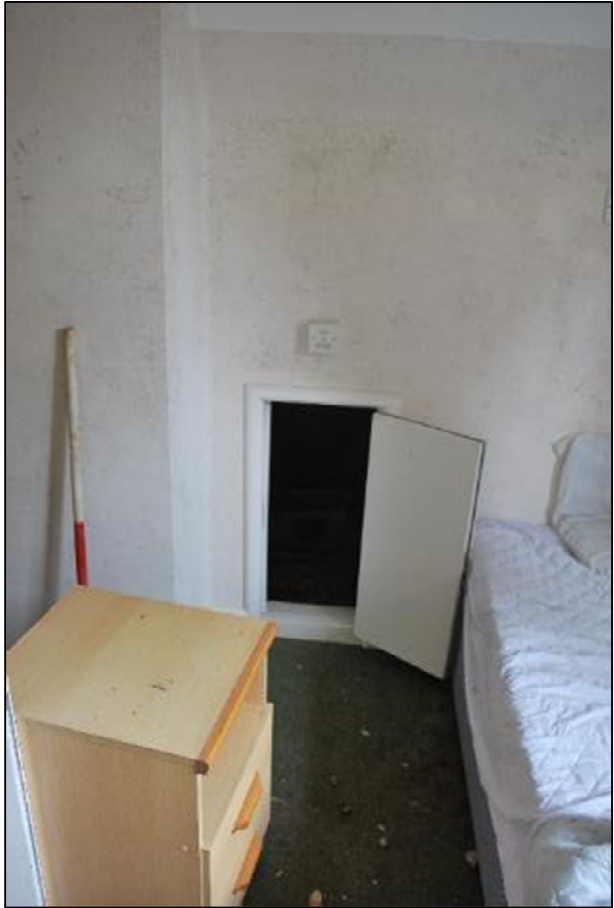
Plate 34 (Shot 326): Access to the roof cavity in Bedroom 6, looking southeast 1m scale

- 6.31 The second floor has also been recently renovated. It consists of four rooms, all of which have been used as bedrooms (Plate 33) prior to the building falling into disuse. The rooms are consistent in style as those on the first floor. There is also access into the roof cavity from Bedroom 6 and the hallway (Plate 34).

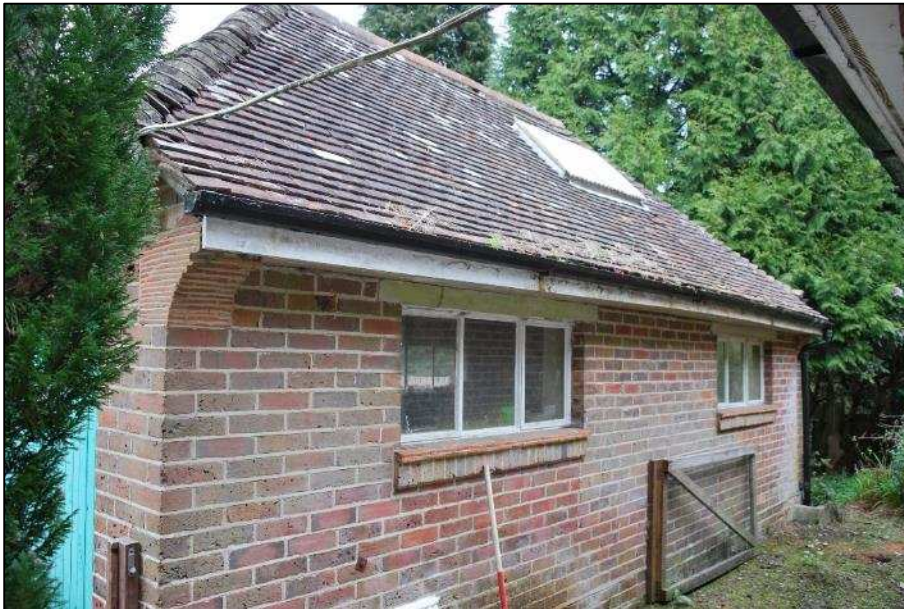
Plate 36 (Shot 337): Southeast facing elevation of the garage, looking north, 1m scale

northwest and southeast facing elevations, evenly distributed and positioned immediately below the eaves (Plate 36). The rear of the building (the northeast facing elevation) appears to have been rebuilt as some point with a three light casement window at the centre and a blocked (with concrete) door to the north of the elevation. A temporary wooden shelter has also been constructed against this wall (Plate 37).

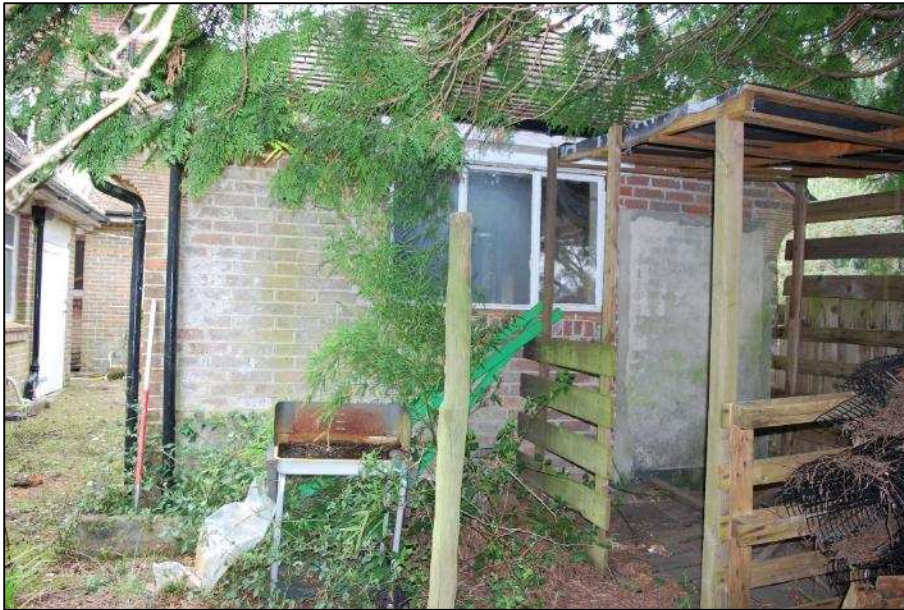
Plate 37 (Shot 342): Northeast facing elevation of the Garage, looking southwest 1m scale

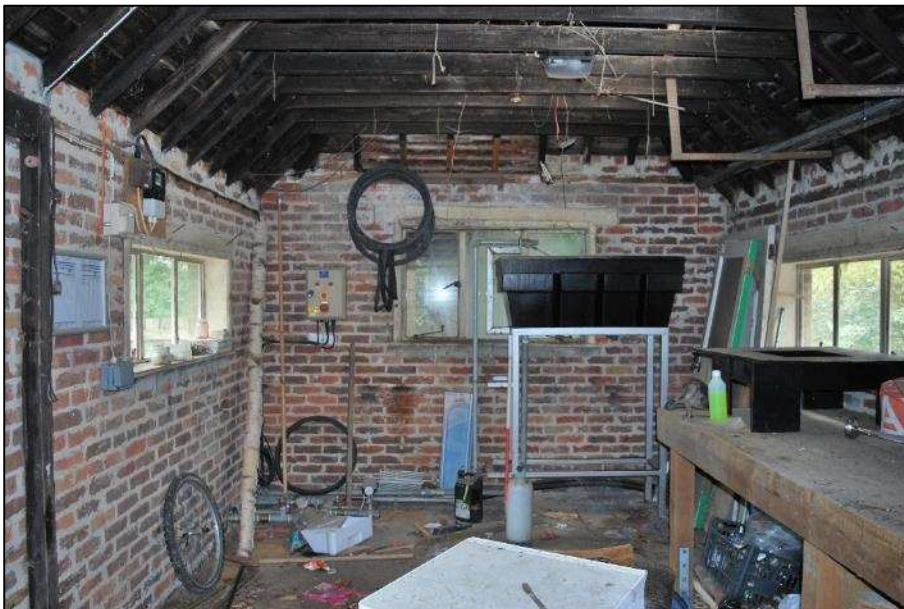
Plate 38 (Shot 343): Interior of the garage, looking northeast, 1m scale

- 6.34 Internally the garage has an open timber framed roof which has been mended at the north-eastern end. Pipework and a water tank are built in to this end of the garage as well (Plate 38). A workbench lines the south-eastern elevation and has been bolted to the floor.

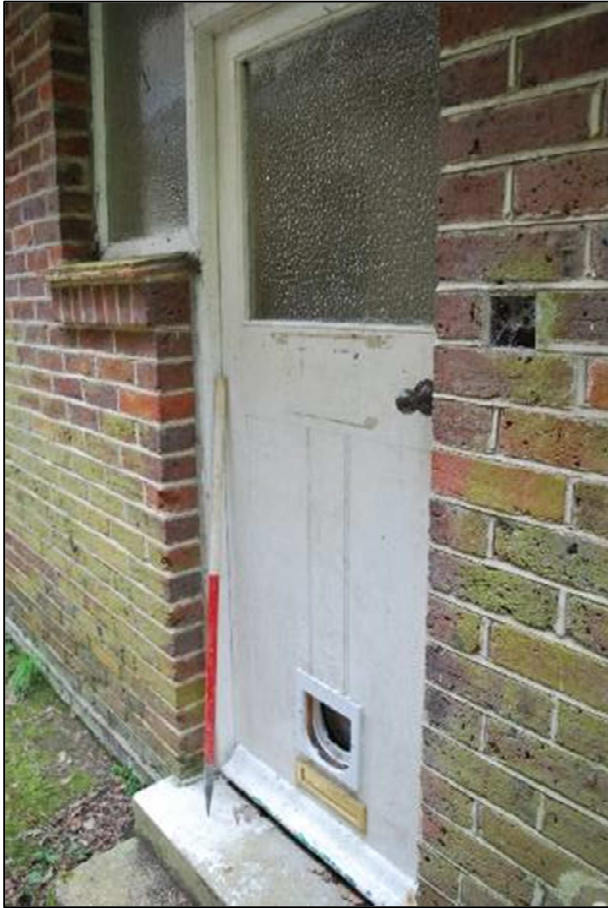
Plate 39 (Shot 365): Entrance to the bungalow, looking north, 1m scale

- 6.36 Entrance to the bungalow is from the southwest elevation through a white painted wooden door, with a transom window above and a single light window to the left (Plate 39). One other window occupies the elevation to the southeast of the doorway.

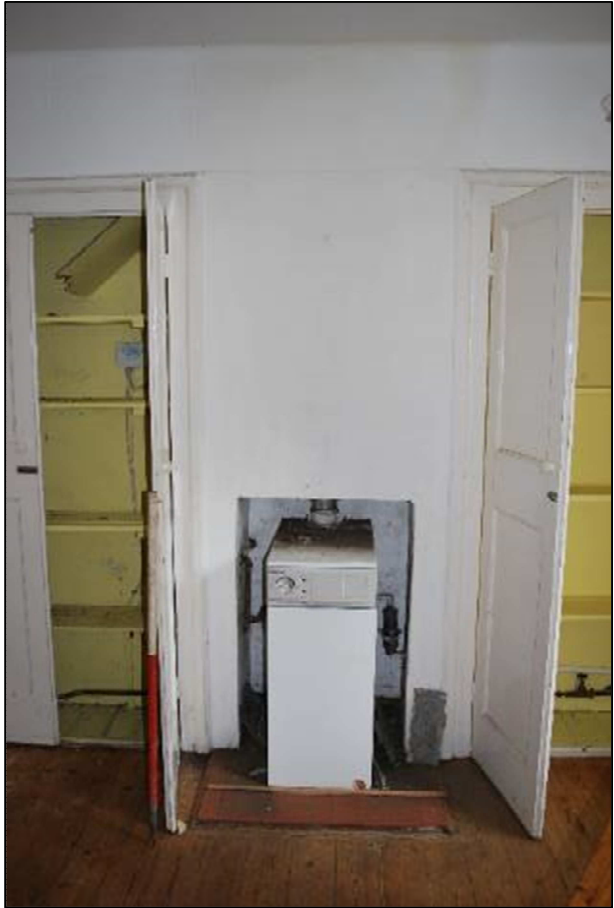
Plate 46 (Shot 407): Boiler housed in the back of the sitting rooms chimney breast, looking northeast, 1m scale
