ARCHAEOLOGICAL DESK-BASED ASSESSMENT AND EARTHWORK SURVEY:

LAND OFF CAISTOR ROAD, SWALLOW, WEST LINDSEY, LINCOLNSHIRE

By
Allen Archaeology Limited
Report Number AAL 2016145

October 2016

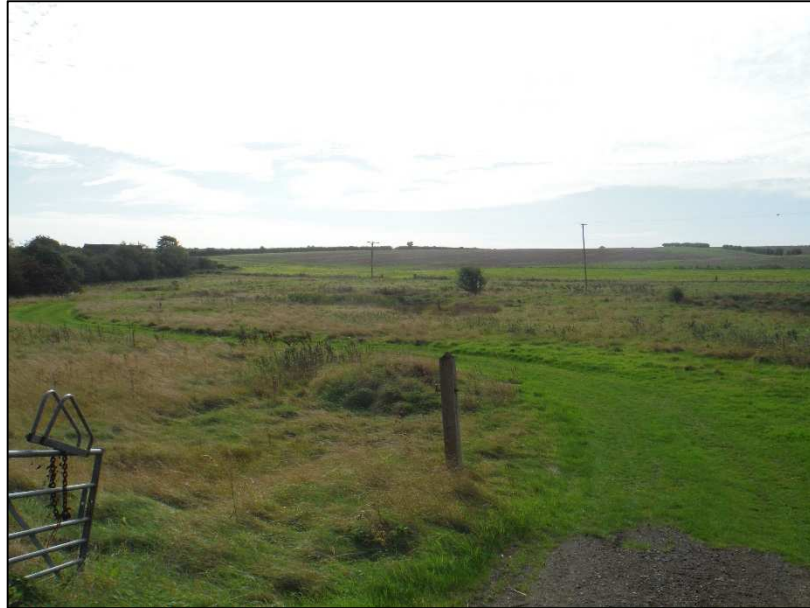
Plate 1: The development site from Caistor Road, looking south

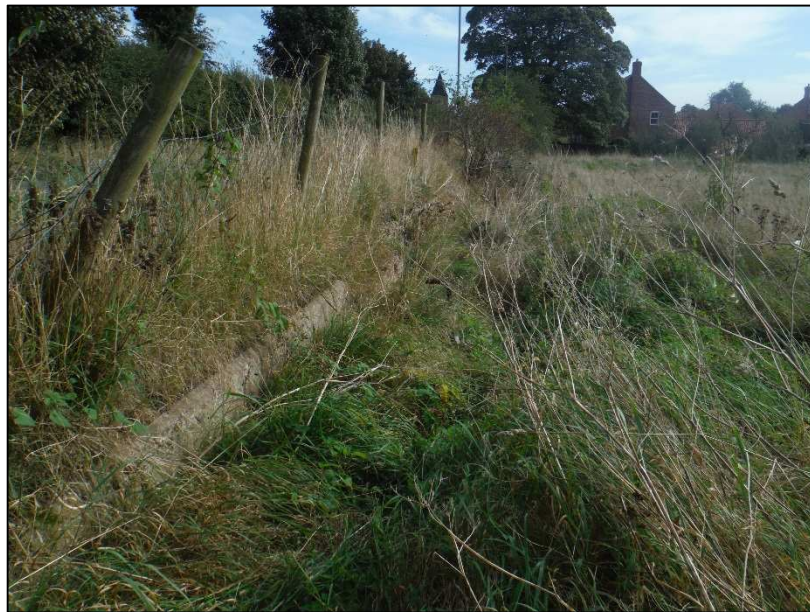
Plate 2: Hedge and boundary wall forming the site boundary to the north of the development site, looking east

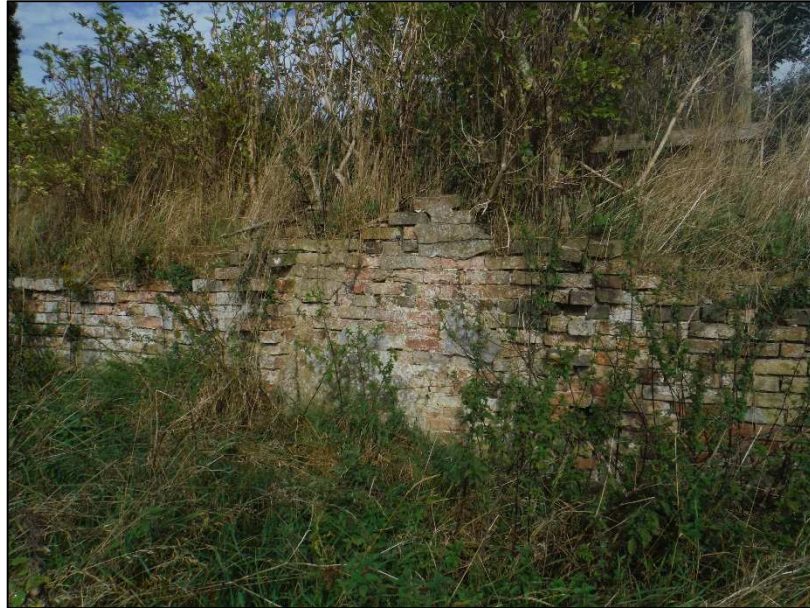
- 6.3 There are no standing structures on the site, however, sections of the boundary wall appear to include remnants of brickwork associated with the former Glebe Farm buildings; particularly noticeable was a section where the stubs of internal walls could be seen extending from the wall (Plate 3), and an alcove (Plate 4). These can be observed as hactures on Figure 7.

Plate 3: Section of boundary wall showing where internal walls were tied-in, looking northwest

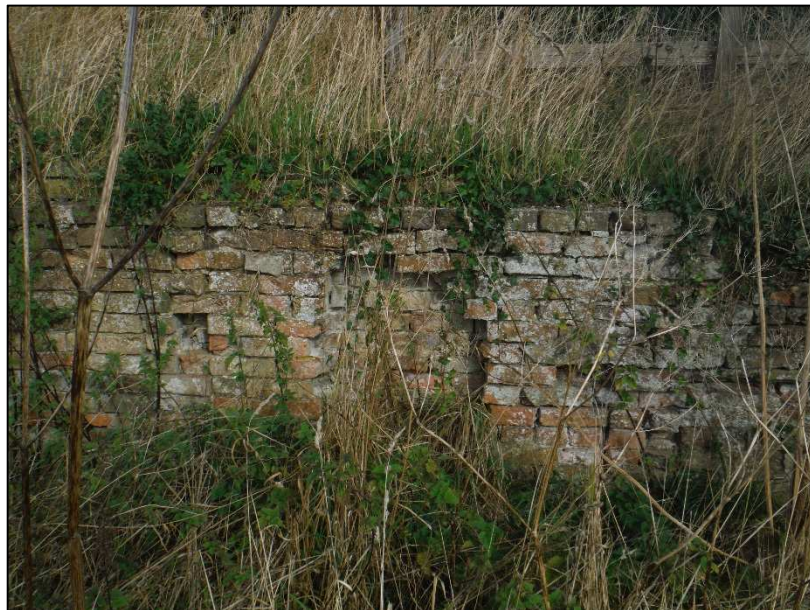
Plate 4: An alcove in the boundary wall, looking north

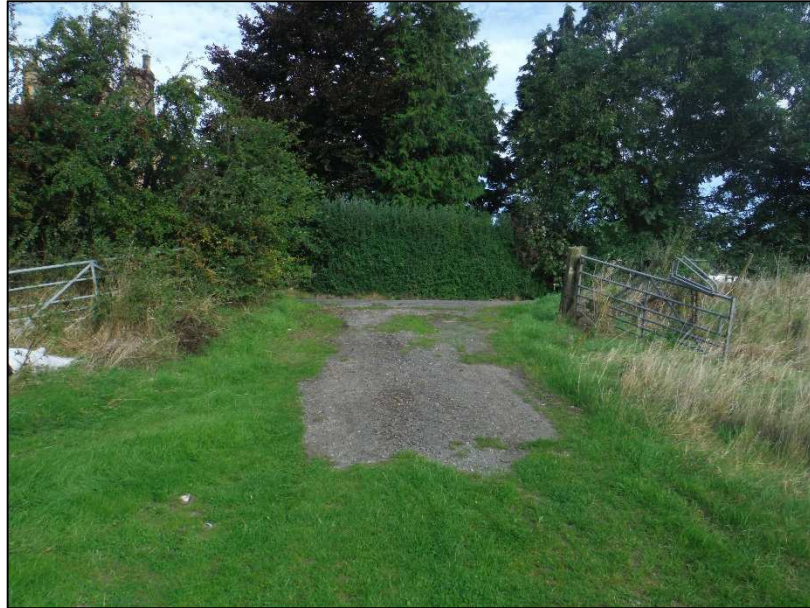
- 6.4 The field was open, but overgrown, making it difficult to observe small changes in topography, but there was a general slope down to the south from the road with a steeper gradient to the north adjacent to the road frontage (Plate 5).

Plate 5: Slope up to Caistor Road, looking north

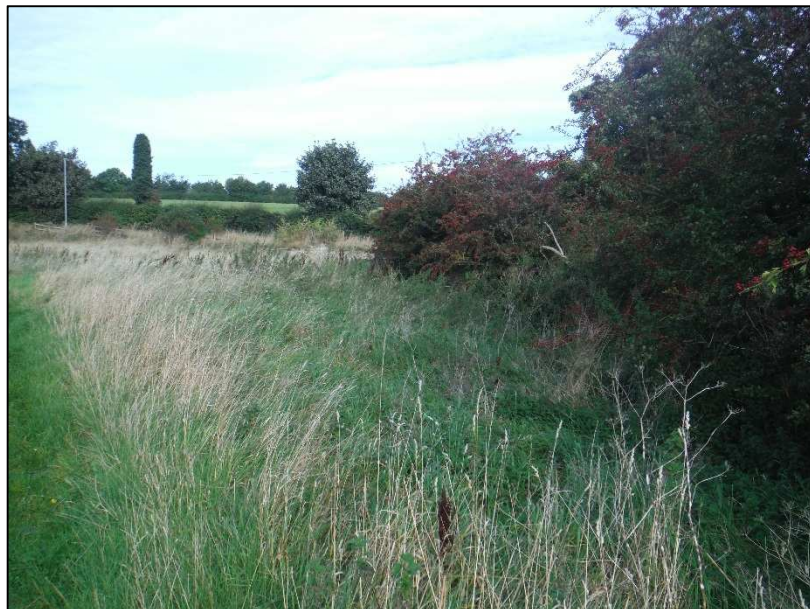
Plate 6: Ditch aligned with old field boundary, looking north

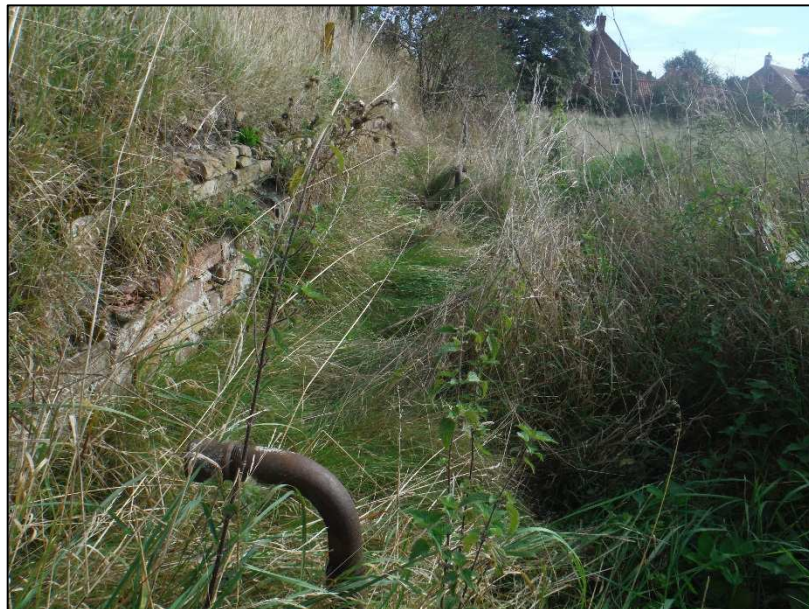
- 6.8 Feature [5] is a slight east – west aligned south facing slope, with a southwards return at its west end, and also appears to relate to a former building. Directly to the north of this [6] is a very clear, raised linear bank running east - west (Plate 7). It is located in the general vicinity of the demolished buildings in the main U-shaped range of former buildings, with metal pipework protruding from the ground between the bank and the boundary wall suggesting this may be an overgrown pile of demolition material associated with the former buildings (Plate 7, Plate 8).

Plate 8: Pipework in-situ between the bank and boundary wall, looking east

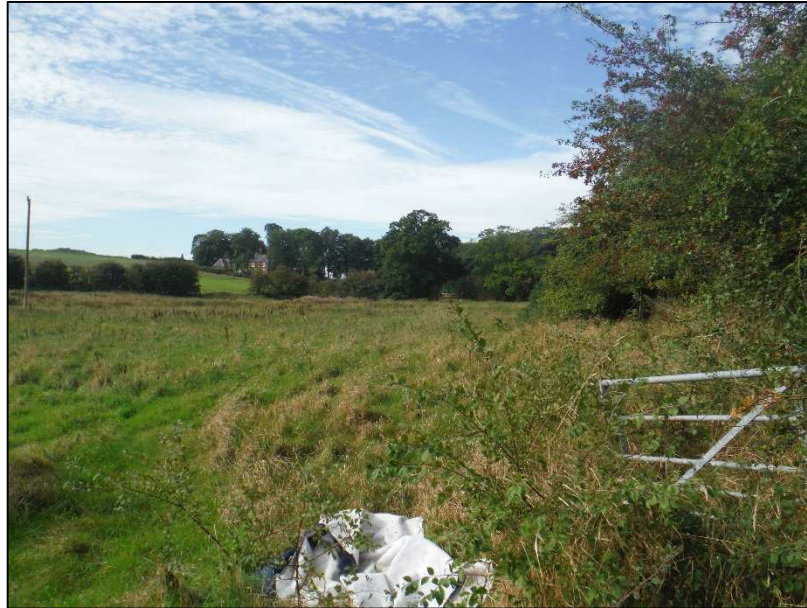
- 6.9 There were a further three circular or semi-circular features [7], [8] and [9] recorded as part of the survey. Features [7] and [8] were located in the vicinity of Glebe Farm and are likely to be related to the demolition of the buildings. Feature [9], located to the west of the entrance to the site, was a very distinct mound near the hedge (Plate 9). [9] appears on the RCHM(E) survey

(Everson *et al.* 1991) as more of an elongated mound, but appears to have slumped since this recording took place.

Plate 9: Mound [9] next to the hedge, looking west

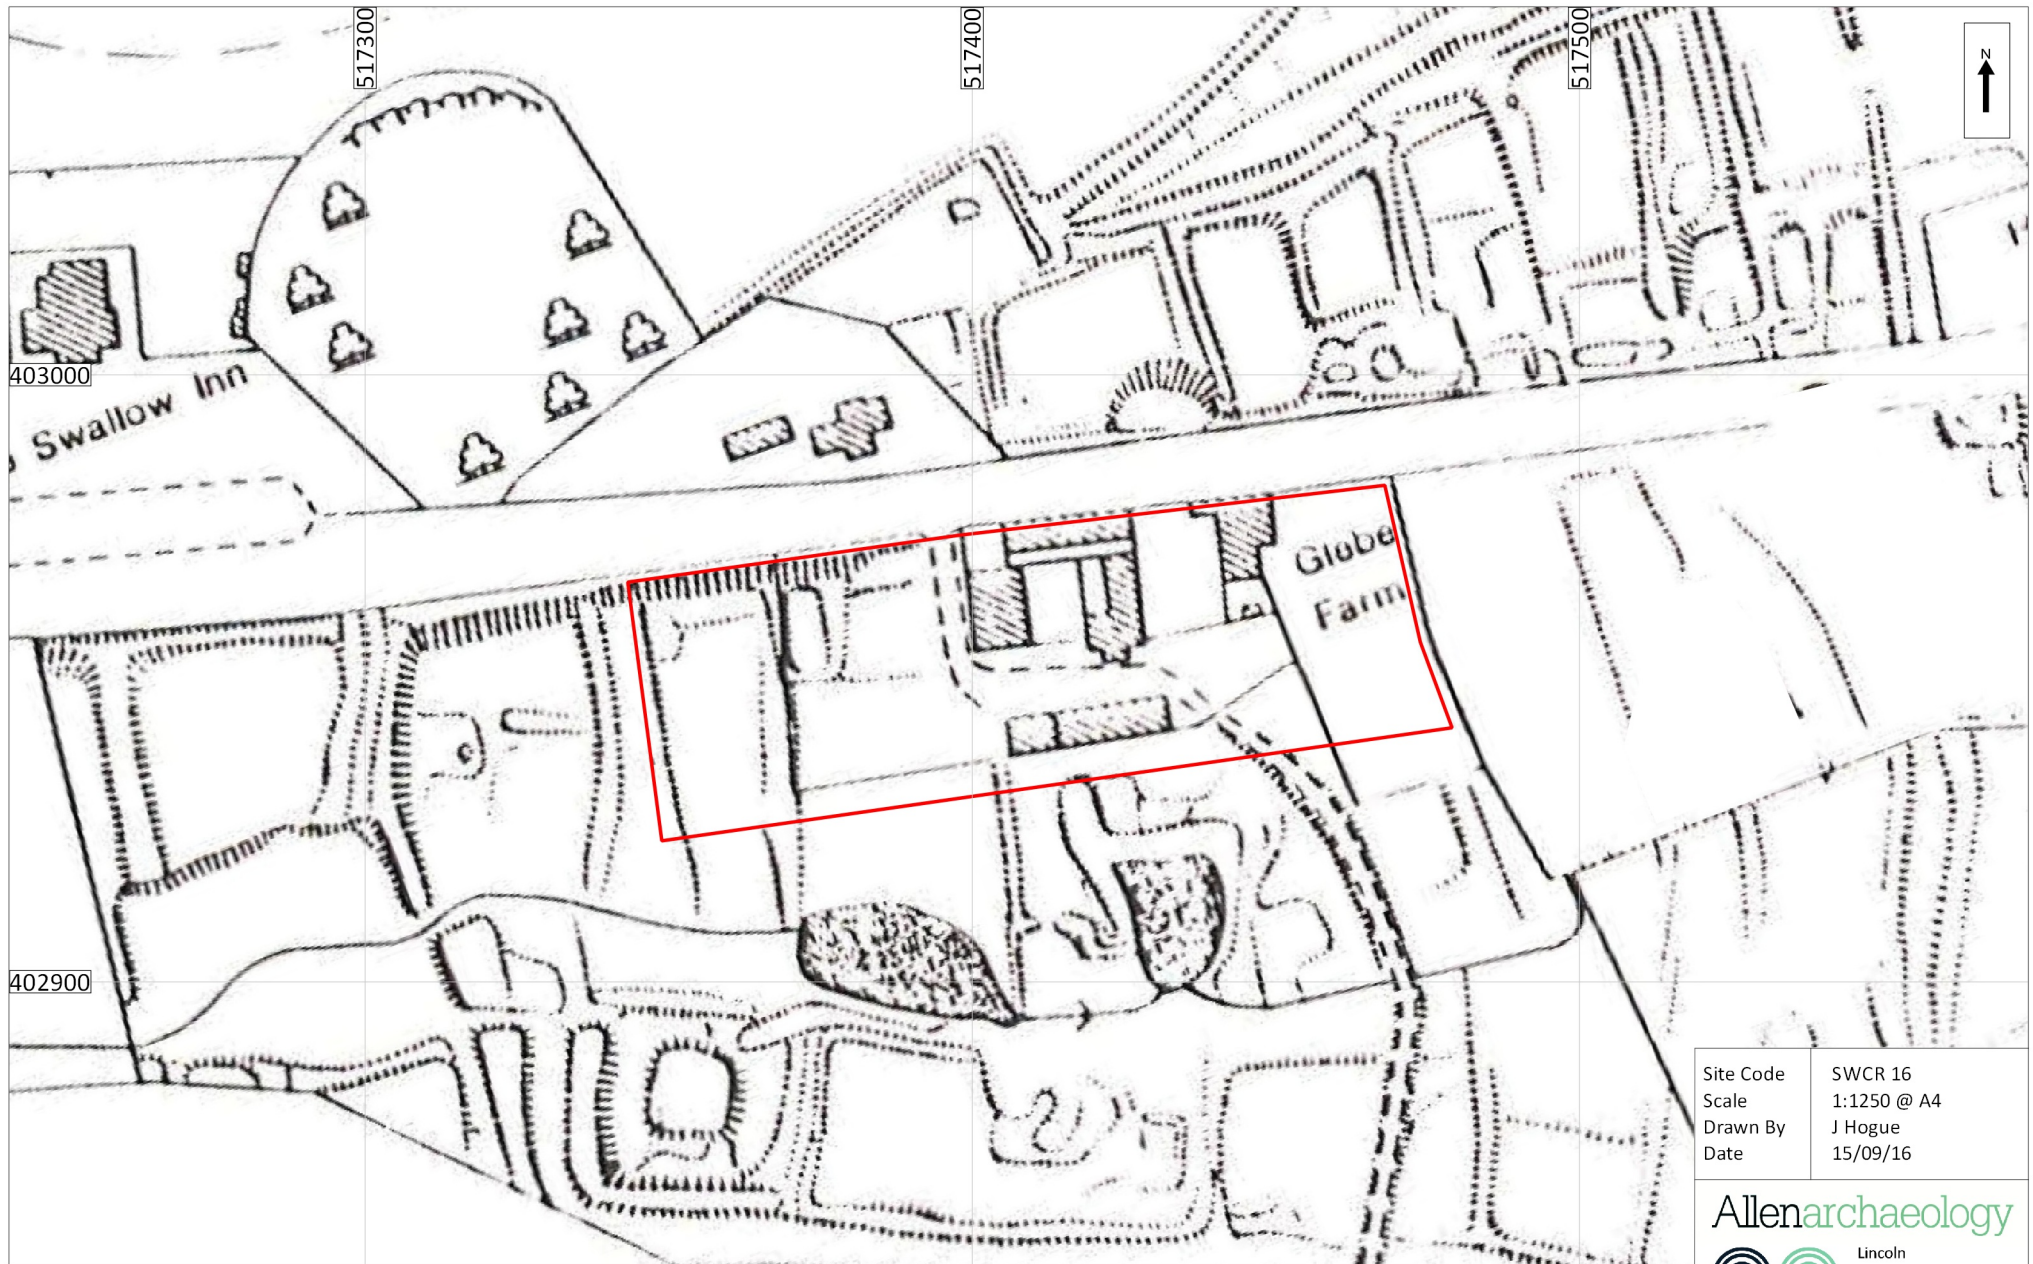
- 5.8 Glebe Farm (Site 16) is a farmstead which appears on the 1806 Swallow Enclosure map (Figure 4), and was demolished in the late 20th century. It was the subject of the earthwork survey detailed below and shown on Figure 3.

Figure 3: Extract of earthwork survey of Swallow village with site outlined in red (after Everson et al. 1991)

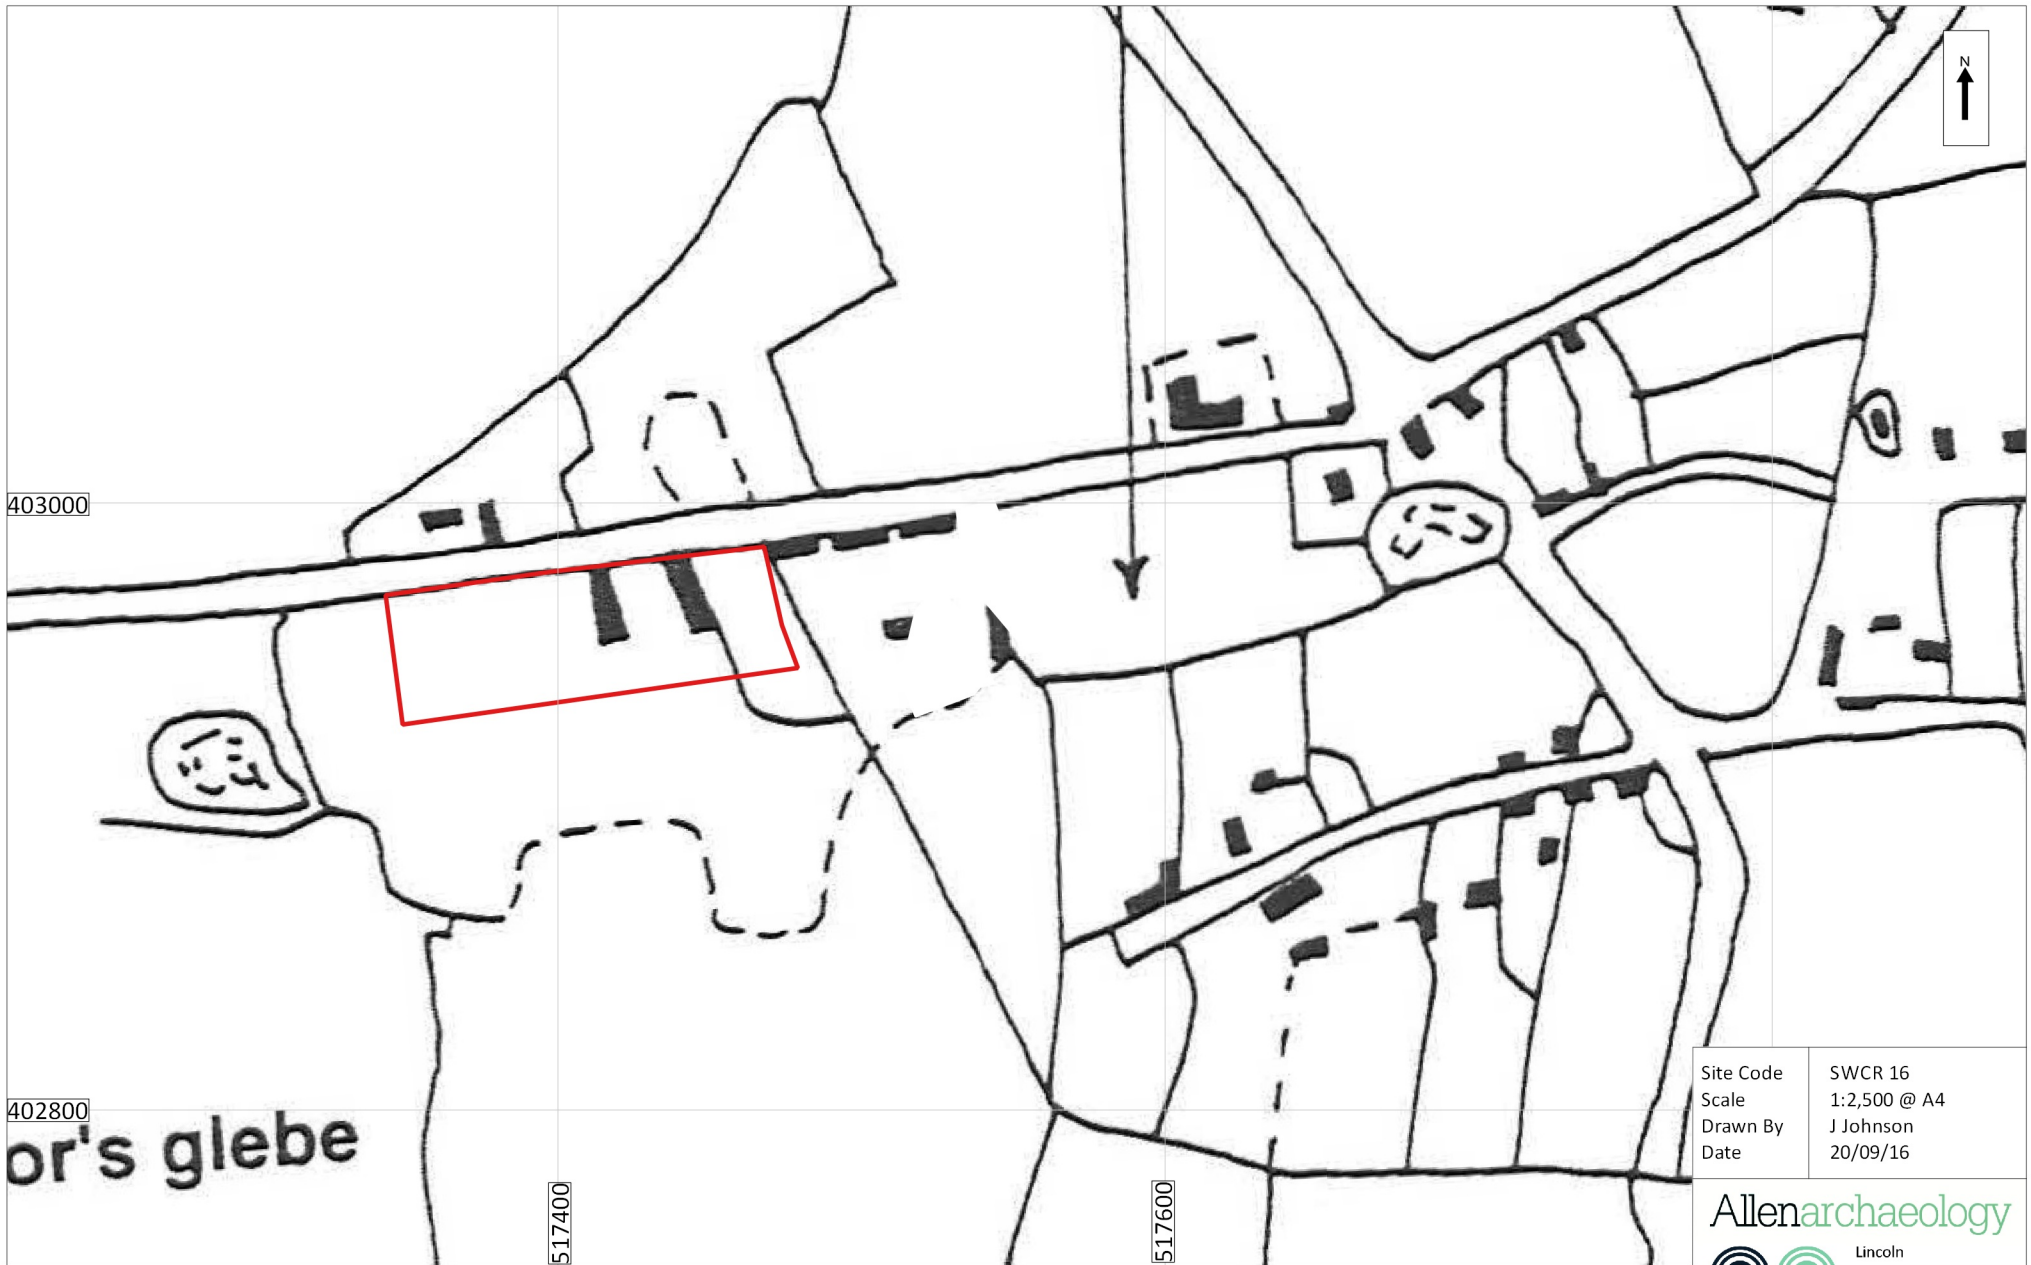
- 5.7 An early cartographic representation of the site is shown on the 1806 Swallow Enclosure map, indicating the presence of two large buildings within the site extending south from the road,

which are likely to be associated with the modern Glebe Farm. The site also encompasses open land to the west of these buildings, with a few dispersed buildings within further agricultural land immediately to the east (Figure 4). The surrounding area is primarily open fields, although there is small scale development to the east of the site, towards the village centre.

Figure 4: Extract of 1866 Swallow Enclosure map with site outlined in red

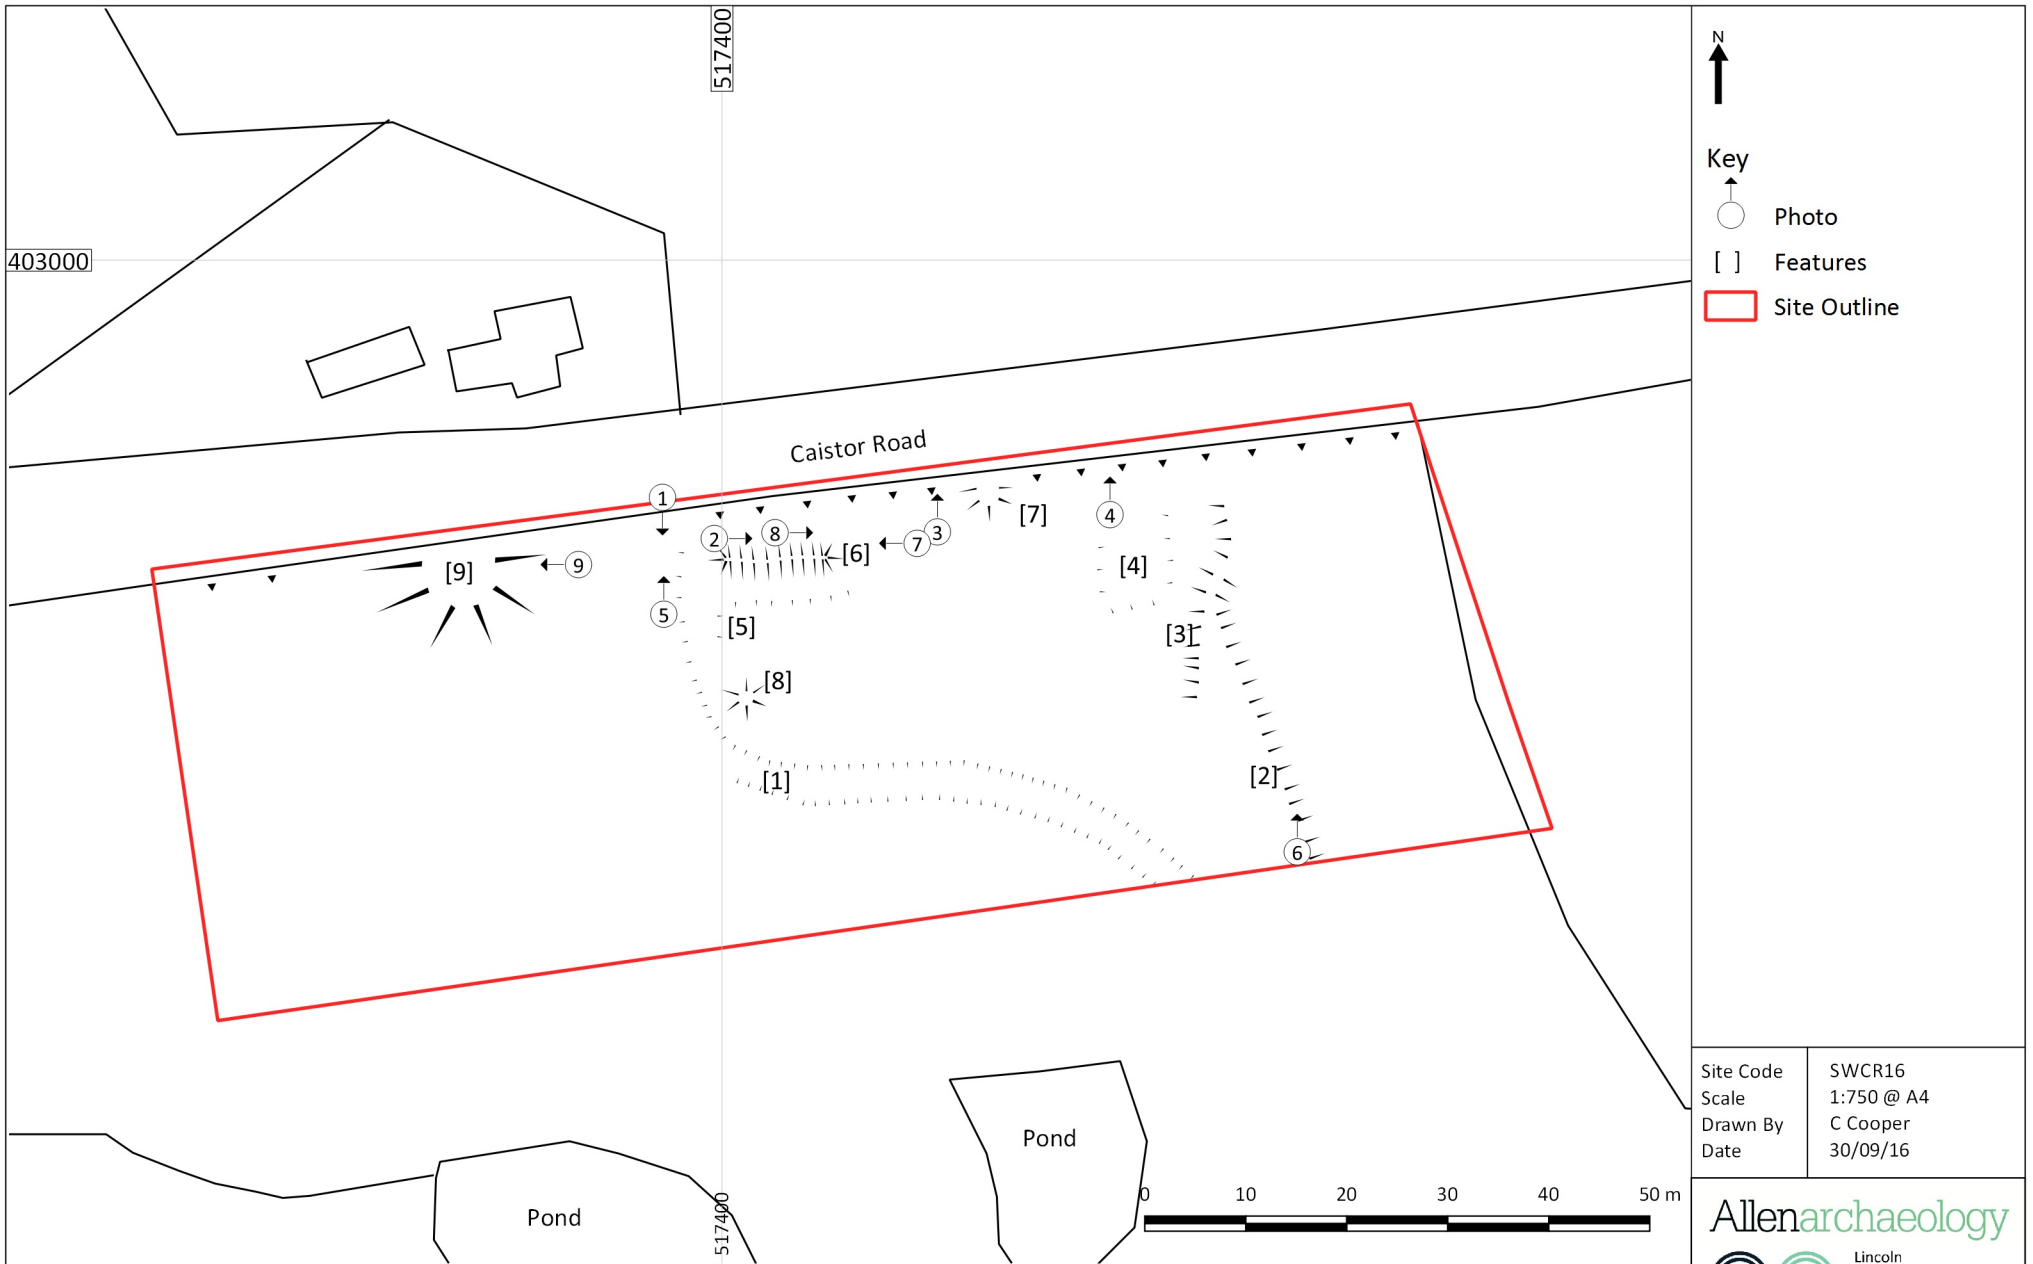
- 4.4 A full photographic record was made of the site, capturing images of both the earthworks themselves and of ground conditions at the time of the earthwork survey. The location of all photographic views was recorded and is shown on Figure 7.

Figure 7: Plan of the site showing earthworks [1] - [9], with location and direction of site visit photographs
