ARCHAEOLOGICAL WATCHING BRIEF REPORT:

SNETTERTON RENEWABLES ENERGY PLANT EFFLUENT PIPELINE, NORFOLK

By Allen Archaeology Limited Report Number AAL 2017026

March 2017

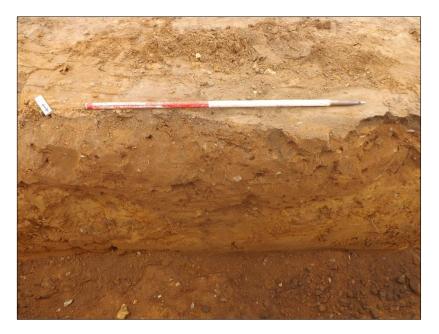
Plate 1: Northeast facing section of ditch [103]

- 6.5 One ditch [103] was recorded in Field 1 to the northwest of the biomass plant. This feature was linear in plan, aligned northeast-southwest, with gradually sloping sides and a concave base. It extended to 2.40m in width and was 0.85m deep (Plate 1). It contained a single undated silting deposit, 104.

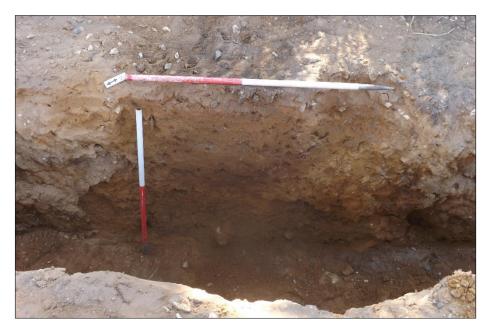
Plate 2: West facing section of ditch [206]

- 6.6 Another ditch was recorded in Field 2. Ditch [206] was east west oriented, with steep sides and a concave base, and contained two fills, 207 and 208, comprising a primary fill of dark greyish brown sand sealed by a light yellowish brown silty sand. Both fills were devoid of finds.
- 6.7 The only finds recovered were a fragment of pottery and a fragment of roof tile from topsoil 200, both of 19th century date.

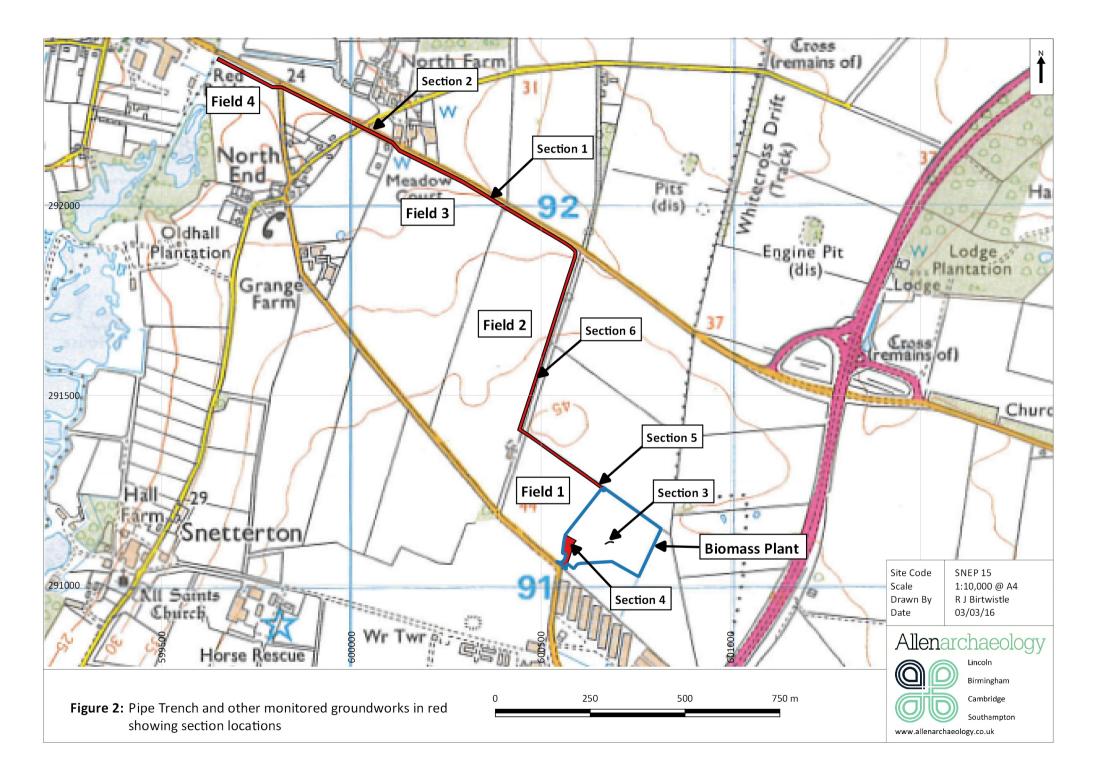
Figure 1: Site location outlined in red	11
Figure 2: Pipe trench and other monitored groundworks in red, showing section locations	12
Figure 3: Selected sections, located on Figure 2	13
Figure 4: Selected sections, located on Figure 2	14

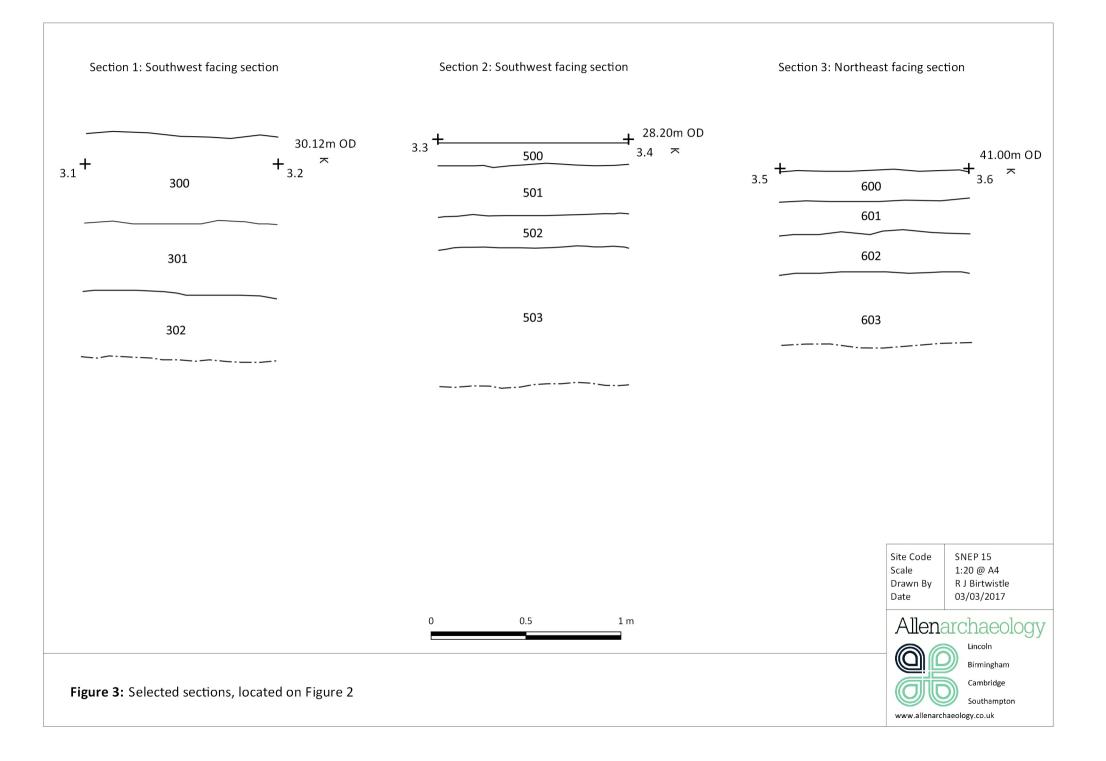
- 6.1 The stratigraphic sequence along the pipeline route was broadly consistent. The natural geology differed slightly across the area, but was predominantly recorded as firm, dark orange sand with frequent flint nodules. Similarly the subsoil, where this was visible, comprised loose, light brown, silty sand with occasional flint inclusions and was at least 0.30m thick. Lastly the topsoil was composed of loose, dark grey, silty sand with moderate flint and sub angular stones and with an average thickness of 0.40m (Figure 3.1).
