## Summary

- An archaeological watching brief was undertaken during the construction of new extensions at The Old White Farmhouse, Green Lane, Westgate, Belton, North Lincolnshire.
- The site lies close to the site of five burials of 15<sup>th</sup> century date, which are believed to be associated with an otherwise unknown chapel.
- The watching brief failed to identify any significant archaeological deposits, other than the foundations of the adjacent farmhouse and the remnants of a brick boundary wall, also associated with the farmhouse.

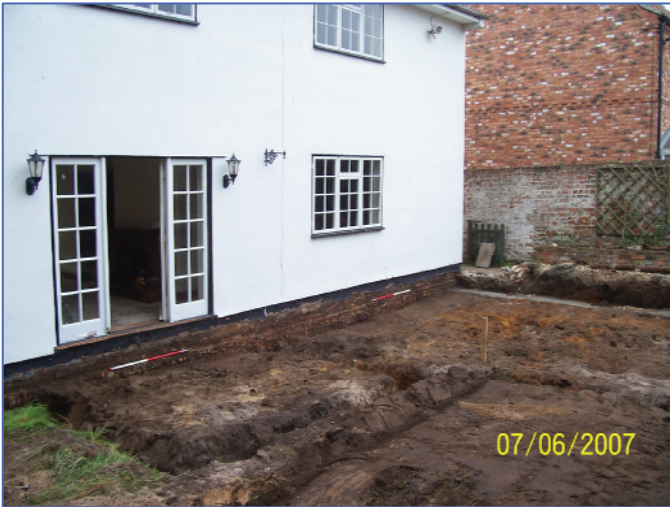
**Plate 1:** Foundation trenches excavated to the south of the existing farm house. Looking north-east

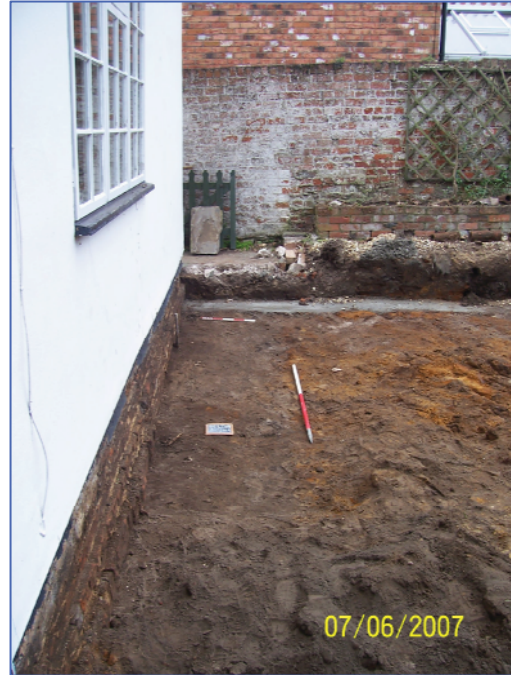
- 6.2 Along the south side of the existing farmhouse, excavations exposed a steep sided construction cut for the farmhouse wall, 102, which was 0.8m wide. The depth of the cut was unknown as it extended beyond the limit of excavation. The construction cut was backfilled with a deposit of dark brown silty sand, 105. The trench also exposed the footings of the existing farmhouse wall, 103, which were 0.7m deep below the existing ground surface, and comprised seven courses of brickwork and a single course of tile, bonded with a fine yellow/brown mortar. No dating evidence was recovered from the foundation trench.

**Plate 2:** Foundation trench [102] exposed in plan. Looking east-north-east.

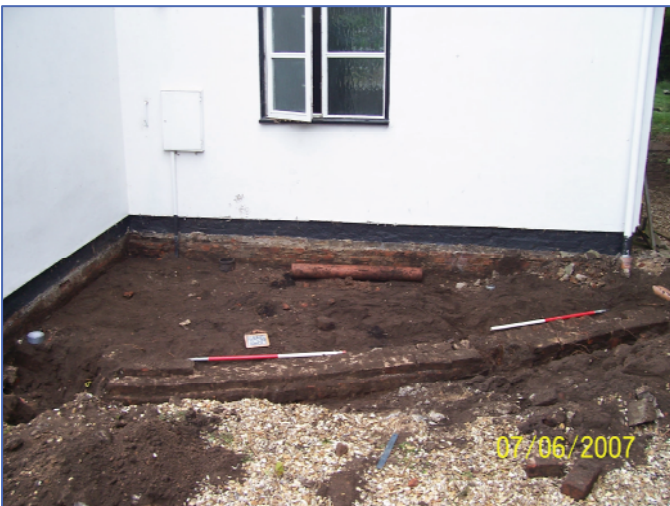
- 6.3 On the north side of the existing building, the groundworks exposed the foundation courses of a former brick boundary wall that broadly followed the line of Green Lane. At its east end it was tied into the farmhouse wall, and was constructed of the same brick type, suggesting they are contemporary.

**Plate 3:** Former boundary wall exposed during groundworks on the north side of the existing farm house. Looking south-south-east.

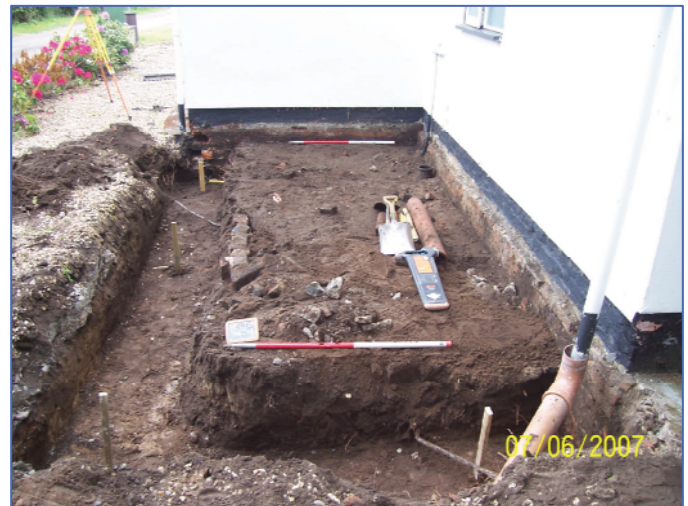
**Plate 4:** Foundation trenches excavated to the north of the existing farm house after removal of the brick boundary wall. Looking east-north-east.
