**HISTORIC BUILDING SURVEY REPORT:  
DUDFIELD NURSERIES, TAVERN LANE, SHOTTERY, WARWICKSHIRE**

Planning Reference: 11/02803  
NGR: SP 18645 64813  
AAL Site Code: SHDN17  
OASIS Reference Number: allenarc1-281454

Report prepared for Grevayne Properties Limited

By  
Allen Archaeology Limited  
Report Number AAL2017056

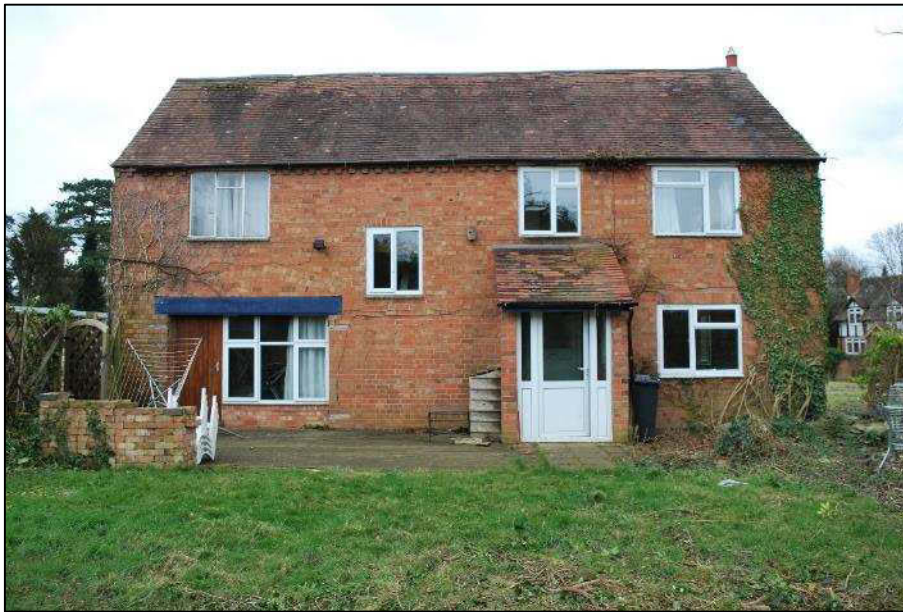
- 6.2 The surveyed building is a two storey brick house, built in Flemish Garden Wall bond, irregularly patterned between red and cream, creating an uneven appearance to the façade. There is a course of black engineering bricks at the base of the wall, no doubt added as a damp proof measure. The roof is of plain ceramic tiles and is a simple double pitched gable roof, with dentil course below the eaves (Plate 1).

- 6.5 The final window in the elevation, sits between ground and first floor level, indicating the location of the staircase (Plate 1).
- 6.6 There is only one chimney on the building, the chimney breast for which projects out from the southeast elevation and is topped with a modern ceramic pot. There were two modern uPVC windows to the east of the chimney one on the ground floor and one at first floor level (Plate 6). The course of engineering bricks runs behind the chimney stack, suggesting the stack is a later addition.

*Plate 1 (Shot 57): Southwest elevation, looking east-northeast (1m scale)*

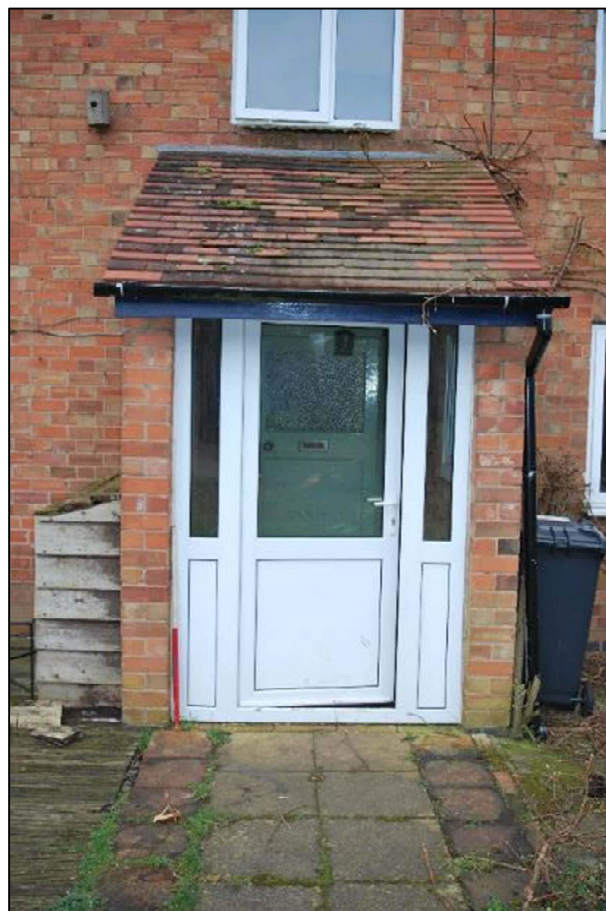
- 6.3 There are two entrances to the building, both on the southwest elevation (Plate 1). Slightly to the south of the centre of the elevation a brick lean-to porch projects from the elevation. It is roofed in the same plain tiles as the main building, but the better condition of this and the brickwork, indicate it is a more recent addition. The door in this porch is a modern uPVC door with uPVC surround and narrow side lights (Plate 2). The second entrance to the building is located towards the north end of the southwest elevation. Here a wooden door has been inserted adjacent to a modern uPVC casement window. A heavy blue lintel runs across both the door and window and sits below a segmental arch suggesting this may have formed a single large opening (Plate 3). The door and window sit within a recessed opening, on either side of which are two stone blocks with steel pintles, suggesting the opening originally had a set of large double doors.

*Plate 2 (Shot 56): Porch projecting from southwest elevation, looking east-northeast (1m scale)*

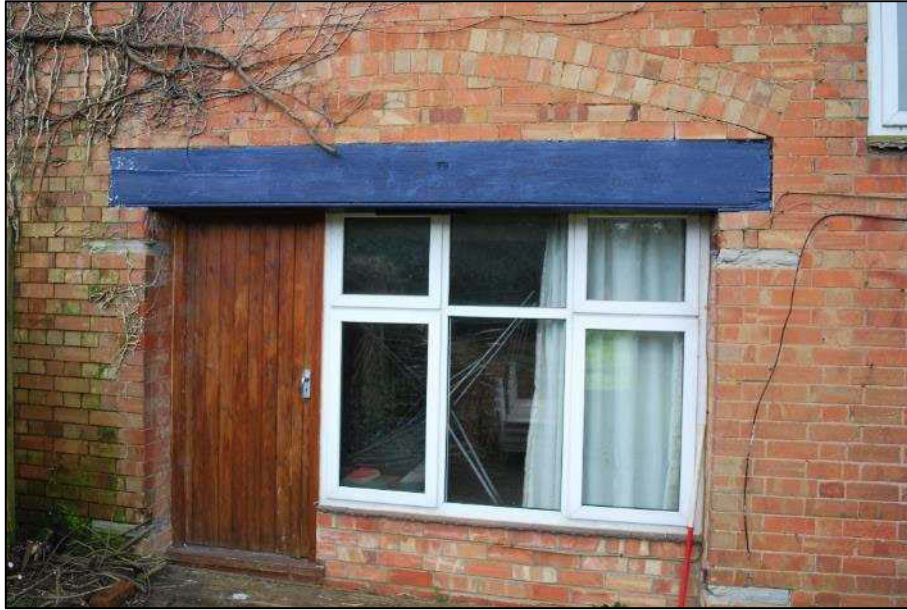
*Plate 3 (Shot 60): Second doorway and window inserted into previous opening, looking northeast (1m scale)*

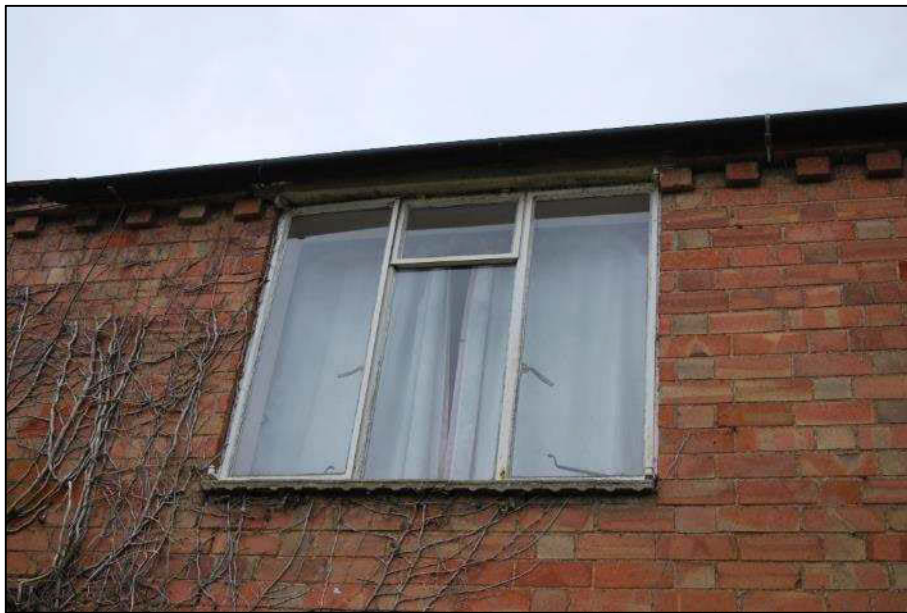
- 6.4 Above this door and window is a single glazed casement window with thin wooden glazing bars (Plate 4), which may be original or at the very least, rather older than the remaining windows in this elevation, all of which are modern uPVC double glazed windows. There are two further windows at first floor level, one directly above the porch and one to the south of this, with an identical window directly below it with a soldier arch above (Plate 5).

*Plate 4 (Shot 63): Window above garage door, looking northeast*

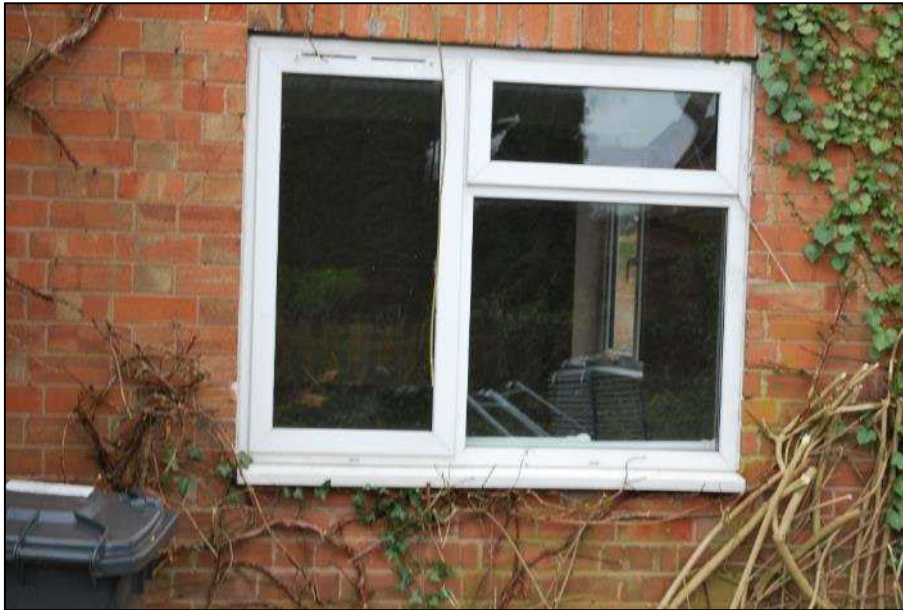
*Plate 5 (Shot 67): Ground floor window on southwest elevation, looking east-northeast*

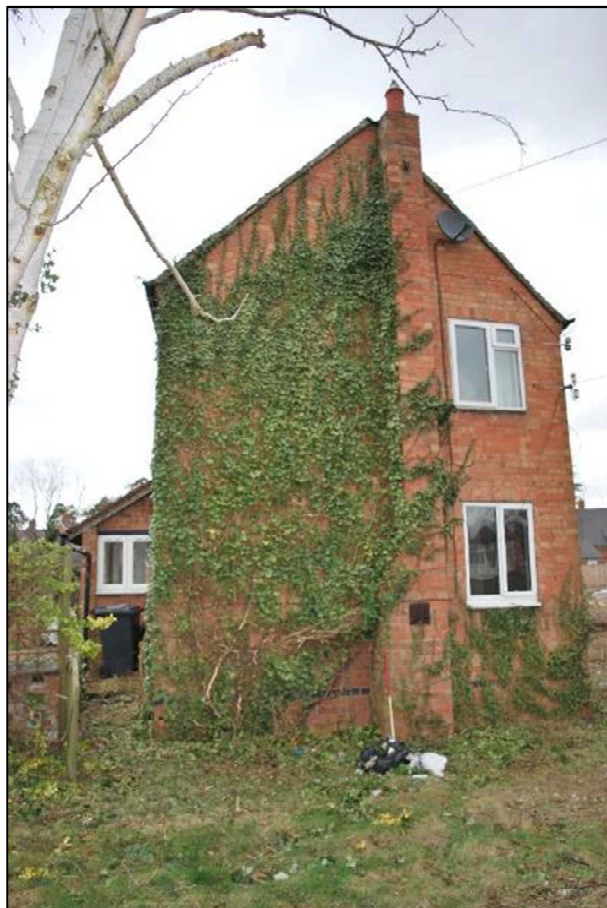
*Plate 6 (Shot 69): Southeast elevation, looking north (1m scale)*

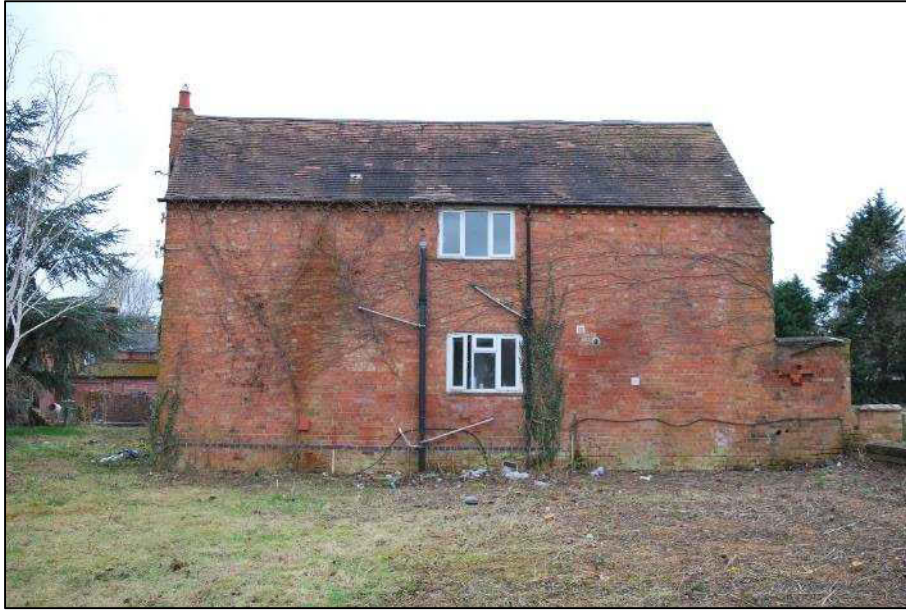
- 6.7 There are two windows on the north-eastern elevation, both located towards the centre of the building, one at ground floor and one at first floor level. They are both modern double glazed uPVC windows with the ground floor window being offset slightly to the north from the first floor window. There is a small area of brick repair to the south of the ground floor window which may indicate the location of a small blocked window. The course of engineering bricks continues along this elevation, but stops short just to the north of the windows (Plate 7). This corresponds with the position of the large opening on the opposing elevation, but there is no evidence for a corresponding opening on this elevation.

*Plate 7 (Shot 73): Northeast elevation, looking west-southwest (1m scale)*

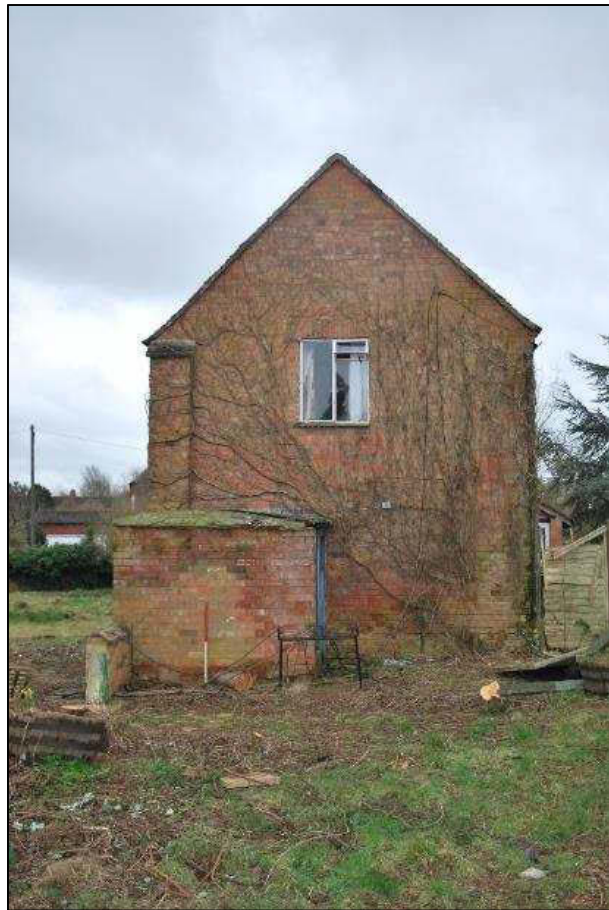
- 6.8 The northern gable has a single window at first floor level and is a single glazed window with thin wooden glazing bars, below a soldier arch lintel. A segmental arch is also visible above this lintel, suggesting alterations to the window opening. A single storey brick outbuilding abuts the eastern part of the elevation, with a door on its west elevation and a short stub of a low brick boundary continuing to the north (Plate 8). The outbuilding partially conceals a brick buttress on this corner of the building.

*Plate 8 (Shot 76): Northwest elevation, looking south-southeast (1m scale)*

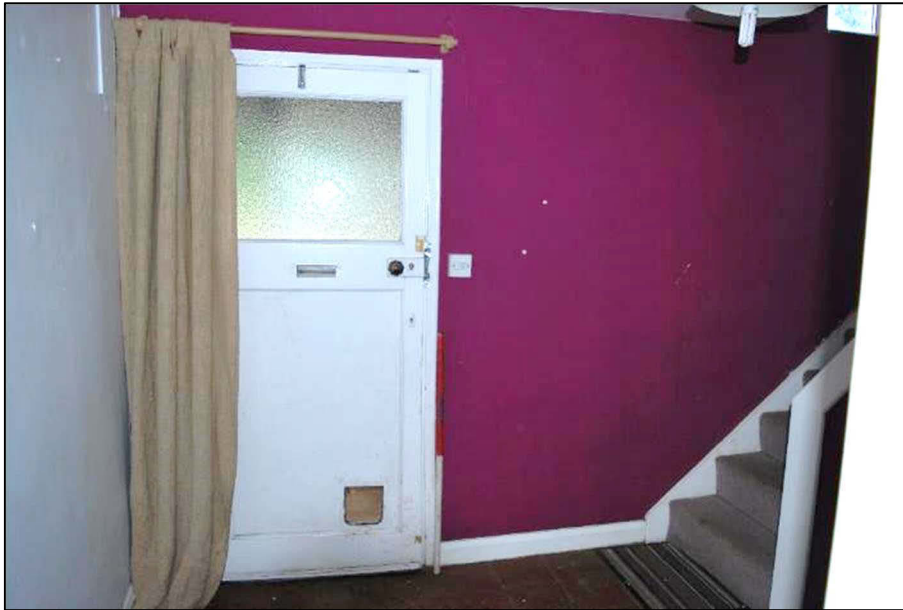
- 6.9 The projecting porch on the southwest elevation conceals an external door (Plate 9), further indicating the later date of the porch. It opens into a hallway with a staircase to the left of the entrance. It is a 90° winder staircase, and the space below the stairs can be accessed from slightly further to the north (Plate 10).

*Plate 9 (Shot 33): Door leading out to the porch, looking west (1m scale)*

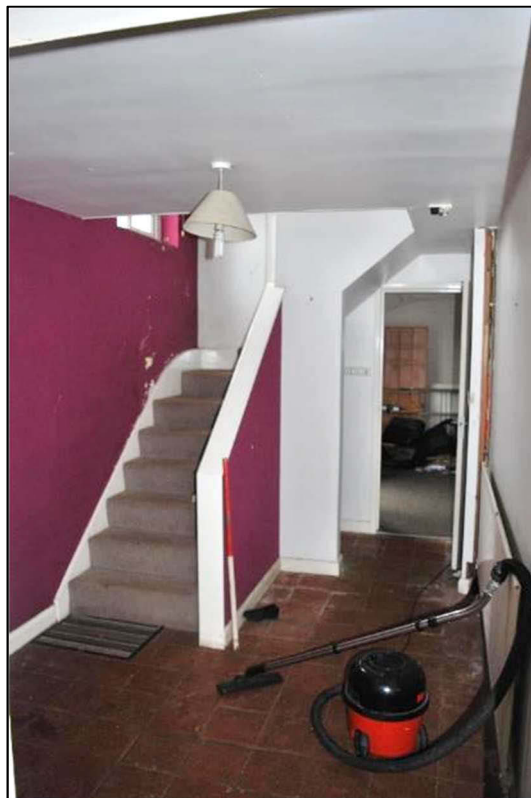
*Plate 10 (Shot 34): Staircase, looking north-northwest (1m scale)*

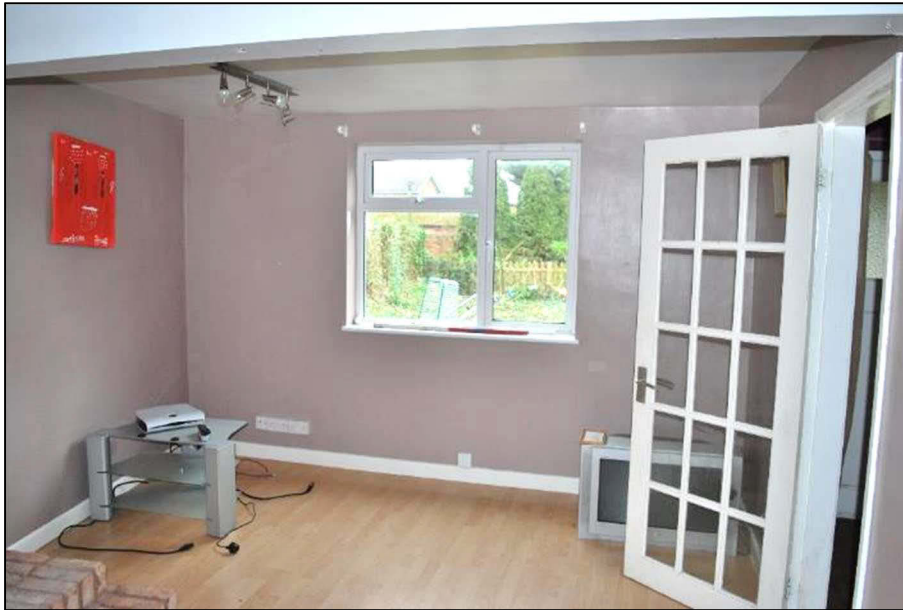
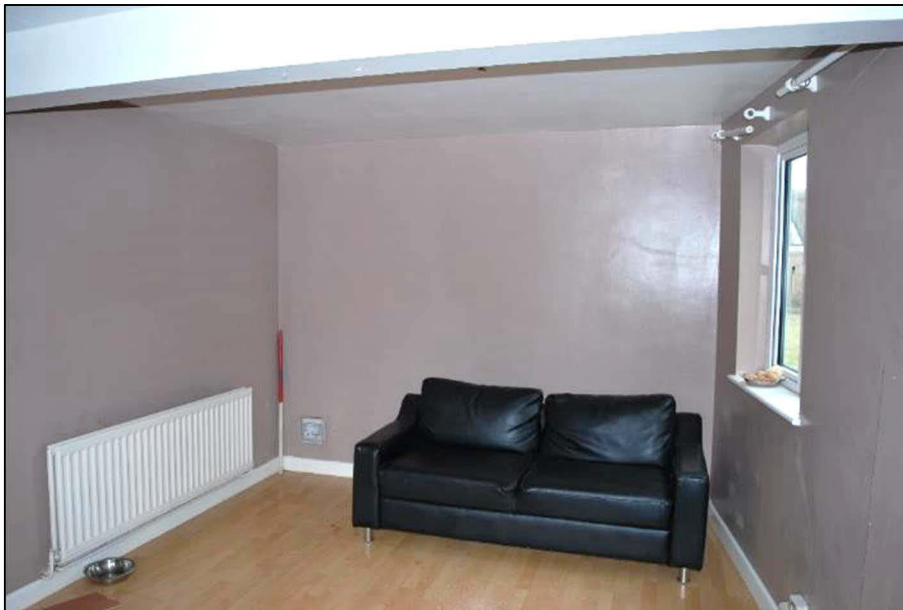
- 6.10 Three further doors open off the hallway. To the south a door provides an entrance to the living room. The room has modern décor with a laminate floor and an exposed lintel runs north – south (Plate 11 and Plate 12). On the south wall is a small brick plinth which is probably a modern addition to house a wood or coal burner (Plate 13).

*Plate 11 (Shot 49): Living room, looking west-southwest (1m scale)*

*Plate 12 (Shot 48): Living room, looking east-northeast (1m scale)*

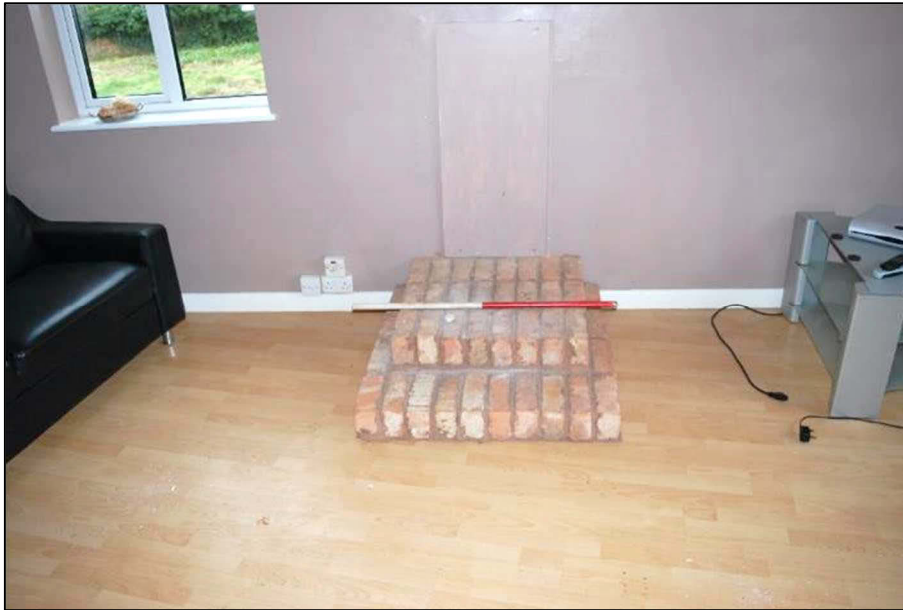
*Plate 13 (Shot 45): Brick plinth in living room, looking south-southeast (1m scale)*

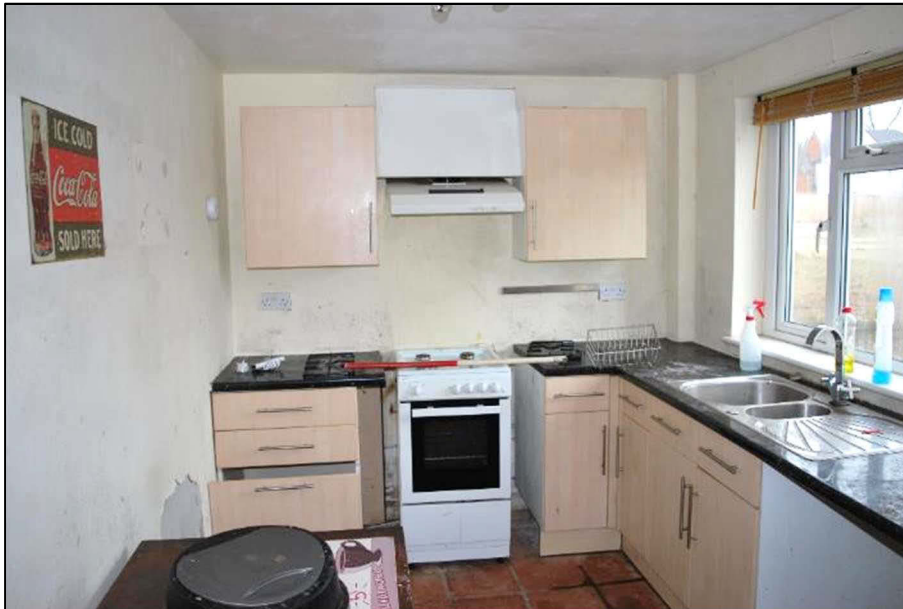
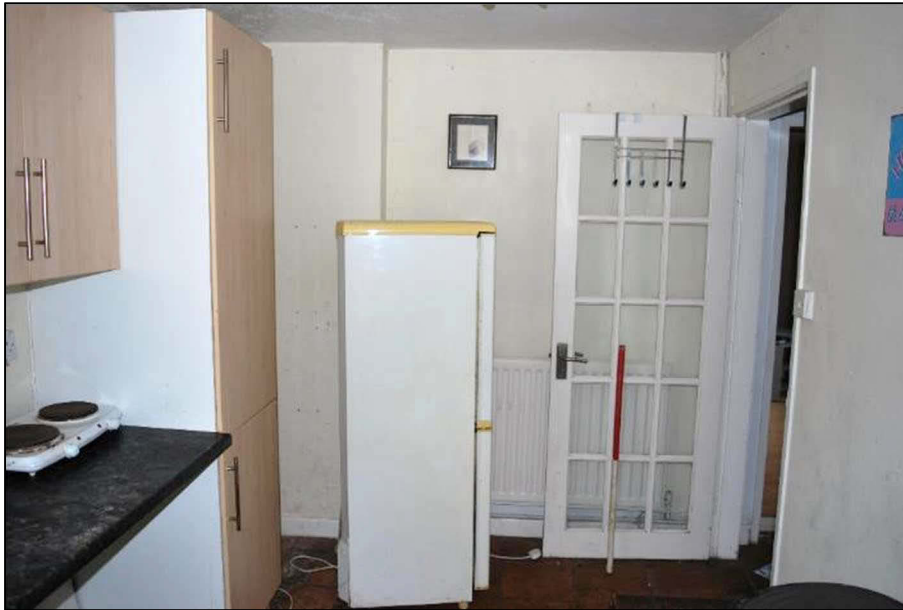
- 6.11 Directly opposite the porch a door leads from the hall into the kitchen. This is a long galley style kitchen which has modern fixtures and fittings (Plate 14 and Plate 15).

*Plate 14 (Shot 41): Kitchen, looking north-northwest (1m scale)*

*Plate 15 (Shot 43): Section cut out from southeast wall of kitchen, looking south-southeast (1m scale)*

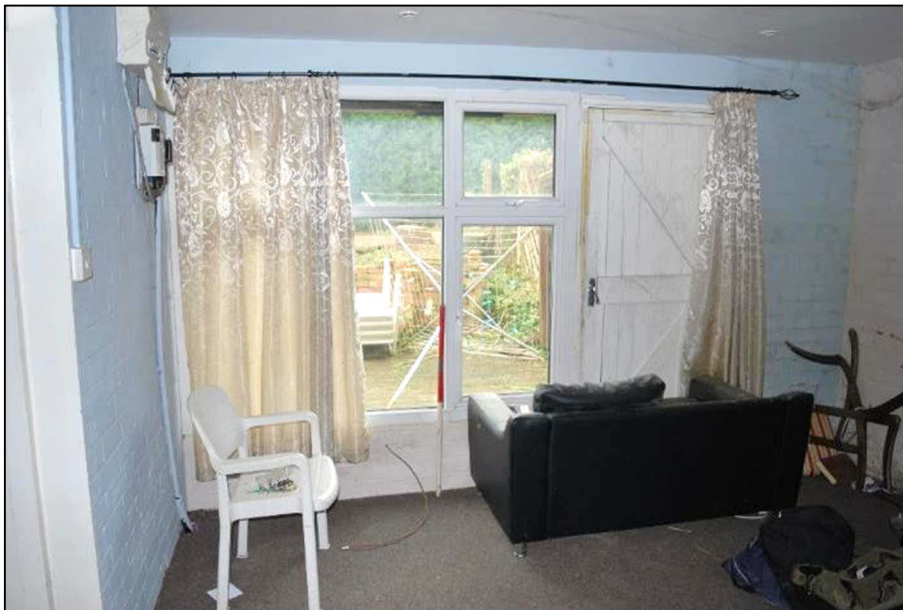
- 6.12 The final door leads into the northern part of the house, most recently in use as a bedroom (Bedroom 1) (Plate 16). This room again has modern fixtures and fittings and a boiler is located in the south-eastern corner of the room.

*Plate 16 (Shot 36): Bedroom 1, looking west (1m scale)*

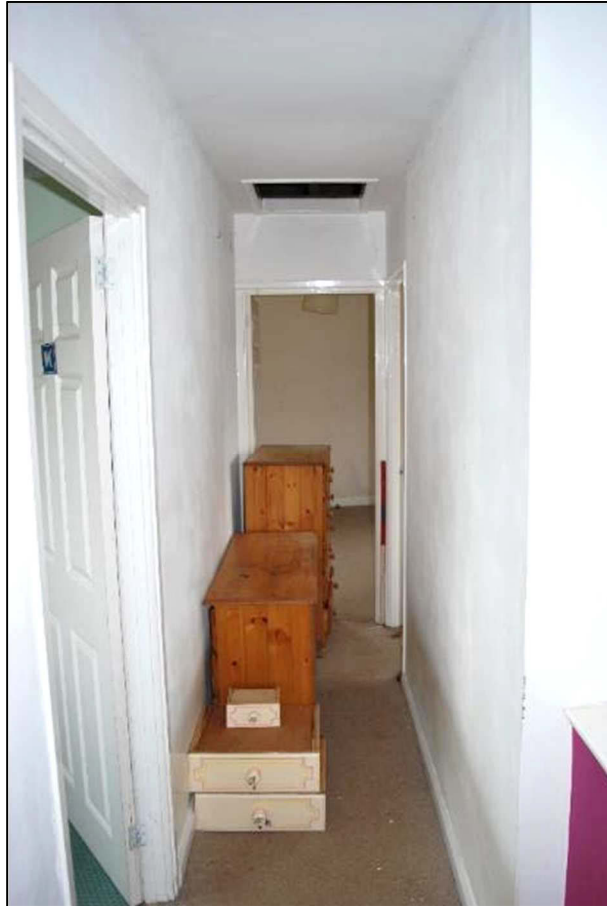
*Plate 17 (Shot 14): First floor landing, looking south-southeast (1m scale)*

- 6.13 Up the stairs a landing (Plate 17) provides access to three bedrooms and a bathroom. The bathroom is a long thin room, lit by a large window on the north-eastern wall. It is fitted with a modern bath and shower units and a built in cupboard (Plate 18).

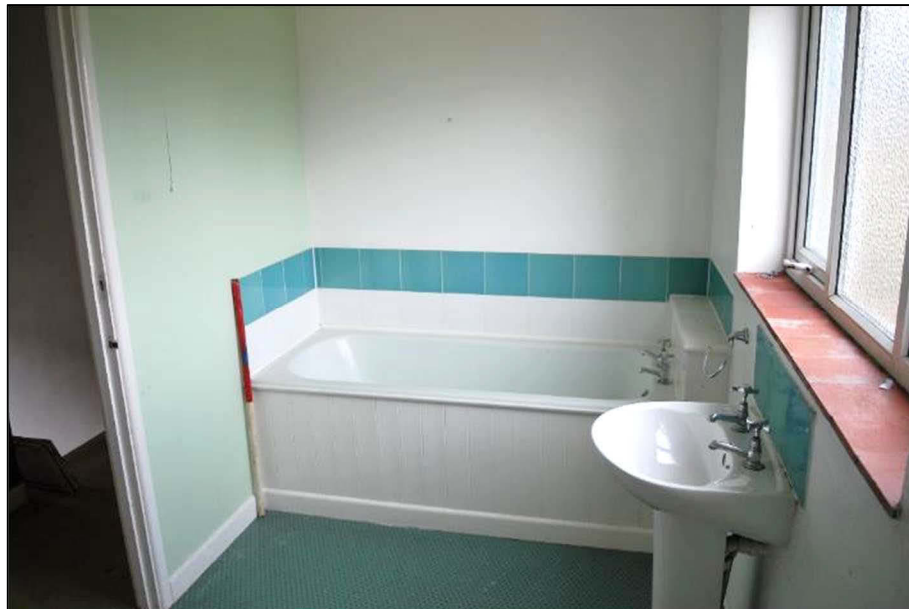
*Plate 18 (Shot 19): Bathroom, looking north-northwest (1m scale)*
