**HISTORIC BUILDING SURVEY REPORT:
LAND AT POTASH ROAD, MATCHING GREEN, ESSEX**

Planning Reference: EPF/2724/16
NGR: TL 54374 12013
AAL Site Code: MAPR 17
Museum Accession Number: pending
OASIS Reference Number: allenarc1-288499

Report prepared for RCT Construction Limited

By
Allen Archaeology Limited
Report Number AAL 2017093

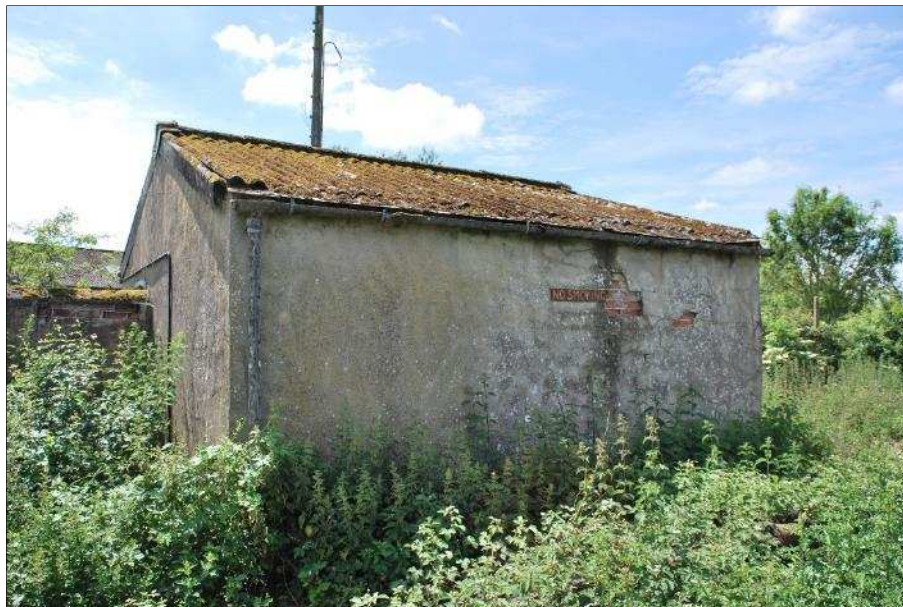
6.3 The central area of the site is occupied by a single-storey, red-brick, rendered building with a double-pitched, gabled roof of corrugated steel. A portion of the render is missing on the north elevation adjacent to a 'No Smoking' banner, exposing an area of stretcher bonded red-brick (Plate 1).

Plate 1 (Shot 27): North elevation of pumping station, looking southwest

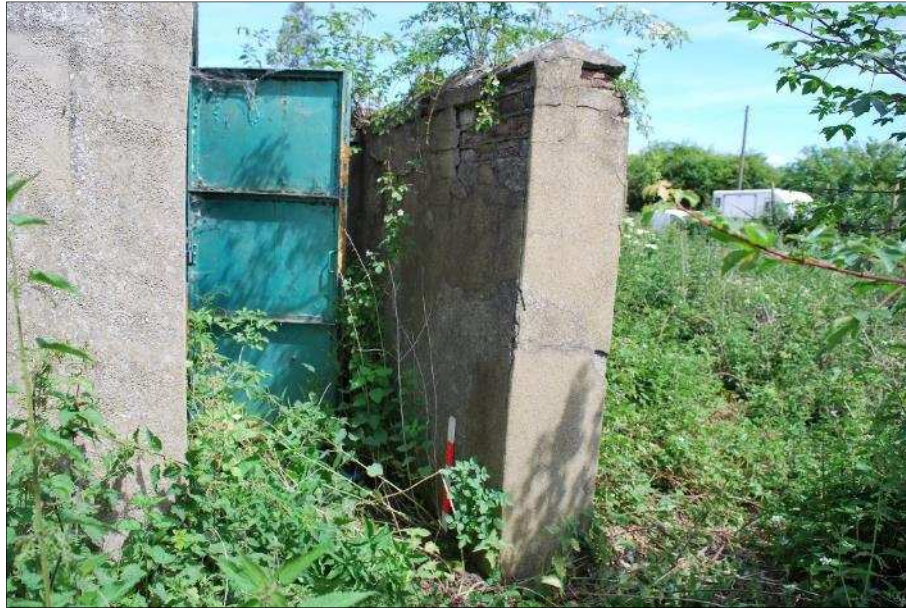
6.4 Attached to the east elevation is an L-shaped, red-brick, rendered wall with rendered saddle-back coping which extends east and returns southwards to partially enclose the doorway on this elevation (Plate 2). The door itself is of green painted steel sheeting, riveted to an internal steel frame (Plate 3). This pattern is repeated on the west elevation (Plate 4). There is a green painted, wooden electrical cabinet with double doors attached to the elevation (Plate 5).

Plate 2 (Shot 2): Boundary wall and eastern doorway, looking north (0.5m scale)

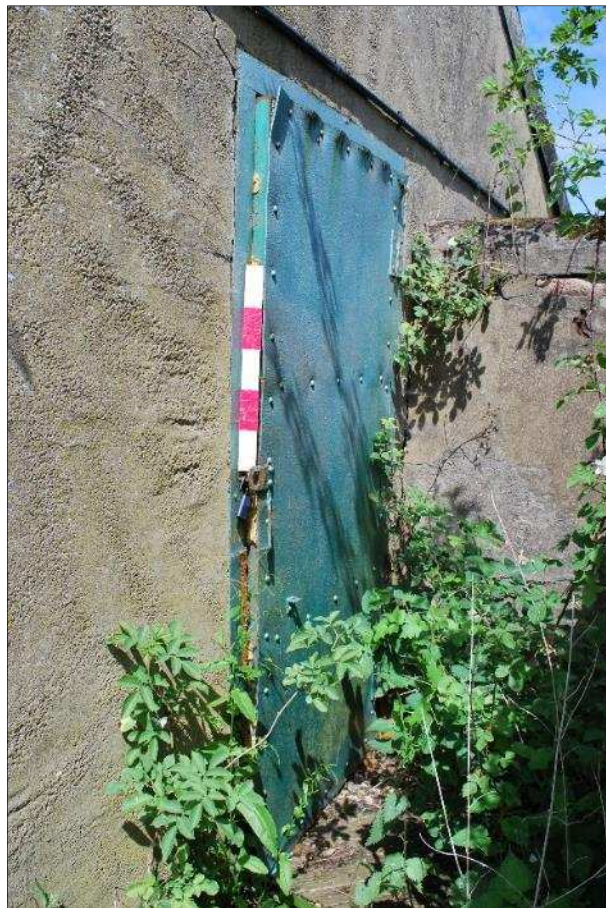
Plate 3 (Shot 5): Steel door on east elevation, looking northwest (0.5m scale)

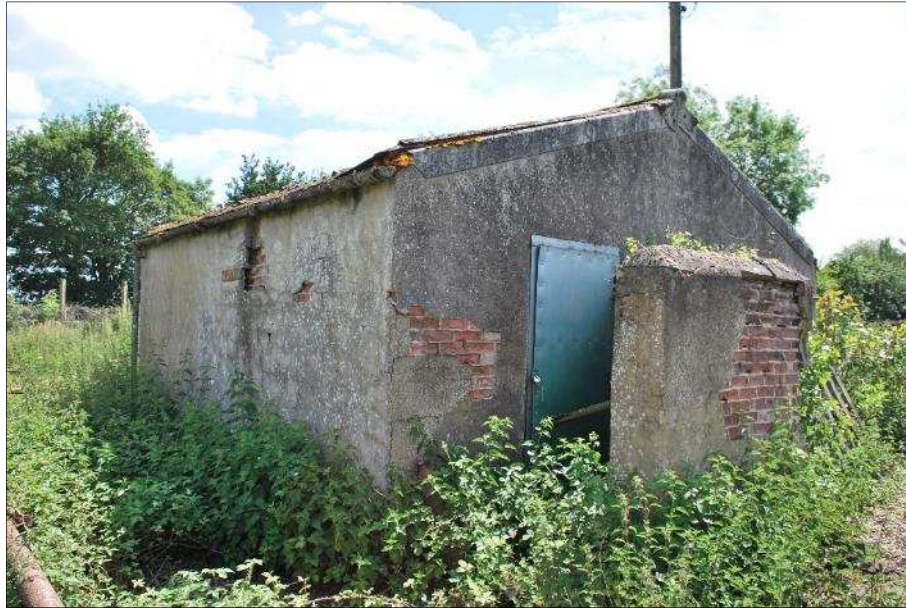
Plate 4 (Shot 28): West and north elevations, looking southeast

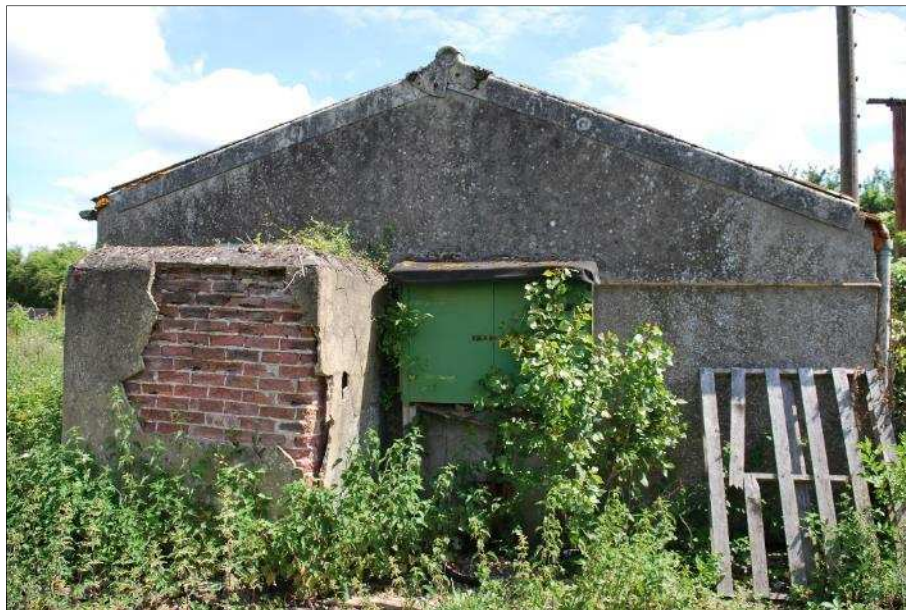
Plate 5 (Shot 30): West elevation, looking east

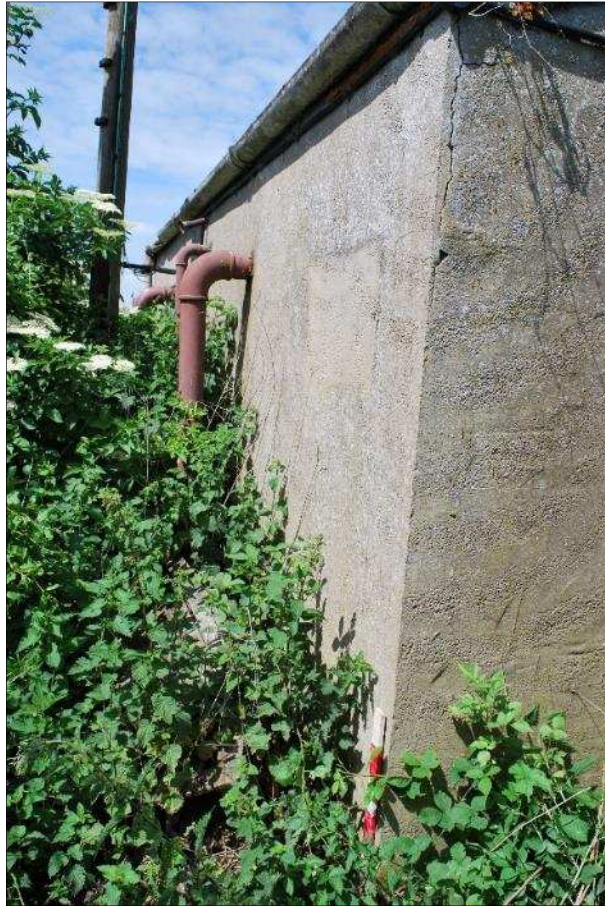
- 6.5 An array of metal pipework is evident along the southern elevation, generally rising vertically and turning 90⁰ to enter the building around eye level. The source of the pipework is not evident due to dense vegetation in this area (Plate 6).

Plate 6 (Shot 3): External pipework on south elevation, looking west (0.5m scale)

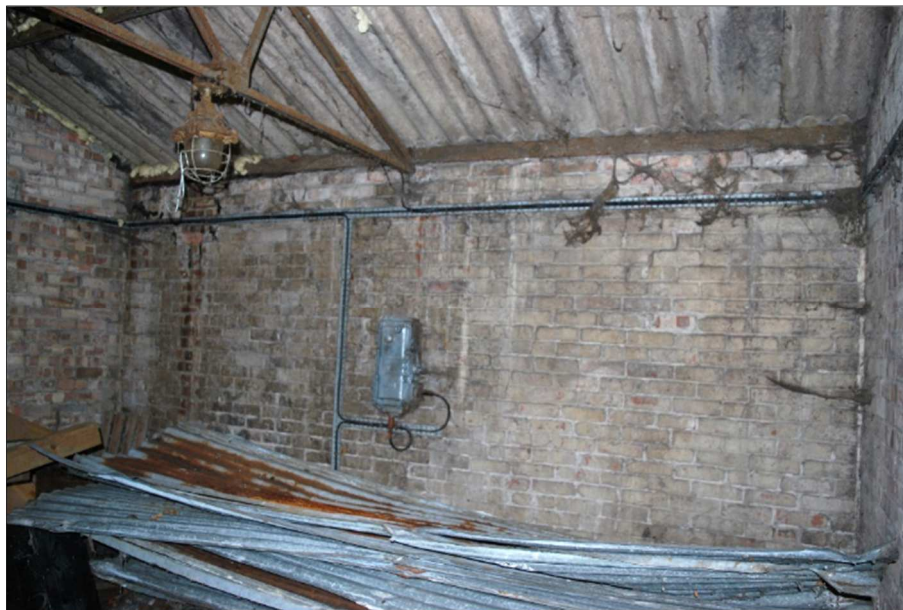
Plate 7: (Shot 23): General internal view showing corrugated metal stored within building, looking northwest

- 6.6 The pumping station is currently in use for the storage of corrugated metal, and other assorted building materials (Plate 7). The interior walls are whitewashed brickwork.
- 6.7 The roof structure is entirely in metal, with corrugated steel roofing and a single truss comprising a tie beam, with king bolt and diagonal bracing struts, supporting the purlins (Plate 8). An electric light fitting is attached to the tie beam.

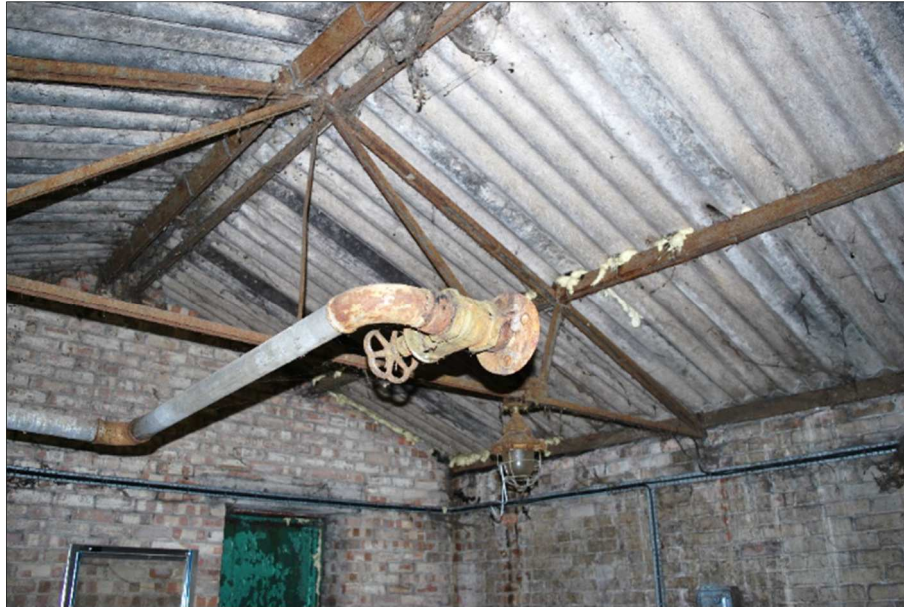
Plate 8 (Shot 13): Metal roof truss and pipework, looking northwest

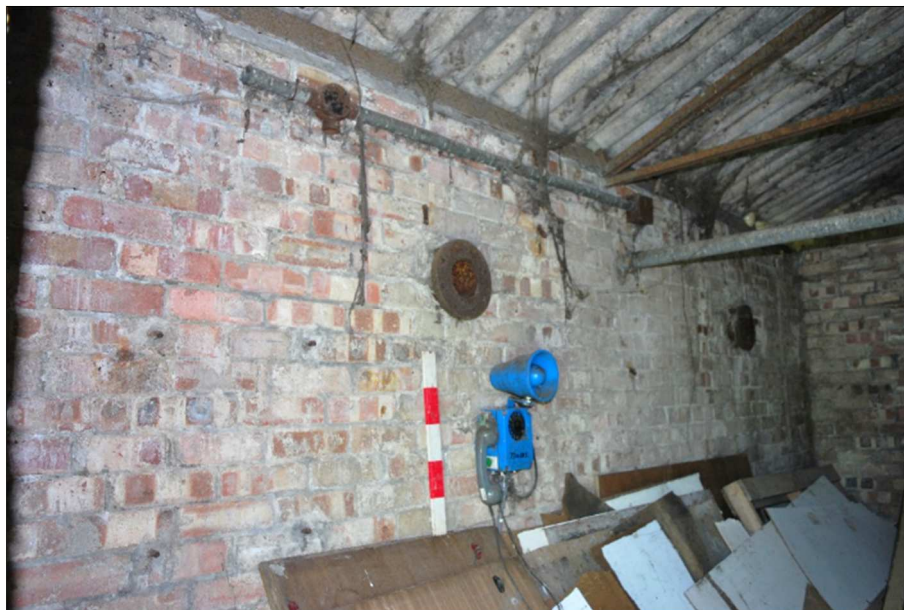
- 6.8 Several elements that relate to the former utilisation of the pumping station are visible, including a phone, metal electrical switch and large metal electrical fuse box with associated cabling (Plate 9 and Plate 10).

Plate 9 (Shot 11): Southern wall with fixtures, looking southwest (0.5m scale)

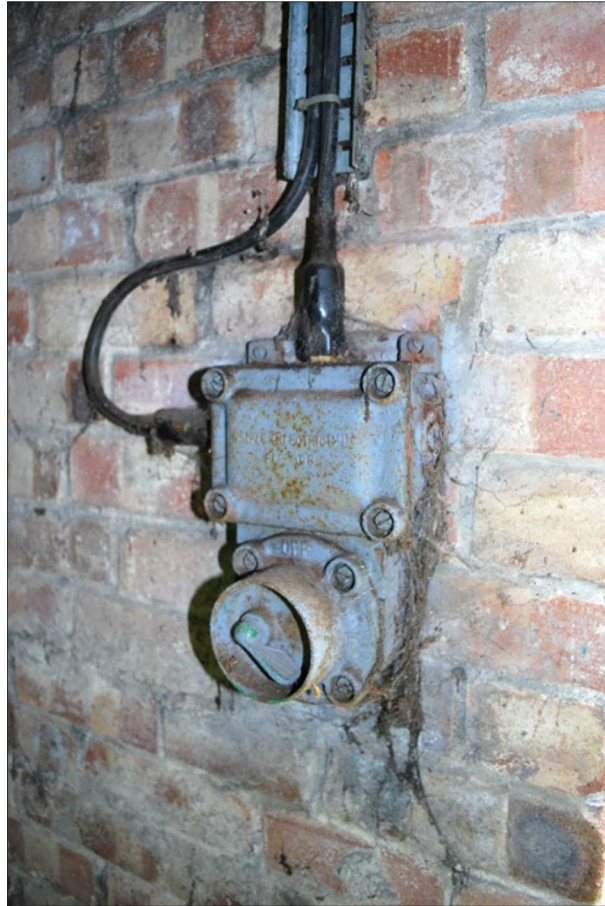
Plate 10 (Shot 14): Metal electrical switch panel on eastern wall, looking northeast

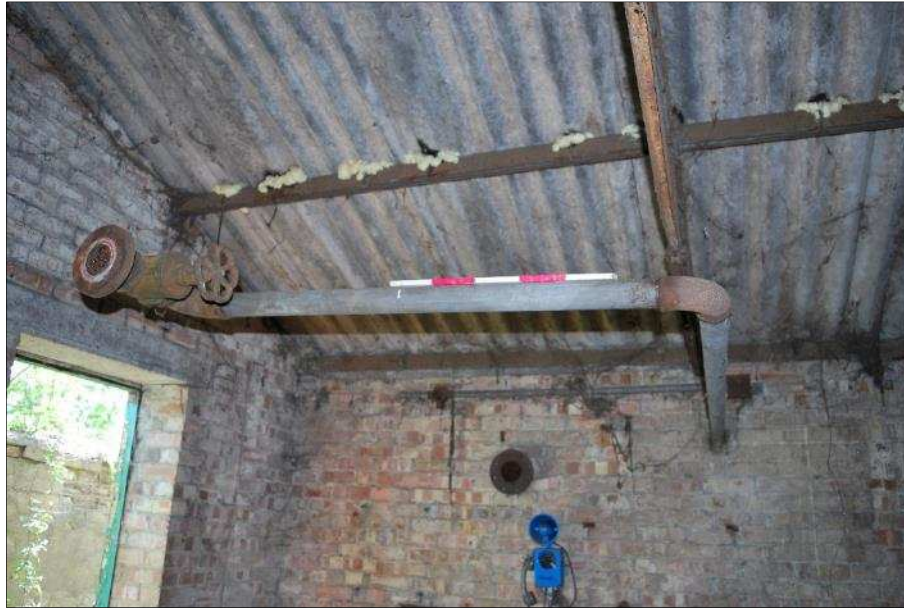
- 6.9 Steel discs on the south wall relate to the position of two external pipes, probably having been capped off at a later date. The third pipe extends through the south wall, turning east and then north and ending with a valve and tap (Plate 11). This pipe has also been capped off in a similar fashion to the pipes on the south wall.

Plate 11 (Shot 18): Pipe extending from southern elevation, looking south (0.5m scale)

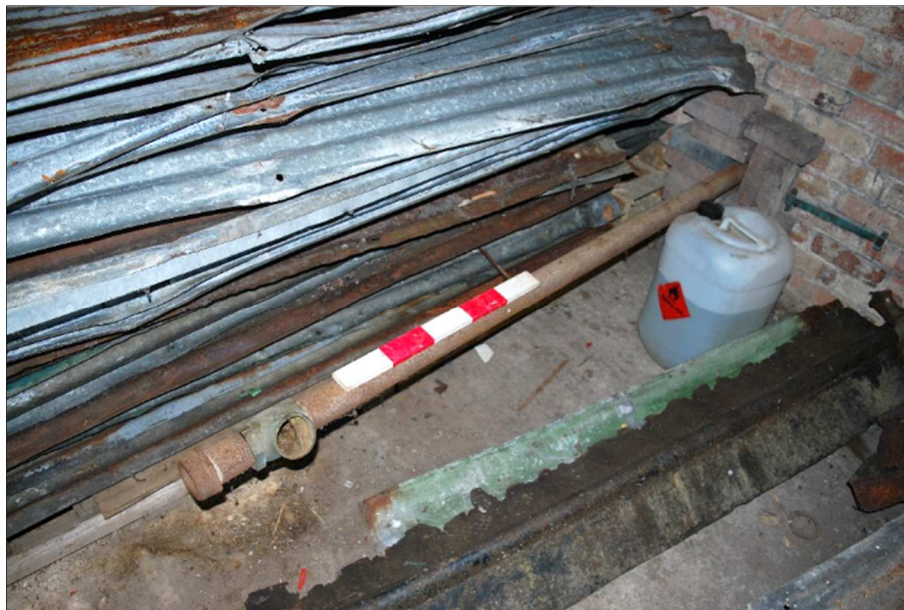
Plate 12 (Shot 17): Pipe extending from eastern elevation, looking northeast (0.5m scale)

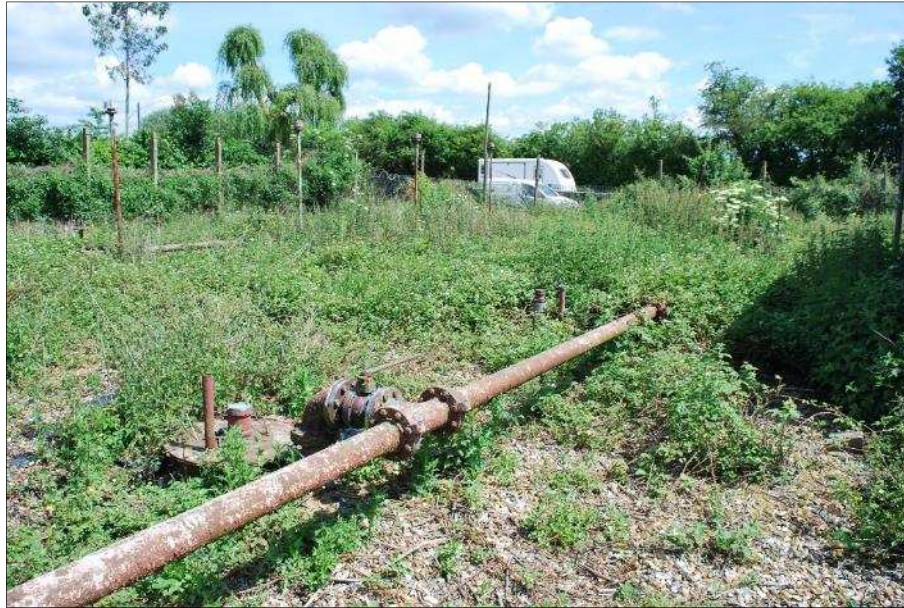
- 6.10 To the north of the pumping station there are six subterranean fuel storage tanks, connected by an above-ground network of pipes. The four westernmost tanks appear to be connected by pipes orientated east-west across the site (Plate 13), whilst the two remaining tanks to the east are connected by pipes running south towards the pumping station. The pipes run roughly 300mm above the ground, with each tank attached by a curving connector.

Plate 13 (Shot 35): Network of above-ground pipes associated with fuel tanks, looking northeast

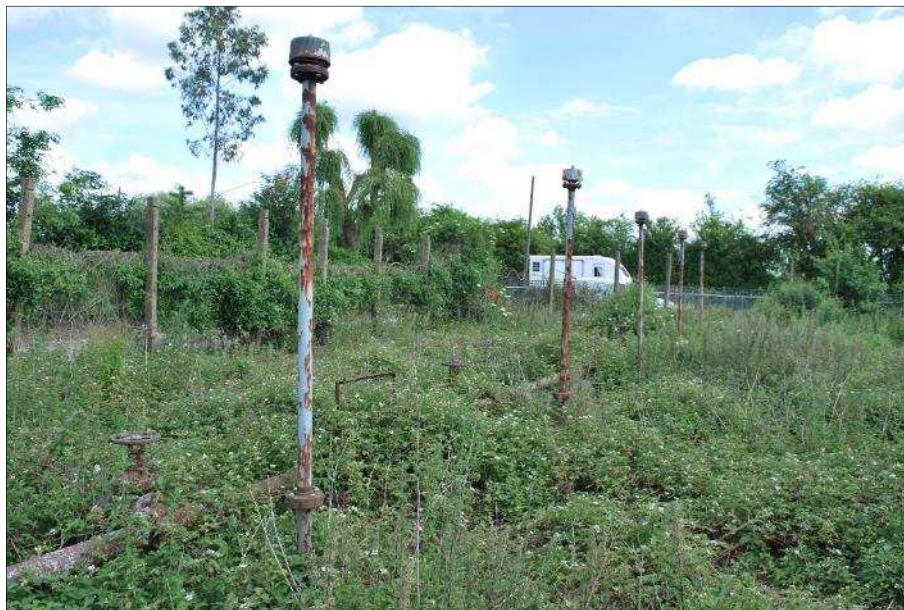
- 6.11 At the northern end of each fuel tank there are a series of tall, thin ventilation shafts extending to a height of approximately 2.2m, situated immediately to the south of the east – west aligned pipes and connectors (Plate 14).

Plate 14 (Shot 41): Vertical above-ground vents and ground-level valves at north end of fuel tanks, looking northeast

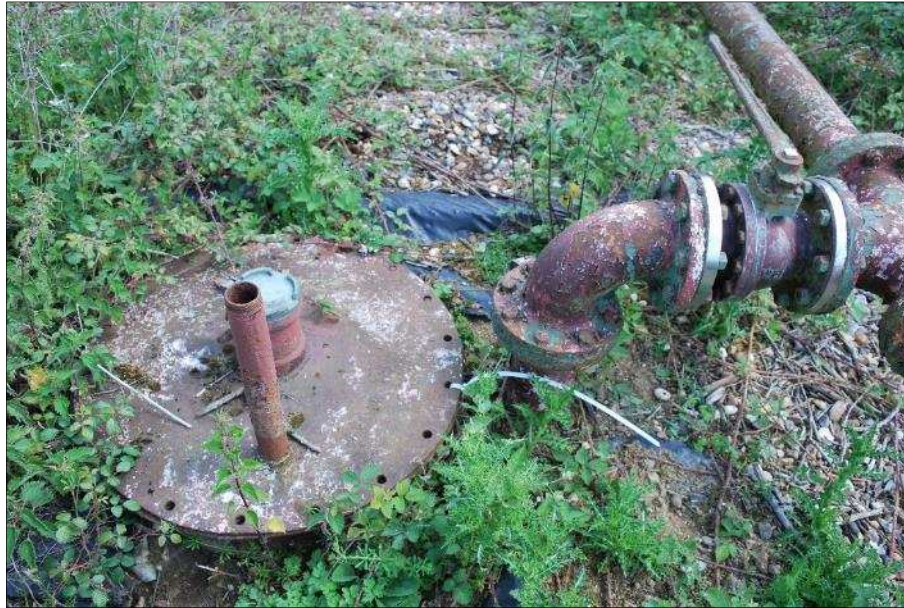
- 6.12 At the southern end of each fuel tank there are large, circular access shafts covered with a steel plate, situated immediately north of the east-west pipeline and connectors (Plate 15).

Plate 15: (Shot 37): Circular access vent and connecting pipework, looking east

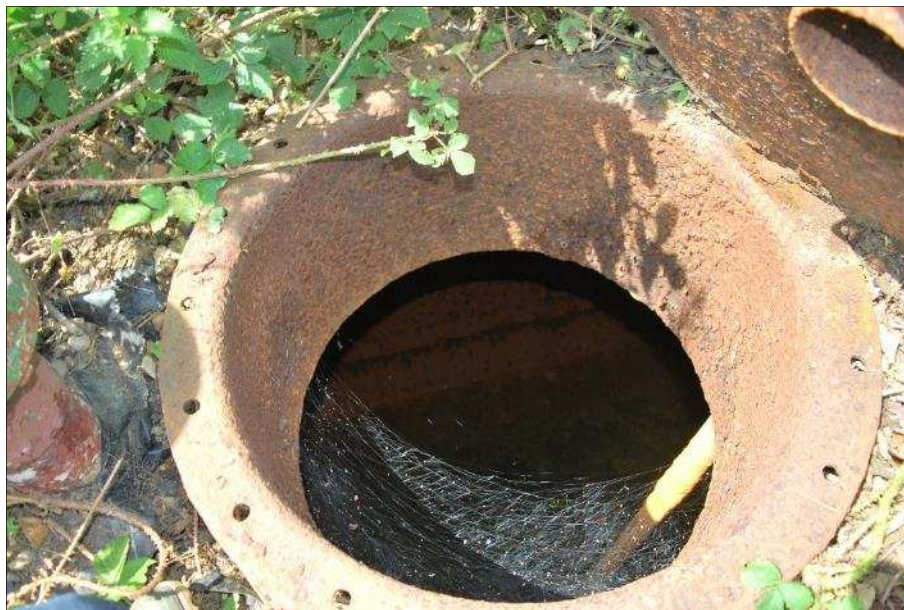
- 6.13 These circular vents allow access directly into the fuel tanks, probably for rapid disposal or maintenance purposes (Plate 16). Views into the fuel tanks were obscured due to lack of light.

Plate 16: (Shot 47): Circular access shaft into subterranean fuel tank, looking northwest

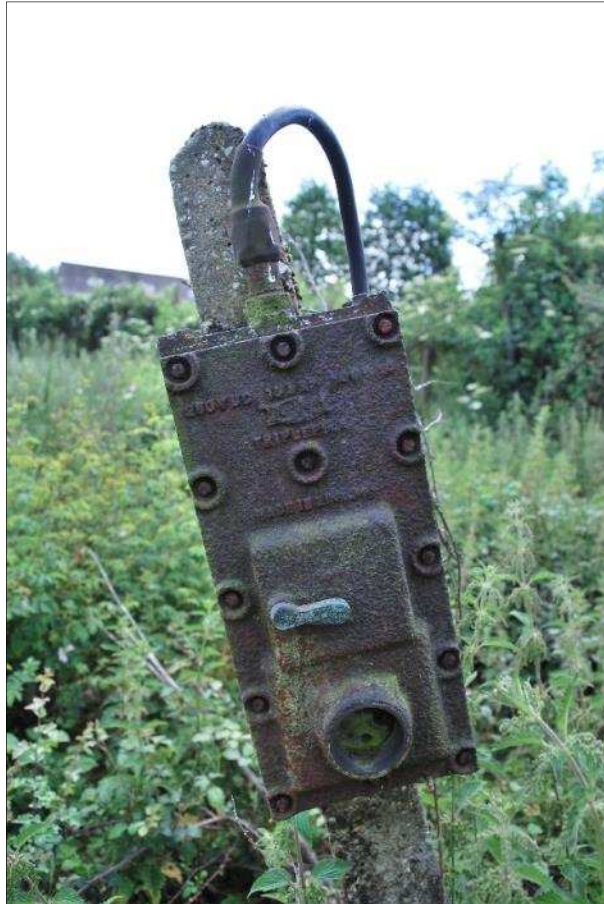
- 6.14 A concrete pillar with attached metal electrical box is present at the northwest corner of the site (Plate 17). This is possibly an emergency shut off system related to the pumping of fuel.

Plate 17: (Shot 44): Metal electrical box at northwest of site, looking south

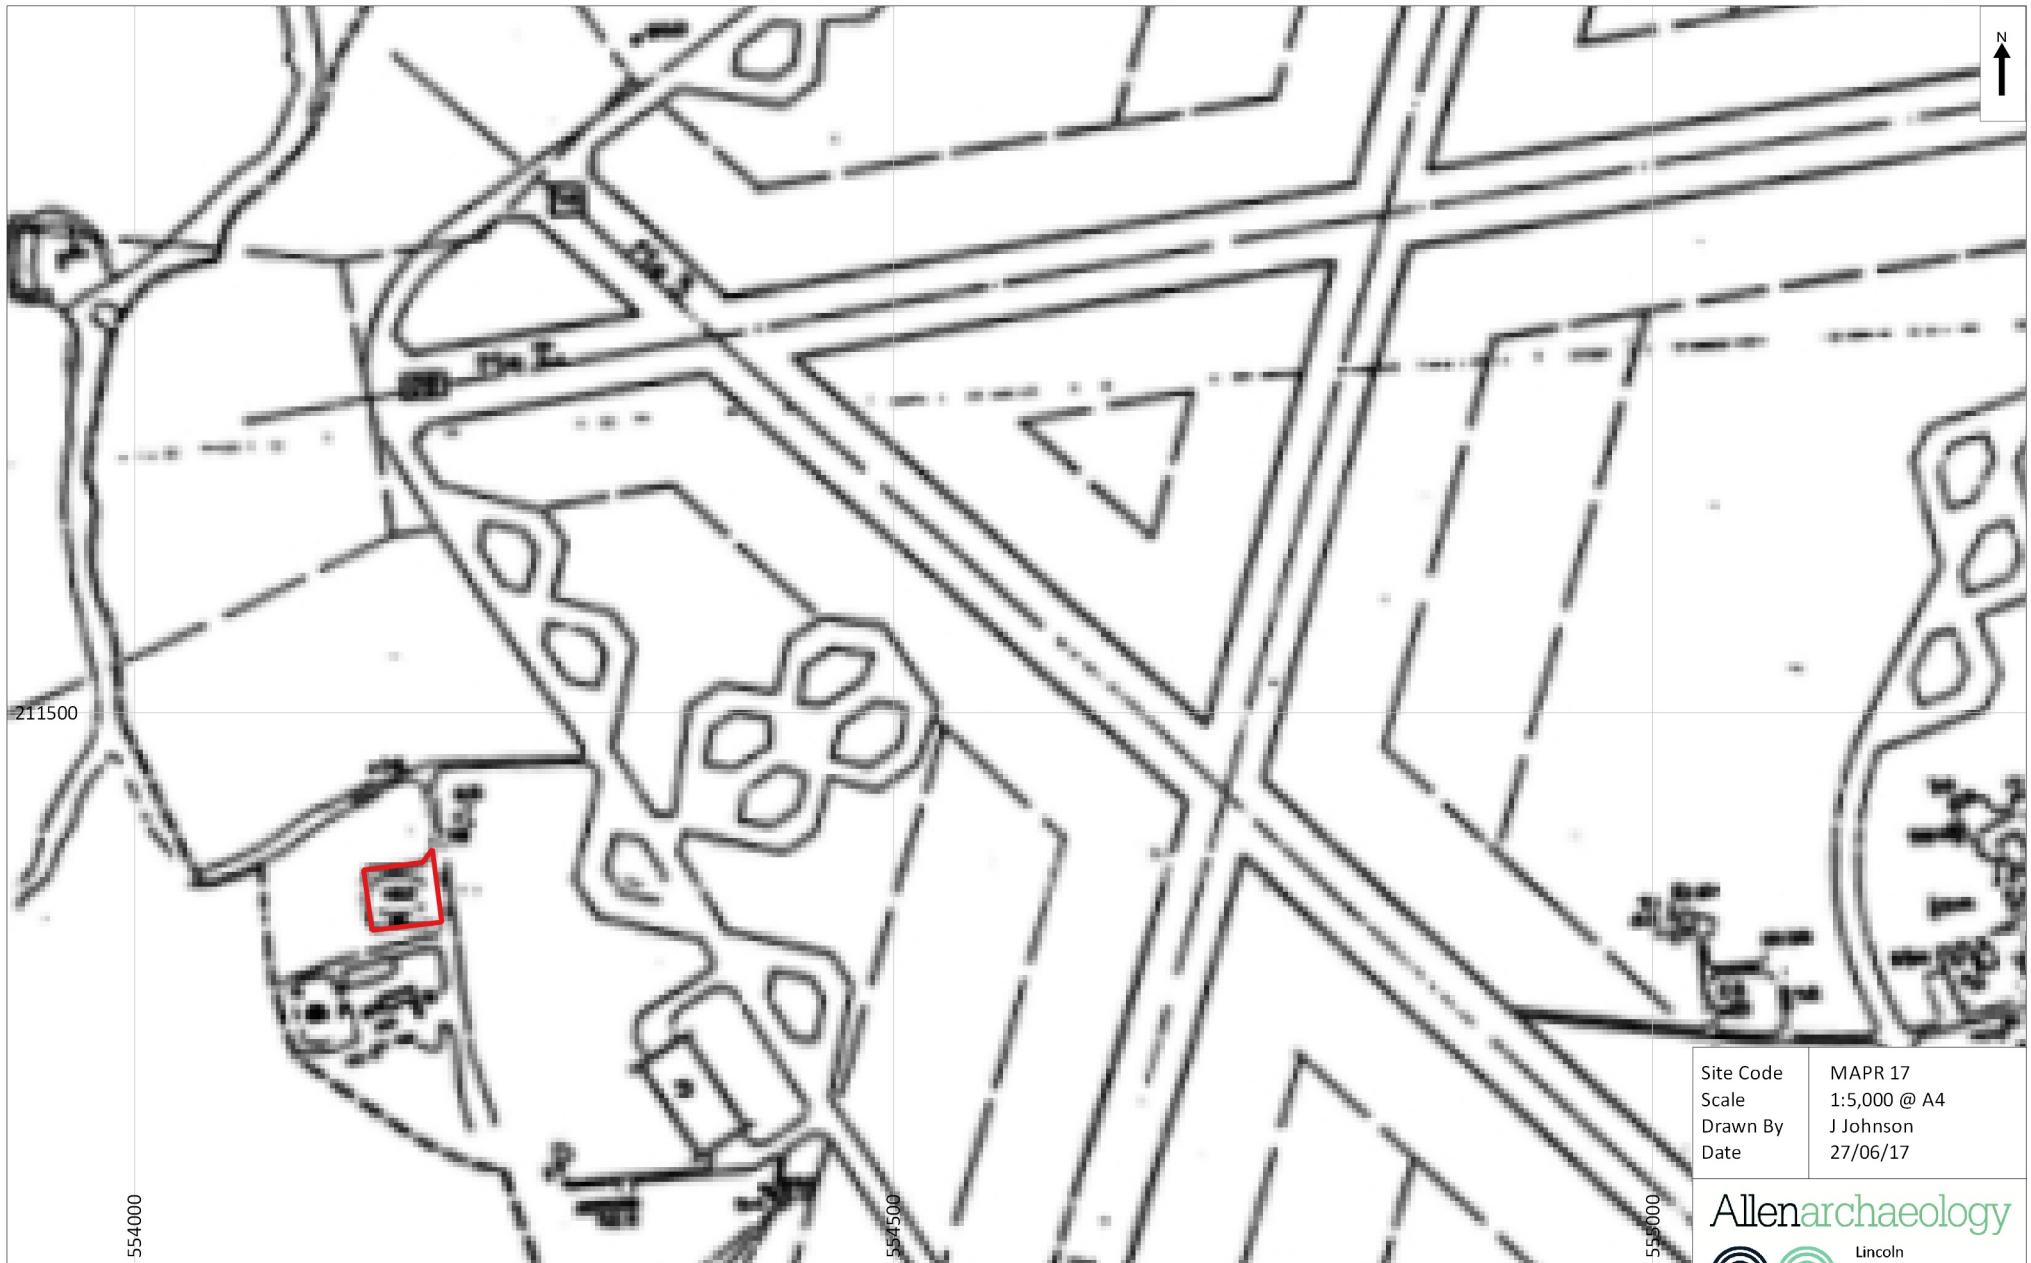
Figure 3: Extract of RAF Matching Green layout map with site in red

- 4.2 The airfield, known as RAF Matching (Station 166), is reported to have been constructed late in the war, opening around January 1944, and was operational for just over a year. It consisted of three large concrete runways, 50 loop-style hardstands, two T2 hangars, a number of blister hangars, and a wide range of ancillary and support buildings – connected by approximately three miles of roadway. The fuel store is located at the western edge of the airbase, no doubt as a factor of the potential risk of explosion or fire (www.wartime-airfields.com) (Figure 3).

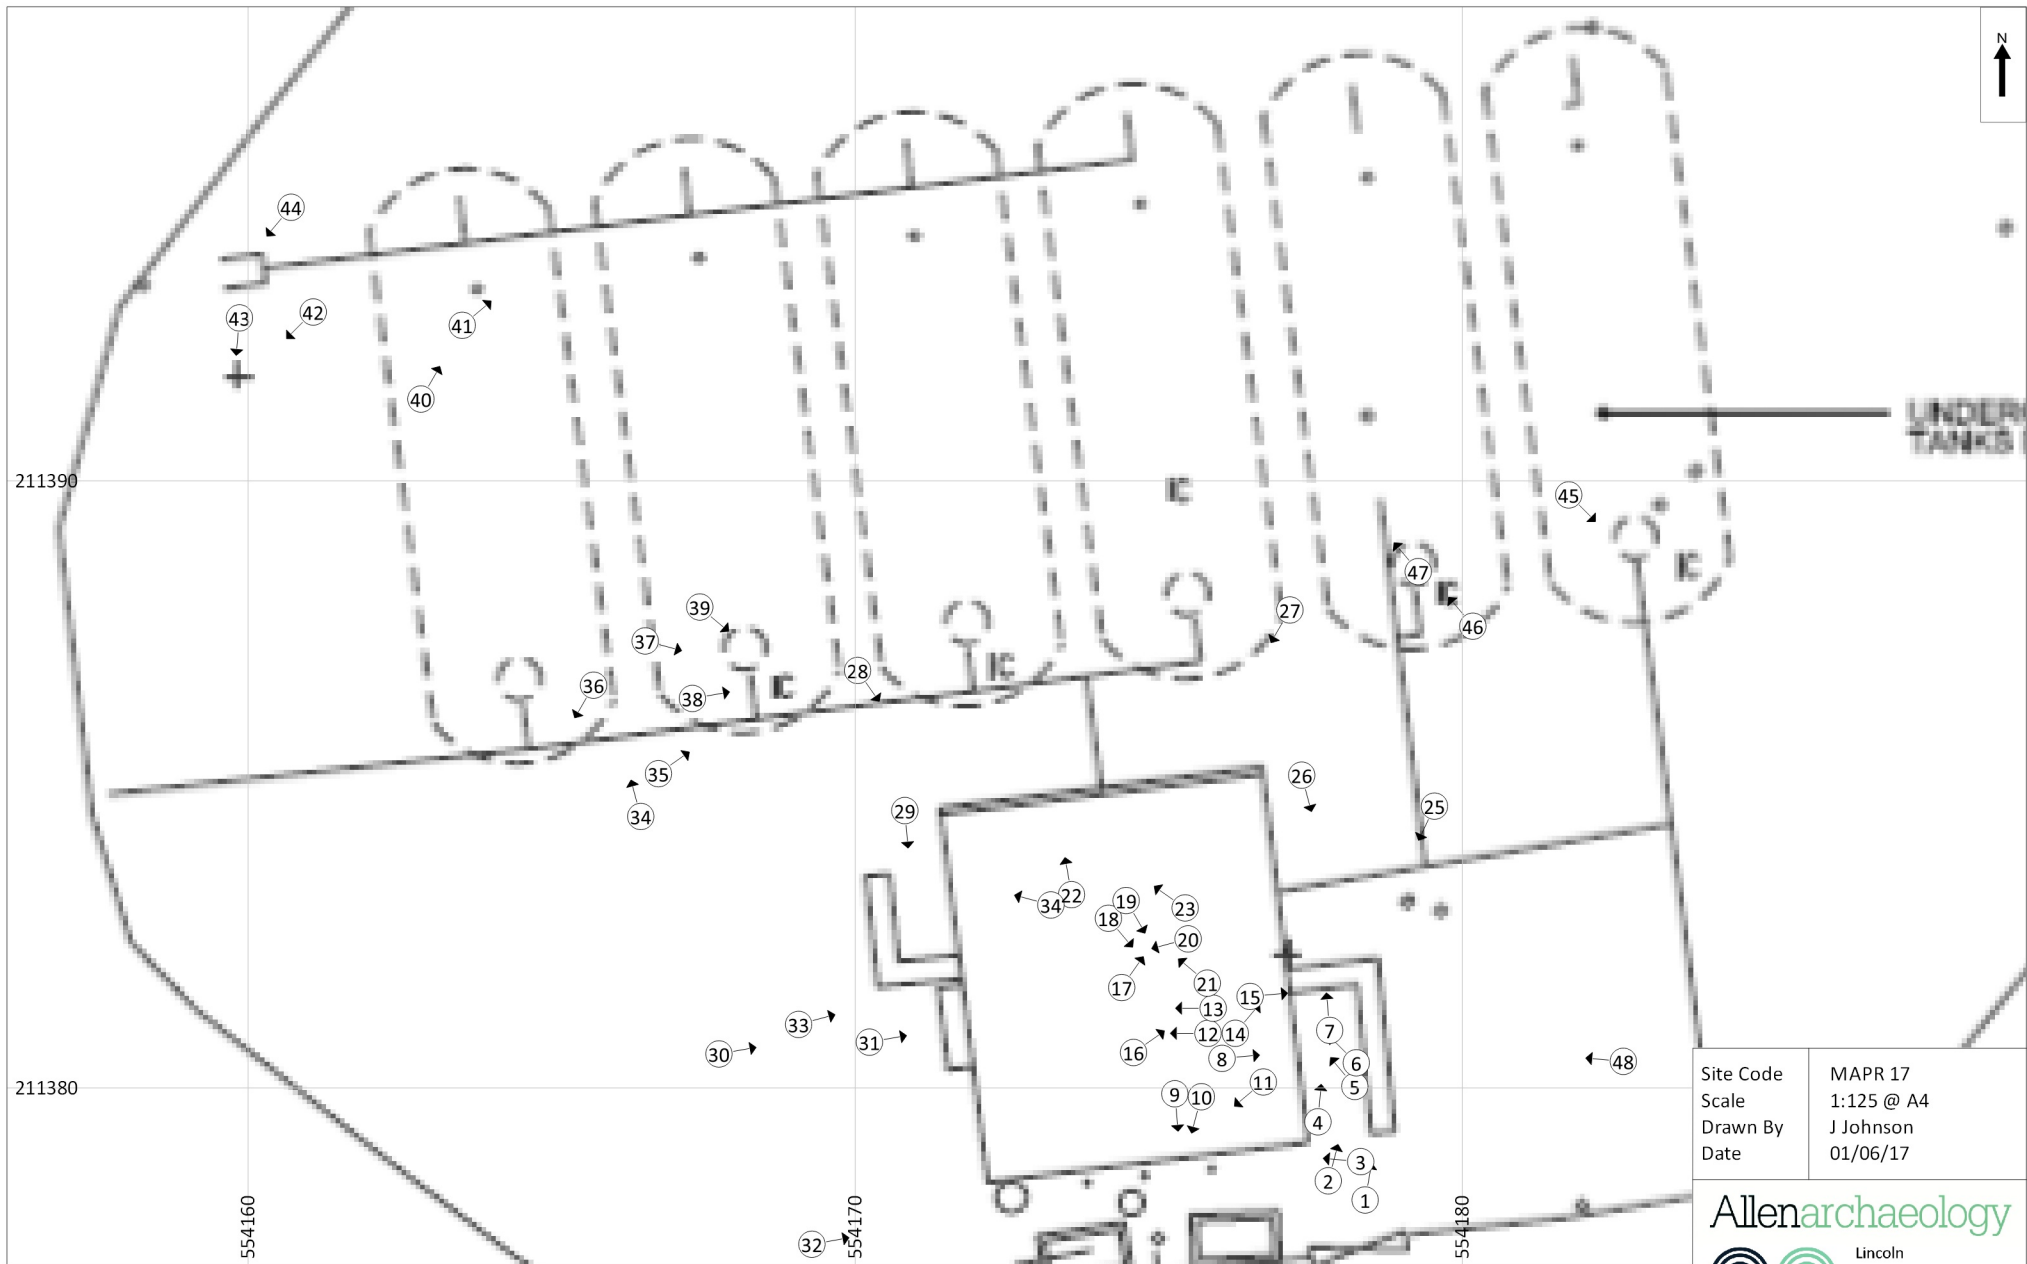
Figure 4: Location and direction of photographs, base plan provided by client

6.1 The location of the development site is shown on Figure 2. An account of the exterior of the building will be given before commenting on the interior. The location of each photograph is shown on Figure 4 and can be cross referenced by shot number with the photographic archive list (**Error! Reference source not found.**). Elevation drawings are shown on Figure 5.

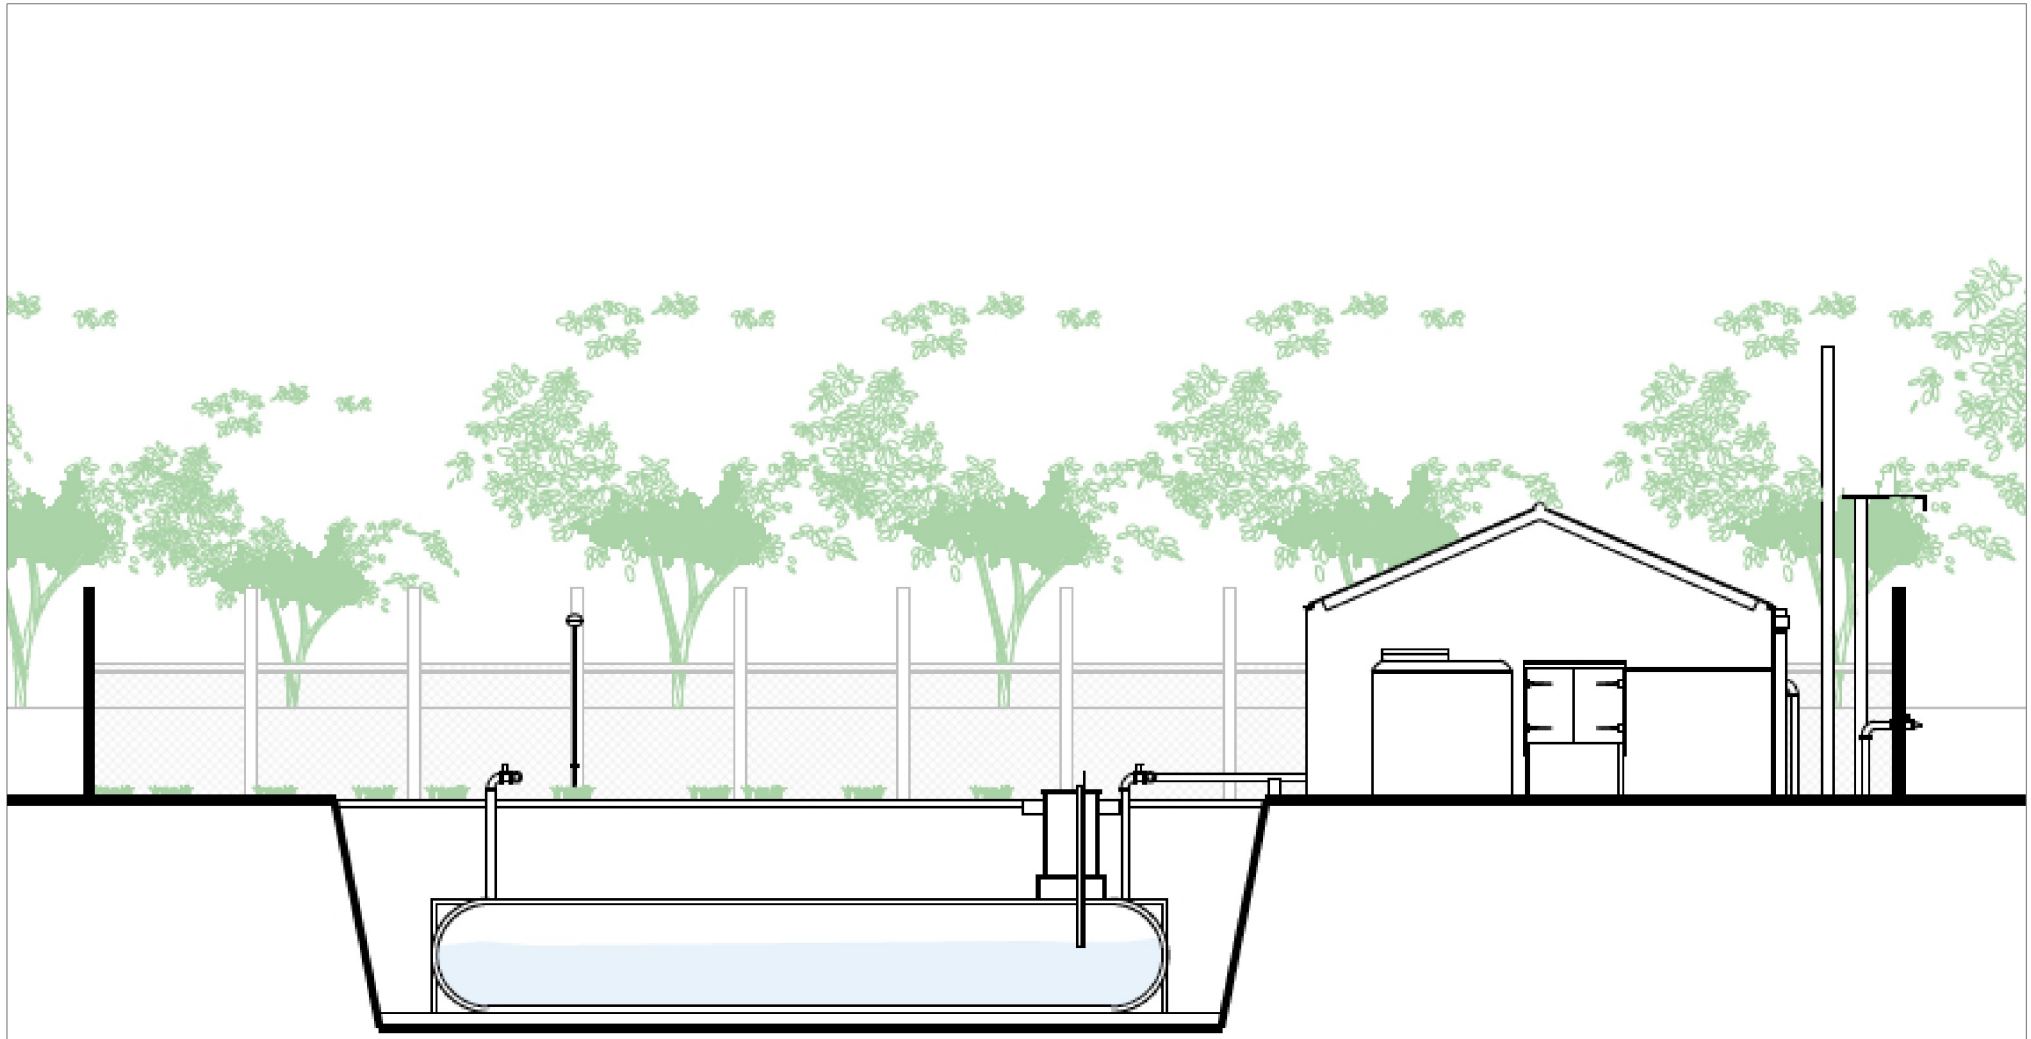
Figure 5: West-facing elevation of pumping station and west-facing section of fuel tank, drawing provided by client
