**HISTORIC BUILDING SURVEY REPORT:**

**15 RAMSEY ROAD, RAMSEY FORTY FOOT, CAMBRIDGESHIRE**

By  
Allen Archaeology Limited  
Report Number AAL 2018022

February 2018

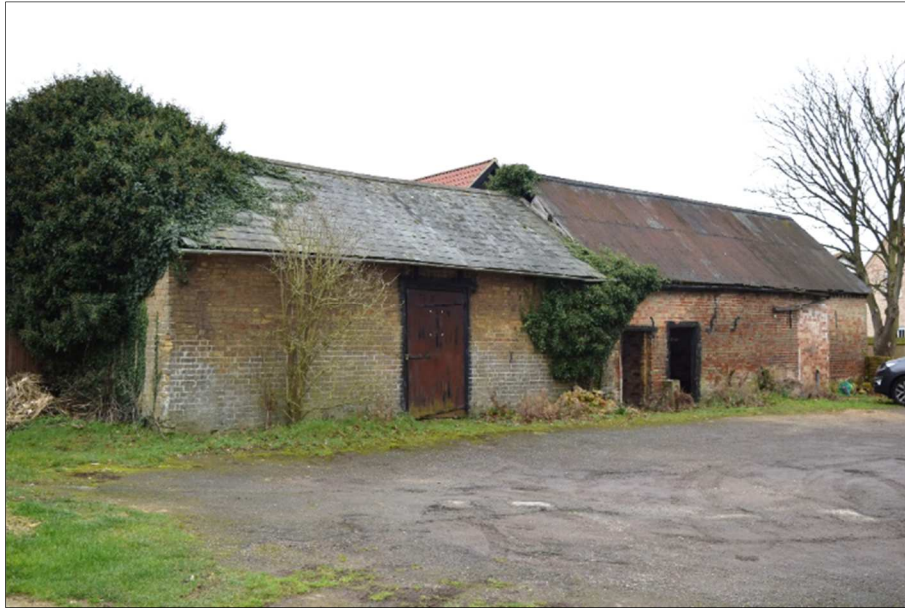
*Plate 1 (shot 2): General view of the barns. Looking southwest, 1m scale*

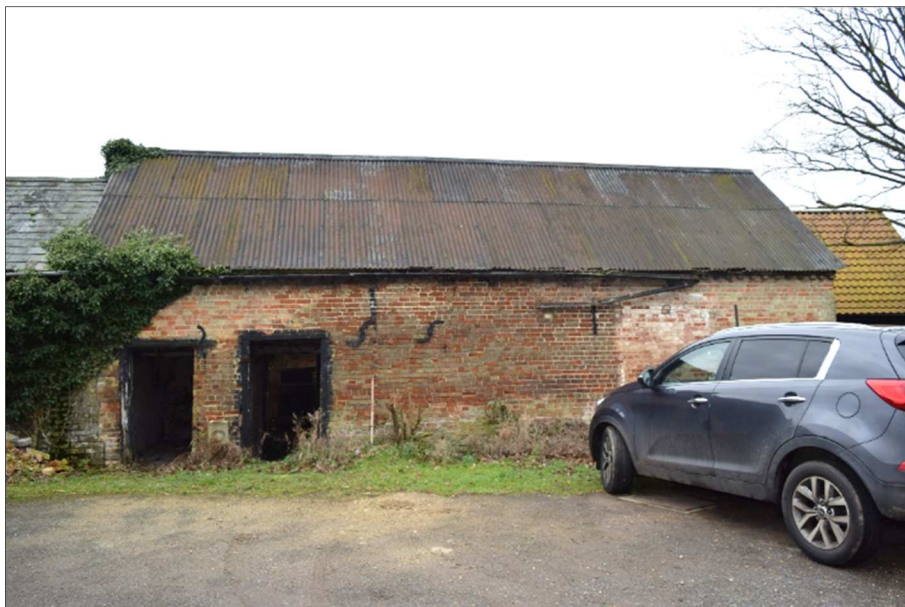
6.2 The red brick barn measures approximately 11.5m x 4.5m (Plate 2). It contains two animal shelters, a storage room and a hay loft. It is built in red, handmade bricks in English bond, bonded with a lime mortar. The bricks were most likely sourced locally, and the Ordnance survey map of 1888 show disused brickworks located only 200m east-northeast of the site. The double pitched roof is clad with corrugated metal sheets and there is a dentil course under the eaves. There may originally have been entrances from the northeast.

*Plate 2 (shot 9): Northeast-facing elevation. Looking south, 1m scale*

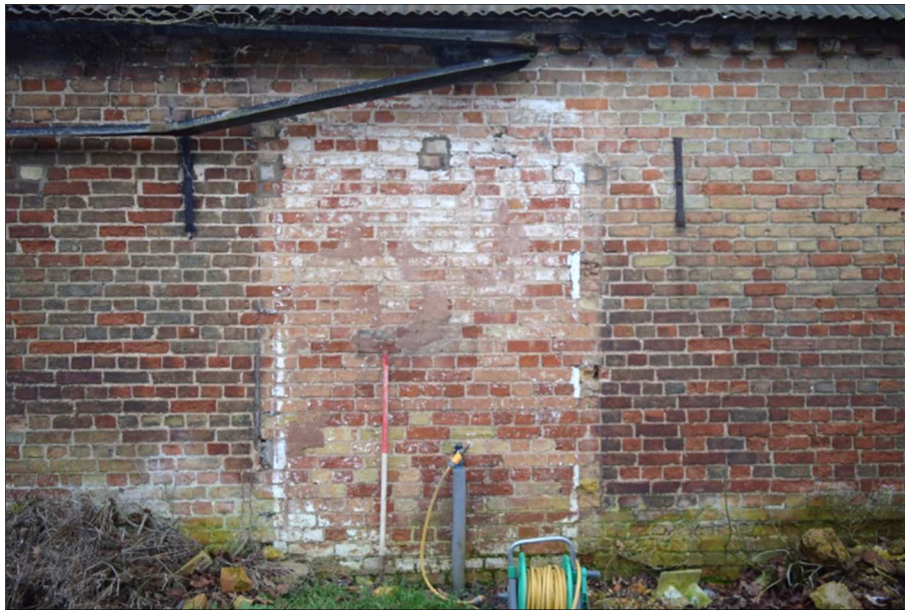
- 6.3 A large brick segment towards the northwest corner appears to have recently been repaired as well as having had something stored in front of have been attached to the wall and showing an outline in white paint (Plate 3). This may have been the position of an earlier opening.

*Plate 3 (shot 27): Bricked-up opening on northeast elevation. Looking south, 1m scale*

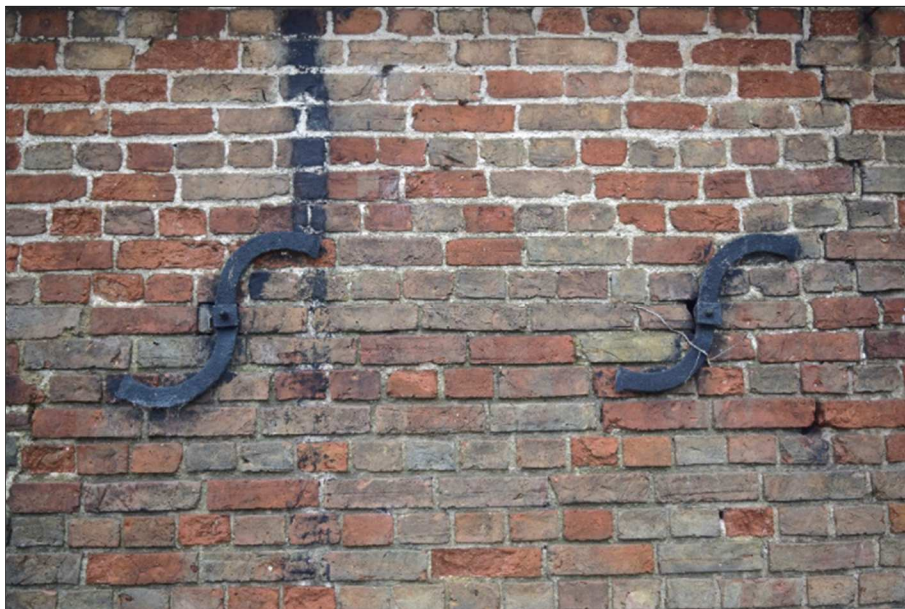
- 6.4 The northeast and opposing southwest elevation have, in antiquity, been strengthened by tie rods held together by S-shaped and I-shaped tie plates (Plate 4).

*Plate 4 (shot 10): S-shaped tie plates on southwest elevation. Looking south*

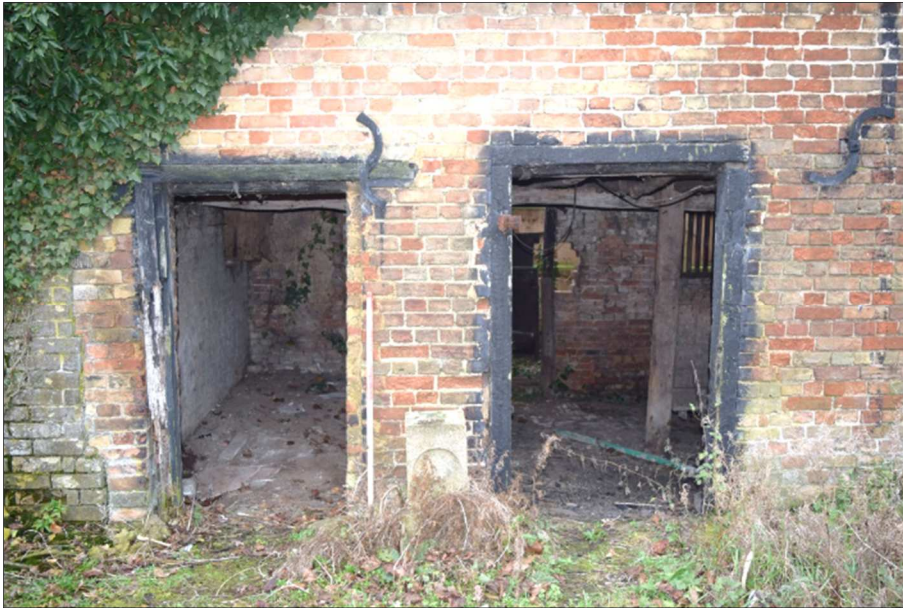
- 6.5 The existing doorways lead into the southeast animal shelter and the storage room (Plate 5). The doorframes are still in situ but the doors have been removed.
- 6.6 To the rear of the building, on the southwest elevation is a small square window with wooden frame and bars as well as two door openings (Plate 6). The original heck door to the southeast

*Plate 5 (shot 11): Openings on northeast elevation also showing abutting barn to the left. Looking south, 1m scale*

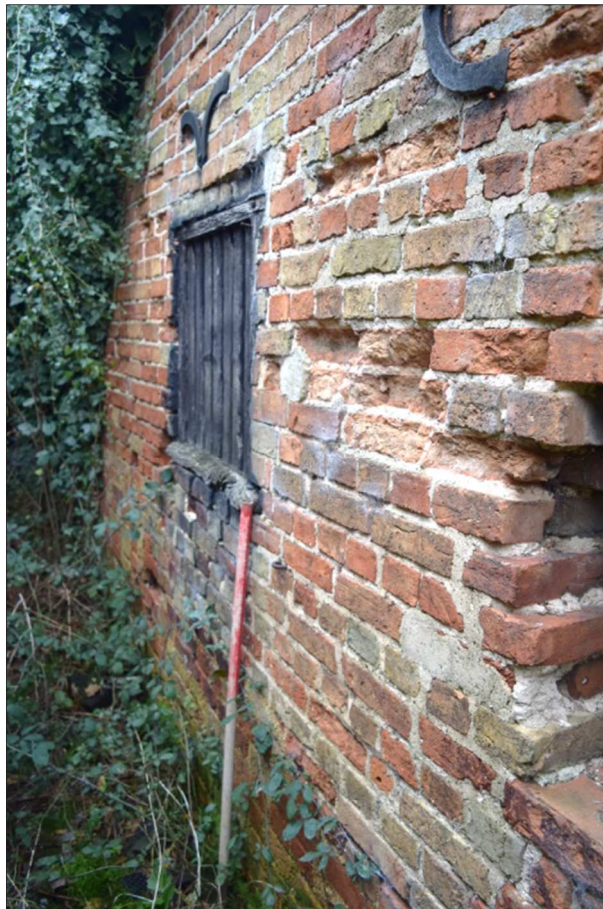
*Plate 6 (shot 12): Window on the southwest elevation. Looking northwest, 1m scale*

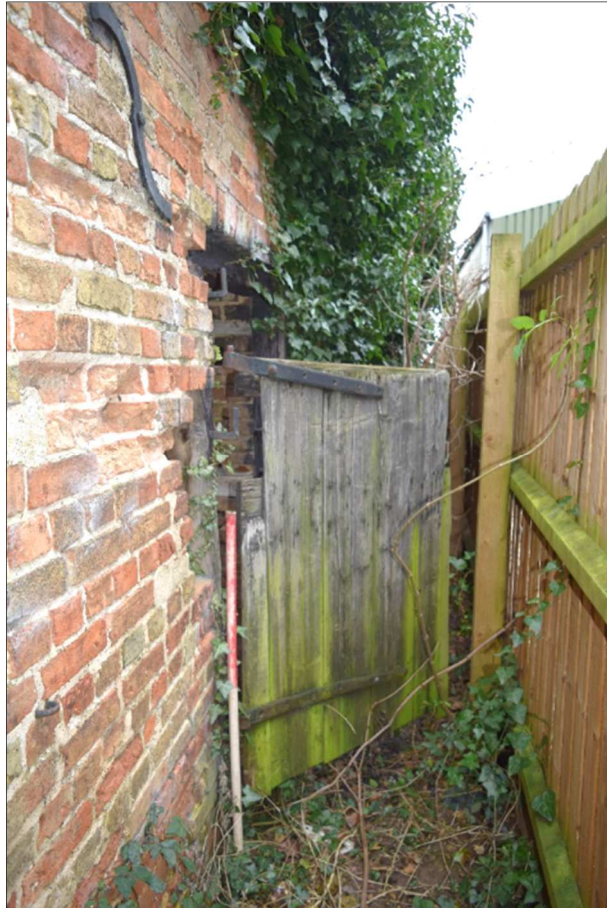
animal shelter has been replaced by a plank and batten door on strap hinges with plain ends (Plate 7).

*Plate 7 (shot 13): Door on southwest elevation. Looking southeast, 1m scale*

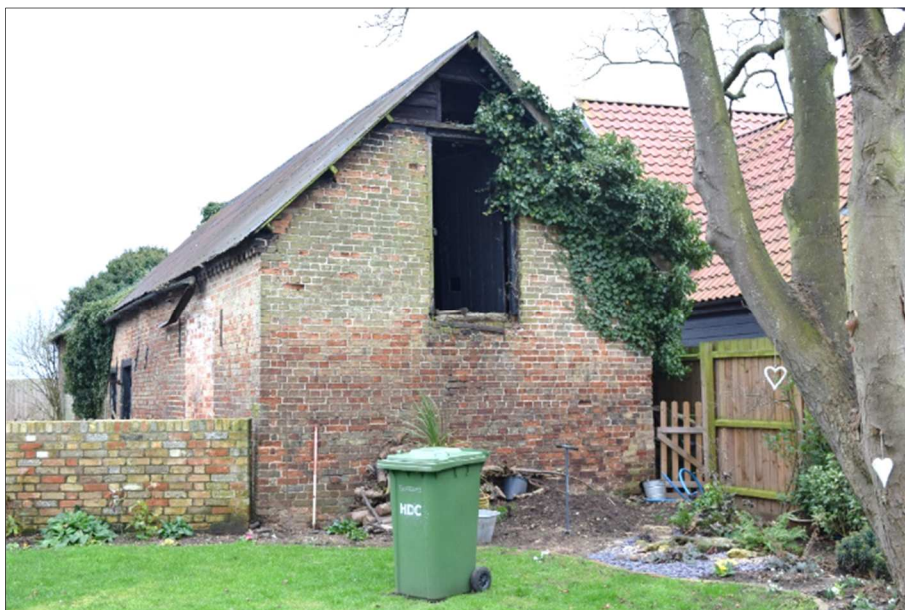
- 6.7 The loft has a large doorway on the northwest gable, although inaccessible during the survey. Above the doorway there is barge boarding and a small square window.

*Plate 8 (shot 38): Northwest elevation and loft opening. Looking southeast, 1m scale*

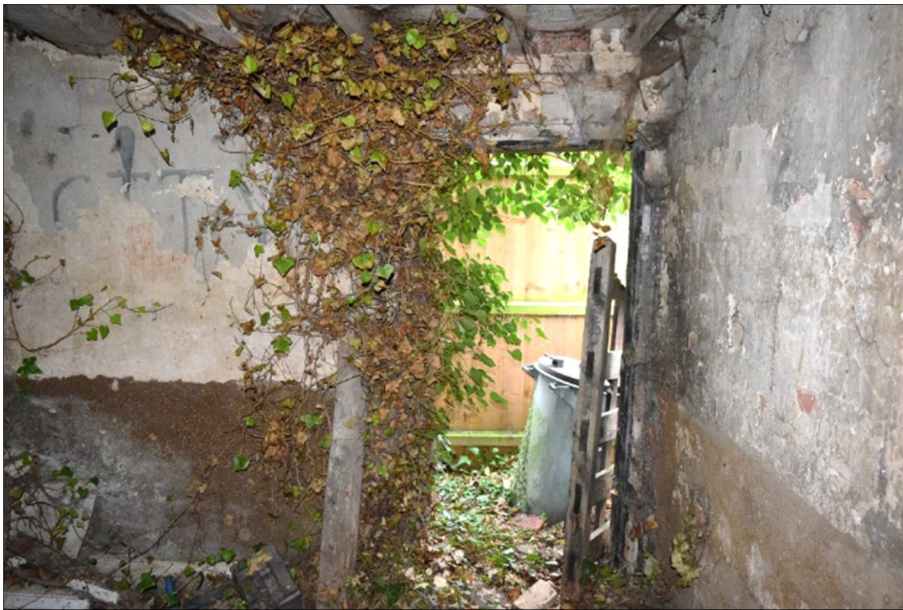
- 6.8 An animal shelter is located in the northwest of the barn. The ivy which covers much of the exterior has also intruded inside the building through the doorway. There is no door present (Plate 9).

*Plate 9 (shot 41): Doorway to northwest animal shelter. Looking southwest*

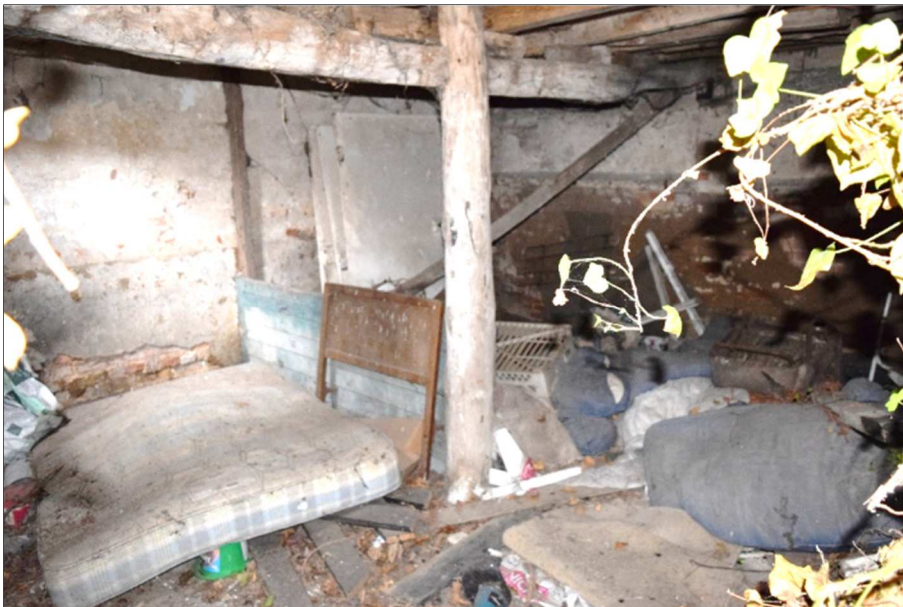
- 6.9 The space has of late been used as general storage (Plate 10 and Plate 11). The shelter has a central upright timber beam supporting a timber bressumer, above which there appears to be a mix of older and recently replaced timber joists, with wooden floor boards above. Large parts of the walls have been rendered. The general clutter in the room made it hard to distinguish any other fixtures or agricultural features.

*Plate 10 (shot 39): General view of northwest animal shelter. Looking northeast*

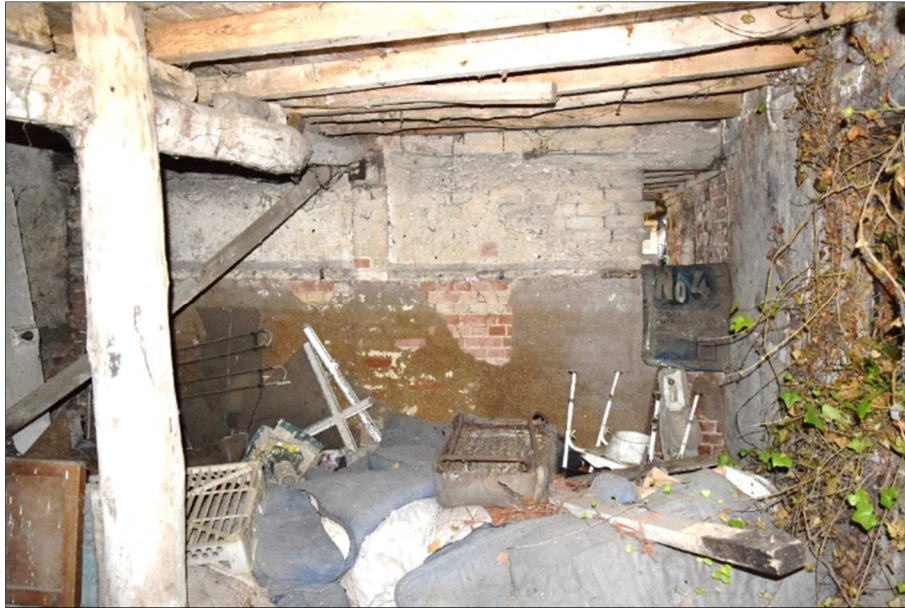
*Plate 11 (shot 40): General view of northwest animal shelter. Looking southeast*

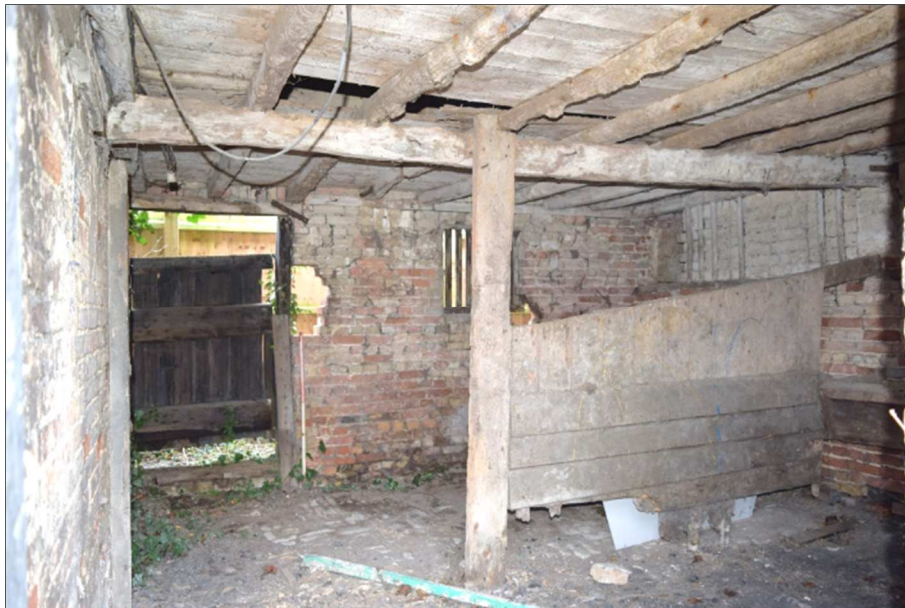
- 6.10 The central part of the barn comprises a stable with two stalls (Plate 12). The partition wall to the north consists of a brick wall with an above wooden partition. The wooden partition has been bricked up from the northwest animal shelter (Plate 13). Below the earlier partition is a wooden feeding trough with tethering rings.

*Plate 12 (shot 15): General view of southeast animal shelter. Looking southwest, 1m scale*

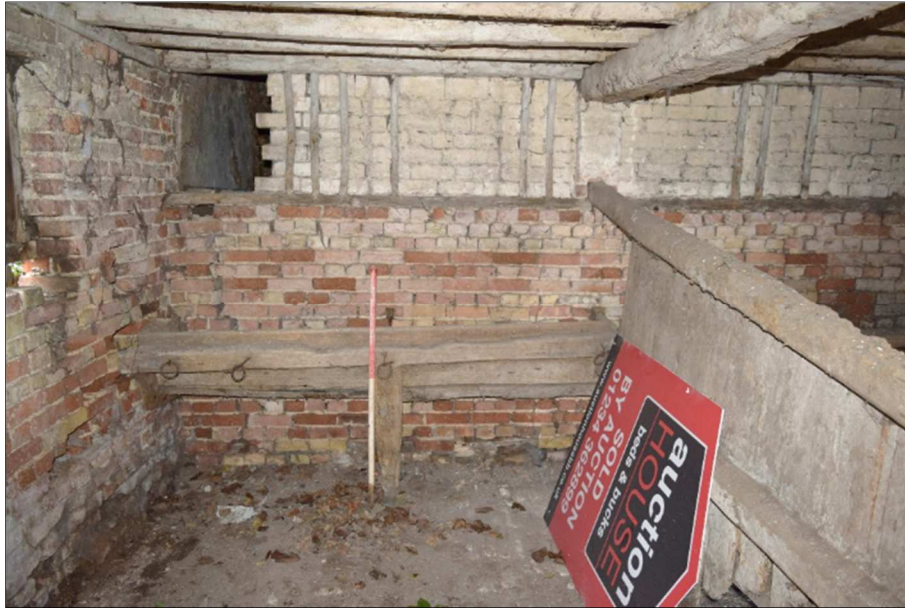
*Plate 13 (shot 16): Representative view of the southwest stall showing wooden partition above the bricks. Looking northwest, 1m scale*

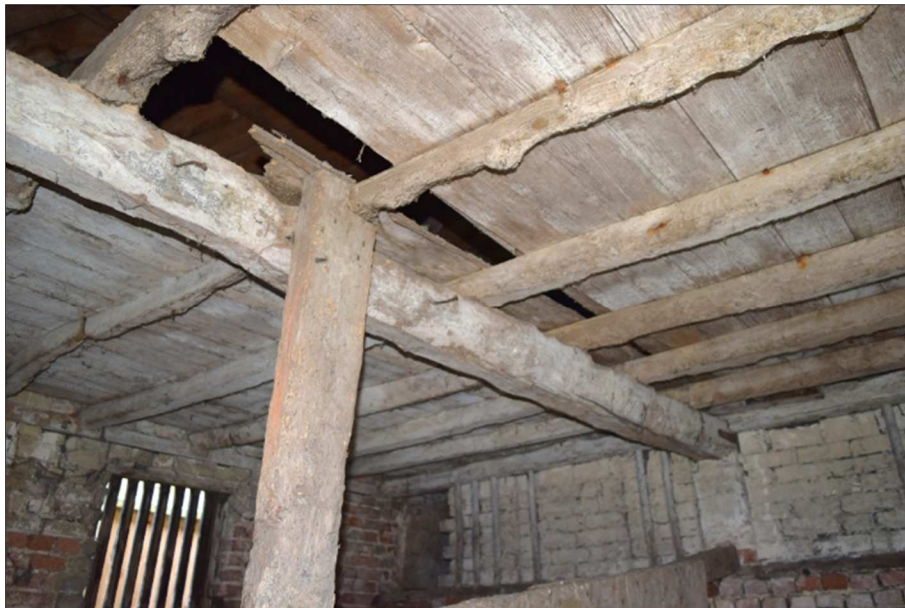
- 6.11 The loft floor joists have been attacked by woodworm and in some places these have been replaced. The plank floor above is tightly fitted although some holes exist (Plate 14).

*Plate 14 (shot 18): Ceiling and loft floor joists. Looking southwest*

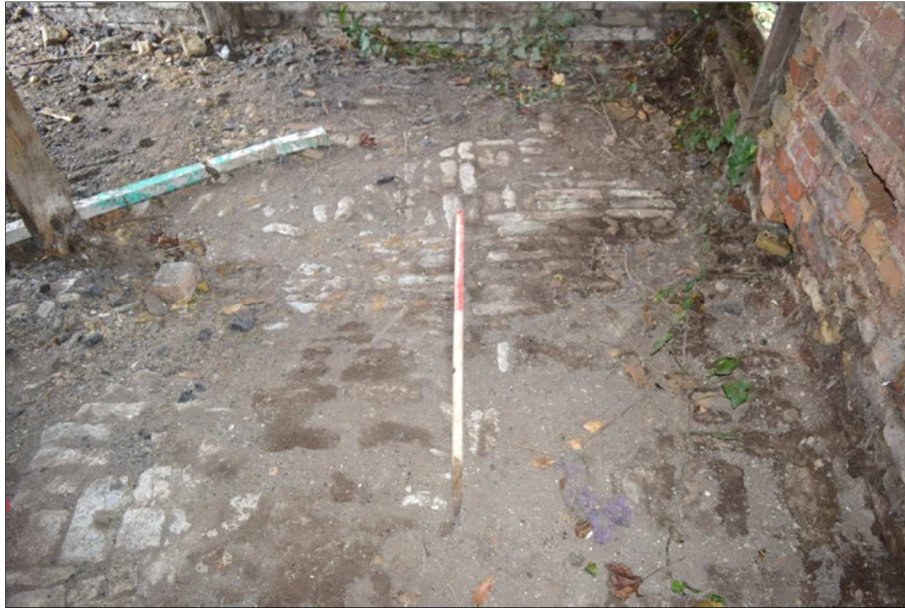
- 6.12 The floor is of bricks laid on edge with two alternating orientations, and is worn and uneven (Plate 15).
- 6.13 The smallest room to the southeast has various nails nailed into the walls, perhaps to hold various tools in place or hang equipment (Plate 16). There were no larger fixtures or fittings to suggest it has been used as a tack room. If it was not used for storing tools it may have been used to store fodder or roots for feeding animals or other stock that needed to be kept under shelter.

*Plate 15 (shot 22): Representative view of brick floor. Looking southeast, 1m scale*

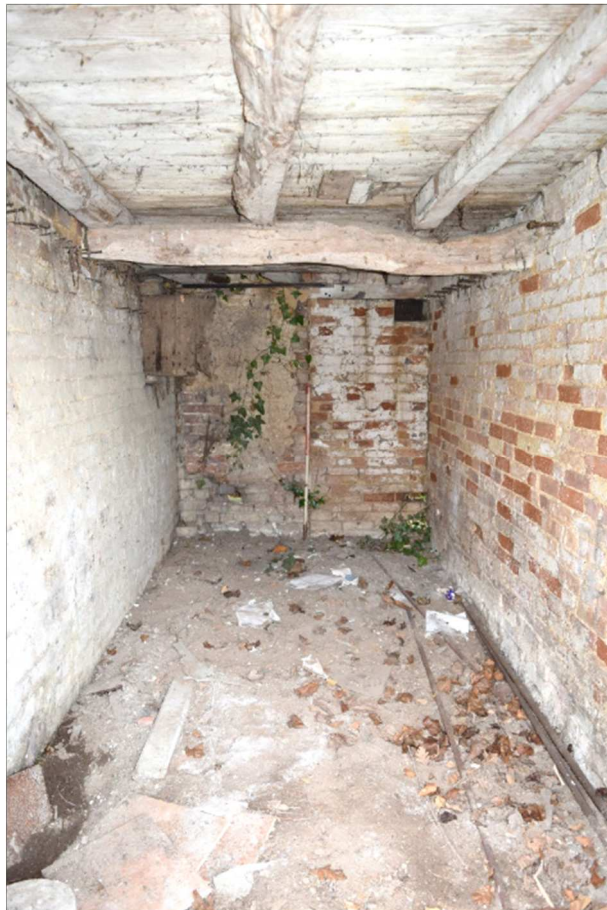
*Plate 16 (shot 29): General view of storage space. Looking southwest, 1m scale*

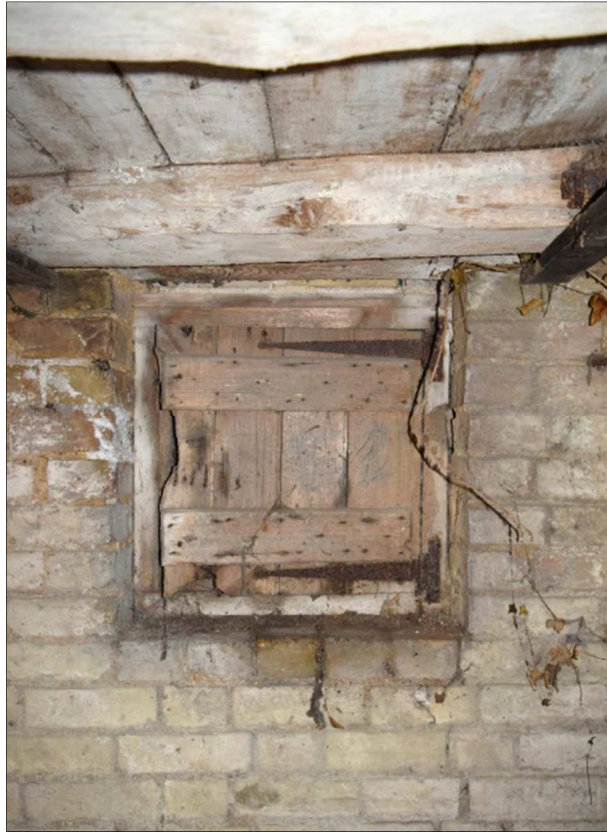
- 6.14 A small window into the adjoining Yellow brick barn was located towards the southeast corner suggesting there was a need for a direct link between these two buildings, emphasising the hypothesis that this was used as a storage (Plate 17).

*Plate 17 (shot 30): Window in storage room. Looking southeast*

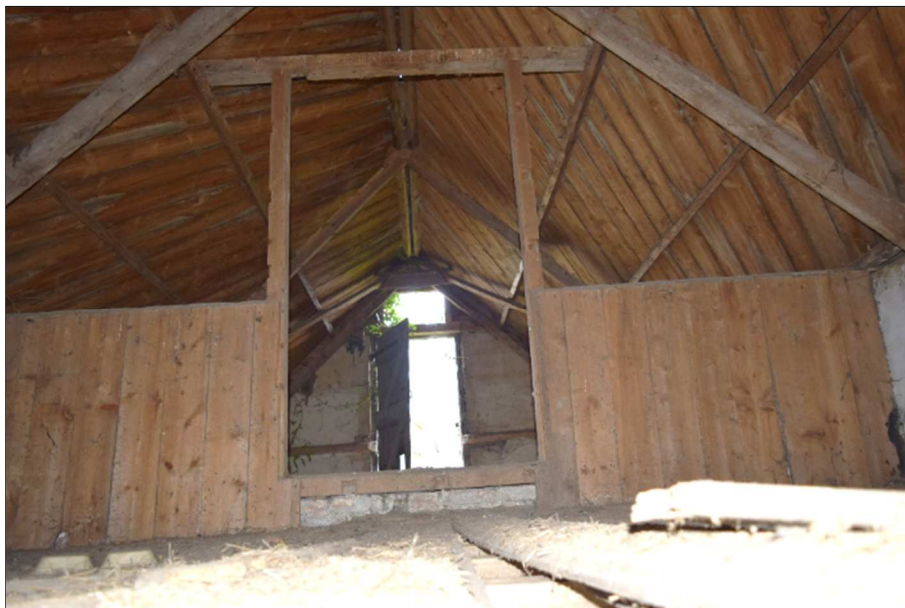
- 6.15 The loft spans the entire length of the barn. It was only possible to survey through holes in the ceiling. It revealed a wooden partition half way across the loft with a lower floor towards the south. Remnants of hay suggests it has recently been used for storage (Plate 18 and Plate 19). The roof structure consist of principal rafters with above purlins on top of which the roof has been completely boarded. The walls are plastered.

*Plate 18 (shot 24): General view of the loft showing remanence of hay. Looking northwest*

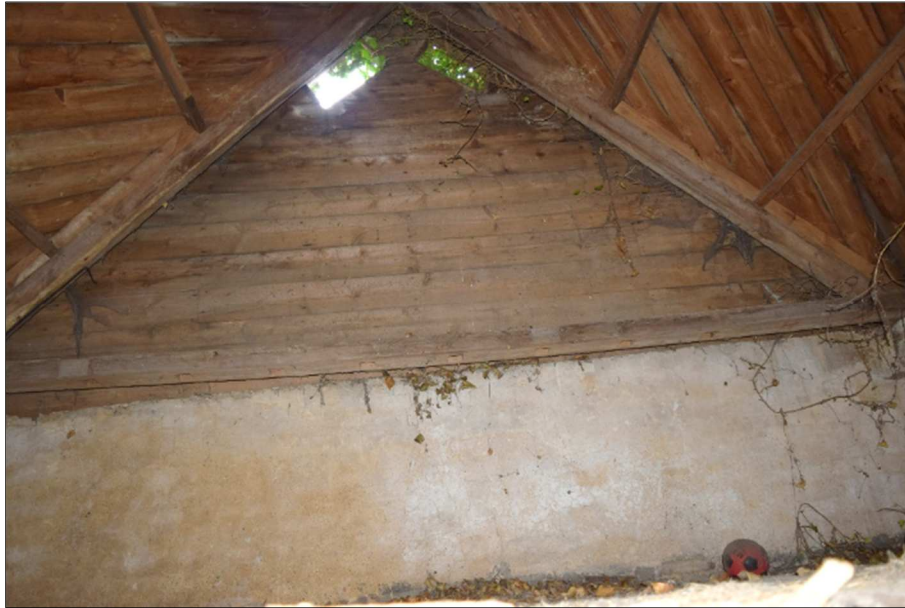
*Plate 19 (shot 25): General shot of the loft showing rendered walls. Looking southeast*

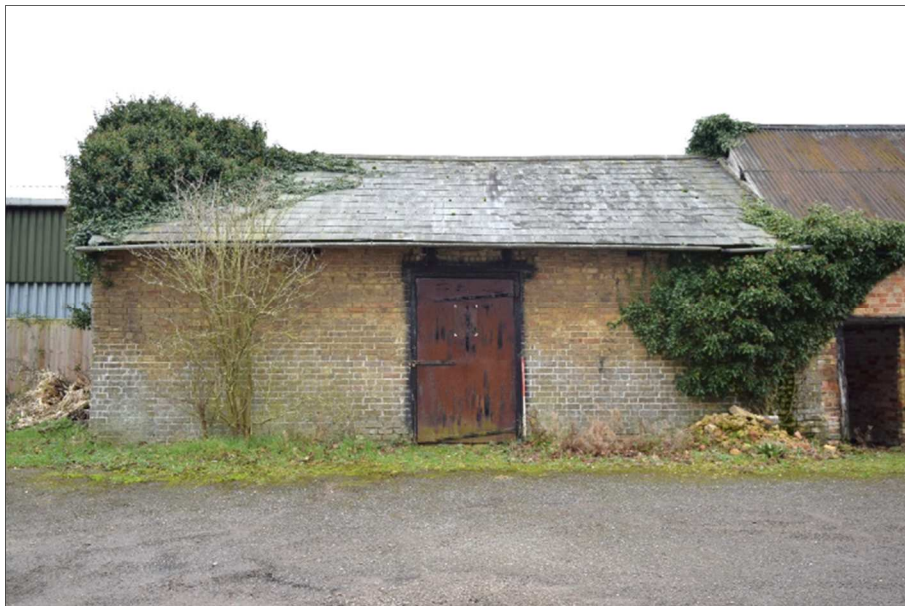
- 6.16 The yellow brick barn measures approximately 9m x 4.5m. It has been built in handmade Gault bricks in Flemish garden wall bond (Plate 20). The double pitched roof is covered in slates. Located to the front and back are two large openings, opposing each other. The majority of the southeast elevation was covered in vegetation and could not be surveyed in any more detail (Plate 21).

*Plate 20 (shot 7): Northeast elevation. Looking southwest, 1m scale*

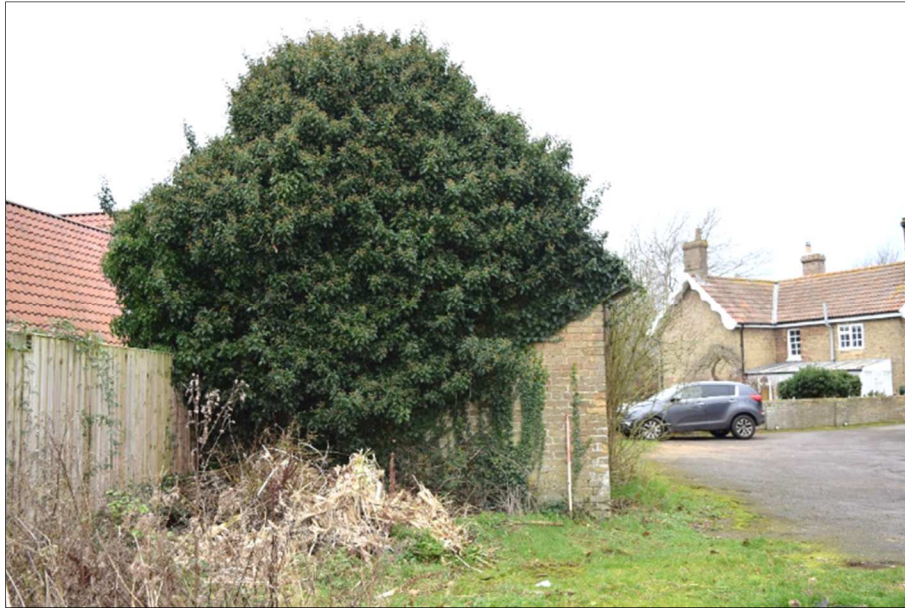
*Plate 21 (shot 8): Southeast elevation largely covered by vegetation. Looking northwest, 1m scale*

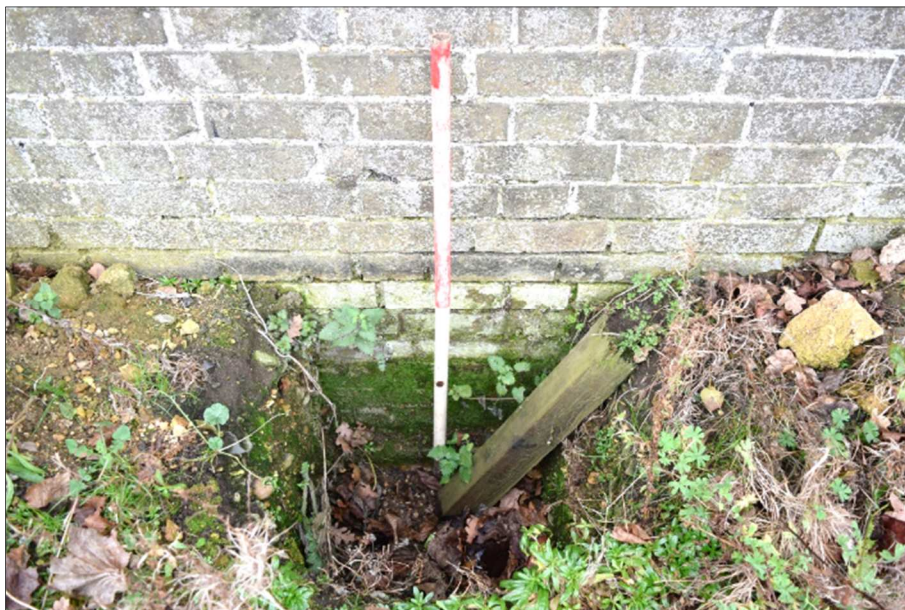
- 6.17 An inspection pit outside the northeast elevation showed a stepped foundation approximately 0.5m below the ground surface (Plate 22).

*Plate 22 (shot 37): Inspection pit revealing stepped foundation. Looking southwest, 1m scale*

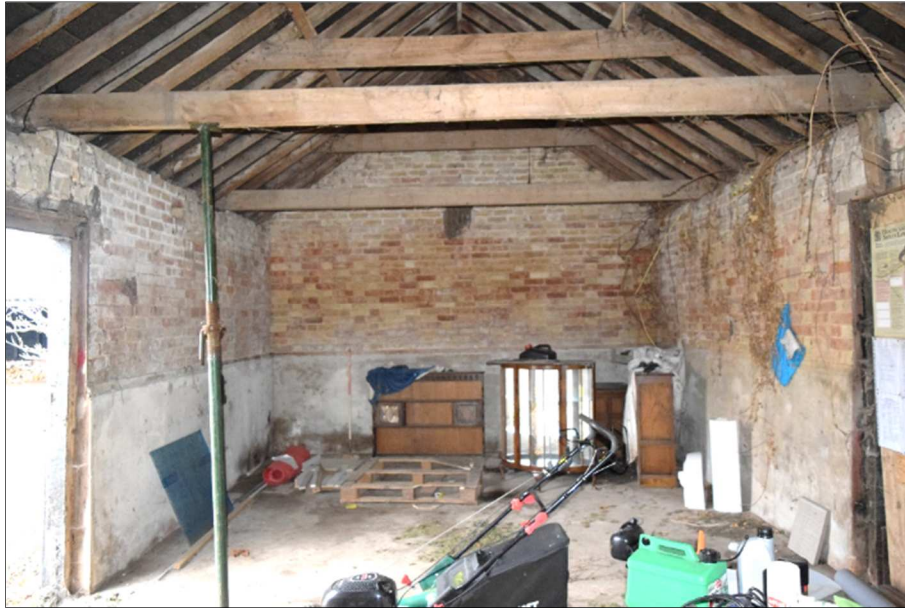
- 6.18 The interior of the barn has no subdivisions, and there is no loft (Plate 23 and Plate 24). No other openings apart from the two doorways and the small window to the adjoining storage has been observed, blocked or otherwise. The floor is of concrete and the walls have been rendered from the floor halfway up (Plate 25).

*Plate 23 (shot 31): General view of the barn. Looking southeast, 1m scale*

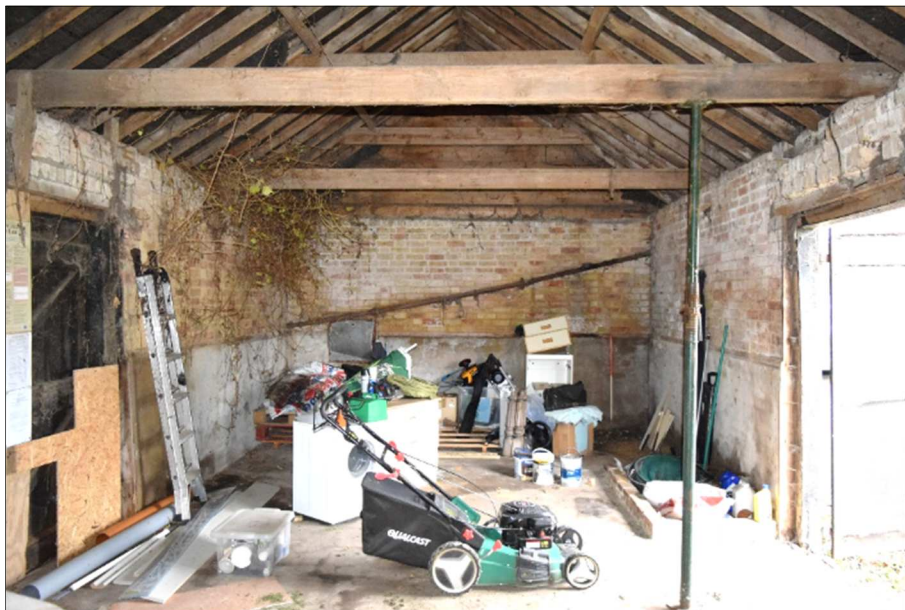
*Plate 24 (shot 32): General view of the barn. Looking northwest, 1m scale*

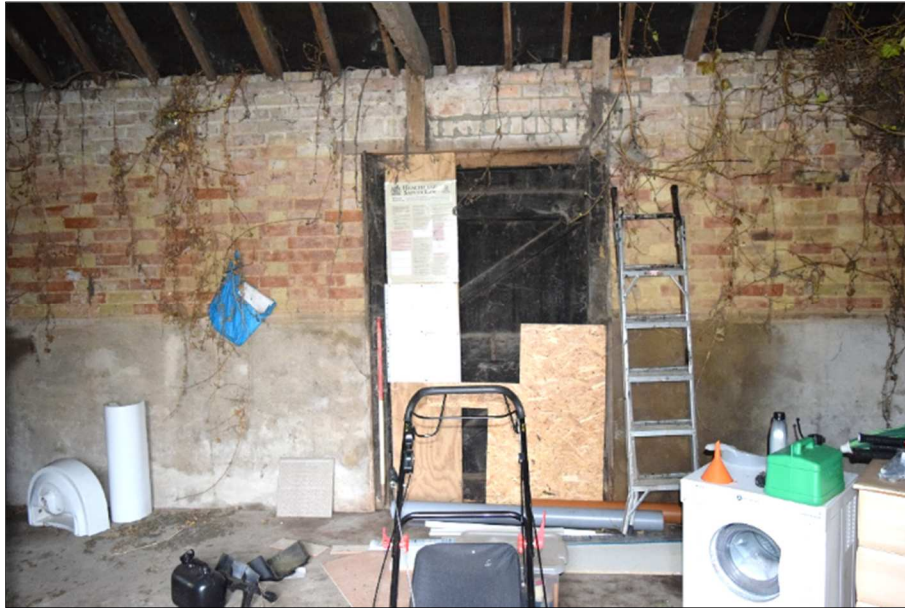
*Plate 25 (shot 34): Opening on southwest elevation. Looking southwest, 1m scale*
