**ARCHAEOLOGICAL EVALUATION REPORT:
TRIAL TRENCHING ON LAND AT DRAPERS PLACE, SPALDING, LINCOLNSHIRE**

Planning Reference: H16-0888-17
NGR: TF 24716 22594
AAL Site Code: SPDP 17
Museum Accession Number: LCNCC : 2018.1
OASIS Reference Number: allenarc1-311242

By
Allen Archaeology Ltd
Report Number AAL2018046

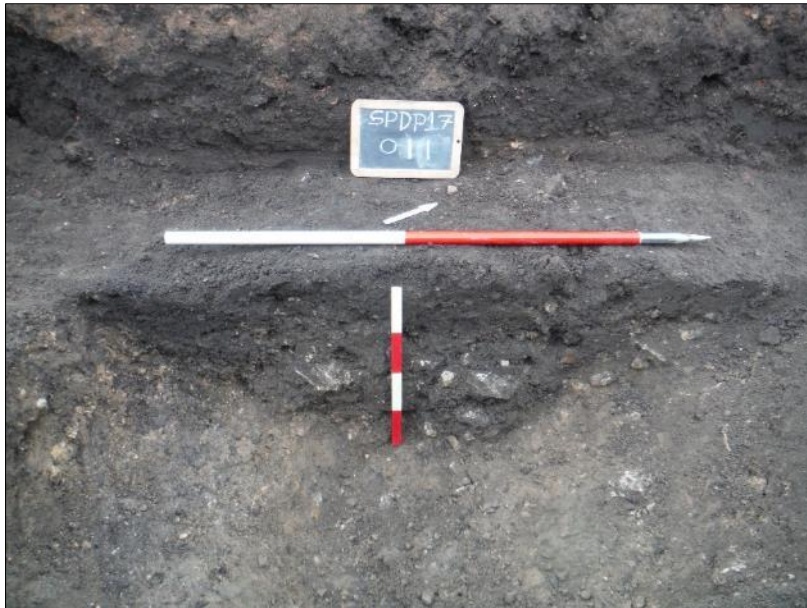
- 7.2 Several features were recorded cutting layer 103. Four shallow, truncated postholes were recorded in the trench, one of which, [114], cut a larger pit, [117]. A sherd of 19th to 20th century pottery was recovered from posthole [111], and two sherds, also of 19th or 20th century date were recovered from pit [117], along with two fragments of animal bone (Plate 1).

Plate 1: Southeast-facing section of posthole [114] and pit [117], scales 0.4m and 1m

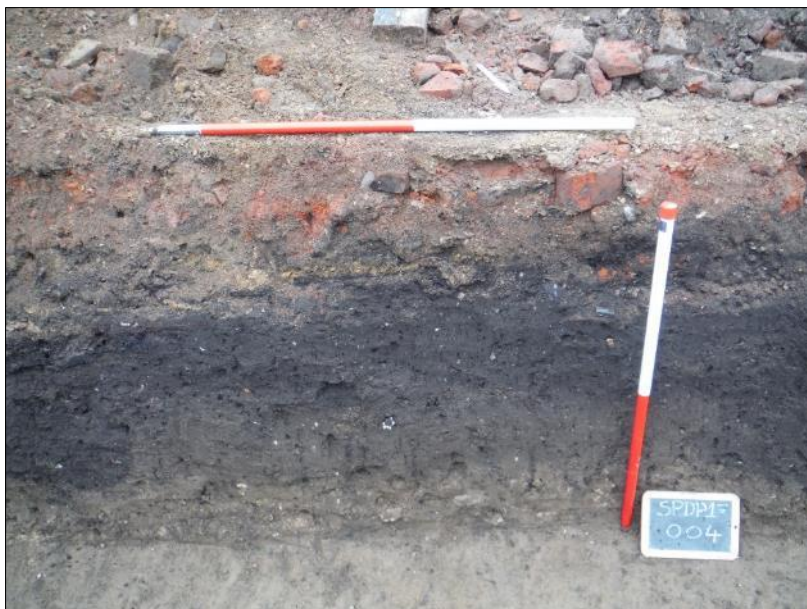
- 7.3 Trench 2 revealed a sequence of made ground deposits comprising the extant car park surface with underlying hardcore and rubble layer, 201, sealing sandy silt levelling layers 202 and 203, over a natural alluvial layer 204, exposed at c.0.9m depth (Figure 6). Further clean alluvial layers, 205 and 206 were recorded in a sondage at the southeast end of the trench.

Plate 2: Northeast-facing representative section in Trench 2, scales 1m

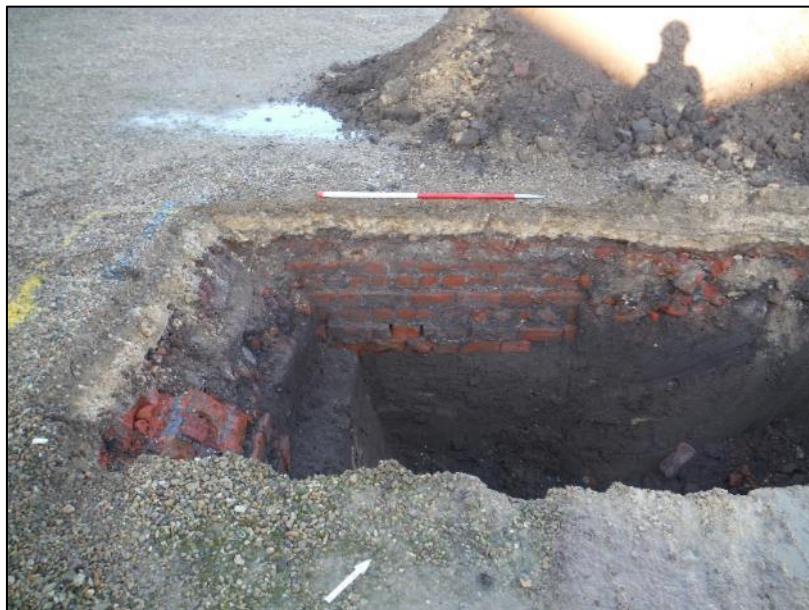
- 7.5 At the southwest end of the trench were the remnants of two brick walls, 302 and 303, extending to approximately 0.55m below the existing ground surface. Both walls had a stepped profile suggesting that they represent below ground wall foundations.

Plate 3: Southeast-facing section of 302, scale 1m

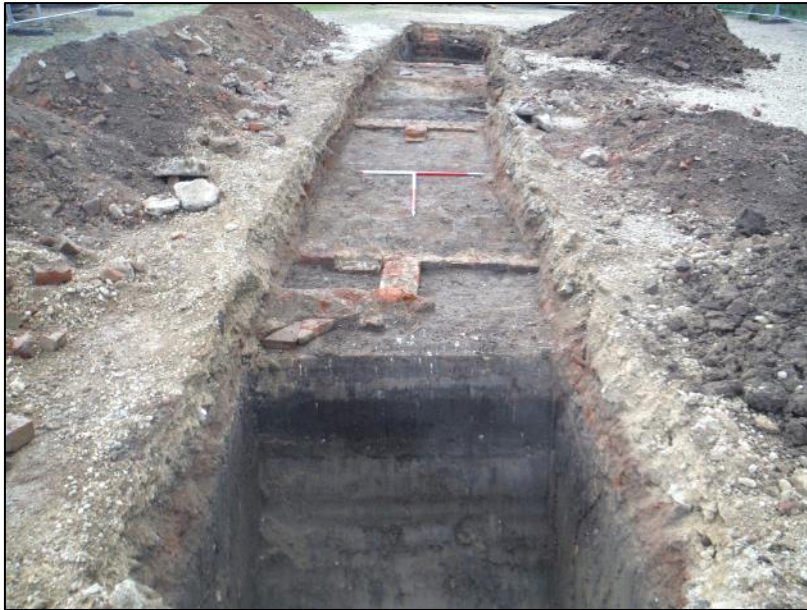
- 7.6 Aligned northwest to southeast across Trench 3 were a number of 19th century brick wall footings 304, 307, 308, 309, 310 and 312. Wall 304 again exhibited a stepped profile. Immediately to the northeast of 304, was a spread of grey mortar with occasional tile 305, and immediately to the northeast of this, was another spread of pale yellow mortar 306. These deposits may represent bedding layers for former floor or yard surfaces.

Plate 4: Northwest-facing shot of Trench 3, scales 2 x 1m

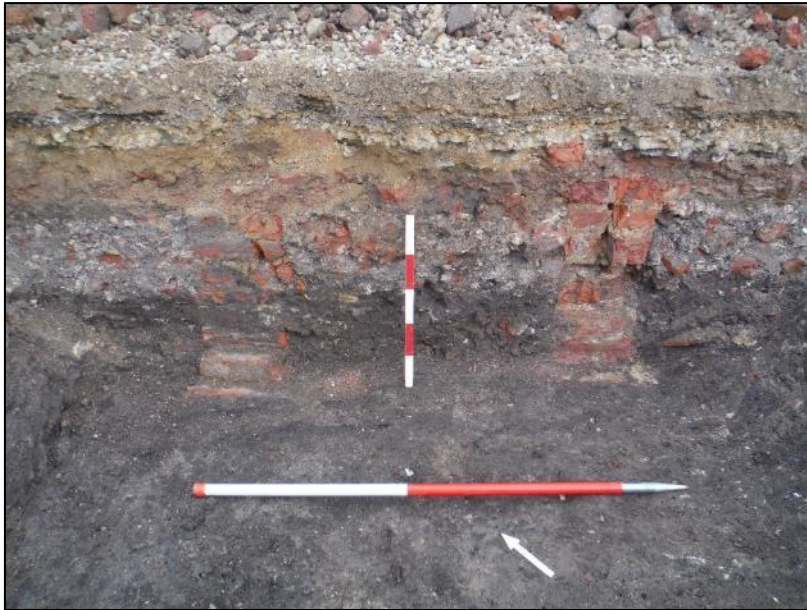
- 7.9 Southeast of 406 two sections of vertical brick wall, 407 and 408 were exposed in the southwest facing section of the trench. The two walls were approximately 0.9m apart, and may represent two sides of a fireplace or chimney base.

Plate 5: Southwest-facing section of Trench 4 showing chimney place footings 407 and 408. Scales 1m, 0.50m

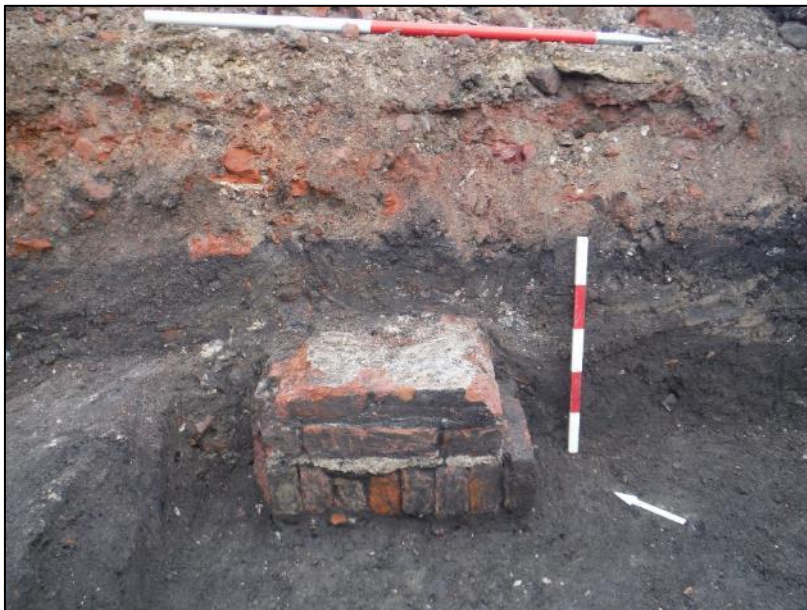
- 7.11 Approximately 2m to the southeast of 412, extending from the northeast trench edge was part of a 19th to 20th century brick wall footing 413. Roughly 1.5m to the southeast of 413, again extending from the northeast trench edge was the remains of a square brick structure 414, possibly representing a gate post or wall terminal. At the very southeast end of the trench, again extending from the northeast edge of the trench was a circular brick structure 415, with domed superstructure, probably representing a brick-lined soakaway.

Plate 6: Gate post 414, scales 1m, 0.50m

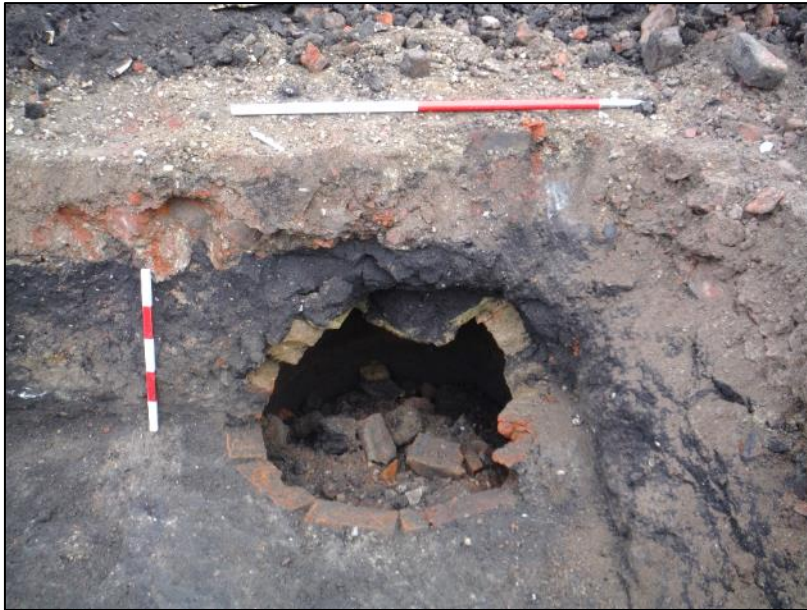
Plate 7: 19th to 20th century soakaway 415, scales 1m, 0.50m

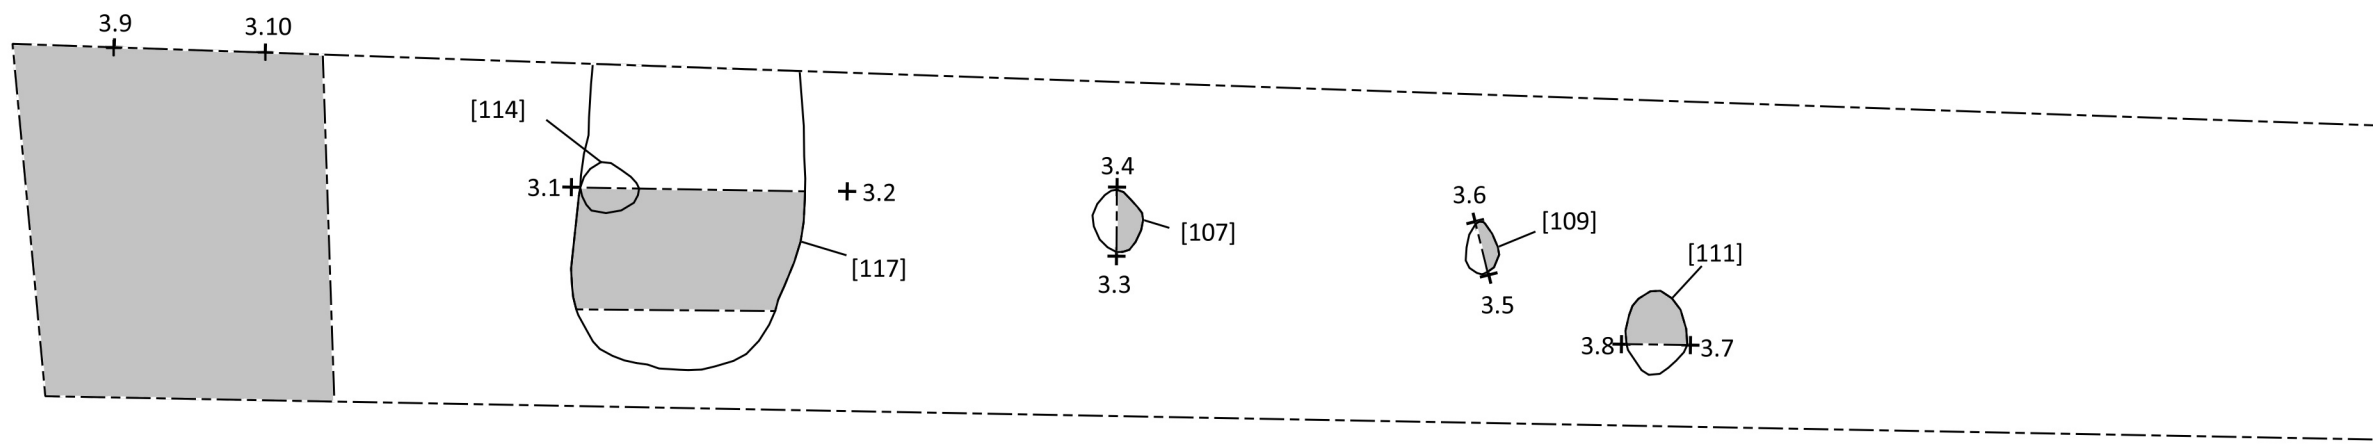
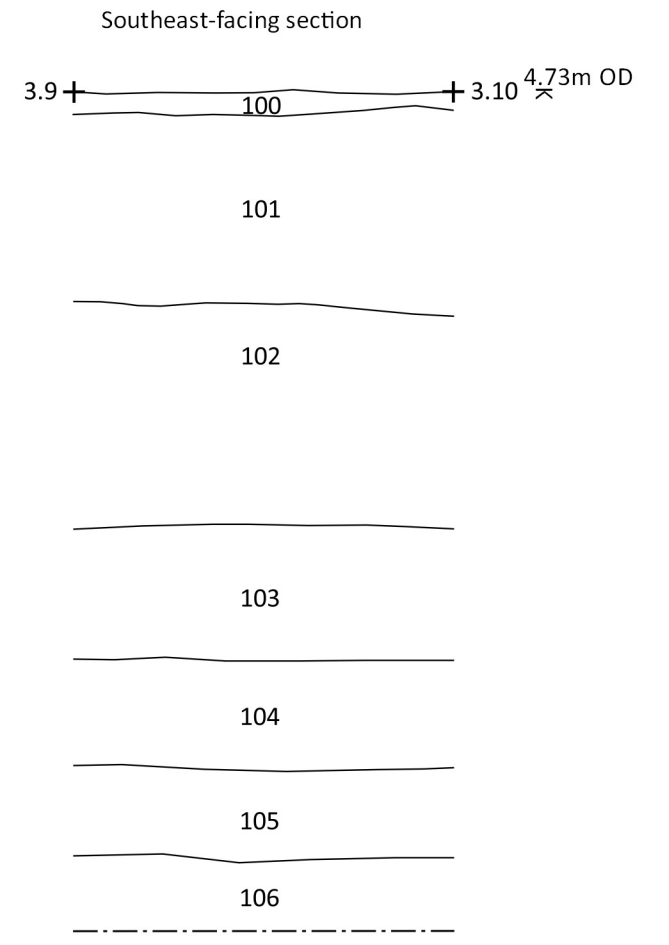
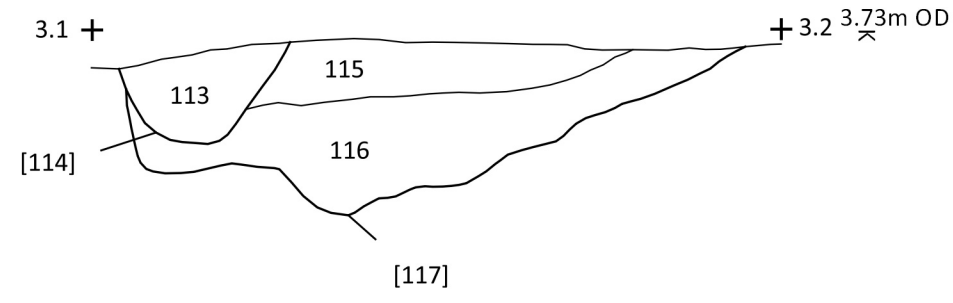
Figure 3: Plan and sections of Trench 1

- 7.1 Trench 1 was located towards the centre of the proposed development area, aligned northeast to southwest (Figure 3). Beneath the car park surface was a deep levelling layer of hardcore and rubble, 101, sealing a layer of grey sandy silt, 102, with frequent small ceramic building material fragments. Beneath this, at c.0.8m below the existing surface was a 0.35m thick layer of brown clay, 103, which seals other natural alluvial deposits, 104 – 106. Three sherds of pottery of 19th to 20th century date were recovered from 103, along with a single sherd dating from 13th to 14th century.

Southeast-facing section of posthole [114] and pit [117]

Northeast-facing section of post hole [107]

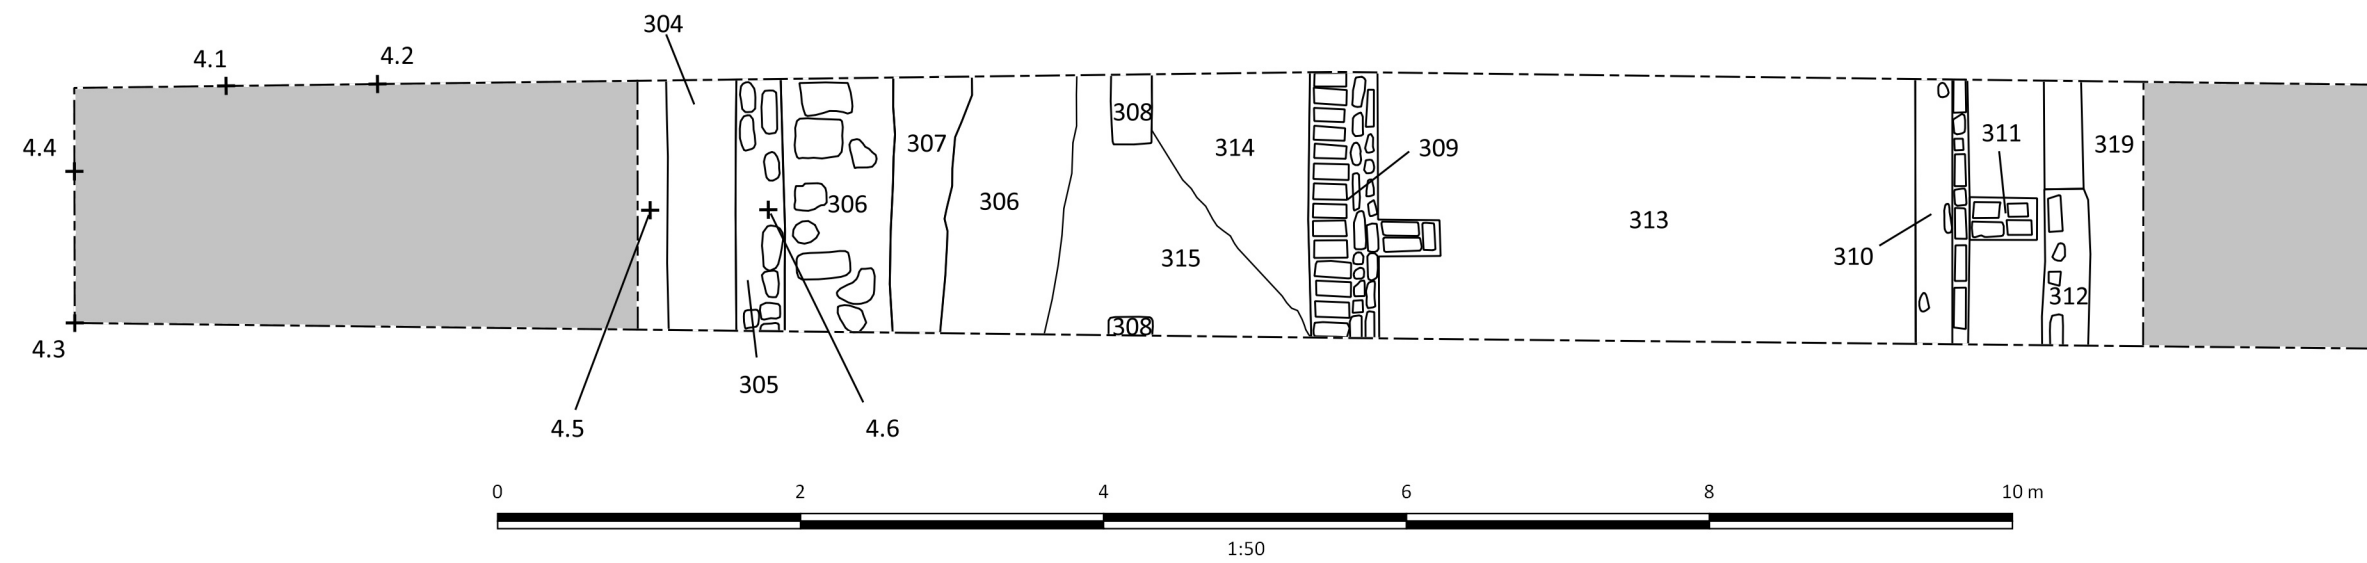
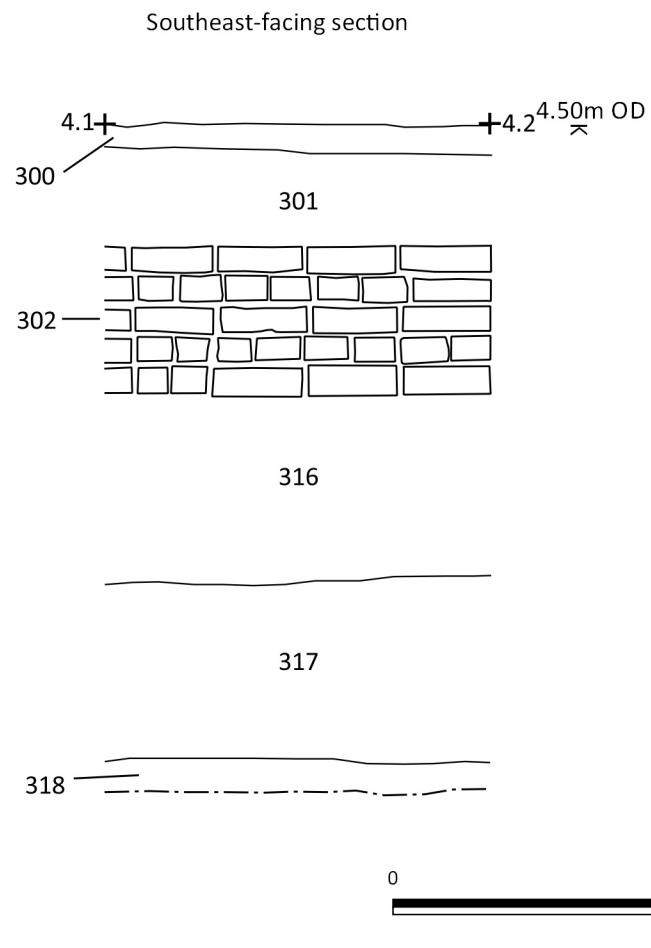
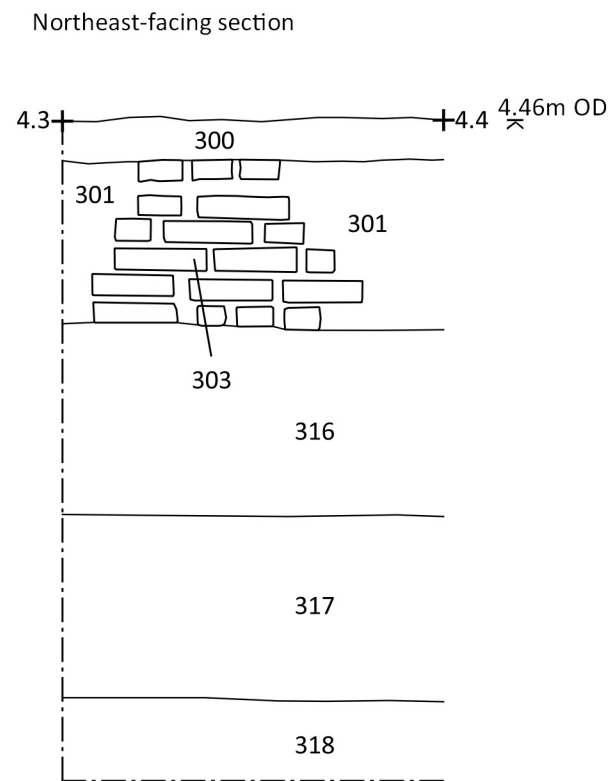
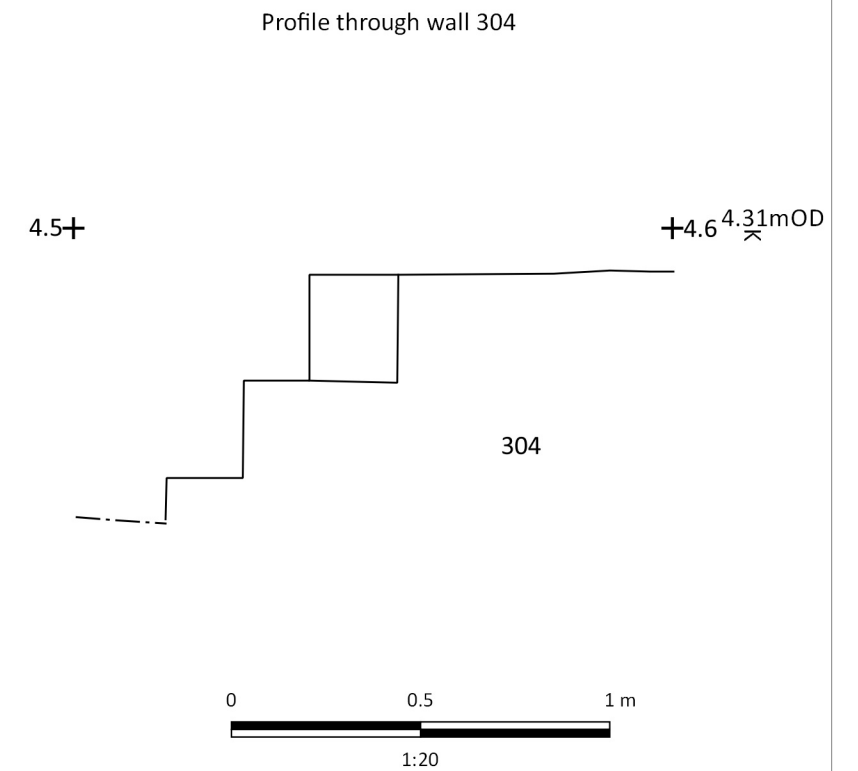
Figure 4: Plan and sections of Trench 3

- 7.4 In Trench 3 the 0.05m thick gravel car park layer 300, sealed a 0.04m thick hardcore layer 301, which sealed a number of 19th century levelling layers of grey/brown silts and clays, 313 – 317, over a natural alluvial layer 318, which extended below the limit of excavation at c.1.75m (Figure 4).

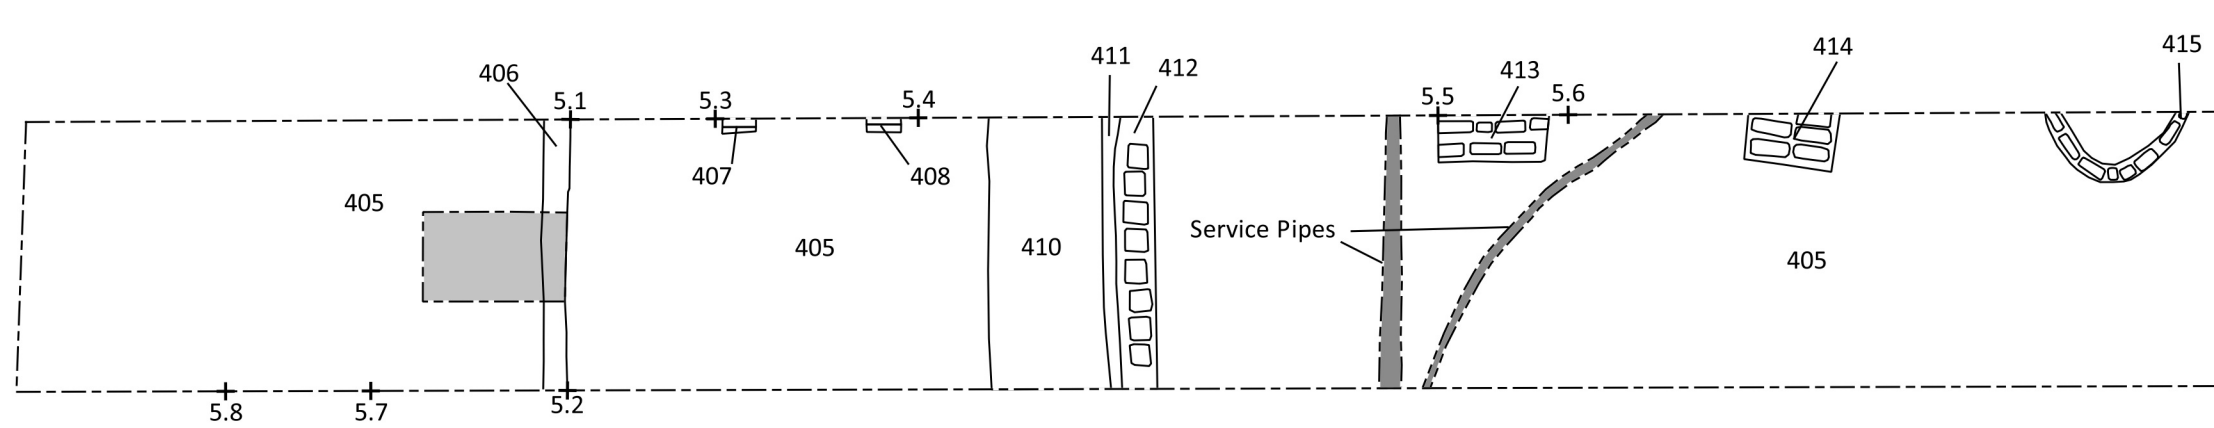
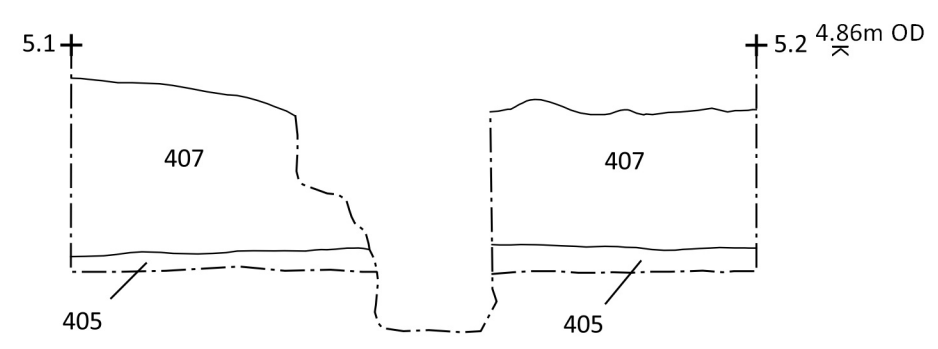
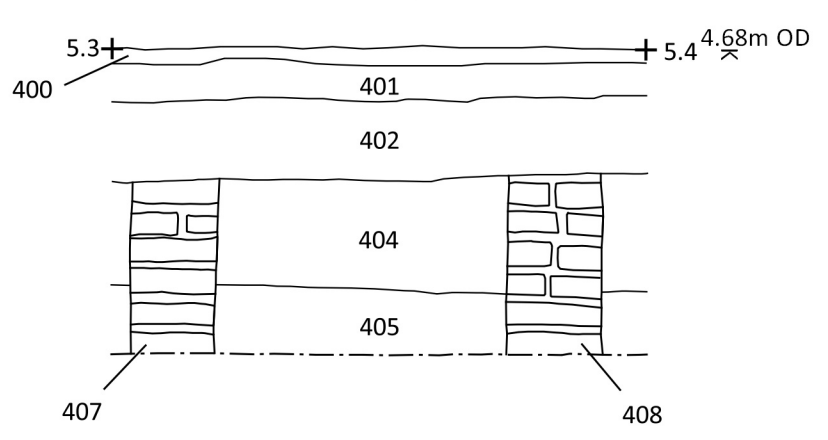
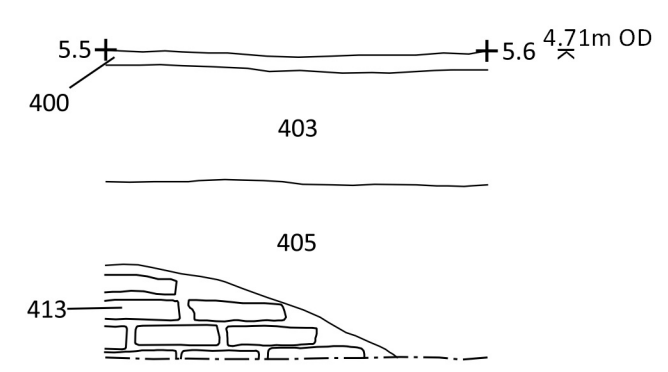
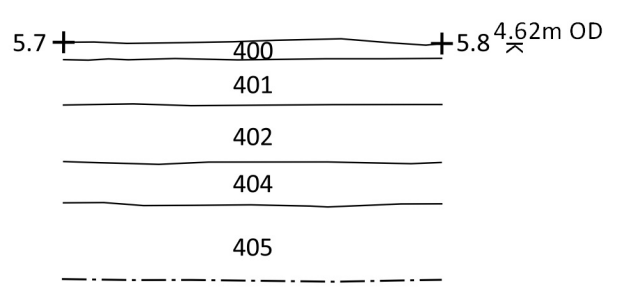
Figure 5: Plan and sections of Trench 4

- 7.7 In Trench 4 a 0.05m thick car park gravel layer 400 sealed a 0.04m thick hardcore layer 401 (Figure 4). This sealed levelling layers, 402, 404, and 405.

- 7.8 Aligned northeast to southwest across Trench 4, were several 19th to 20th century brick wall footings 406, 410 and 412. Wall 406 had a stepped profile suggesting it represented the foundation courses of a former building, the base of which was at c.0.55m below the existing ground surface.
