- 1.1 Allen Archaeological Associates was commissioned by Oasis Residential Limited to undertake a photographic survey of a complex of agricultural buildings that are being converted into residential units at Hall Farm, Main Street, Honington, Lincolnshire.
- 1.2 The methodology conforms to a specification prepared by this company (Clay 2007), the English Heritage guidelines in *Understanding Historic Buildings: A Guide to Good Recording Practice* (English Heritage 2006), and the local guidelines in the *Lincolnshire Archaeological Handbook: A Manual of Archaeological Practice* (LCC 1998).
- 1.3 A copy of the building survey report and the full project archive will be submitted to the local museum in Lincoln, 'The Collection', for long-term storage, and will be stored under the Museum Accession Number 2007.174.

- 3.1 A planning application has been submitted for the conversion of the existing barns into four new dwellings (Planning Reference S/04/1622/43). As a condition of planning, South Kesteven District Council has requested the undertaking of a photographic survey of the buildings prior to the undertaking of any works.

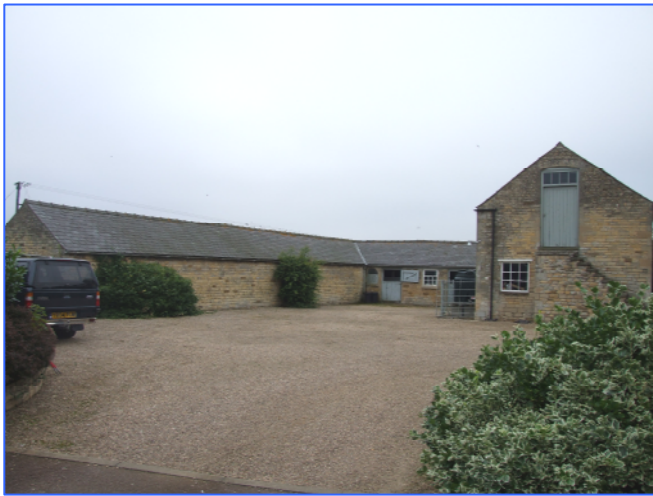
Plate 1: General view of the northern part of the barn complex, looking south-west towards granary Building A, stable block Building B, and the north wall of the cart shed Building C.

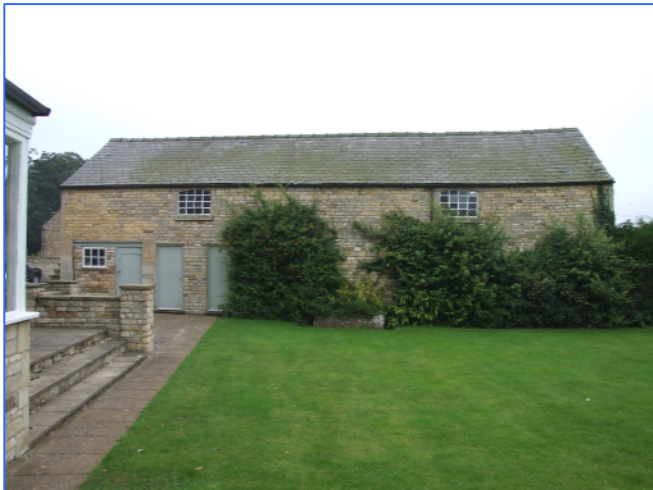
- 5.2.2 Another similar opening has been partially blocked with stone in the north elevation, and replaced by three doors and a window. In the centre of this blocked opening is a pillar of ashlar blocks, which is probably an original feature. Much of the remainder of the north elevation is obscured by vegetation. A further door, which appears to be original, is evident in the west elevation.

Plate 2: North elevation of granary Building A, looking south-east. The door and window at the east end of the elevation, and possibly the two adjacent doors, have replaced an opening into the cart shed.

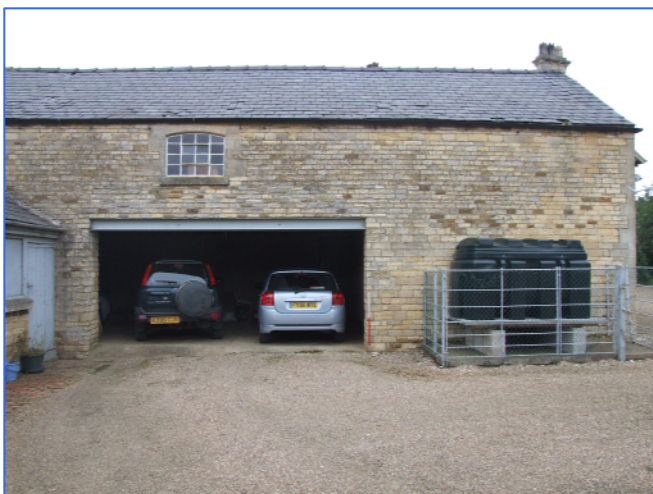
- 5.2.1 This building was a large two storey structure, measuring approximately 16.4m by 5.8m. It has saw tooth quoins of neatly dressed ashlar blocks on the external corners of the building. The ground floor is likely to have been used as a cart shed, as suggested by the large opening in the south elevation. It currently has a new concrete floor and is in use as a garage and store. A septic tank stands on a concrete plinth immediately to the east of this opening.

Plate 3: South elevation of the granary/cart shed Building A, looking north-north-west.

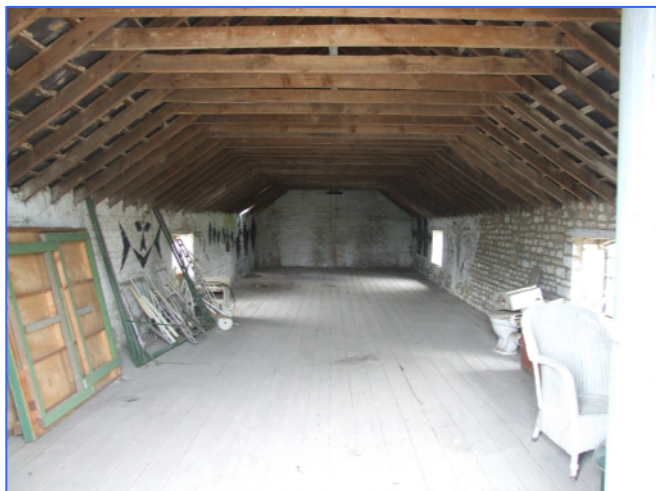
- 5.2.3 Stone steps at the east end of the building allowed access to the upper storey, which was probably used as a granary or hay loft to store feed for the horses. Such an arrangement is paralleled in farm buildings of this date throughout England, with the granary close to both the farmhouse and the stables (Brunskill 2004). The upper storey has two windows in the north elevation and one in the south elevation, all with large stone sills and segmental arches of ashlar blocks and a saw tooth arrangement of ashlar blocks on each side. The interior of the building has no other features of note.

Plate 4: Upper storey of granary/cart shed, looking west-south-west.

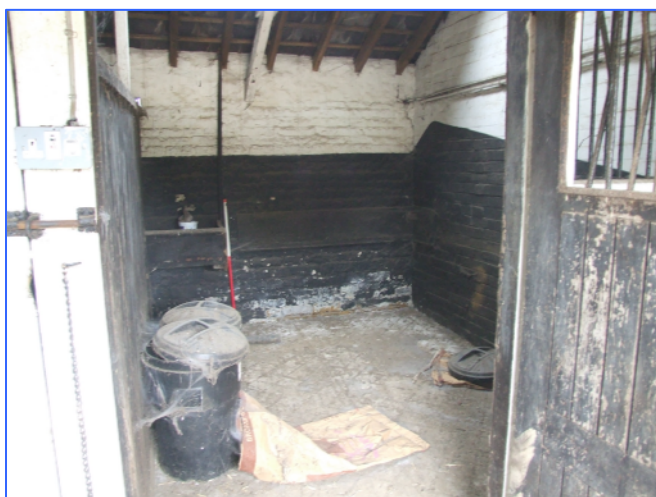
- 5.3.4 The stable block comprises four stalls, each fronted by wooden panelling and a door with an iron grille. The lower parts of the walls of all four are painted black with white paint above. There are two wooden stable doors in the east elevation, each with a window to its south. The northern window has an ashlar sill and lintel and is divided by wooden mullions and transoms into six small lights (small panes of glass) in the lower part of the window and a single large light at its top. The southern window also has an ashlar sill and a semi-circular arch of ashlar blocks, and is filled with a metal grille.

Plate 5: Interior of one of the stable blocks at the north end of Building B. Looking west.

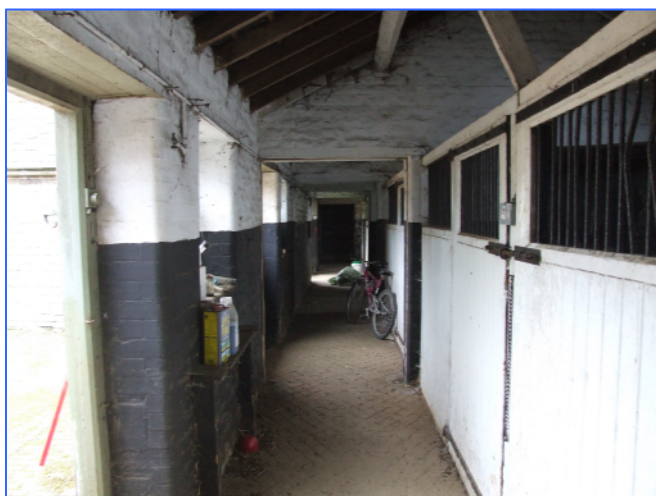
- 5.3.3 The remainder of the block comprises a single large room with a corridor running along its east side, divided into a series of bays principally by stone partitions; although the partition between the two northernmost stalls in the stable block is of wood.

Plate 6: View along the corridor running the length of Building B. Looking south-south-east.

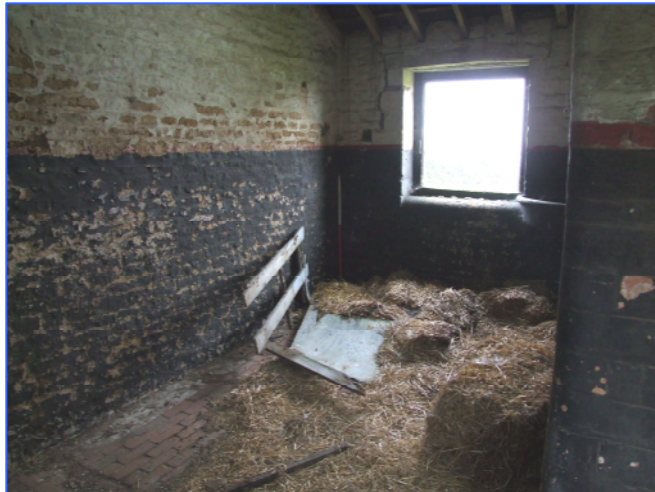
- 5.3.6 To the south of the stable blocks is a range of four buildings, all of which open at their east ends onto the corridor that runs the length of the building. The northernmost room appears to have been used as a storage area, with a window in the west wall.

Plate 7: Possible storage room in Building B. Looking south-west.

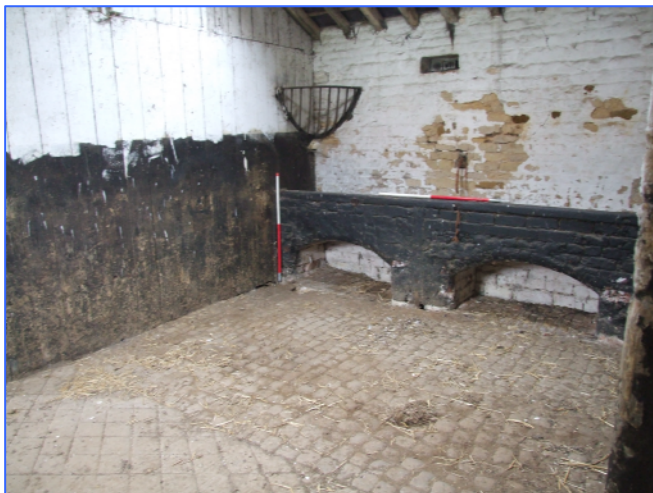
- 5.3.7 The remaining three rooms to the south of this are identical in form, with an arched feeding trough against the west wall. The western part of the floor in each room is of noticeably rougher construction than the eastern part, and slopes down to the east, to facilitate the clearing away of waste.

Plate 8: Room at the south end of Building B, probably used as an animal shelter/feeding room. Looking south-west towards feeding troughs on the west wall.

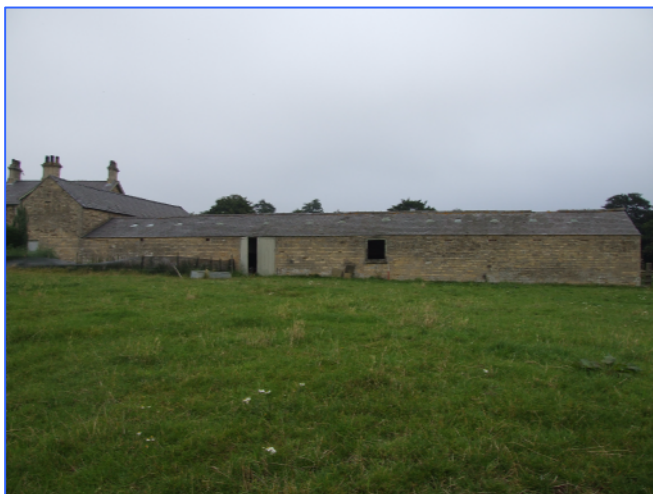
Plate 9: West elevation of Buildings A and B, looking north-east.

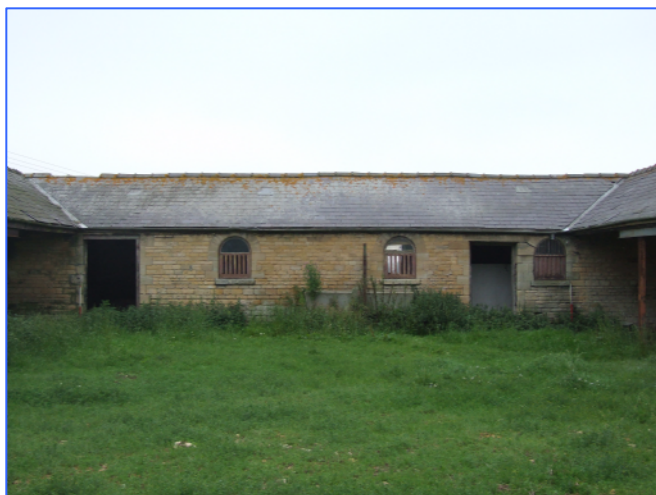
- 5.3.8 In the east elevation of this range there are two openings for doors (the doors themselves are missing), and there are four windows, all of which have an ashlar sill, with a semicircular arch of ashlar blocks. All the windows have a steel grille instead of glass in the lower part, and a semi-circular light of frosted glass in the upper part.

Plate 10: Southern part of the east elevation of Building B, between cart shed Buildings C and D. Looking west-south-west.

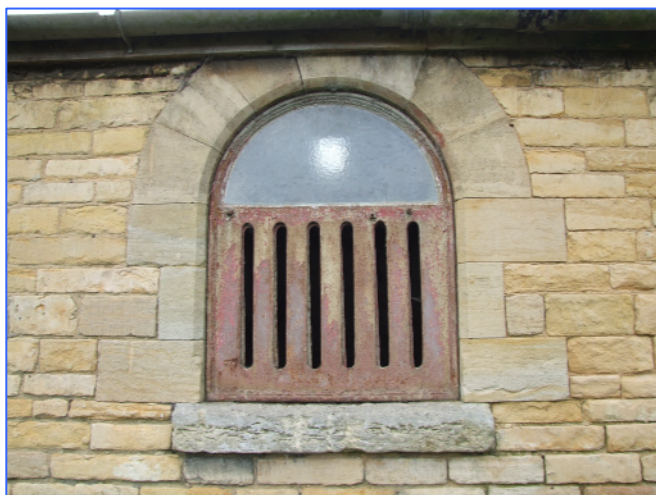
Plate 11: Detail of window in east elevation of Building B. Looking west-south-west.

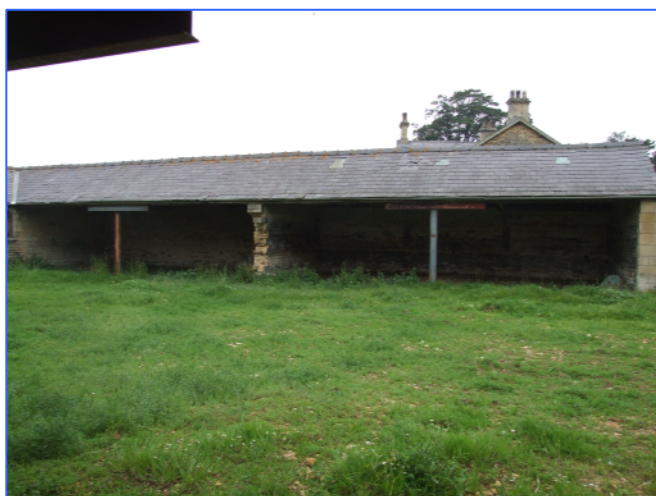
- 5.4.1 This building (along with Building D) forms one of two cart sheds extending eastwards from the east elevation of Building B. It is approximately 20m long and 4.8m wide. The building is divided into two by a central brick wall and is open on its south side apart from two steel girders supporting the roof. A stone boundary wall runs north-eastwards from the north-east corner of the building.

Plate 12: South elevation of cart shed Building C, looking north-north-west.

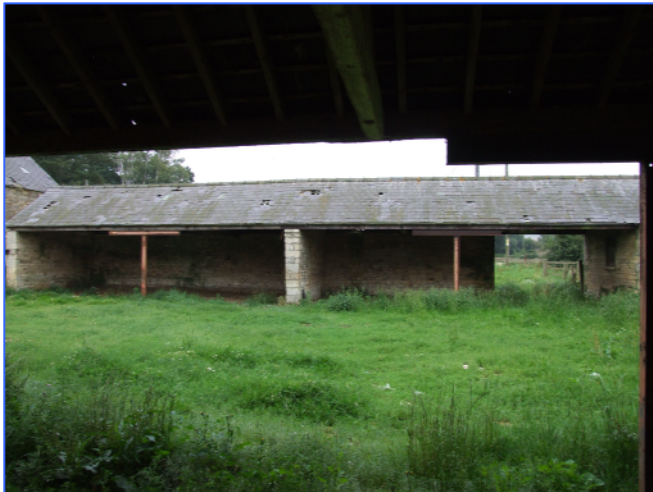
Plate 13: North elevation of cart shed Building D, looking south-south-east. Note the opening at the rear of the building allowing access to the fields beyond.

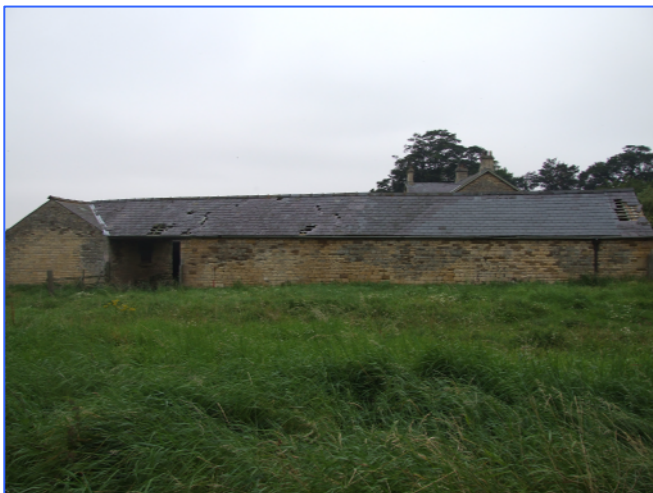
- 5.5.1 Building D was largely identical to Building C, being 20m long and 4.8m wide with a central stone dividing wall and two steel girders supporting the roof. The only major difference was that there was a further large opening in the south elevation allowing access for carts.

Plate 14: South elevation of cart shed Building D and Building B, looking north-north-west.

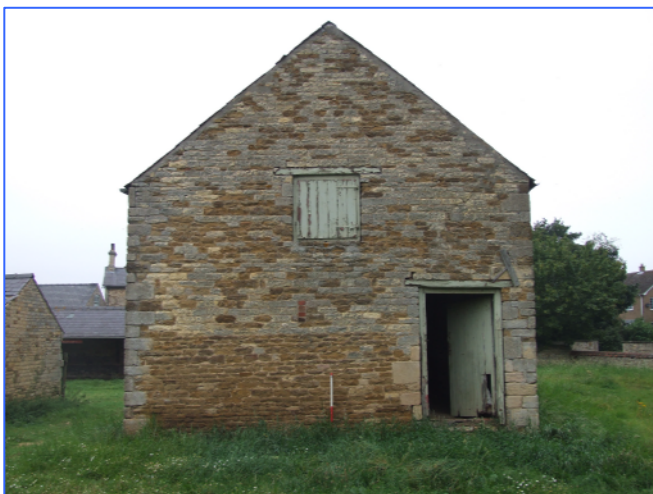
5.6.3 The interior of the barn is a single open room, with a wooden hayloft at the north end. It is likely that this hayloft originally extended the length of the building to form an upper storey as there is a pitching hole is visible at first floor height in the south elevation.

Plate 15: South elevation of threshing barn Building E. Looking north-north-west.

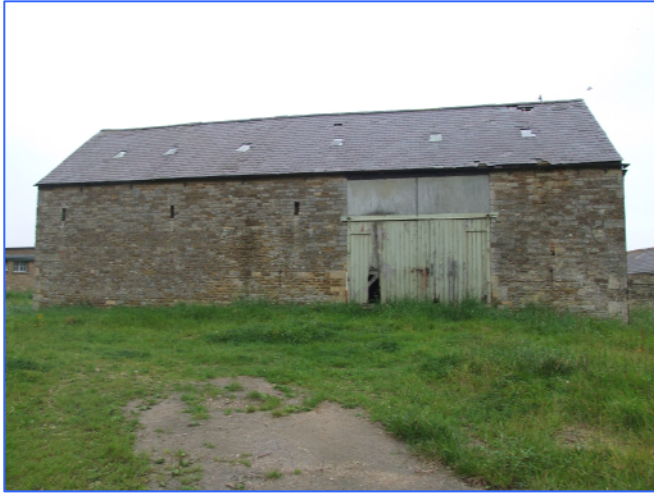
east elevation is a large wooden double door above which is a concrete repair. These two opposing doors are likely to represent either side of a former threshing floor, where the through flow of air was necessary to blow away the chaff, leaving the wheat behind.

Plate 16: East elevation of threshing barn Building E. Looking west-south-west.

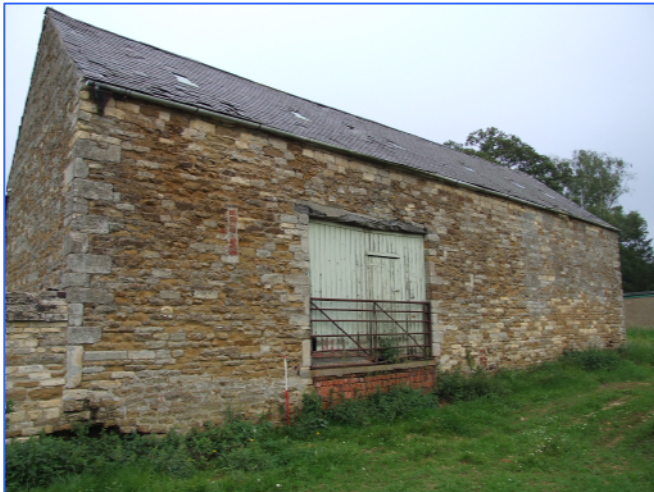
5.6.4 A number of ventilation slots have been blocked in the east, west and south elevations of the barn.

Plate 17: West elevation of threshing barn Building E. Looking east-south-east.

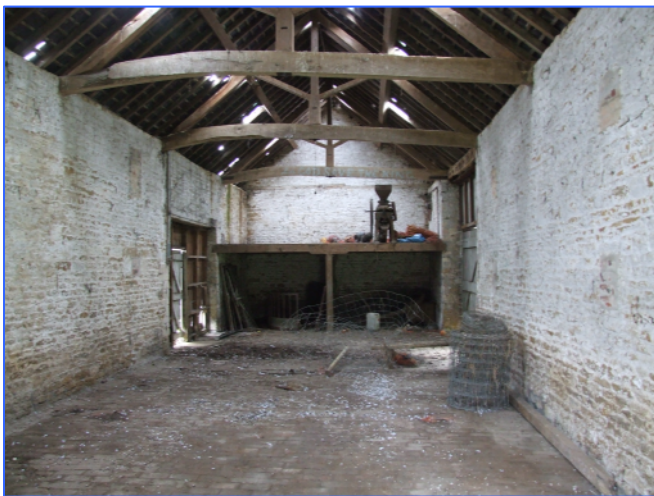
Plate 18: Interior of threshing barn Building E. Looking north-north-west.
