**ARCHAEOLOGICAL MONITORING AND RECORDING REPORT:**

**FLOOD ALLEVIATION WORKS: BUGBROOKE BROOKE, NETHER HEYFORD, NORTHAMPTONSHIRE**

By  
Allen Archaeology Limited  
Report Number AAL2018060

April 2018

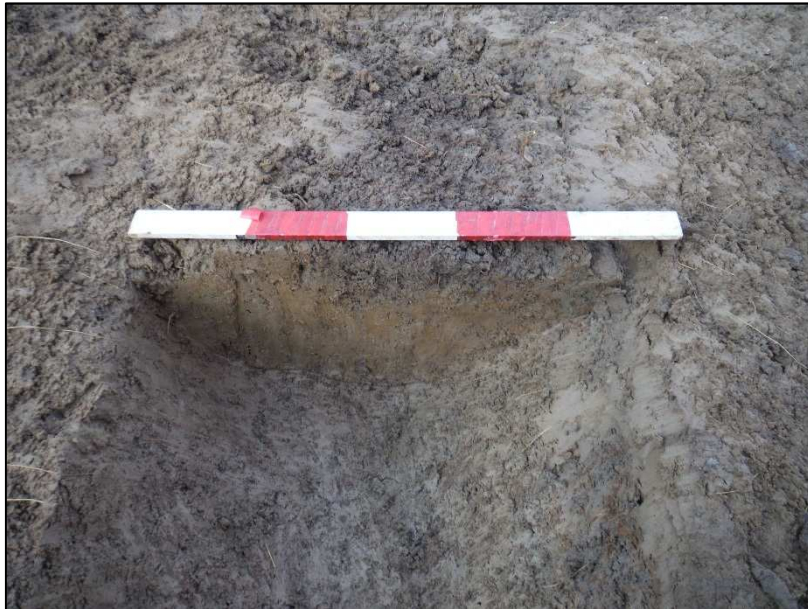
7.2 Feature [104] (Figure 3), was a shallow gully aligned north to south, probably representing a drainage feature (Plate 1). No finds were recovered from the mid reddish grey silty clay fill, 103.

*Plate 1: South-facing section of [104], scale 0.50m*

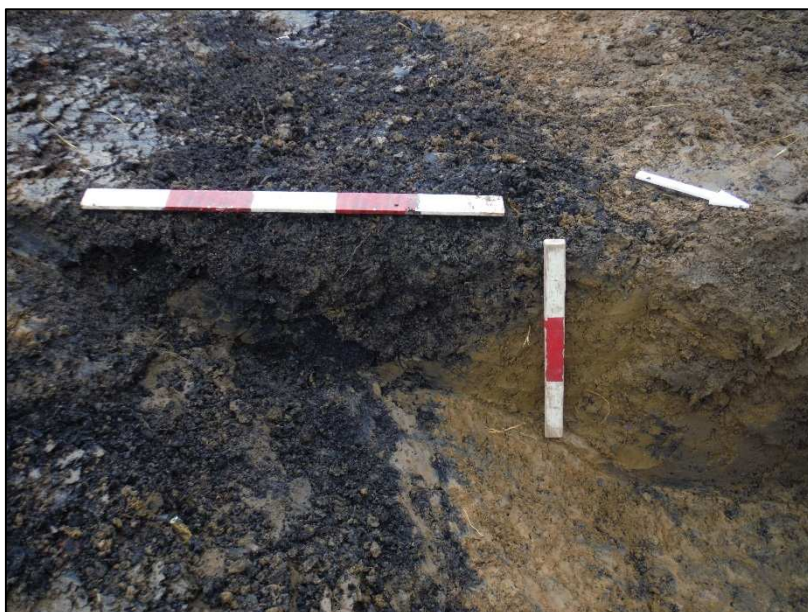
7.3 Sub-circular pit [106] was filled by a black silty clay, 105, containing modern rubbish along with burnt tree roots and wood (Plate 2). Due to its obviously modern nature this feature was not fully excavated (Figure 4).

*Plate 2: Northeast-facing section of [106], scales 0.5m and 0.3m*

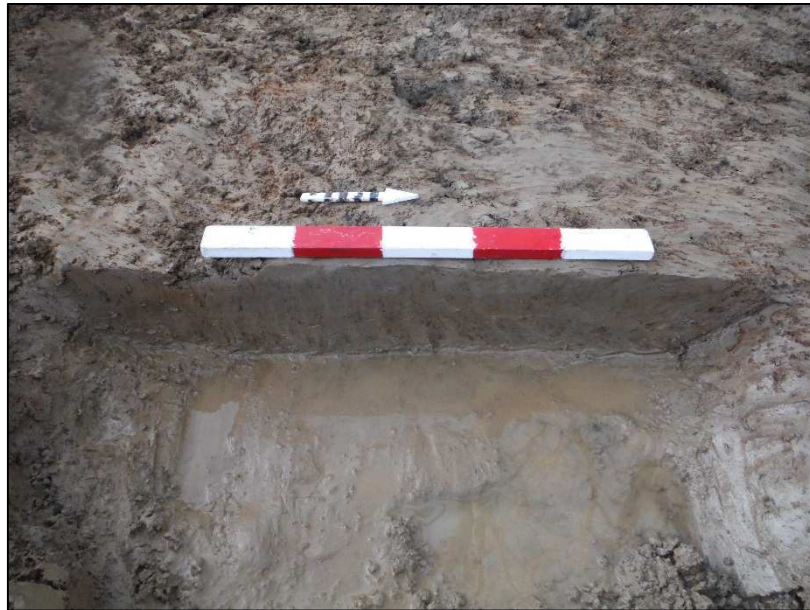
7.4 Linear feature [117] was roughly aligned east to west (Figure 5). It contained two fills, an upper light bluish grey silty clay, 115, and below this a mottled mid reddish grey sandy silt, 116. No

dateable evidence was recovered from either of the fills. This feature was at the level of the river and it was not possible to fully excavate it due to rapid water ingress (Plate 3).

*Plate 3: West-facing section of [117], scale 0.5m*

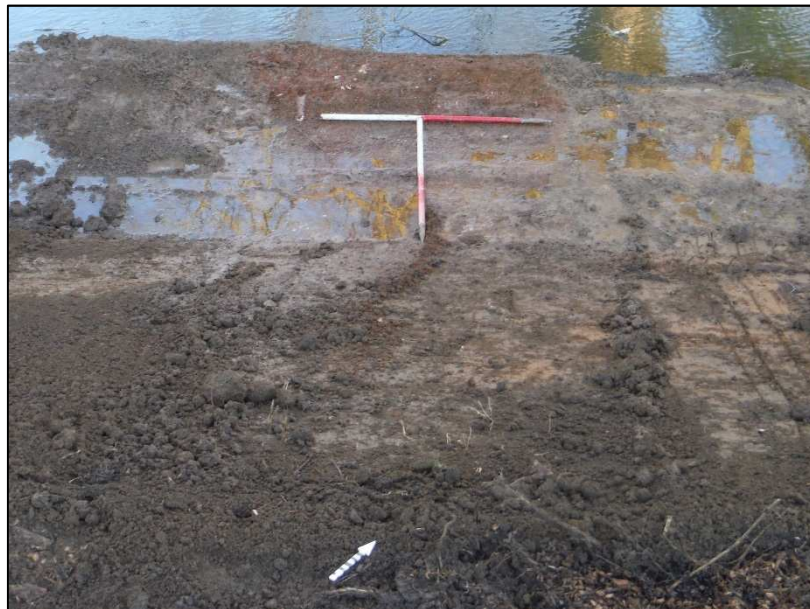
- 7.5 Aligned northwest to southeast, linear feature [120] was clearly modern, with frequent modern pottery sherds within the mid red sandy gravel fill, 119 (Figure 6). This feature was at the level of the river and it was not possible to excavate it (Plate 4).

*Plate 4: Plan view of [120] looking northwest, scales 2 x 1m*

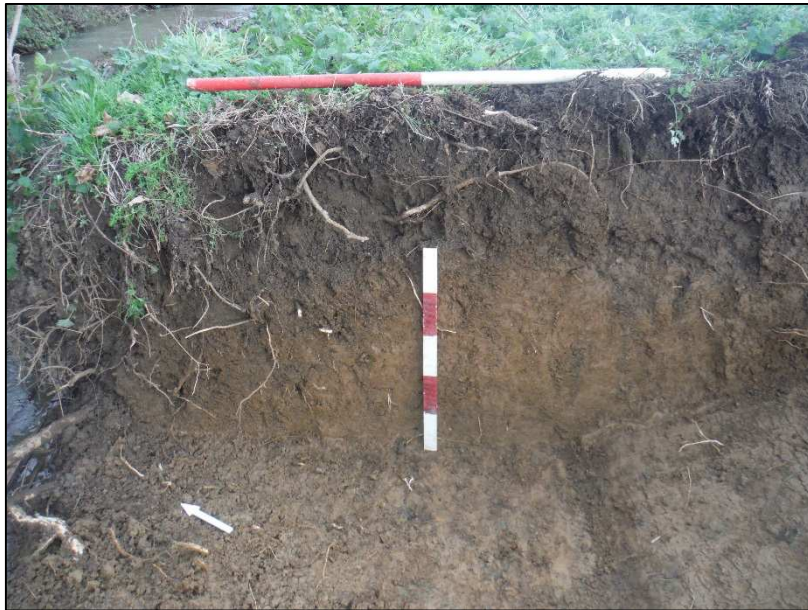
- 7.6 As removal of the overburden for the berm was carried out, representative sections were recorded at various places along the river bank to identify layers that were to be removed (Figure 7). The northern part of the area (Sections 1–4) revealed a series of deposits: topsoil, subsoil and natural geology. The topsoil was a firm, mid brown silty clay, 100, approximately 0.52m thick. This sealed a mid reddish brown silty clay, 101, also approximately 0.52m thick. Below this layer was a firm mid yellow slightly silty clay natural, 102. Roman pottery and ceramic

building material recovered from the topsoil, 100, approximately 30m to the northeast of Section 3 (Figure 2), is likely to be associated with the nearby villa.

*Plate 5: Northeast-facing section 3, scales 1m and 0.5m*

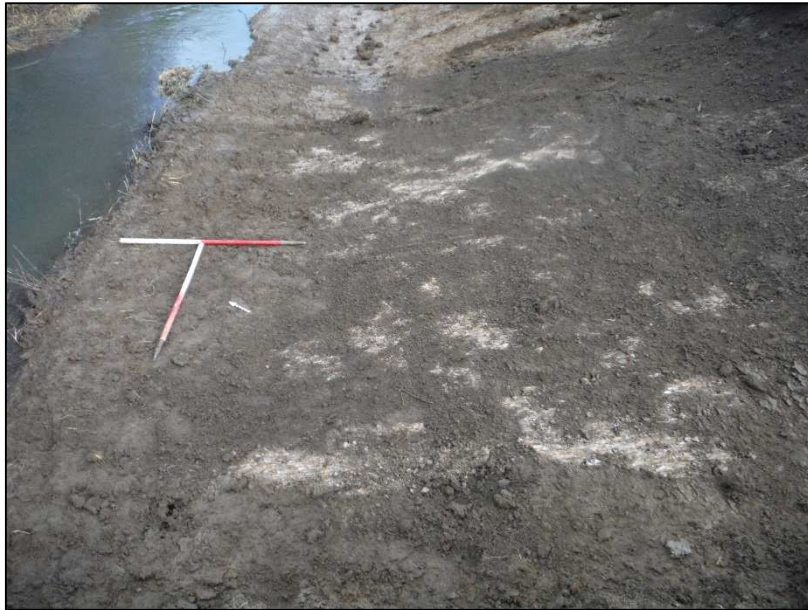
- 7.7 Further to the south (Sections 5–9) there was a change in the natural geology to a mottled orange brown slightly silty clay layer, 112. There were also several other layers below the topsoil within the makeup of the bank within the southern half of the monitored area. These may represent various episodes of river dredging and dumping of dredged material along the bank of the river, or possibly the deposition of material during flooding events.
- 7.8 In between the locations for Sections 6 and 7 within the river bank a large concrete slab/layer was revealed (Figure 2). This sloped down to the edge of the river, parallel with the river bank, but approximately 1m below the top of the bank. The concrete measured 4.25m wide by 0.1 to 0.15m thick. This modern feature may represent an agricultural ramp down to the river (Plate 6).

*Plate 6: View across the concrete feature looking northeast, scales are 2x 1m*

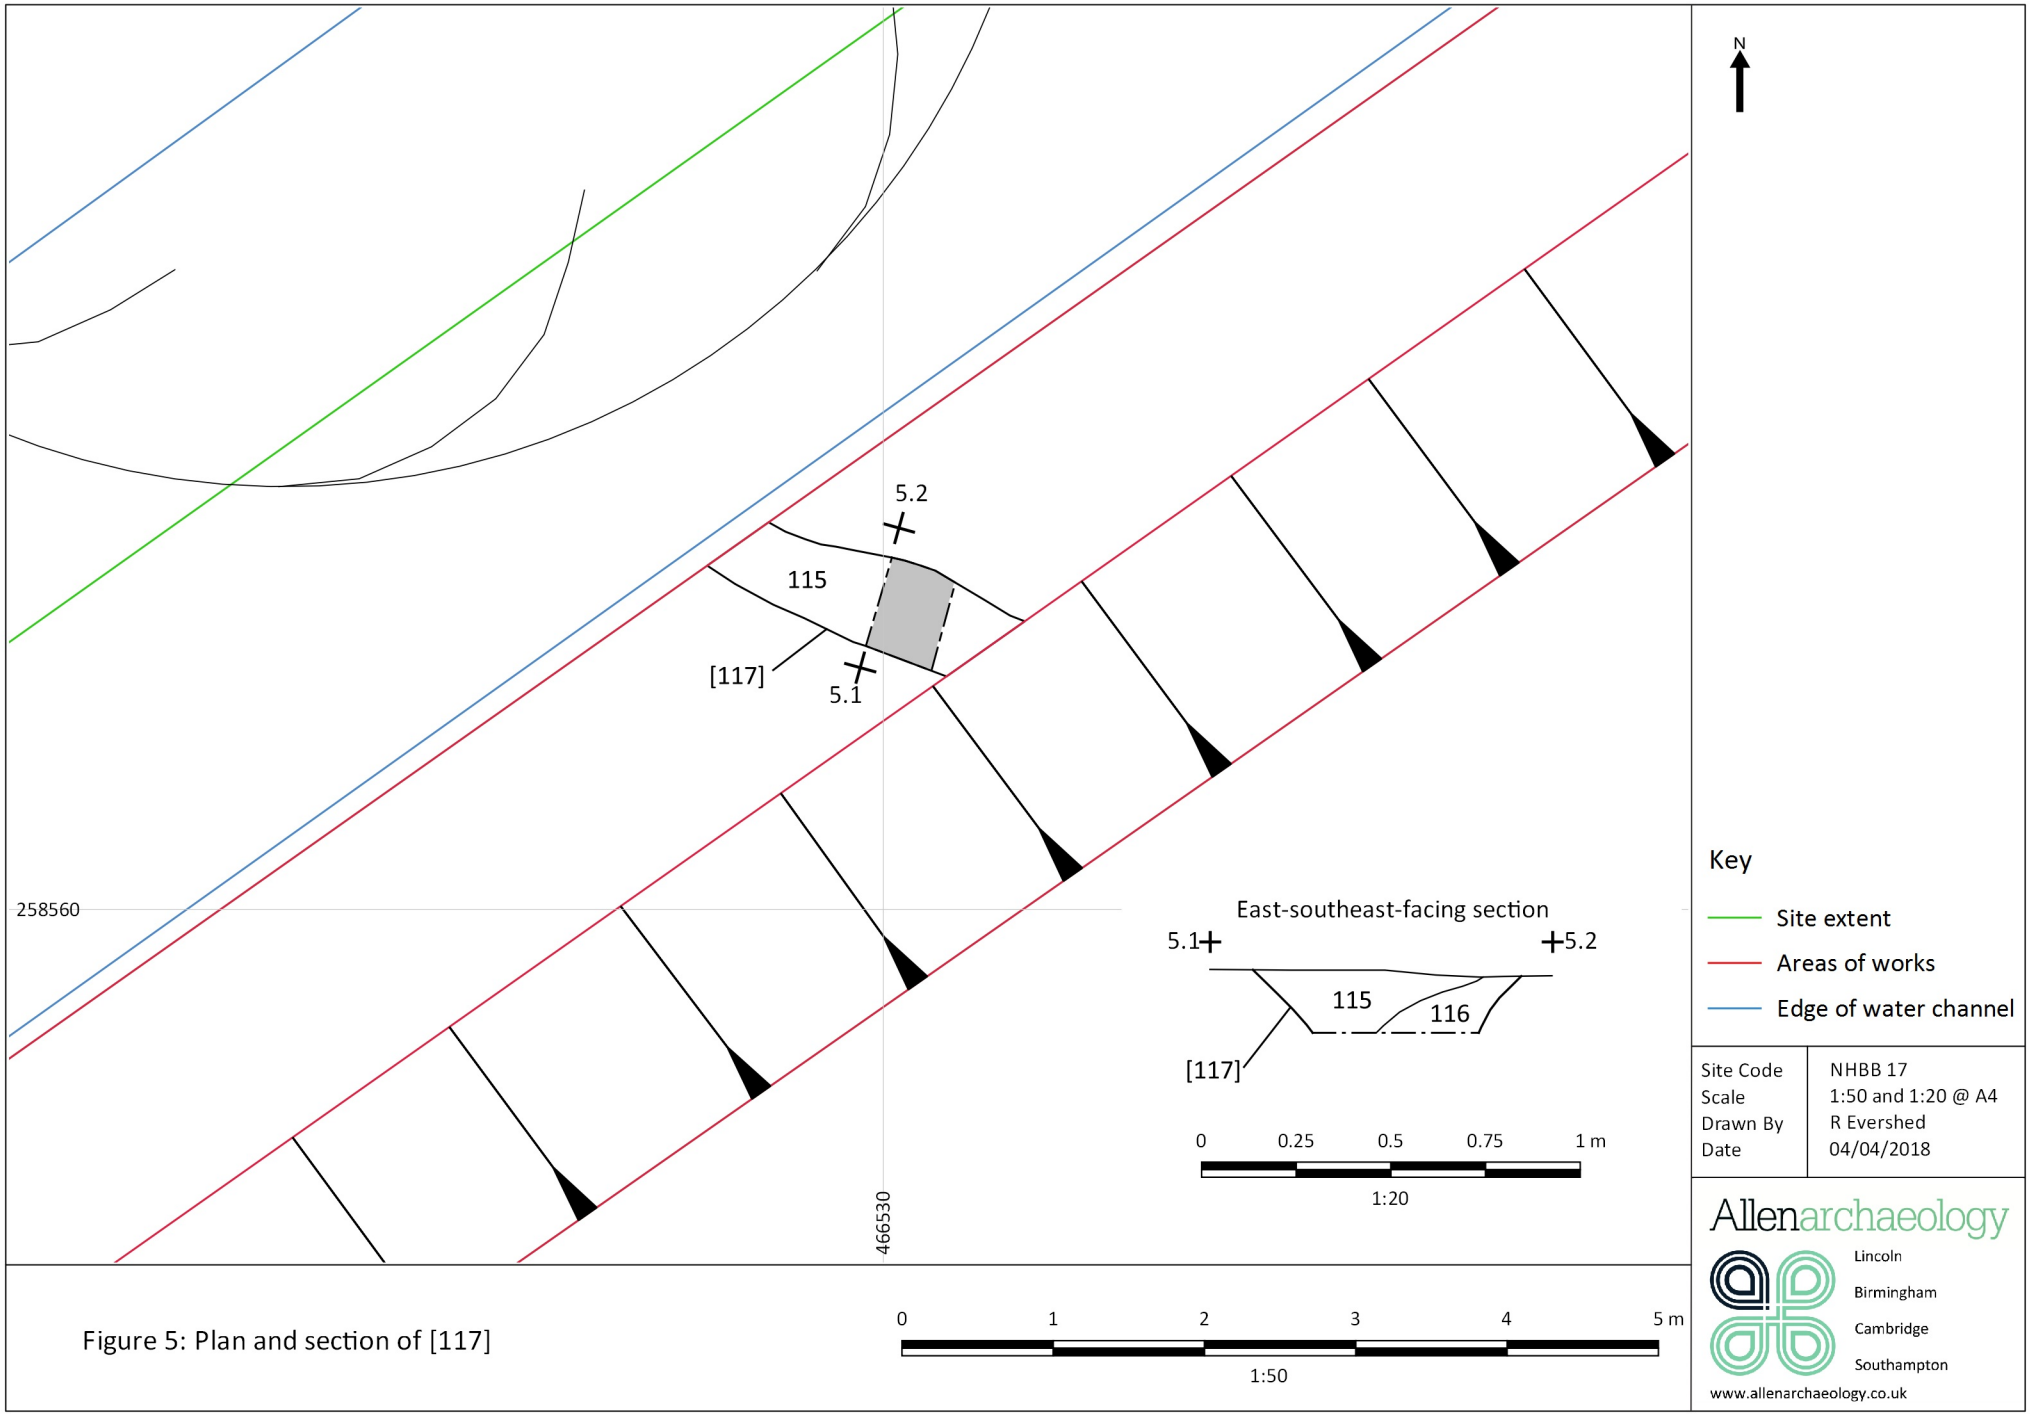
Figure 5: Plan and section of [117]
