**ARCHAEOLOGICAL SCHEME OF WORKS REPORT:
VICTORIA MILL, WATT STREET, SABDEN, LANCASHIRE**

Planning Reference: pre-planning
NGR: SD 77582 37287
AAL Site Code: SAWS 18
OASIS Reference Number: allenarc1-321051

Report prepared for Skipton Properties Ltd

By
Allen Archaeology Limited
Report Number AAL 2018115

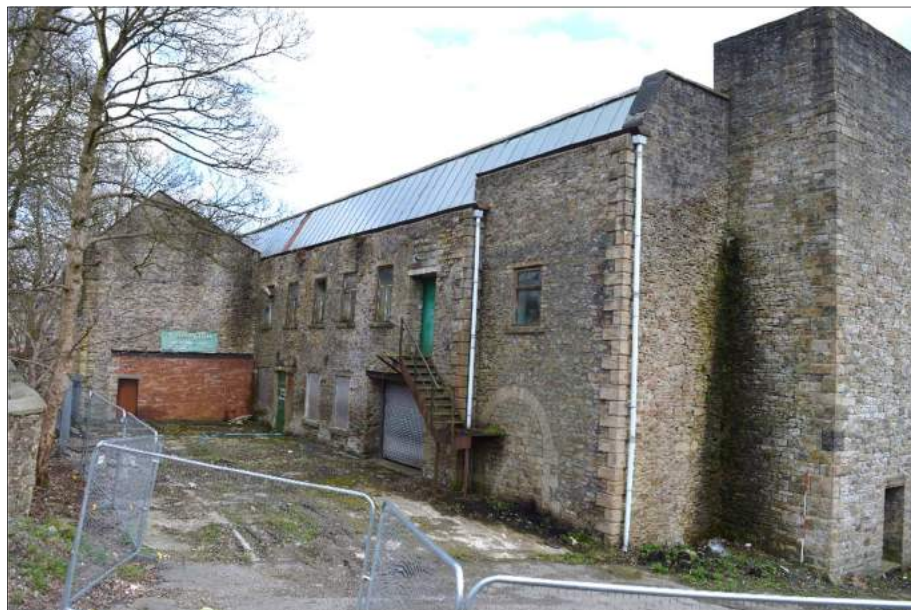
- 7.2 Building A is located in the northwest part of the site on the north side of Sabden Brook and abutted by the later building D. It is the earliest structure on the site and is visible on the Ordnance Survey map of 1844–46 (Figure 10).
- 7.3 The mill structure measures approximately 35m x 16m, which includes later extensions (Plate 1). It is two storeys, and built of coursed stone rubble with ashlar quoins and it has a saw-toothed roof with northlights. It was originally four storeys but a fire in the 1930s resulted in the mill being reduced in height with added extensions to the northeast, southwest and southeast. The majority of the windows fronting Whalley Road are three light casement windows with dressed stone lintels and sills. All ground floor windows have been boarded up.

Plate 1 (shot 375): General view of Building A with later extension to the left. Looking southeast, 2m scale

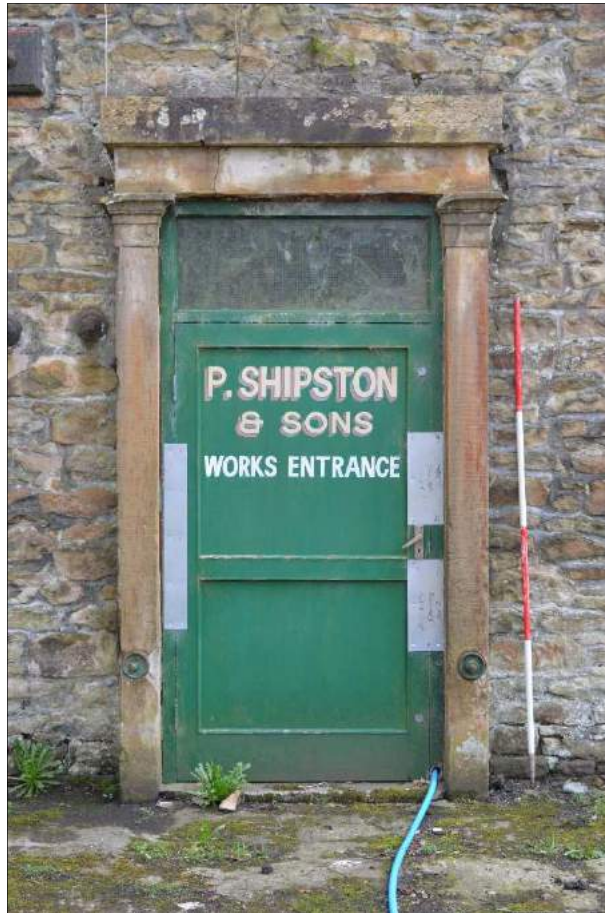
Plate 2 (shot 386): Main entrance of building A. Looking southeast, 2m scale

- 7.4 The main entrance on the ground floor, seemingly a later feature, has a stone surround with plain architrave resting on square cut pilasters. Round, metal patress plates has been used to secure the vertical stones. There are also three square plates above the ground floor windows on this elevation.

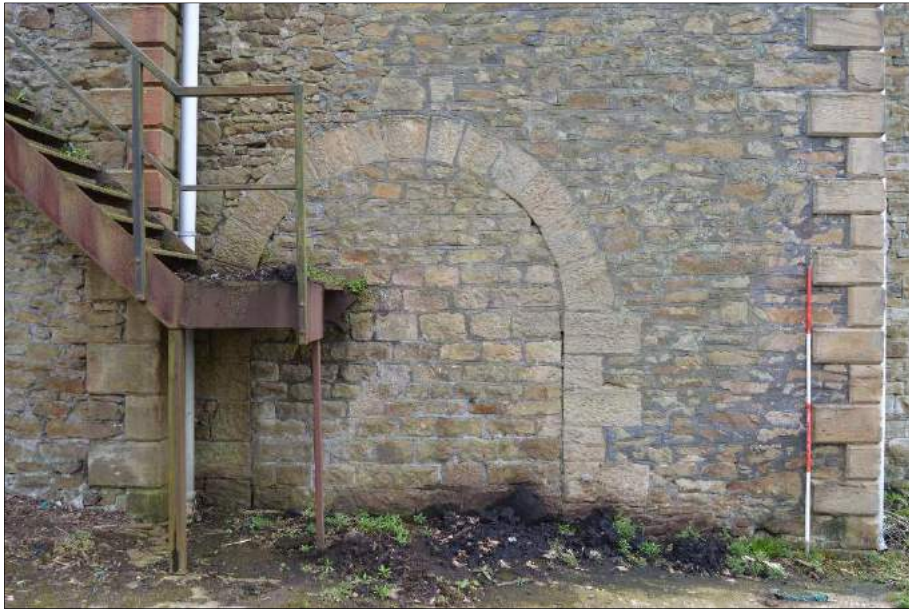
Plate 3 (shot 377): Blocked arched opening to former walk on the northwest elevation. Looking southeast, 2m scale

- 7.5 The space between the workshop and the ventilation shaft may potentially have housed an engine. Unless the structure had primarily been used as storage it would seem likely that it would have contained its own power source, such as an engine house which may have been positioned where the arched opening on the northwest corner has been blocked up. Engine houses were originally part of the main mill and often situated behind a tall window. The ground level outside appears to have been raised at a later date, only revealing part of the former opening, approximately 1m has been concealed (compare with Plate 18 below). A mirroring archway, although not as tall on opposing original elevation has also been bricked up (Plate 3). It is not impossible that the openings formed part of an earlier access to the rear of the building although the interior survey proposes a more functional use. A later fire escape partially blocks the north opening.

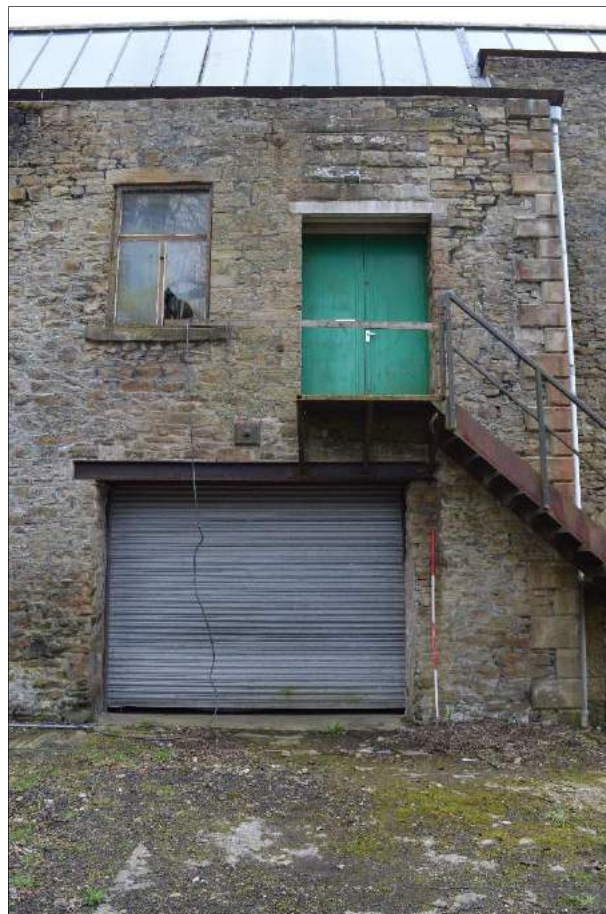
- 7.6 The fire escape leads to a door of later date on the first floor with a smaller opening blocked up directly above the door lintel (Plate 4). Below is a later, large square opening with an RSJ above the metal roller door.

Plate 4 (shot 380): Blocked opening on first floor and new square entrance on ground floor. Looking southeast, 2m scale

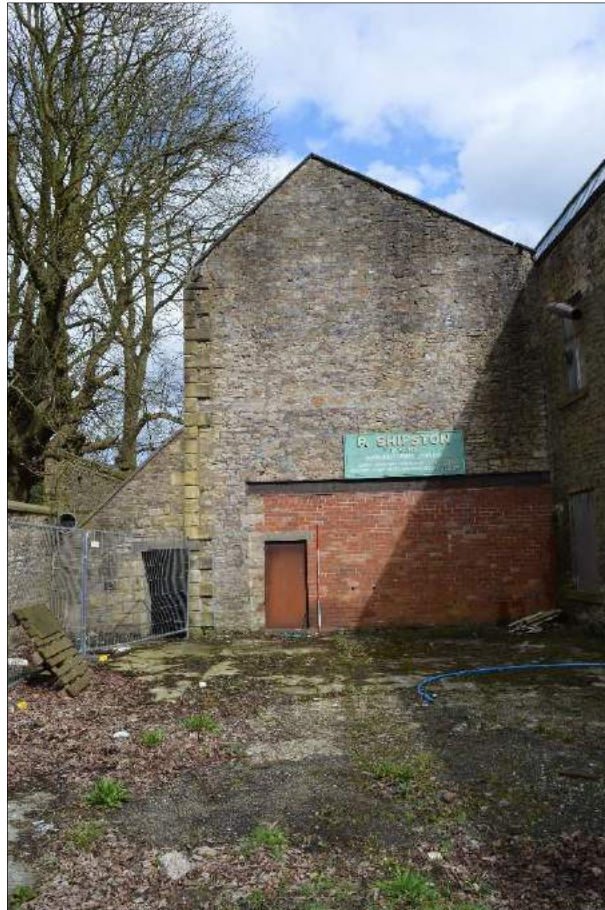
- 7.7 The repairs and rebuild in 1933 were conducted in the same style as the rest of the mill complex with stone quoins and a saw-toothed roof, with north-lights originally in patent-glazing (RDBU/7/2/208/3, Plate 5). There is a straight joint where the extension abuts the earlier mill structure and a large ground floor opening which has subsequently been bricked up. The large opening is in line with an 'existing culvert' from Sabden Brook to Mill Lodge (the mill pond) shown on the 1933 proposed mill plan (Figure 14). A wall has been added at a later date north of the extension. It has been keyed in by shifting and reusing the quoins.

Plate 5 (shot 387): 1933 northeast extension. Looking northeast, 2m scale

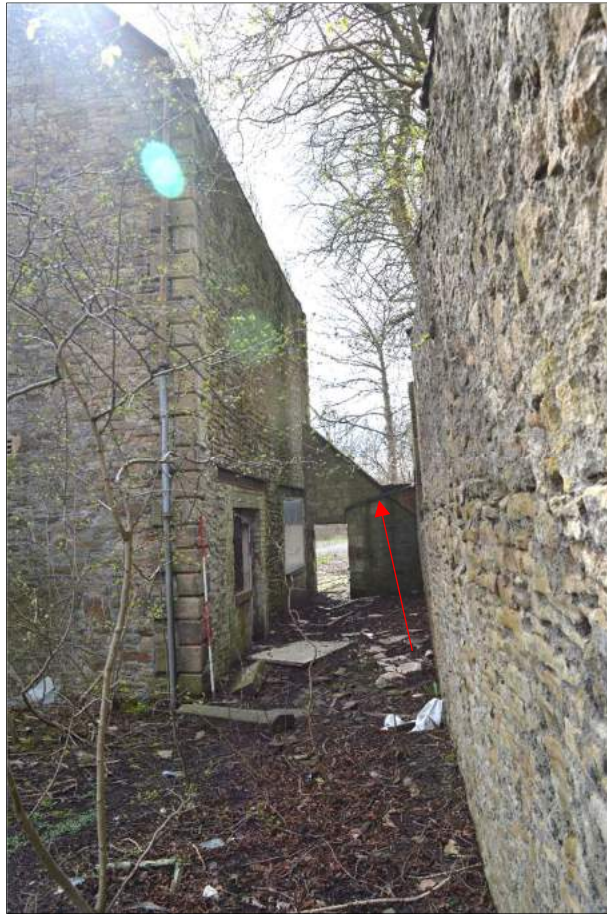
- 7.8 Two large openings on ground floor level on the north elevation have been bricked up and rebuilt into two windows and a door, presumably after the mill fell out of disuse in 1964 (Plate 6). A later lean-to has been removed between the mill and the boundary wall (Plate 6 and Plate 7).

Plate 6 (shot 389): North elevation of the 1933 extension to the left and the boundary wall to the right. Arrow points to remains of roof of demolished lean-to. Looking southwest, 2m scale

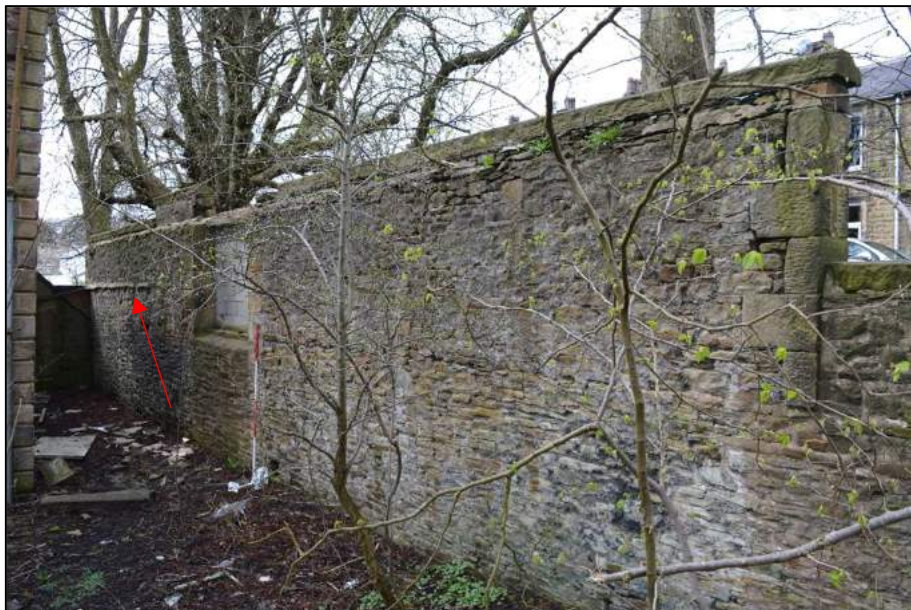
- 7.9 The 1933 northeast extension presumably replaced part of the structure built against the boundary wall and shown on the 1910 Ordnance Survey map and 1950s block plan (Figure 15, RDBU/7/2/208/5). The only trace left of this structure comprises a recently blocked up opening on the said wall (Plate 7).

Plate 7 (shot 394): Boundary wall and former north elevation of 1910 structure. Arrow points to remains of roof structure of demolished lean-to. Looking northwest, 2m scale

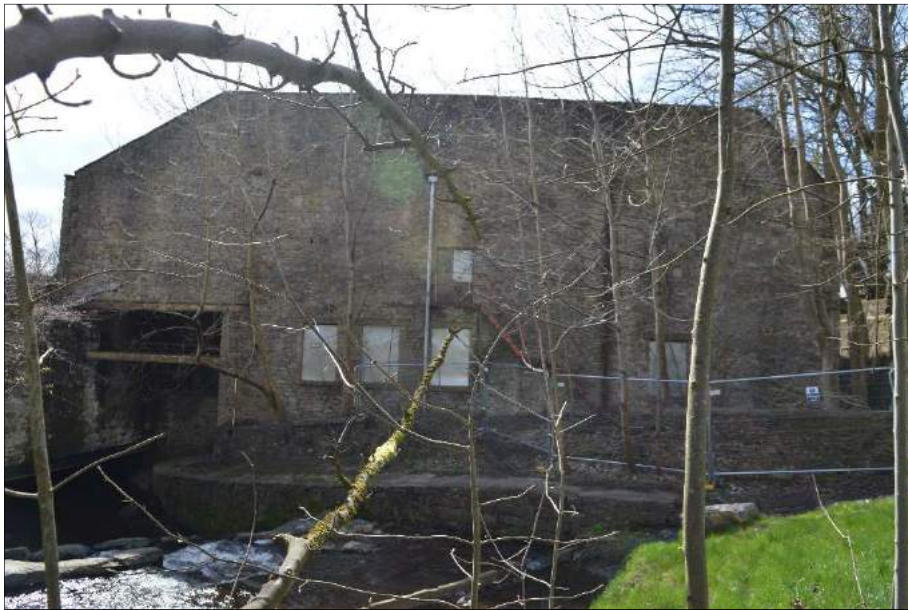
- 7.10 The northeast elevation faces Sabden Brook which meanders its way from Sabden Fold approximately 4.5km to the northeast and flows down the mill weir, through the culvert under the mill and continues its course until it joins River Calder c.4.5km to the southwest. The culvert was added in 1908 when the mill was extended from the south, bridged the river and joined the earlier mill to the north (RDBU/7/2/129, Plate 8).

Plate 8 (shot 405): Northeast elevation of building A showing the culvert to the left. Looking southwest, 2m scale

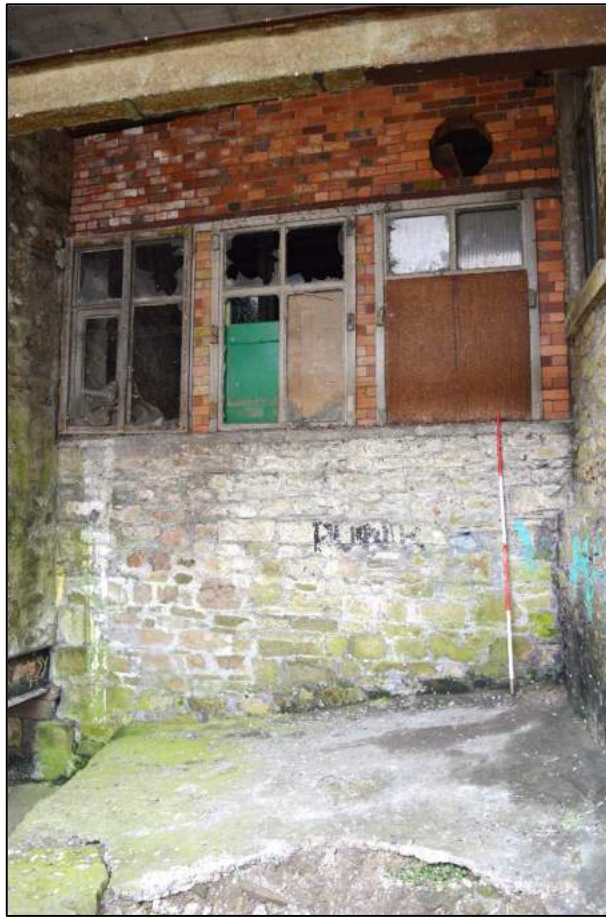
- 7.11 The enlargement of the spinning department located in Building A included the addition of a WC block to the southeast (Plate 9). The extant block is built into the former sloping river bank and the bottom half of the northeast wall is built of stone rubble, which corresponds with the rest of the mill complex and may have worked better as a foundation than the red machine made bricks which make up the upper half of the wall. These stones appear to be reused and may have been removed from the original southeast wall which would have been situated a little bit southwest of the staircase. Three mullioned windows appear to be original although the glazing is in a dilapidated state and has partially been boarded up. The original proposed plan of the extension suggest that there was a gap between the WC block comprising three toilets and the spinning mill, however this appears to have been amended as the extension abuts the earlier structure.

Plate 9 (shot 398): The 1908 WC extension on the southwest corner of Building A. Looking west-southwest, 2m scale

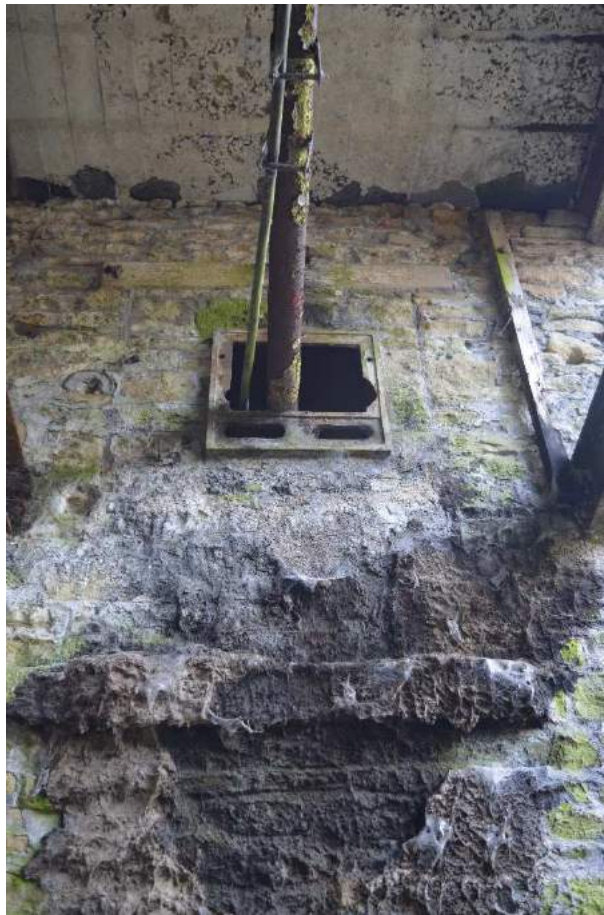
- 7.12 Between building A and the 1908 extension to the south (building E) there are remains of earlier mill fixtures, comprising two opposing, cast iron bearing boxes which would have transferred power from one side of the mill to the other. On the north side of the brook, the box has been fitted into a blocked ground floor opening (Plate 10). The iron pipe and cable(?) running across would appear to be a later instalment.

*Plate 10 (shot 400): Iron bearing box within an earlier blocked up opening on the south elevation.
Looking northwest*

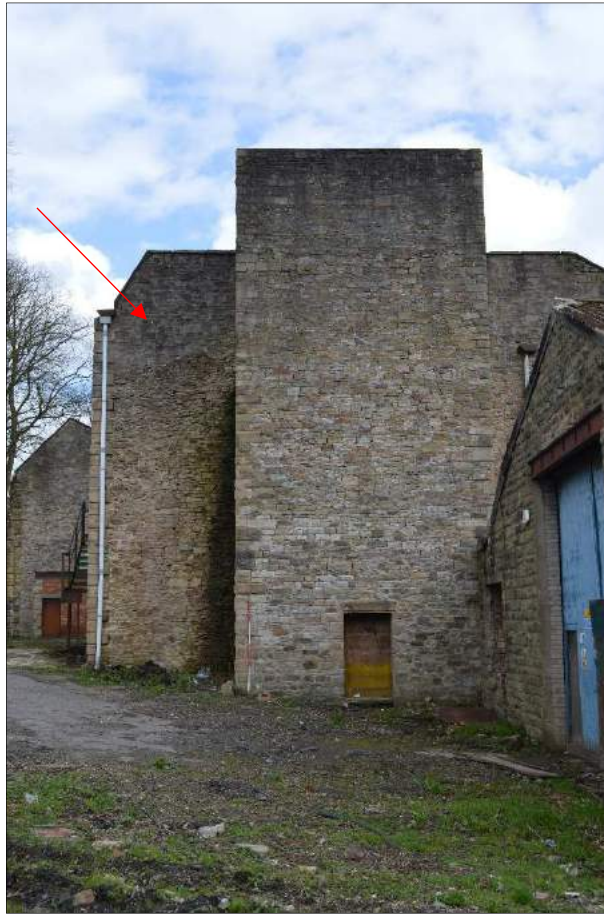
- 7.13 On the southwest elevation is a tall stone rubble ventilation shaft, with an entrance from the west, built between 1963 and 1970 based on cartographic evidence, and thus postdating the textile manufacturing on site. Presumably this large ventilation shaft would have been needed for some sort of combustion appliance, potentially a boiler or water heater. Direct venting is applied to modern combustion appliances to avoid hazards of backdraft. In this instance the appliance would draw combustion air directly from outdoors instead of an occupied indoors (Brumbaugh 2004; HM Government 2010).

Plate 11 (shot 373): Southwest elevation revealing later repair work on the mill and showing the later ventilation shaft. Looking northeast, 2m scale

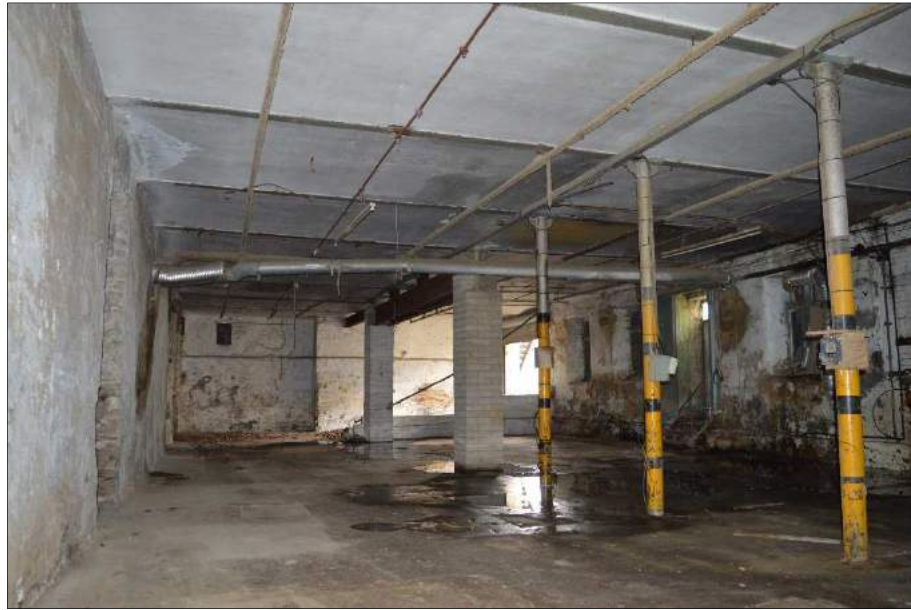
- 7.15 The first floor is supported by columns that may postdate the fire of 1933 and stone partition walls representing part of the earlier mill structures. The workspace to the north displays modern fixtures and fittings (Plate 12). Modern brickwork surrounds two of the columns and an iron beam between the two was likely part of recently removed machinery. Two earlier bearing boxes were located on the west elevation and pipework in the ceiling forms part of the earlier fire protection and sprinkler system which extends throughout the mill (Plate 13). An intact bulb was noticed within the workshop area and resembles the multiple jet sprinkler produced by Mather & Platt Ltd (under the name Grinnell) in the 1940s and 1950s (Plate 14, www.the-lawrences.com/matherplatt/map-fire.htm). The water pump system is located in the early spinning room in building E to the south. Many of the pipes if not the majority throughout this building and across the complex were wrapped with what appeared to be 1940s asbestos lagging (<http://www.asbestosjustice.co.uk/heating-engineers-dangers-asbestos/>).

Plate 12 (shot 311): Ground floor, northern half of building A. Looking

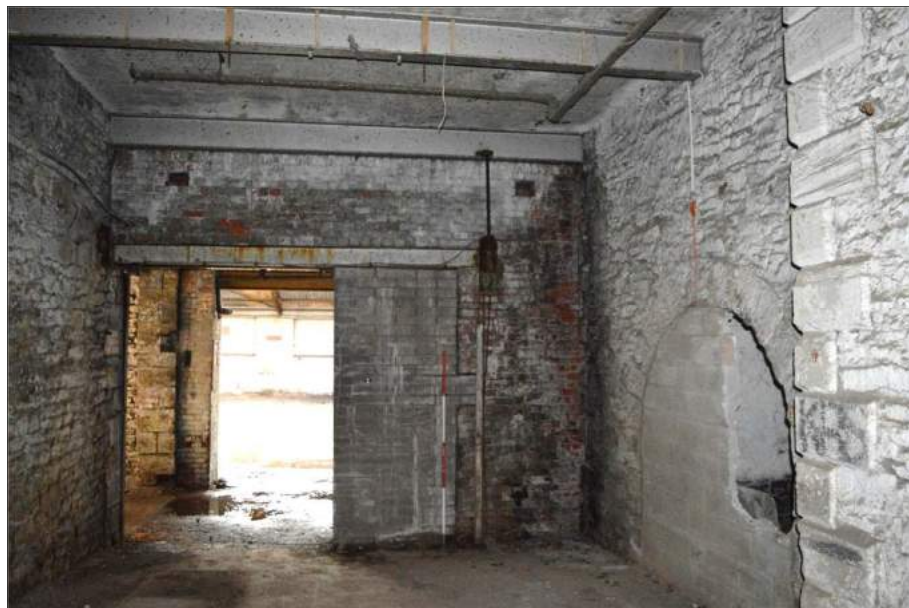
Plate 15 (shot 285): Corridor to the back of the building, looking west-southwest towards building D, 2m scale

- 7.16 The corridor to the south was the result of the 1933 extension, bridging the space between the earlier mill to the north and the 1908 addition to the south. RSJs spans the width of the corridor and offer support to the whole structure (Plate 15). The later brick partition wall, probably from 1933, has a large square opening which appeared to have had a roller door, presumably acting as a fire door, only the chain pulley remains. Part of the opening has been bricked up at a later date.

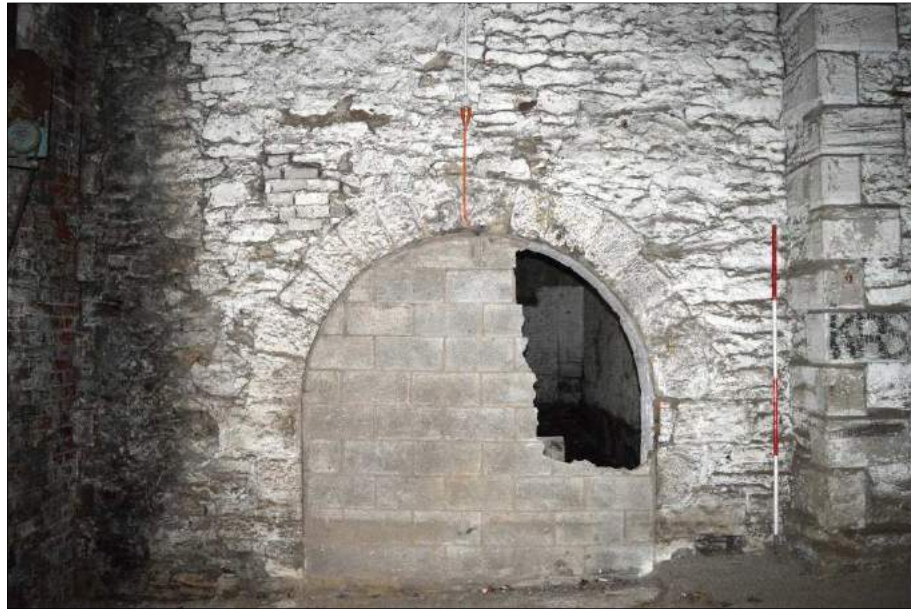
- 7.17 On the north side of the corridor is the original south elevation of the spinning mill and the rounded arched opening which mirrors that to the front of the building. It has recently been blocked with breeze blocks (Plate 16).

Plate 16 (shot 284): Original north elevation and blocked rounded arched opening. Looking northwest, 2m scale

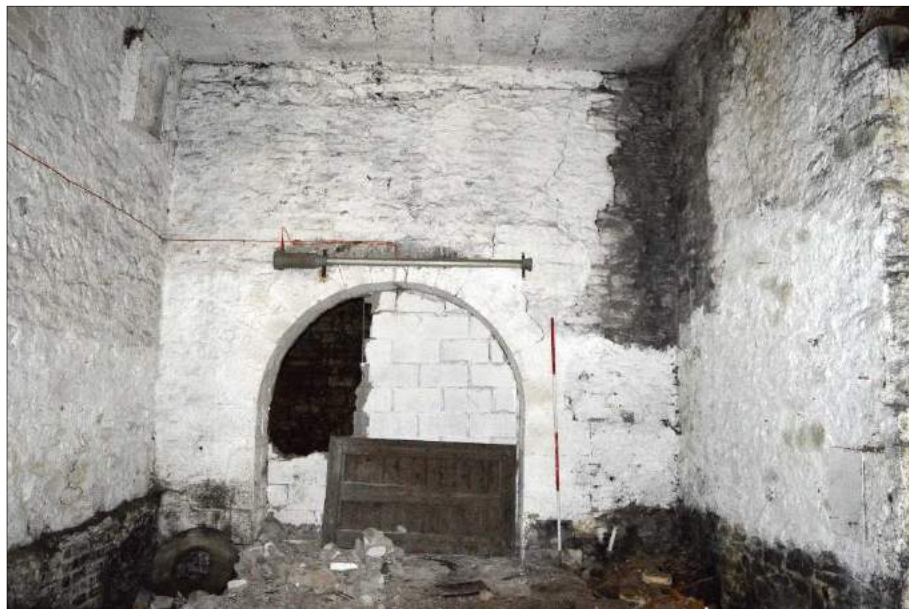
- 7.18 The interior of the 'store room' or what may be the original engine house has a bearing box on the east partition which extends into the ground floor of the spinning mill and later joiner shop (Plate 17). The full height of the north blocked opening is only visible from the inside as the raised ground level on the outside obscures it (Plate 18). It has roughly the same height as the openings found in the engine house of building C. On ground level along the east partition wall are small and square, bricked up openings. The later ventilation shaft to the west opens up directly to this room (Plate 19). The plans from 1933 show a new floor was installed above this room with a concrete floor (Figure 14).

Plate 17 (shot 335): Interior view of the 'store room', potentially original engine room. Looking southeast, 2m scale

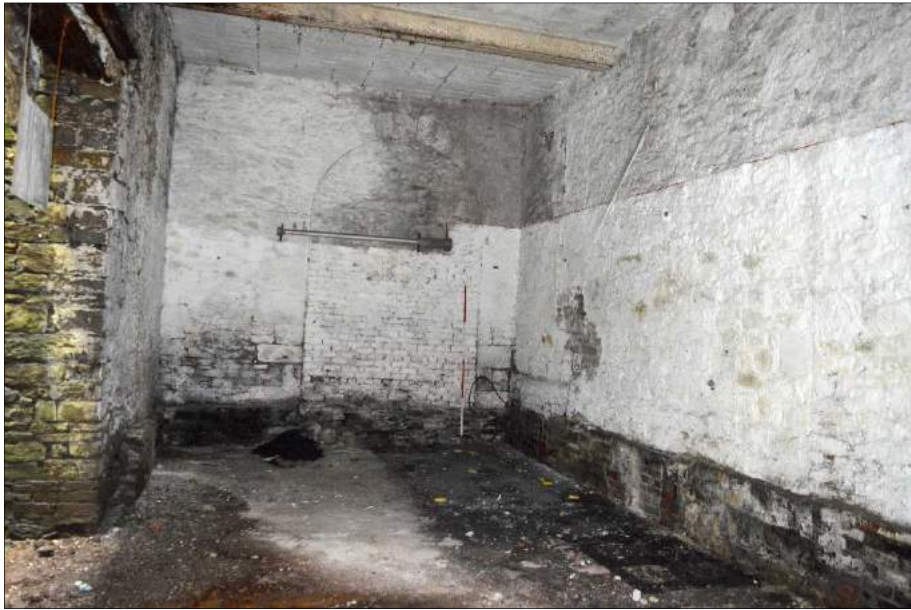
Plate 18 (shot 330): The full height of the arched opening on the mill's north elevation. Looking north, 2m scale

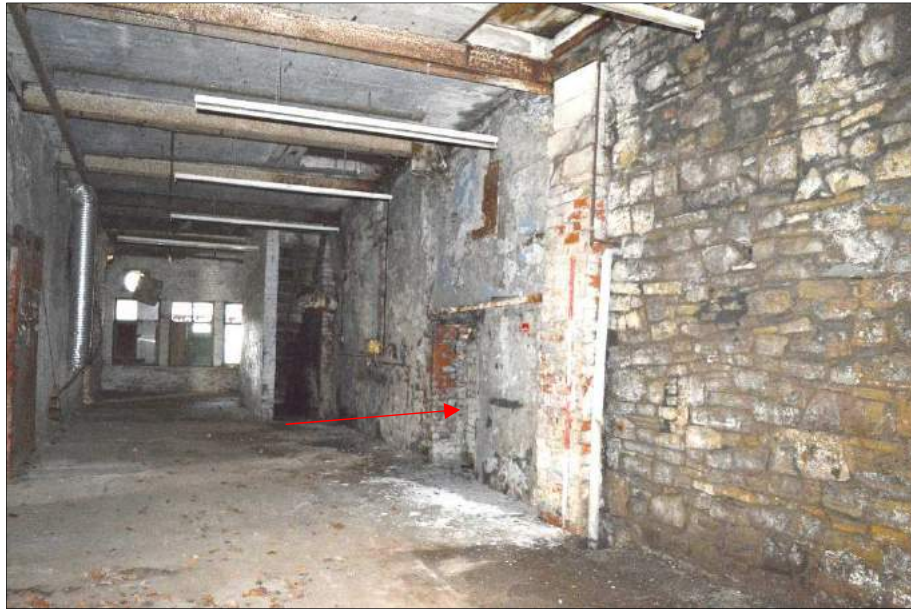
- 7.20 The 1908 opening in the south wall of the early mill has been bricked up. Square holes in the ceiling of previous openings to the first floor are likely to relate to earlier mill apparatus, potentially some form of hoists, small square tie plate and round pattern plate below may have been related to a hoist mechanism (Plate 20 and Plate 22). A blocked window relating to the earliest spinning mill can be seen on the south side of the corridor stairwell leading up to the first floor (Plate 21).

Plate 20 (shot 289): 1933 corridor looking towards the former 1908 lavatories to the east, potential hoist hatch in the ceiling in the foreground. Arrow points to bricked up opening. Looking east-northeast, 2m scale.

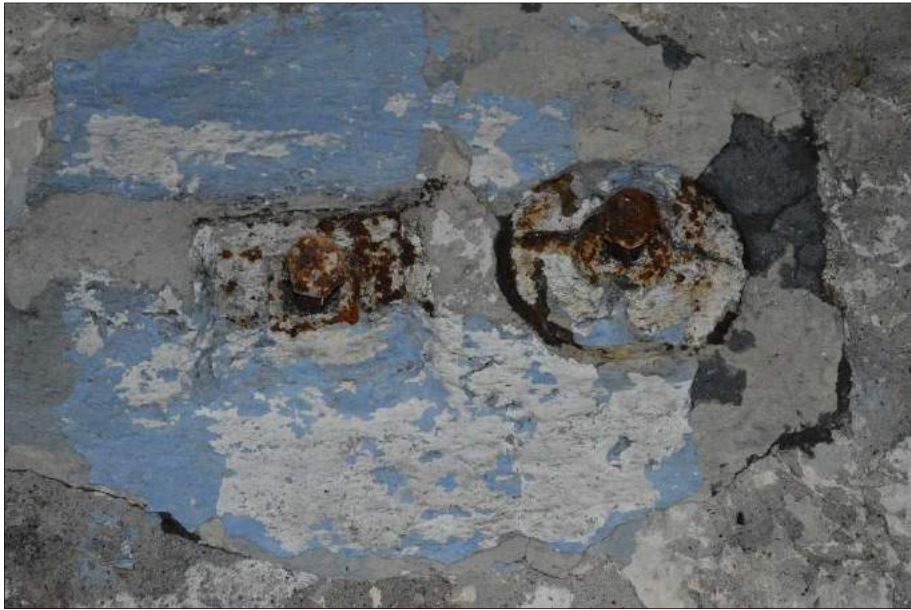
Plate 22 (shot 291): Small patress plates potentially related to a hoist on the south elevation. Looking southeast

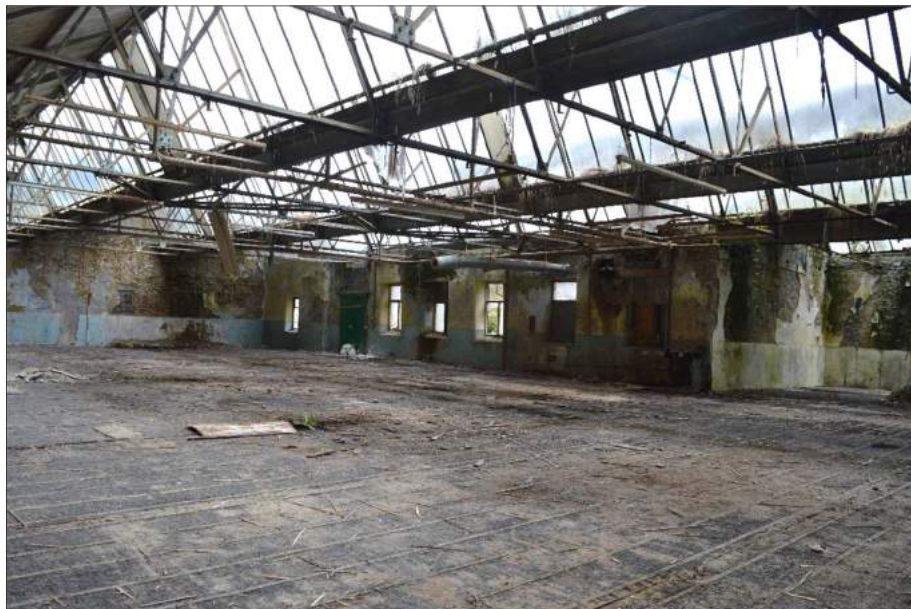
Plate 23 (shot 239): First floor of the spinning mill. Looking northwest, 2m scale

- 7.21 The first floor of the mill consists of one open room. The saw-toothed roof with north-lights provide abundant light. The roof structure described on the proposed cross section of 1933 consisted of lead ridging with asbestos sheets on boards, patent glazing, Warren girders and trusses. The idea has been kept although the current roof is also supported by longitudinal metal girders (Plate 23). On each beam is an L-shaped bracket, presumably related to a spinning process (Plate 24 (257): Metal L-shaped brackets attached to the horizontal truss beam (see arrows). Looking south). The new floor in 1933 was laid with 6" of concrete floor with floor boards above. The floor boards have been removed, only showing the concrete with timber laths.

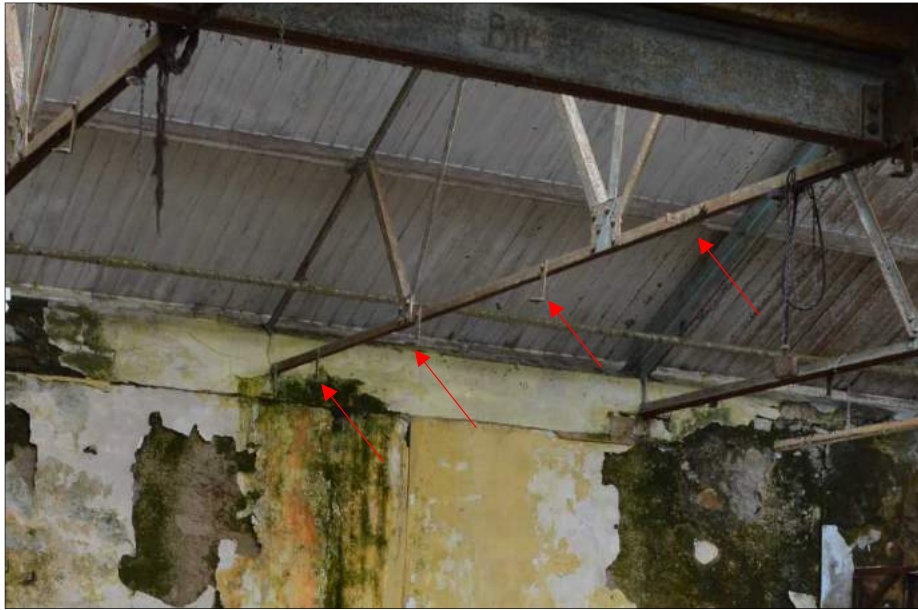
Plate 24 (257): Metal L-shaped brackets attached to the horizontal truss beam (see arrows). Looking south

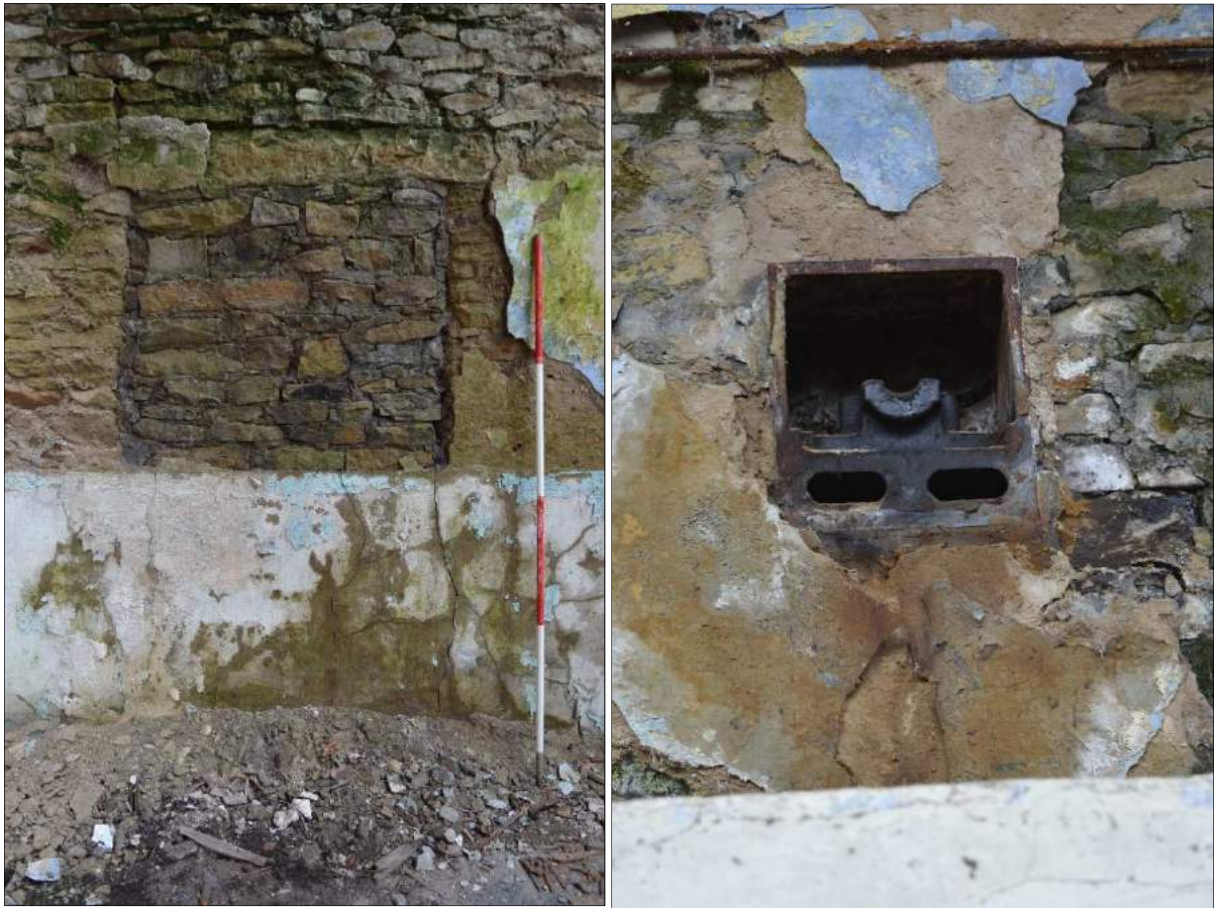
- 7.22 One square and one rectangular opening on the southwest elevation have been blocked up, presumably at the time the ventilation shaft was added (Plate 25). The openings may be earlier bearing boxes running from the possible engine room below. A more intact bearing box with the lower half of a bearing cup is situated above the staircase on the south elevation suggesting power came through building E at some point (Plate 26).

Plate 25 (left)(shot 241): One of two blocked openings on the west elevation. Looking southwest, 2m scale

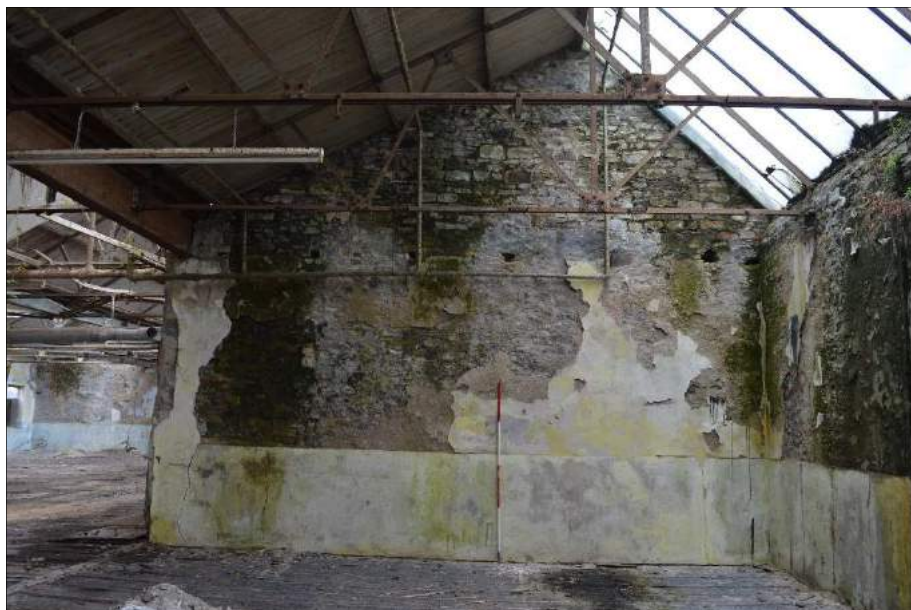
7.23 Holes along the east and west wall of the 1933 extension as well as on the east wall of the original mill may be fixture holes for line shaft corbels holding the bevel gears (Plate 27).

*Plate 27 (shot 251): General view of 1933 extension with holes for fittings along west and east wall.
Looking west, 2m scale*

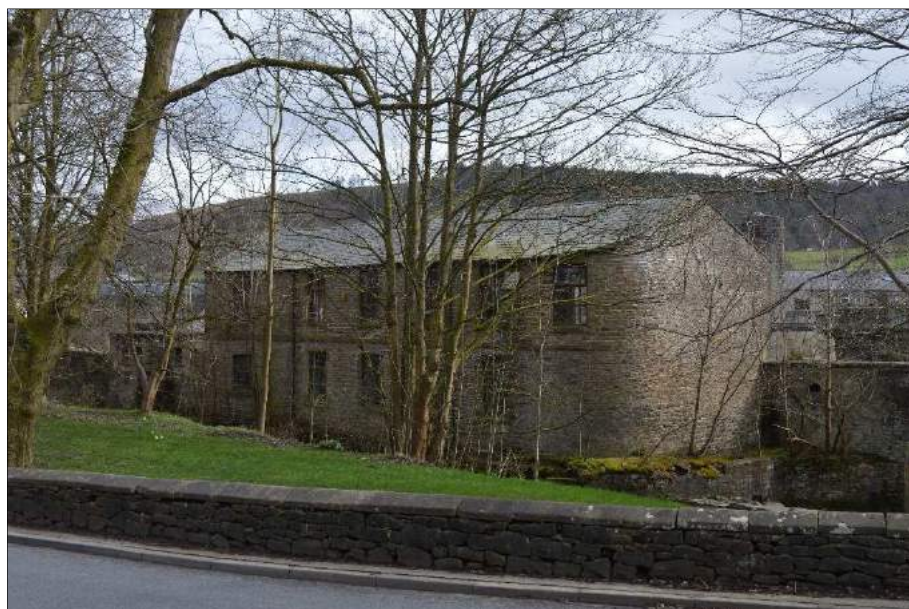
Plate 28 (shot 412): North elevation of Building B, looking southeast

- 7.24 Building B, the former blowing room lies to the south of Sabden Brook and east of the weir (Plate 28). The two storey building is made of coursed, stone rubble with dressed quoins, dressed stone lintels and sills around the majority of openings. The north elevation has also a dressed band course resembling cable moulding between ground and first floor level. The double pitched roof is covered in slate and spans between the low parapets on each gable. A square chimney stack with water tabling and a ceramic crown pot protrudes through the apex of the east gable (Plate 29).

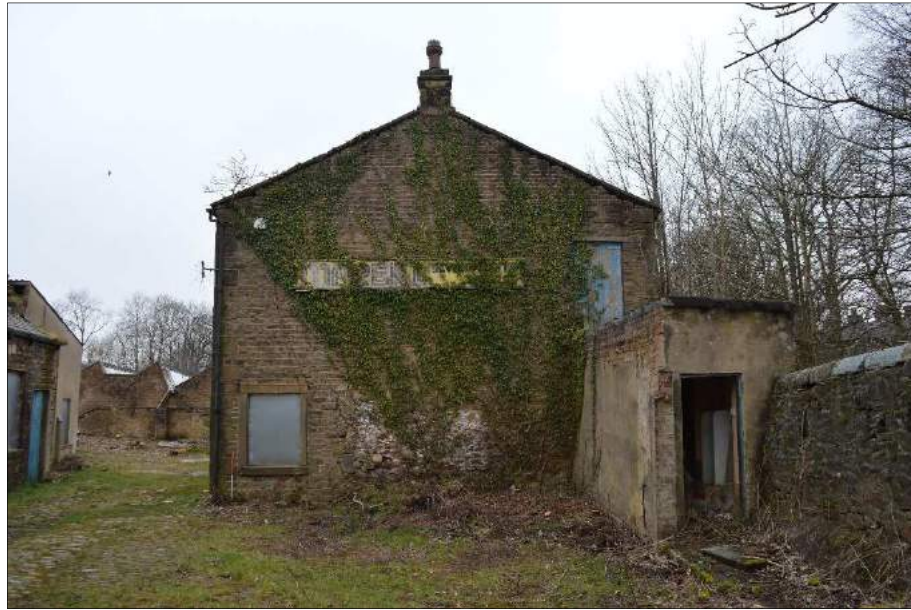
Plate 29 (shot 1): East gable of building B showing 1950s extension to the right. Looking west, 2m scale

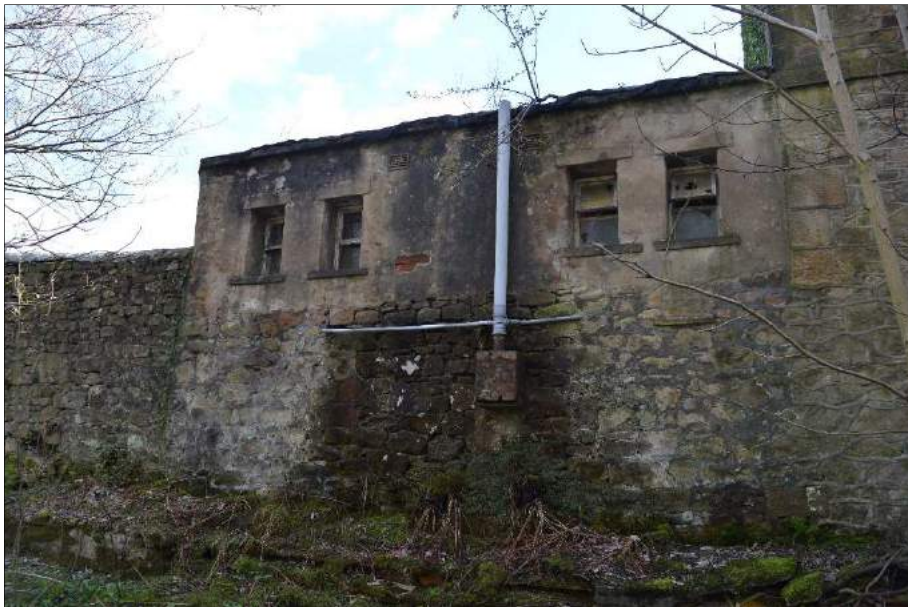
Plate 30 (shot 407): WC extension from 1950 showing men's to the left and women's to the right. Looking south

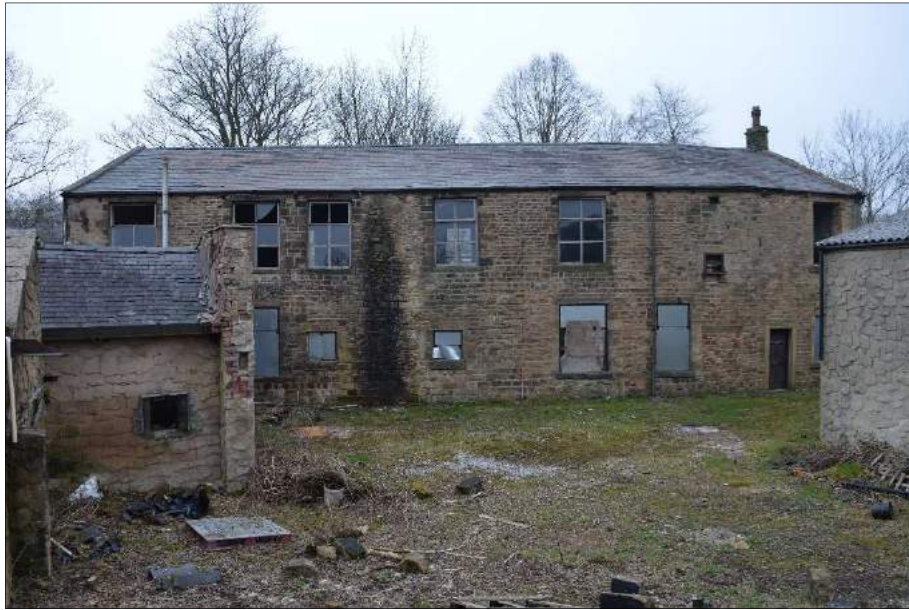
7.26 Several changes have occurred on the south elevation (Plate 31). Originally there would appear to have been seven windows on the first floor with at least four windows on the ground floor. Each opening has been fitted with a six light window with top opening casement. Two ground floor windows have been replaced by later, smaller openings. On the first floor a later bearing box has replaced the former window (Plate 32). A similar sized opening has been blocked up at ground level which could potentially be another bearing box or a flue (Plate 33) and a third opening where the extension from building E abuts building B (Plate 34).

Plate 31 (shot 14): South elevation with extension from building E to the left. Looking north, 2m scale

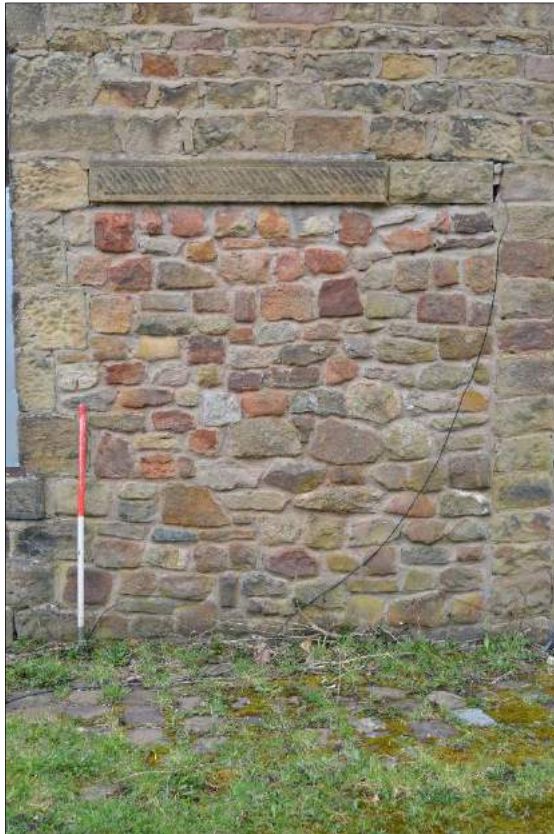
Plate 35 (shot 15): Blocked up later opening on ground floor. Looking north, 1m scale

7.27 Part of an original sill has been re-used blocking up a former opening on the ground floor (Plate 35).

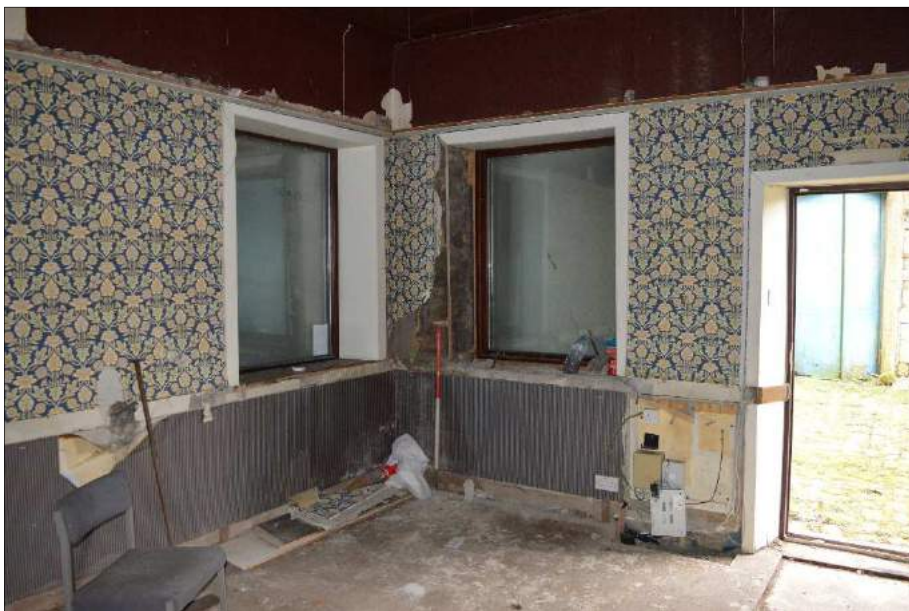
Plate 36 (shot 123): Ground floor from main entrance. Looking southeast, 1m scale

- 7.28 The main access leads into the former office in which the floor may have been built up as there is a step down into the rest of the building (Plate 36).

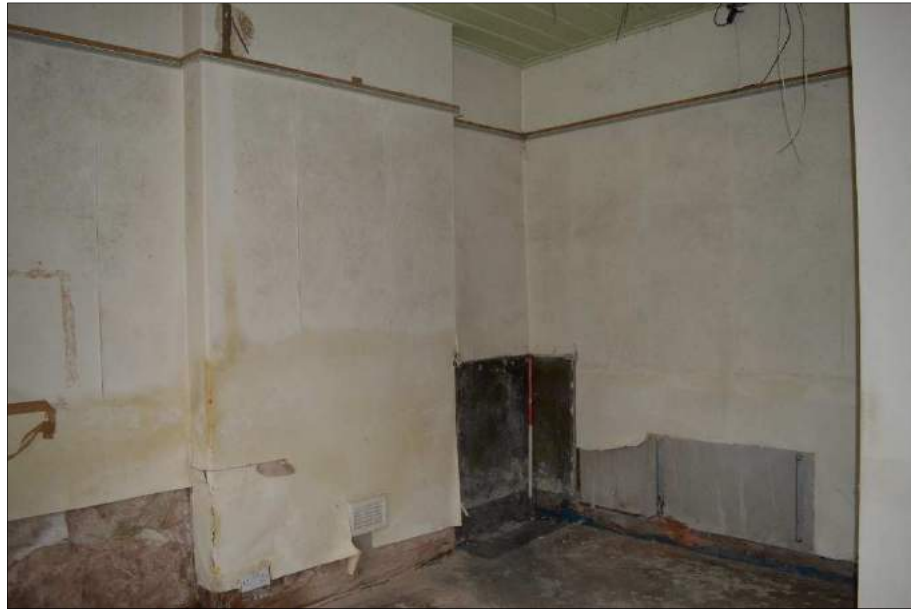
Plate 37 (shot 120): Former office and blocked up fireplace. Looking southeast, 1m scale

- 7.29 The 1950s proposed plan (Figure 15) shows an opening from the office into the female WC. As large parts of the walls were covered in render and wallpaper, no such opening was apparent during the survey (Plate 37). The same room holds a blocked up fireplace, also covered in wallpaper.

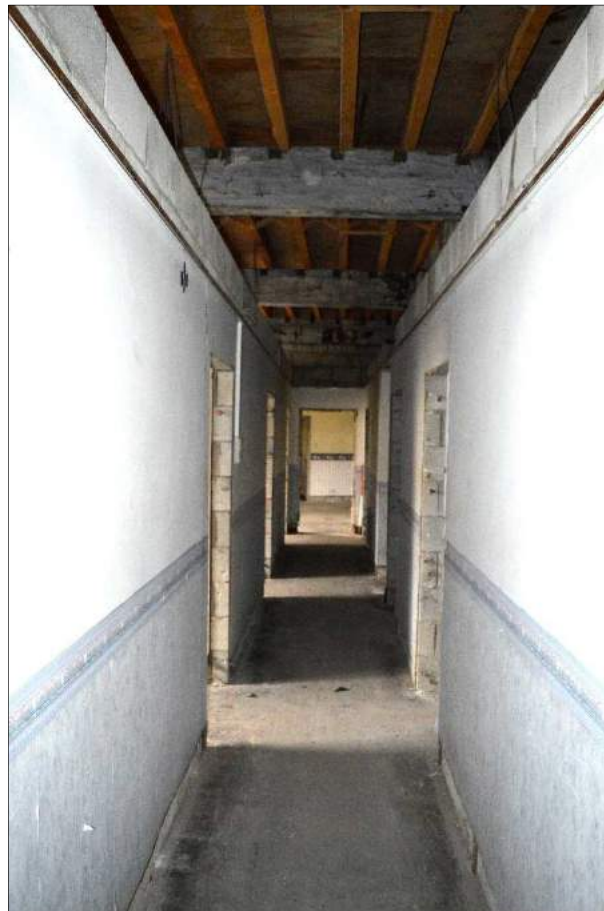
Plate 38 (shot 96): Corridor in the centre of the ground floor. Looking east, 1m scale

- 7.30 A recently added corridor stretches along the centre of the ground floor with breeze block partitioned rooms on either side. The original timber beams spanning the width of the building were extant and reused by a more recent floor construction above (Plate 38). The original timbers displayed joints of former floor joists.

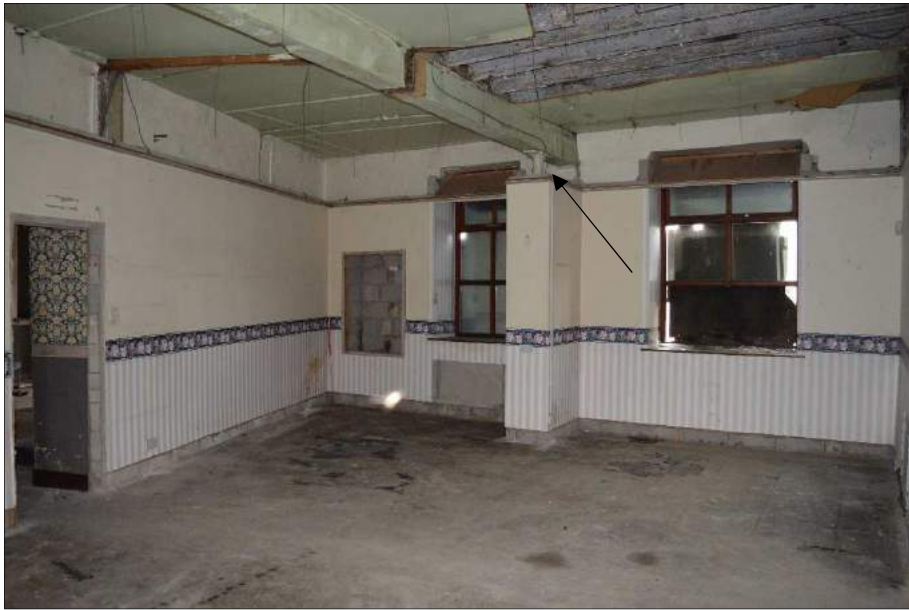
Plate 39 (shot 117): Cast-iron column hidden behind breeze blocks as shown by the arrow. Also notice the original floor joists seen in the ceiling. Looking southeast, 1m scale

- 7.31 Parts of the original floor joists were preserved towards the main entrance. Some of the original cast-iron columns were also extant on ground floor although largely hidden behind later partitions or breeze block cladding (Plate 39). The staircase in the west end of the corridor is a later addition (Plate 40).
