**ARCHAEOLOGICAL SCHEME OF WORKS REPORT:
VICTORIA MILL, WATT STREET, SABDEN, LANCASHIRE**

Planning Reference: pre-planning
NGR: SD 77582 37287
AAL Site Code: SAWS 18
OASIS Reference Number: allenarc1-321051

Report prepared for Skipton Properties Ltd

By
Allen Archaeology Limited
Report Number AAL 2018115

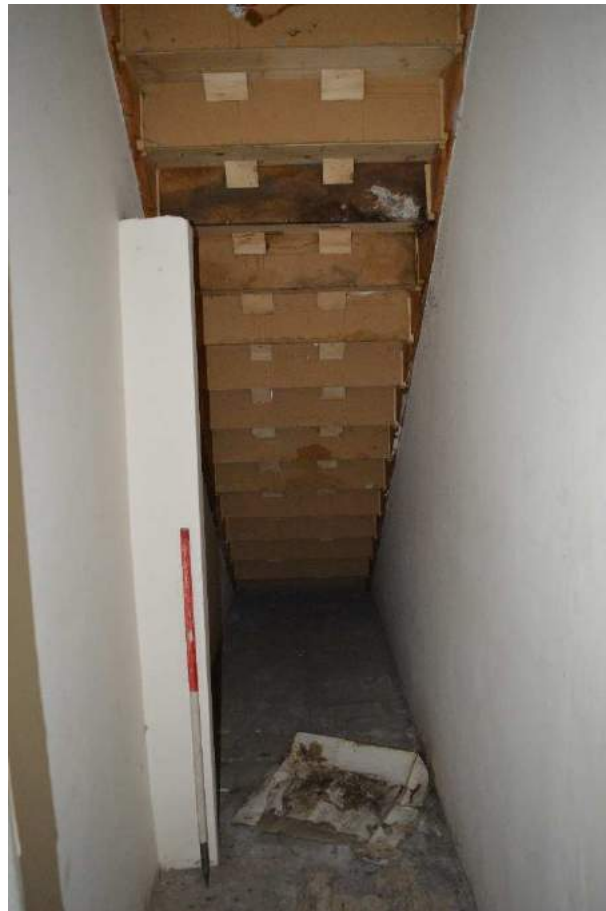
Plate 40 (shot 98): Later staircase to first floor. Looking south, 1m scale

- 7.31 Parts of the original floor joists were preserved towards the main entrance. Some of the original cast-iron columns were also extant on ground floor although largely hidden behind later partitions or breeze block cladding (Plate 39). The staircase in the west end of the corridor is a later addition (Plate 40).

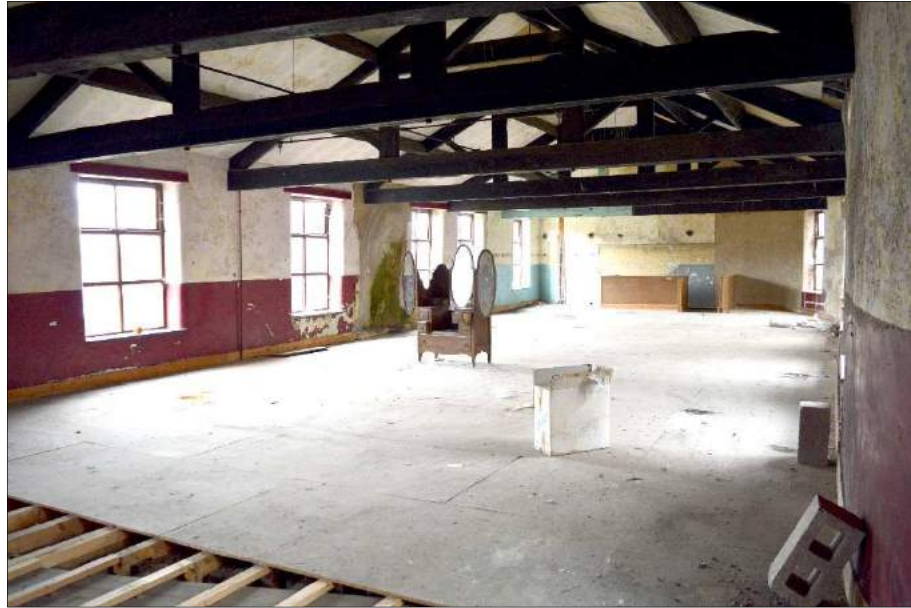
Plate 41 (shot 87): First floor. Looking southwest, 1m scale

- 7.32 The first floor has been left as an open space as it presumably was originally (Plate 41). The roof structure consists of six bays with queen post trusses some of which have carpenter's assembly marks (Plate 42, Plate 43).

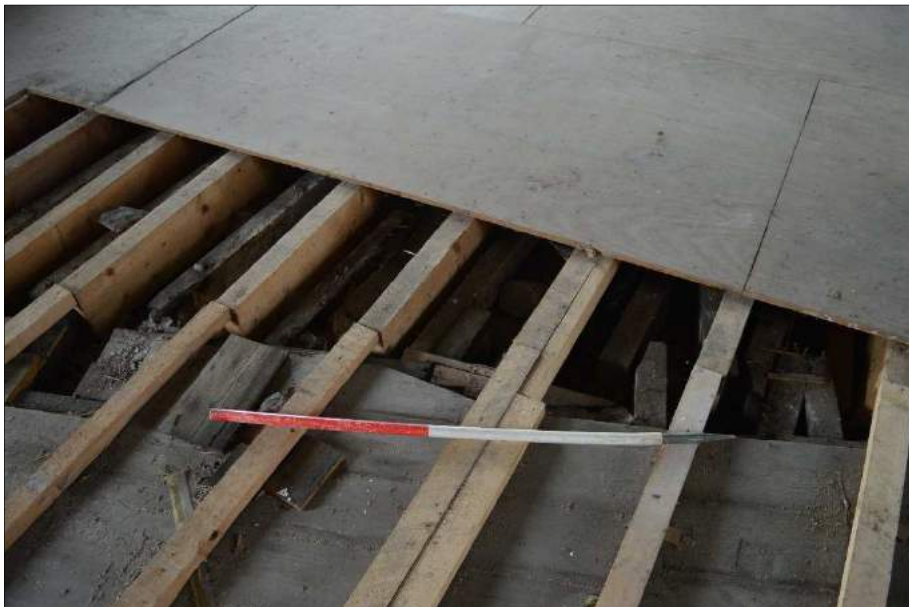
Plate 44 (shot 61): Original floor boards under later joists. Looking east, 1m scale

- 7.33 The floor has been raised but towards the east end the original floor boards can be seen under the later floor joists (Plate 44).

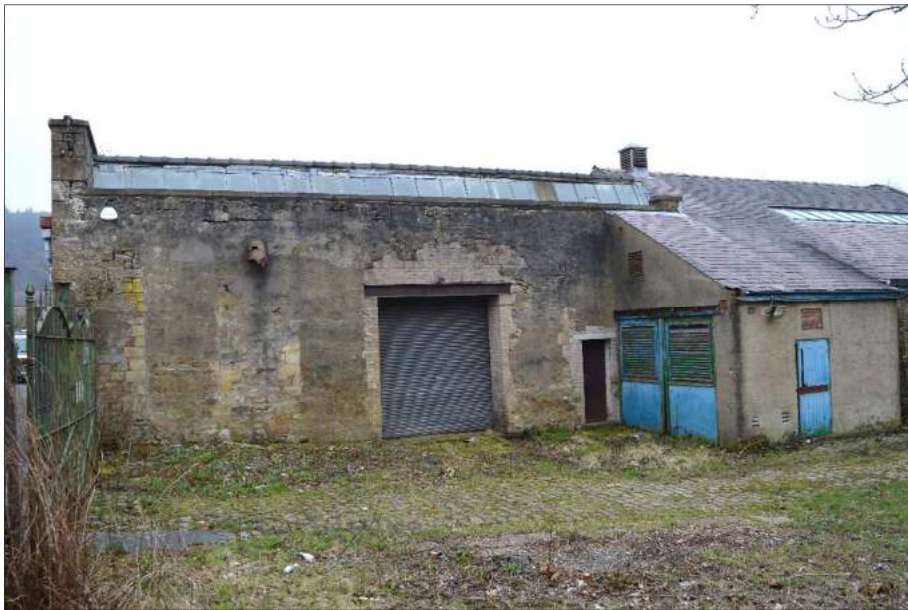
- 7.34 Building C comprises four contiguous buildings with the former engine house situated in the long, broadly east to west aligned structure closest to Watt Street (Plate 45). The structure was originally built in ashlar quoins and dressed surrounds to original openings. Arched windows, characteristic of an engine house, were present on the north elevation, but barely visible under a coat of render. The saw-toothed roof is a later feature added perhaps after the engine house fell out of use, or at least postdates the disastrous fire of 1937 which nearly gutted the engine house and caused the roof to collapse. This type of roof structure became common in other buildings and workshops after it was first introduced to weaving sheds (Giles 1993). The north elevation displays a large square opening with an RSJ lintel and roller door, as well as a smaller entrance to the west, potentially of similar date. These two openings are surrounded by later brick dressings.

Plate 45 (shot 47): Former engine house with blocked up windows to the left and later square opening to the right. Looking southeast

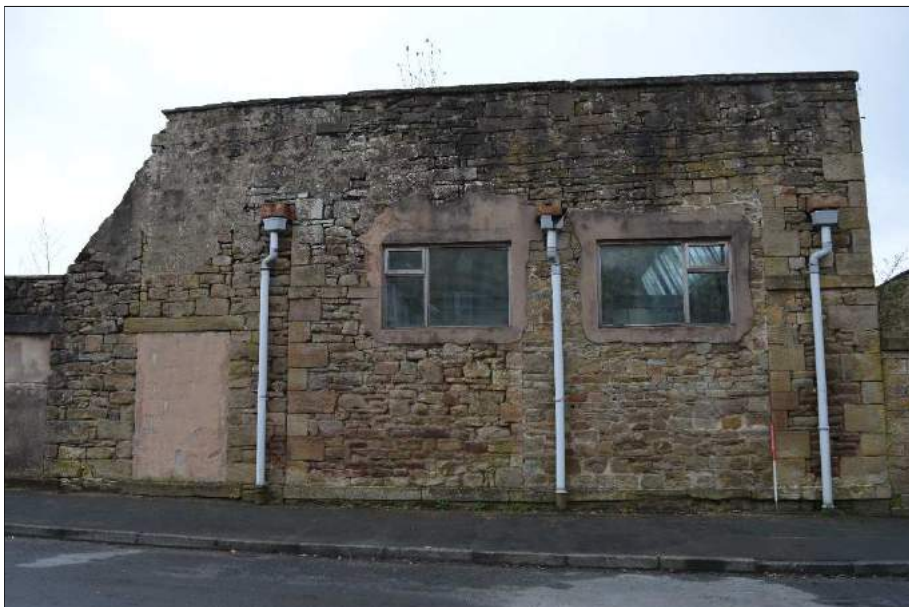
Plate 47 (shot 125): West elevation of engine house with remains of the early 1894 spinning mill left of the quoins. Looking southwest, 1m scale

- 7.35 The east elevation of the engine house is merged with the remains of the former mill built in the mid-19th century and rebuilt in 1894, now only surviving as a boundary wall with blocked up openings of windows and doorways. Two later 20th century windows have been inserted for the engine house (Plate 47). The straight joint running down the centre of the wall may related to an extension which occurred in 1883. Little remains of the original wall of the 1883 stable which adjoined the shed to the north. The wall was rebuilt between 1909 and 1910 when the stables were demolished.

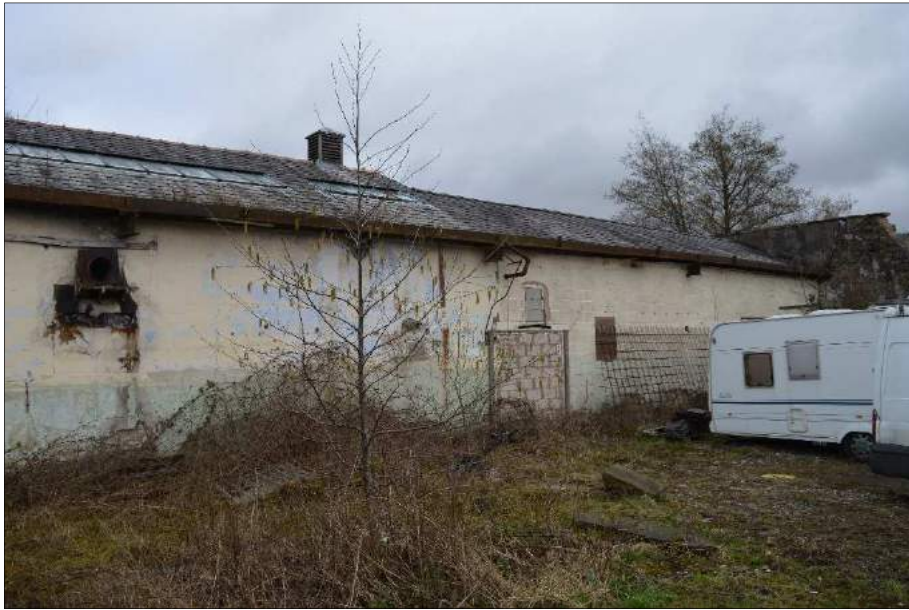
Plate 48 (shot 135): South elevation. Looking north, 1m scale

- 7.36 The northeast part of the engine house's southeast elevation has been rebuilt with breeze blocks (Plate 48), whereas the southwest end of this elevation still retains some early features, including a bearing box and an entrance between the former staircase and hoist (rope race) to the north and the former spinning room to the south (Plate 49).

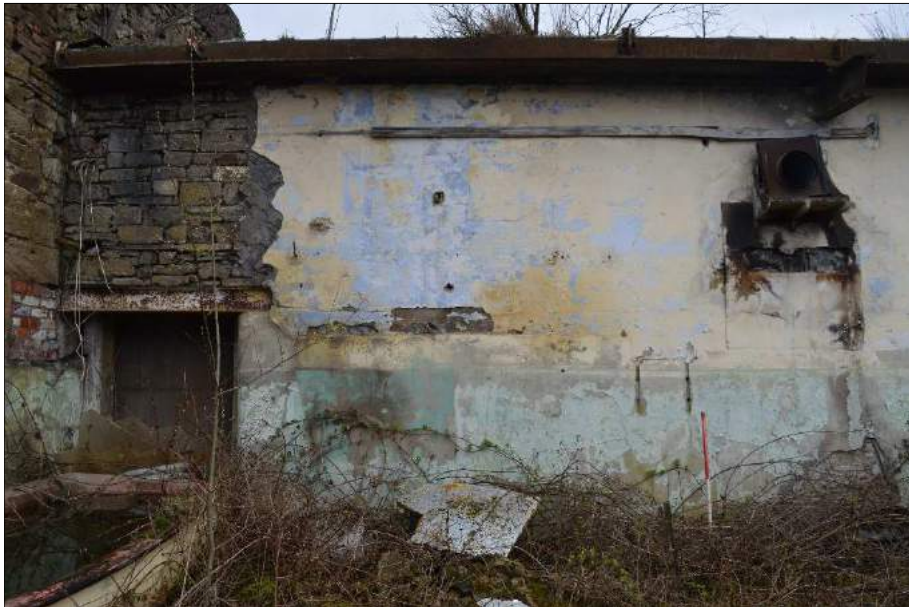
Plate 49 (shot 136): Close up of the south elevation showing former access to the spinning mill as well as an old bearing box. Looking northwest, 1m scale

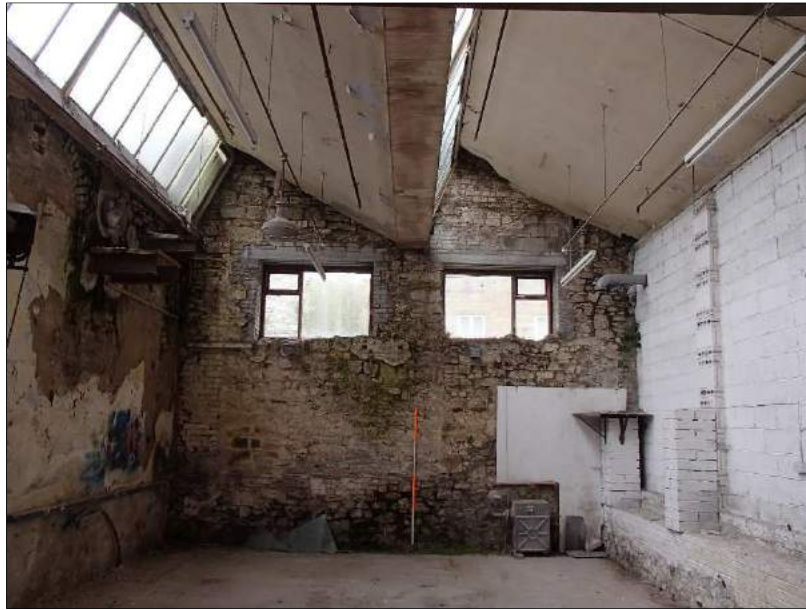
- 7.37 A large part of the interior of the engine house has been rendered and painted, obscuring traces of earlier features. The west wall, which is free of render reveals various brick repairs (Plate 50). The south wall has been rebuilt in breeze blocks and a brick plinth has been built in front of it and on top of the former stone built wall. In the ceiling are remains of a former sprinkler system as seen in building A. The arched brickwork above the former windows is better revealed where the render has fallen off the north wall (Plate 51).

Plate 50 (shot 415): Building C engine house interior, looking northeast, 2m scale

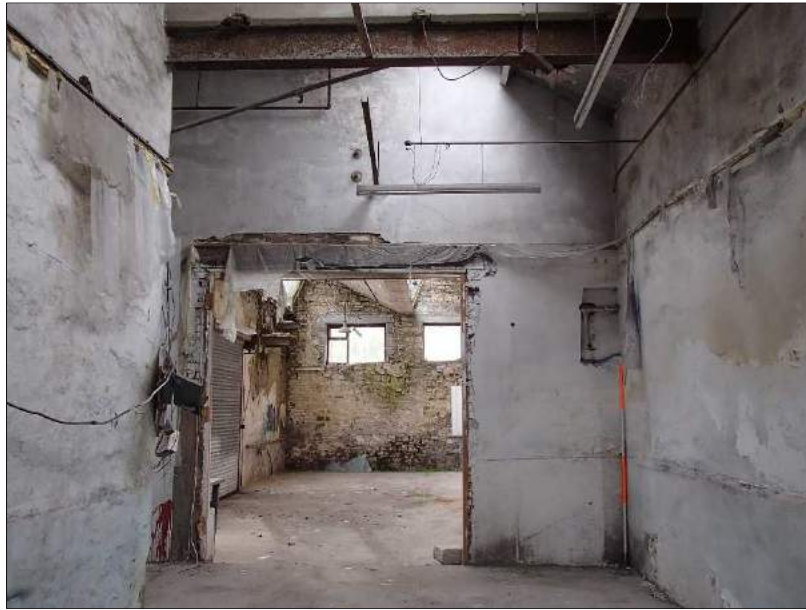
- 7.38 The horizontal cross-compound engine installed in 1883 would have resided in this part of the building, with the flywheel extending into the smaller space to the west in closer proximity to the former hoist and staircase located west of this (Plate 52). The west wall was completely rendered masking earlier features. The remains of two former bearing boxes are noted on the south and north wall however. Drive shafts are likely to have extended into the former spinning mill on ground level and into the former weft warehouse.

Plate 52 (shot 426): Former flywheel house showing later partition and doorway, looking east-northeast, 2m scale

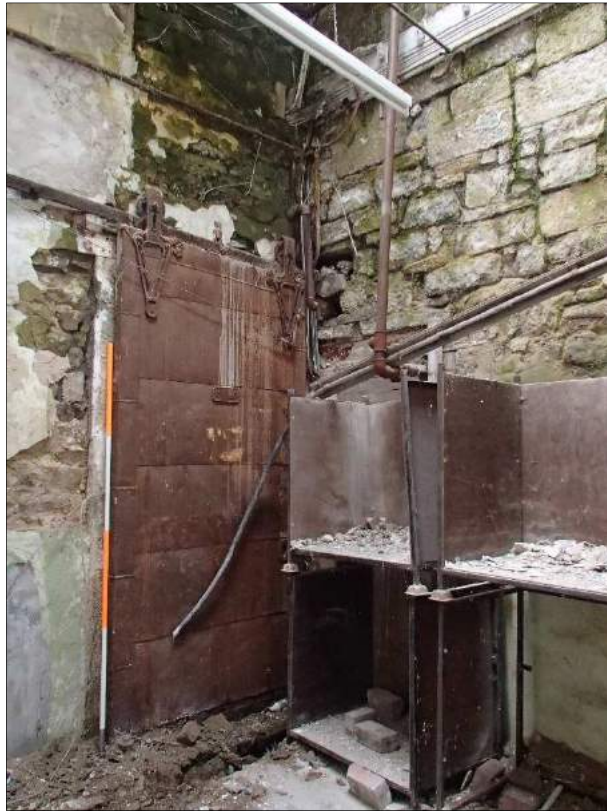
Plate 54 (shot 435): Early fire door from the mill days in the hoist and staircase. Looking south, 2m scale

- 7.39 In the area of the hoist and former staircase, the walls have once again been rendered, obscuring earlier features. There were no fixtures suggesting of a former staircase. An early fire door is located to the southwest into the former spinning mill (Plate 54). On the west partition is a bricked up tall opening of unknown function (Plate 55).

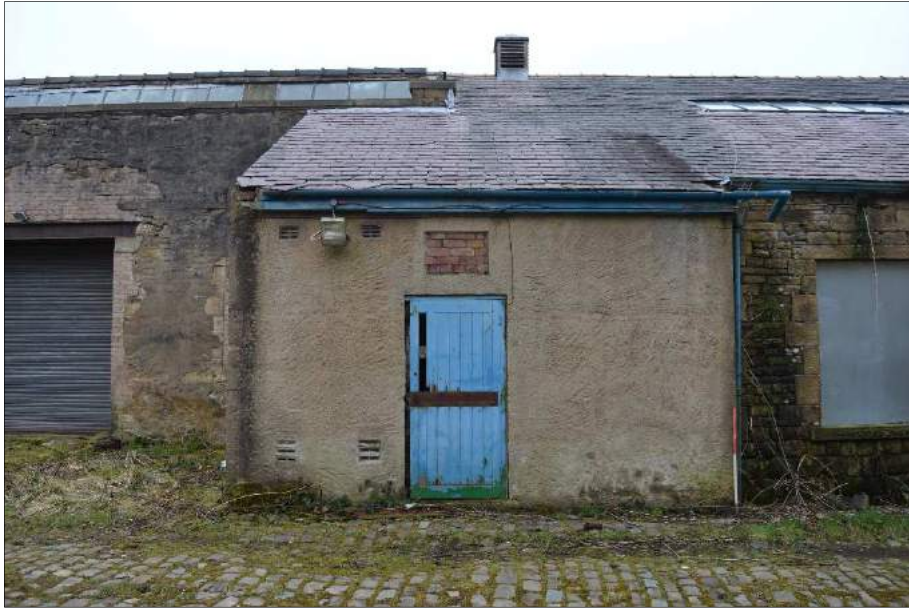
Plate 56 (shot 51): Small extension between the engine house and the former weft warehouse. Looking southeast, 1m scale

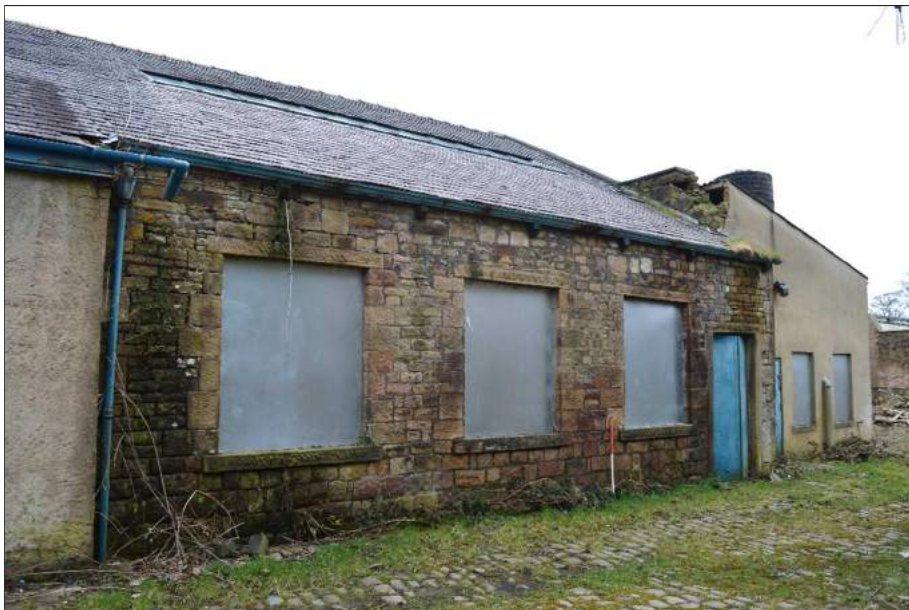
- 7.41 The former weft warehouse was first noted on the 1882 plan (Plate 57). It is built in the same style as the early spinning mills, engine house and blow house with coursed, unsorted and square cut stone. There are quoins on the corners of the structure and ashlar stones surrounding the windows. The sills and lintels have been dressed in the same style as on building B, even the door jambs are ornate (Plate 58). The plank and batten double doors have a tight fit and appear to be original. The roof is double pitched and covered in slate, a roof light extends across the north pitch. The roof was laid at the same time as that on the adjoining lean-to shed.

Plate 57 (shot 48): Former Weft Warehouse (1882). Looking south, 1m scale

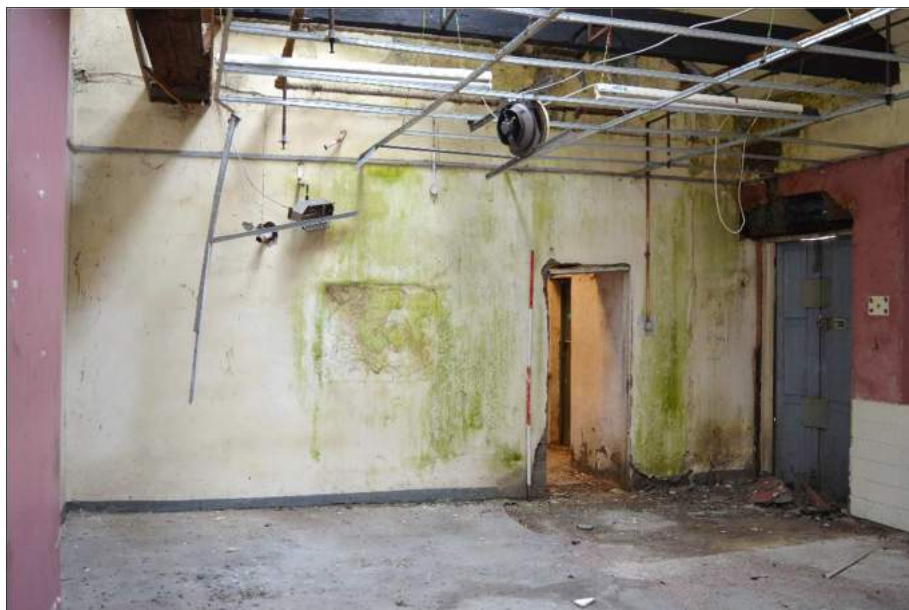
Plate 59 (shot 352): West partition wall. Looking northwest, 2m scale

- 7.42 The interior space has been split into two compartments at a later date. The one to the west has a blocked opening on the west partition wall (Plate 59). A sprinkler system is present but somewhat obscured by later fittings in the ceiling. Behind the partition wall to the east is a small space, which until recently housed numerous fuse boxes (Plate 60).

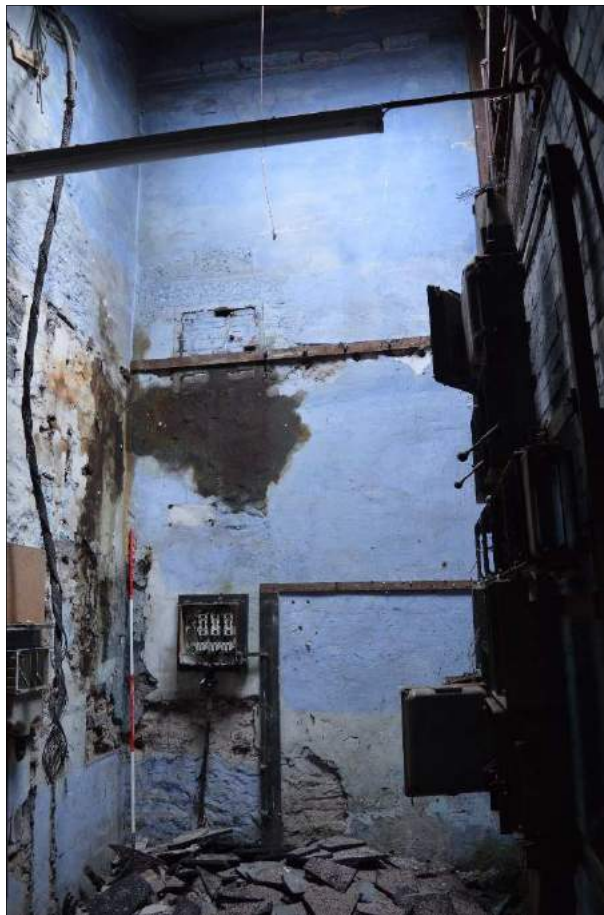
Plate 61 (shot 361): Bearing box on south wall. Looking southeast, 2m scale

- 7.43 The bearing box on the south wall corresponds to that visible in the room where the flywheel would have been housed. The power would have been transferred into this point and perhaps with the use of a bevel gear forwarding the power down the length of the warehouse (Plate 61).

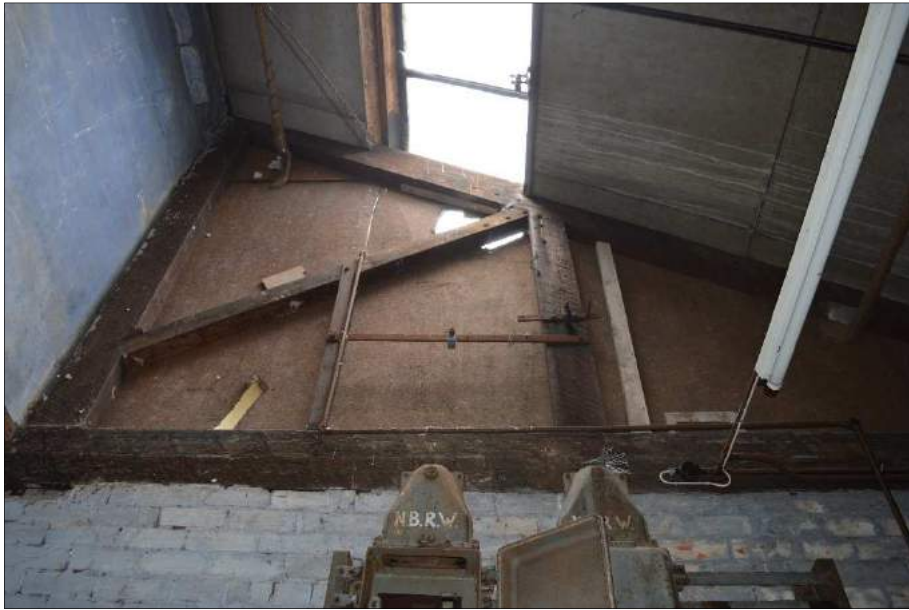
Plate 62 (shot 366): Roof truss. Looking southwest

- 7.44 The roof truss comprises a tiebeam, posts and strut supporting a rafter (Plate 62).

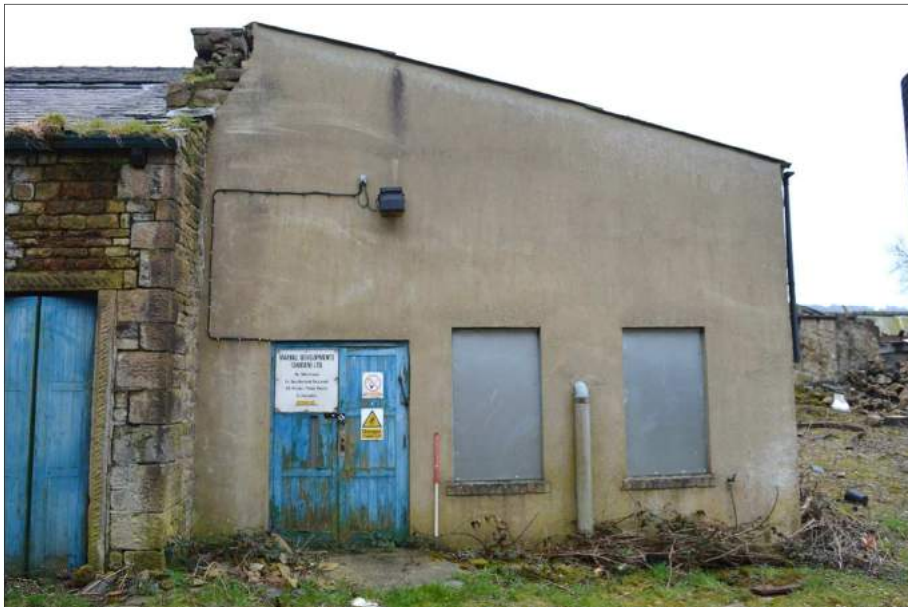
Plate 63 (shot 43): Lean-to extension, northwest elevation. Looking southeast, 1m scale

- 7.45 The lean-to extension west of the former weft warehouse dates to the late 19th century. The 1892 block plan indicates the presence of a structure that follows the line of the north elevation, whereas the earlier plan of 1882 show a structure in this location but one where the north elevation extends beyond the current limit of the warehouse.
- 7.46 The building has a mono-pitched roof with probable corrugated asbestos sheeting. The north and the west elevations were rendered and that to the west had a scaled effect (Plate 63 and Plate 64). The northwest elevation comprised the main entrance with two boarded tall windows.

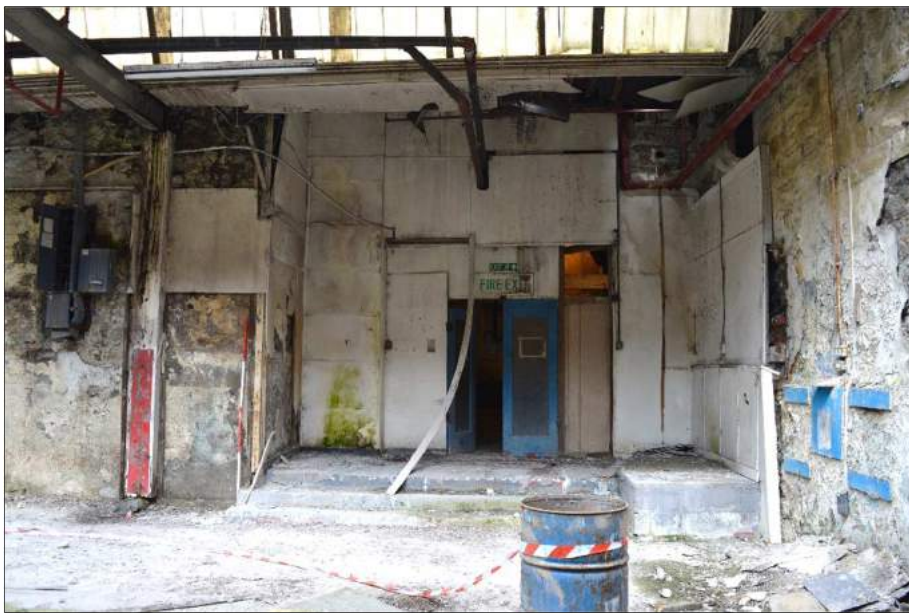
Plate 65 (shot 208): Southeast partition wall into the former spinning/weaving department. Looking northwest, 2m scale

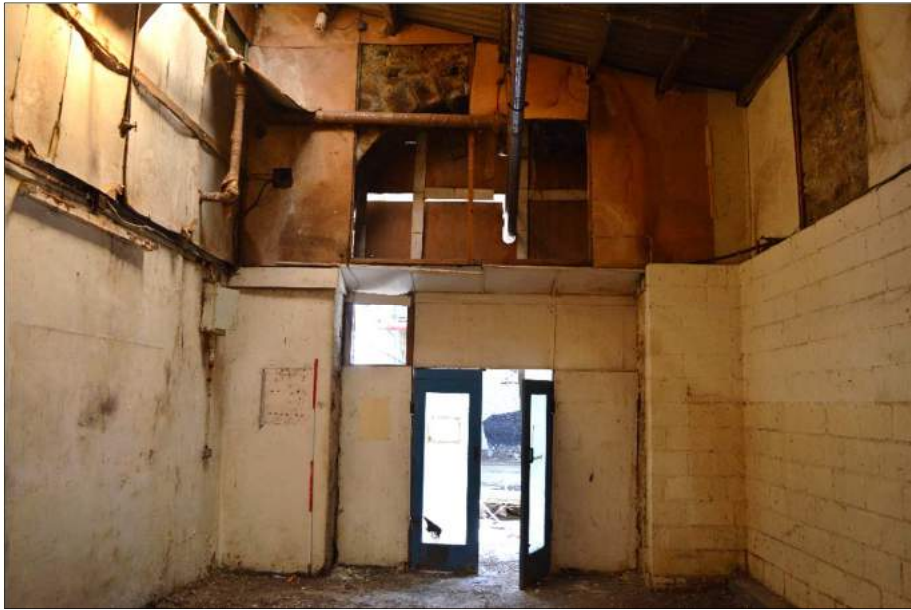
Plate 66 (shot 343): Interior view of later partition. Looking southeast, 2m scale

- 7.48 Part of the cladding has come off the interior revealing a concealed stone arch on the south wall (Plate 66). The east interior wall had been extensively rendered as well as boarded and the lower part of the east wall was clad with breezeblocks thus obscuring any earlier features. Lagged pipework of the former sprinkler system ran along the east part of the ceiling and a separate (presumed) water pipe entered through the south opening with an outlet to the north (Plate 67). A gas outlet was also fixed on the north wall. The steps and landing to the north reveals a drop of c.0.5m in height between the exterior ground surface and the interior floor surface.

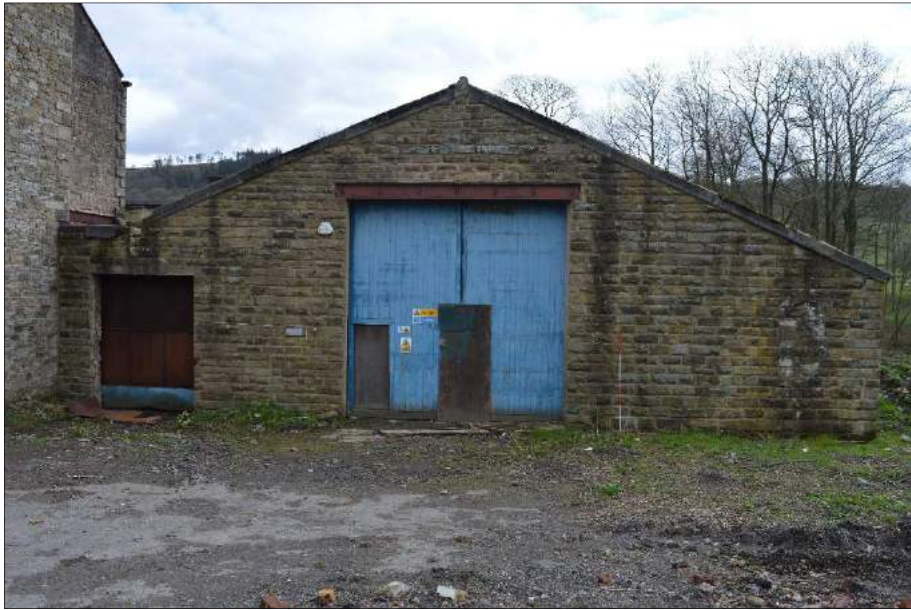
Plate 68 (shot 371): North elevation of D. Looking south, 2m scale

7.49 Building D first appears on the Ordnance Survey map of 1970. It appears to be later than the ventilation shaft to the east, built between 1963 and 1970. The stone and brick built structure is aligned roughly north to south on the northern bank of Sabden Brook and built on top of a backfilled mill pond and demolished 1908 WCs. The corrugated sheet roof has a low and wide pitch with roof-lights along each side. On the north elevation are two entrances, a large double door in the centre with a wicket door on the left-hand side and a smaller opening to the east (Plate 68).

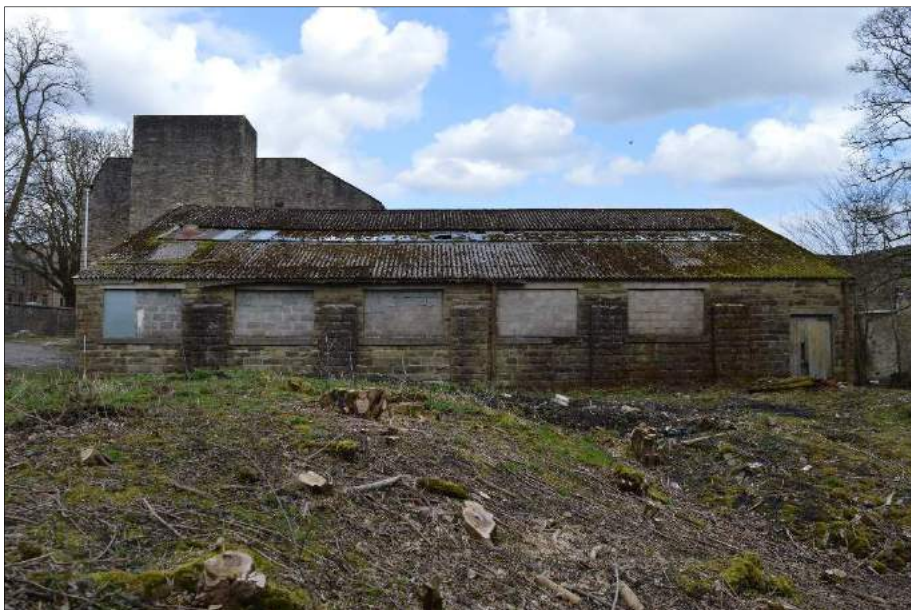
Plate 69 (shot 370): West elevation. Looking east-northeast, 2m scale

- 7.50 The west elevation is in six bays with five supporting pilasters and five windows, all blocked with breeze blocks (Plate 69). There is an entrance towards the south end with a concrete or stone lintel and hinged plank and batten door blocked from the inside with breeze blocks.

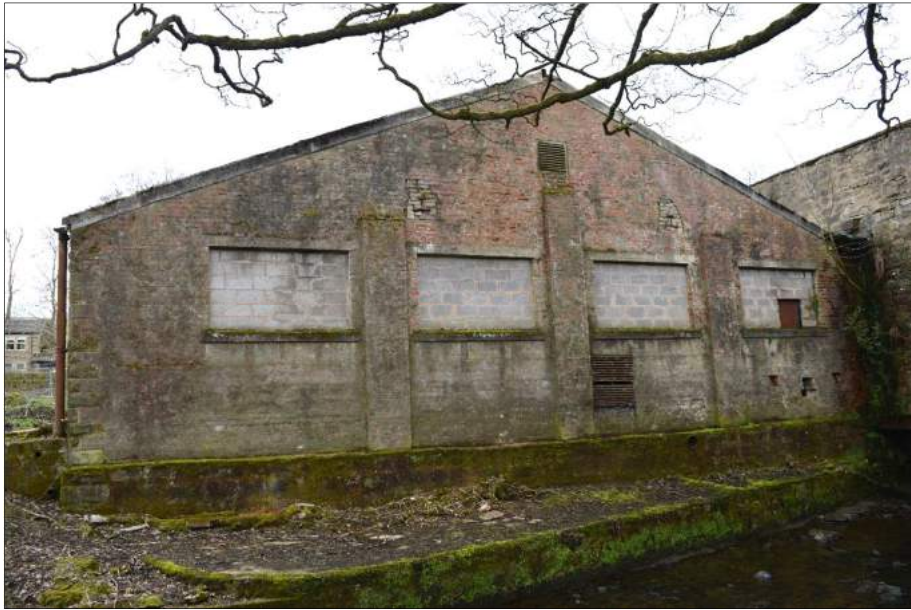
Plate 70 (shot 193): South elevation. Looking northeast

- 7.51 The south elevation is built of brick with stone quoins, with three pilasters on a stone plinth and four windows, all blocked with breeze blocks. There are ventilations holes above the central pilaster and on ground floor level (Plate 70).

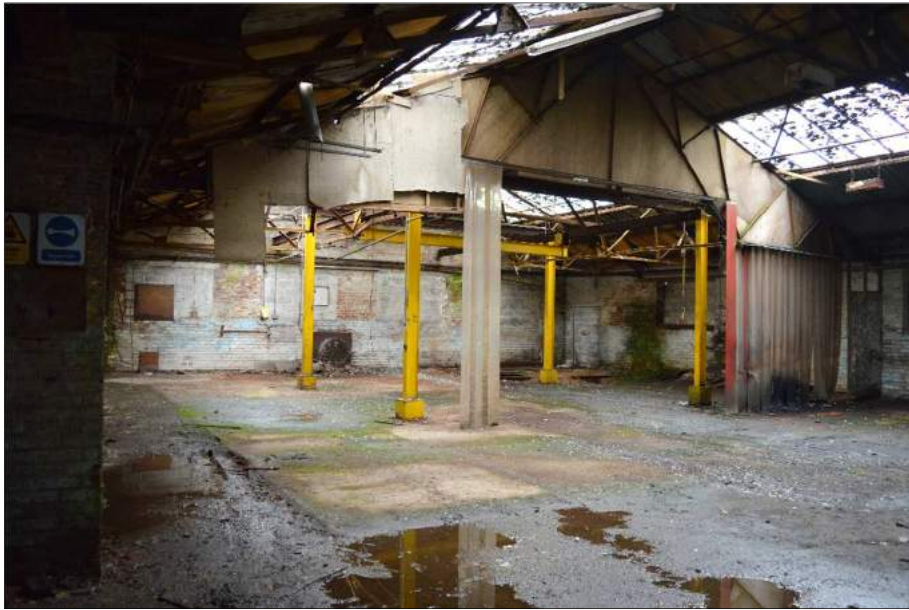
Plate 72 (shot 228): General view towards the south. Looking south, 2m scale

- 7.52 The building was recently used by Marbill for spraying polyurethane coatings on to various items and some modern machinery is left in the building (http://www.marbill.co.uk/spray-products/?doing_wp_cron=1529051057.2042019367218017578125#!). The interior was largely an open space with evidence of a partition to the south in form of PVC strip curtains (Plate 72). The roof was supported by steel truss rafters.

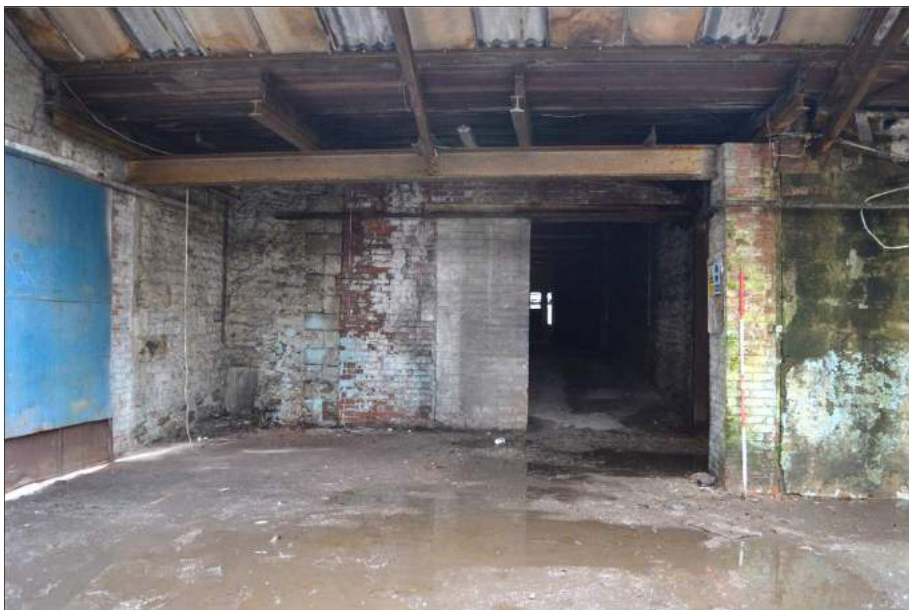
Plate 73 (shot 233): General view towards the old mill. Looking northeast, 2m scale

- 7.53 The relationship to the ventilation shaft can be seen on the north wall, where there is a straight joint between the brick wall of building D which abuts the earlier stone quoins of the ventilation shaft to the east. A later brick wall abuts the original mill walls to the north and to the south, it has a later infill presumably added in after building D was erected (Plate 73).

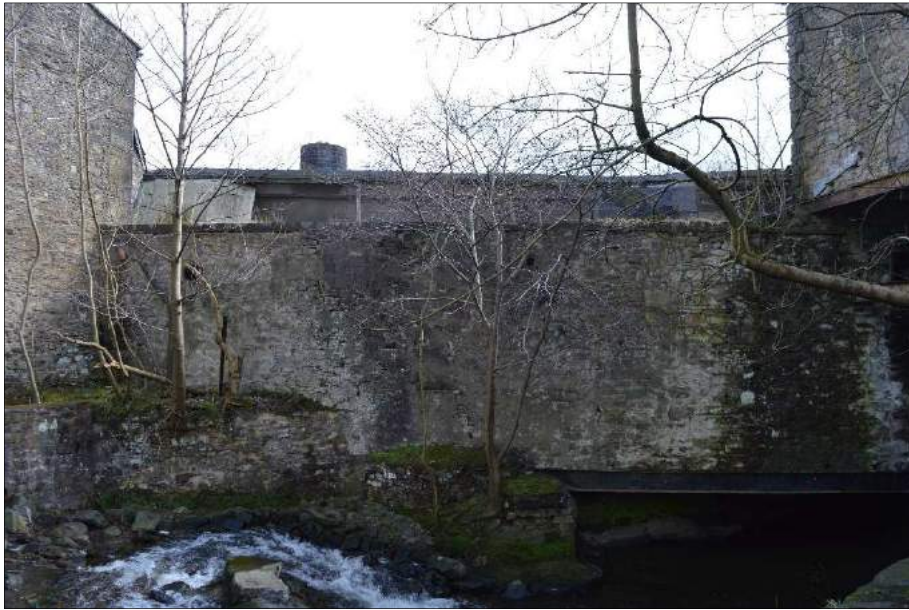
- 7.54 Building E was an addition to the mill, erected in 1908. The new extension incorporated the ground of the former gasometer and presumably also any associated retorts, which exploded in 1907 causing damage to surrounding structures. The north elevation of the single storey structure spans across Sabden Brook and incorporates an underfloor culvert (Plate 74 and Plate 75).

Plate 74 (shot 408): North elevation with culvert. Looking south

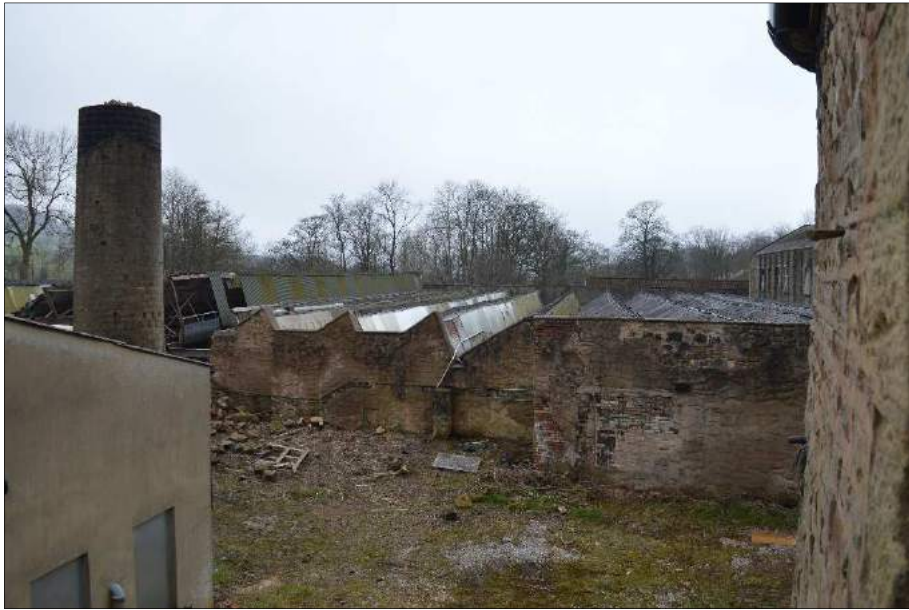
Plate 76 (shot 57): Overlooking northeast elevation and roof of building E. Looking west-southwest

- 7.55 The building again displays the saw-toothed roof with north-lights typical of the complex (Plate 76). The east elevation has been rendered in the same style as building C's south extension.

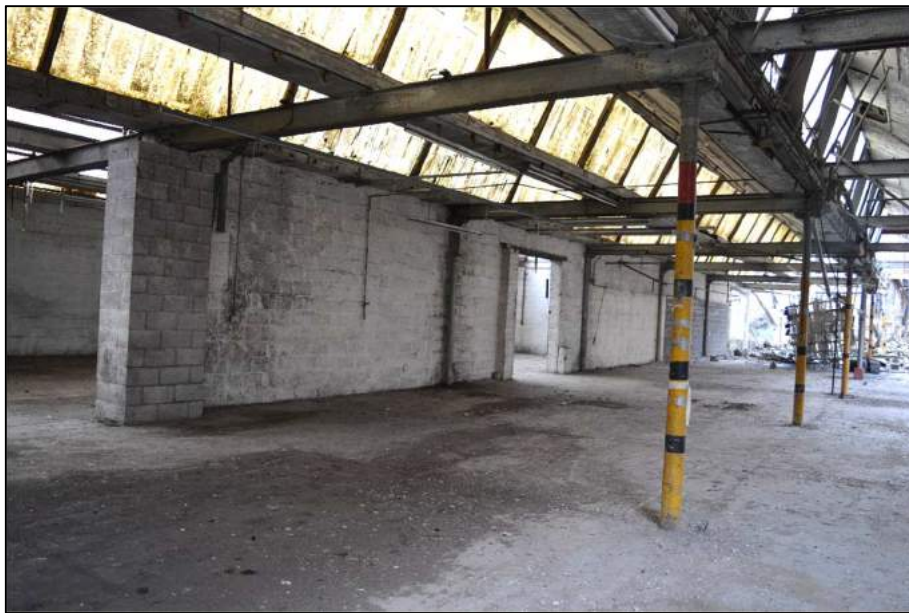
Plate 77 (shot 222): General shot of former carding room, later columns may follow the line of the original partition between spinning room and carding room. Looking north

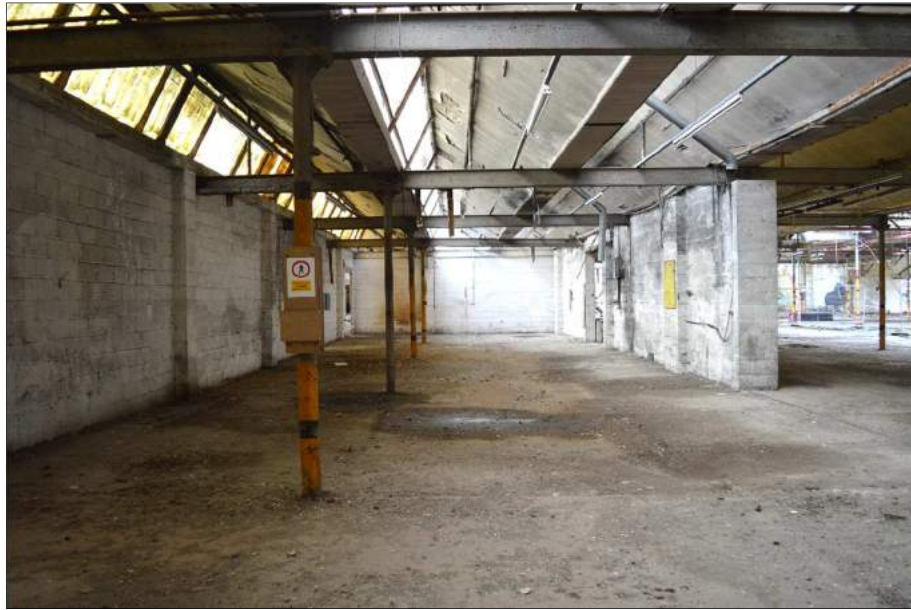
Plate 78 (shot 169): Later division of the carding room postdating 1970. Looking northeast, 2m scale

- 7.57 Breeze block partitions have been added at a much later date, presumably after 1970 (Plate 78 and Plate 79). Steel columns of different dates support steel girders and metal roof trusses. Most of the columns show south-facing line shaft mounting surfaces as well as west-facing mounting surfaces towards the east and the chimney.

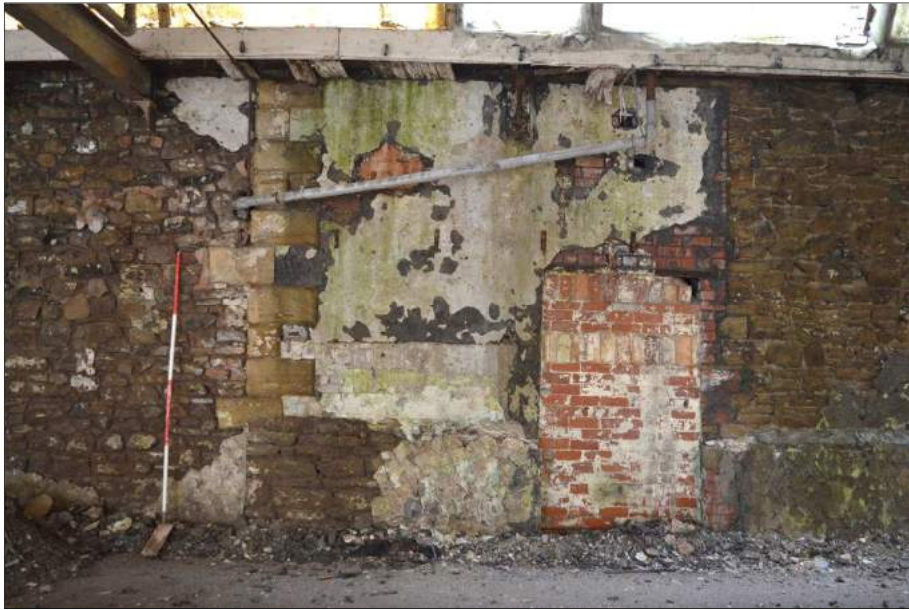
Plate 80 (shot 156): Quoins and plinth of original spinning mill and blocked access between the former spinning department and the carding room. Looking northwest, 2m scale

- 7.58 The earliest elements were recorded along the north wall where the original spinning mill elevation and plinth was incorporated into the later north elevation of the carding room (Plate 80 and Plate 81). Some of the quoins have been re-used to better key in the two walls. There are also earlier openings which were bricked up at a later stage, presumably after the mill had fallen out of use.

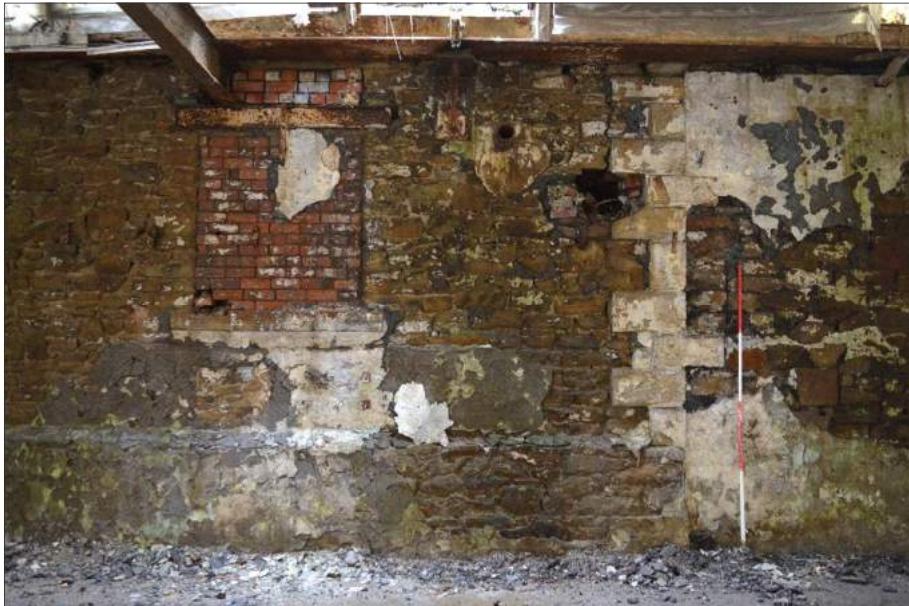
Plate 81 (shot 157): Bricked up earlier opening, plinth and quoins of original mill. Looking northwest, 2m scale

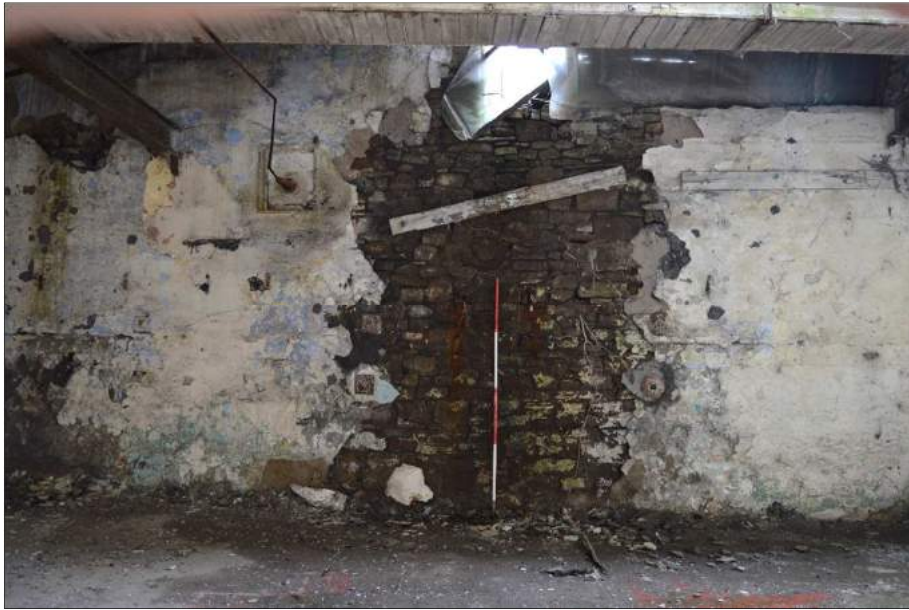
7.59 Along the same north wall is a former bearing box which has found a later re-use as a pipe access way (Plate 82).

Plate 82 (shot 159): Former bearing box on the north wall. Looking northwest, 2m scale

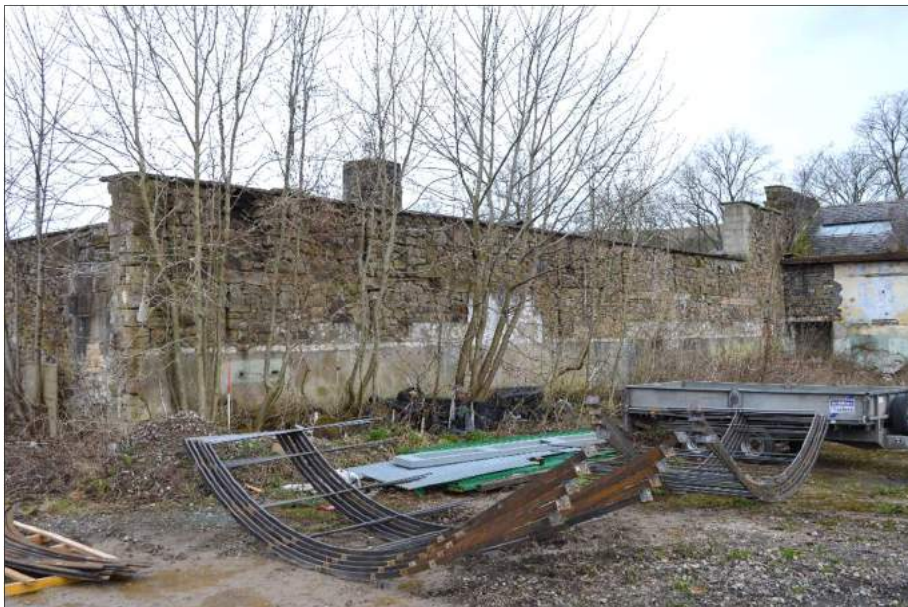
Plate 83 (shot 139): North elevation and partition wall to former mill. Looking northwest, 1m scale

7.60 Structure F is situated between the mill pond to the west and what was once a four storey spinning mill (now demolished) to the east. It has been present on site since at least 1882 and is likely to date back to the mid-19th century. The east wall was originally a partition wall to the mill (Plate 83) and displays a series of blocked windows. A roof scar from a later saw-toothed bay can be seen close to the former staircase and hoist room. The roof scar is situated roughly on first floor level, there are no traces left of a second floor with attic above. The bay incorporates a bricked up entrance which was suggested on the proposed plan from 1894 between the former mill and weaving department (Plate 84).

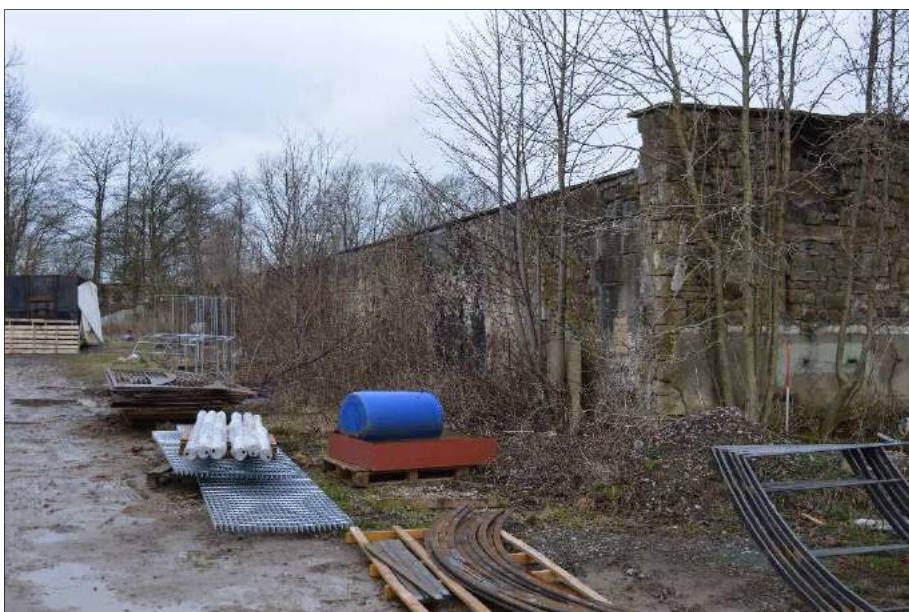
Plate 85 (shot 140): South partition of the weaving shed. The yard was once occupied by the former spinning and carding room. Looking west, 1m scale

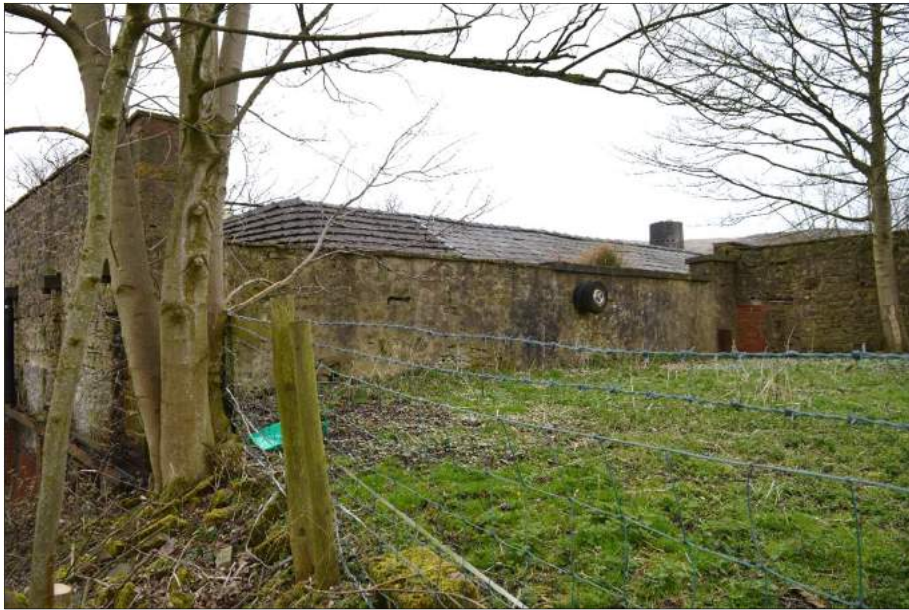
- 7.62 The former weaving shed has partly been built into a bank causing the interior floor surface to be situated below ground surface which is well illustrated on the 1898 section for the altered WC (Figure 13). This may have been a deliberate attempt to create moisture within the weaving shed as cotton as well as flax was best woven in damp conditions (Historic England 2017, Giles 1993).

Plate 86 (shot 185): South elevation of the weaving shed and west elevation of former spinning and carding room to the left. Looking north

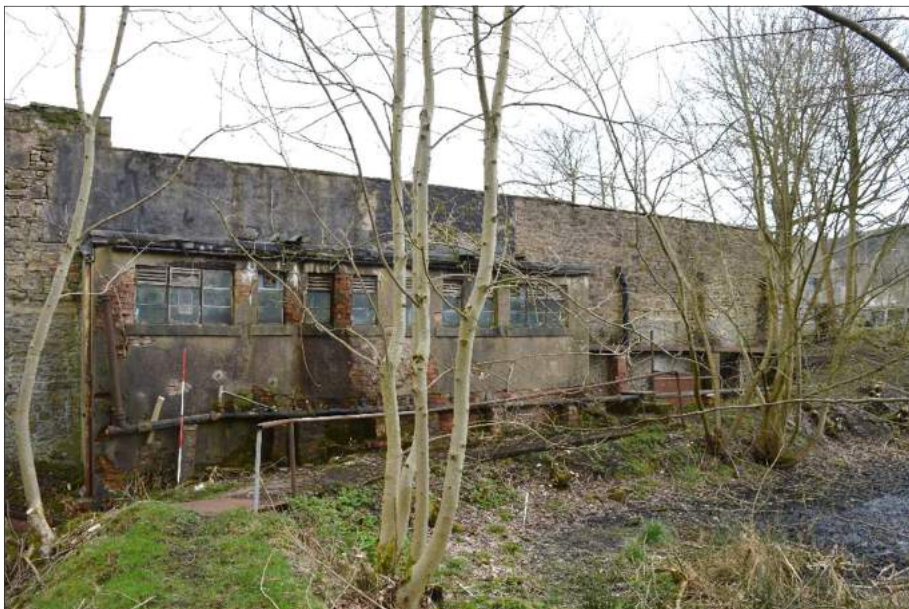
Plate 87 (shot 191): Lavatories from 1947 on the west elevation. Looking east, 2m scale

- 7.63 Mixed gender lavatories dating to 1947 are still present on the west elevation, completely built in brick and rendered, with windows facing west (Plate 87).
