**ARCHAEOLOGICAL SCHEME OF WORKS REPORT:
VICTORIA MILL, WATT STREET, SABDEN, LANCASHIRE**

Planning Reference: pre-planning
NGR: SD 77582 37287
AAL Site Code: SAWS 18
OASIS Reference Number: allenarc1-321051

Report prepared for Skipton Properties Ltd

By
Allen Archaeology Limited
Report Number AAL 2018115

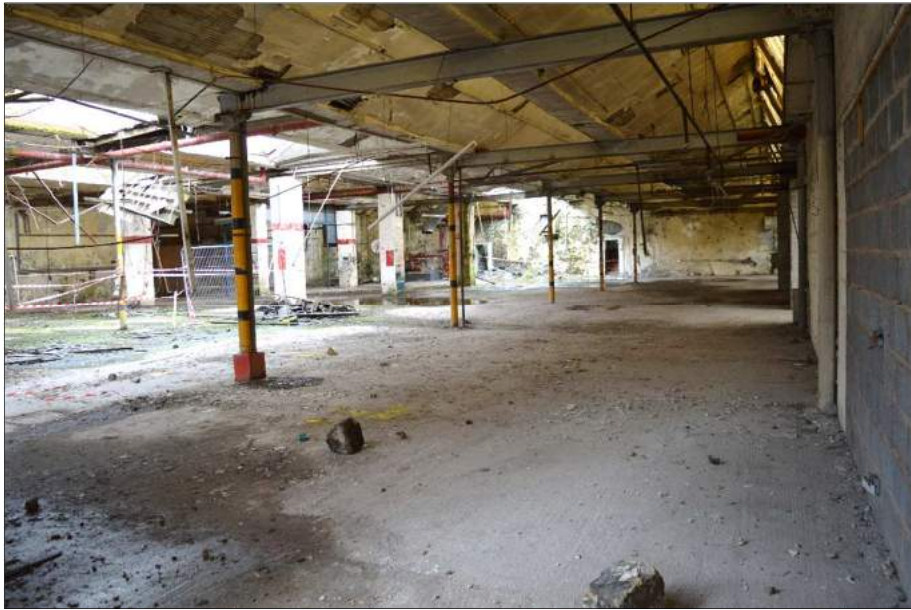
Plate 88 (shot 171): Steel column structure with steel girders and roof trusses. Looking northeast

- 7.64 The interior of the former weaving shed has the same construction as the later carding room to the north. Steel columns, sometimes encased in brick, support steel girders and roof trusses. The south-facing part of the roof has been lathed and boarded (Plate 88). Large parts of the south wall have been blocked with breeze blocks and rendered thus hiding any earlier features (Plate 89).

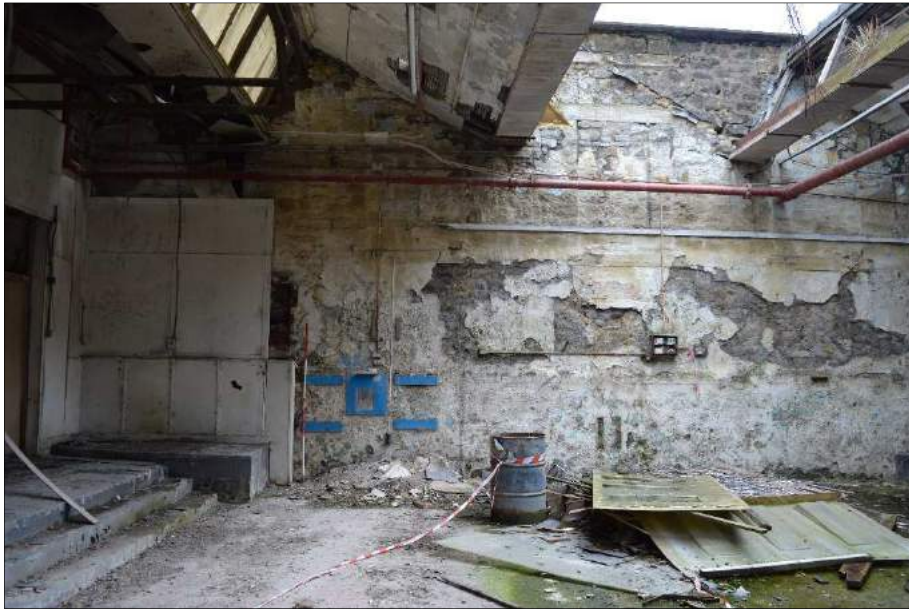
Plate 90 (shot 210): Representative view of the east partition wall. Looking northeast, 2m scale

- 7.65 The east and former exterior wall of the four storey spinning mill, displays dressed lintels and sills of for the blocked up windows (Plate 90). Those on the reversed and east-facing (interior) side were not dressed. There was no indication of ground floor windows having been present on this elevation. The saw-toothed roof is a much later addition, perhaps added after the spinning mill to the east was demolished. Scars on the south partition wall show remains of an earlier north to south aligned roof with west-lights, presumably aligned in such way as to maximise the natural sunlight into the ground and first floor of the spinning mill (Plate 91).

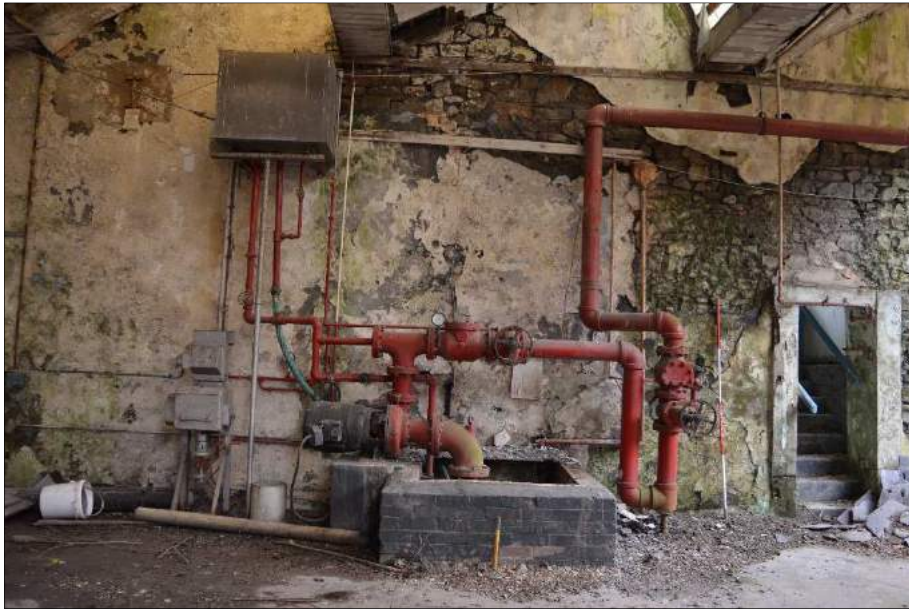
Plate 92 (shot 182): Water pump system by Mather & Platt. Looking southwest, 2m scale

- 7.66 The central water pump system for the sprinkler system is located in the former weaving shed along the west elevation and in close proximity to the mill pond, which would have been its main water source. The fire pumps, bedplates and pipework were often painted red, as in this case, to easily distinguish them from other water fed services (<http://www.the-lawrences.com/matherplatt/map-fire.htm>). The valves and alarm devices control and monitor the water's flow. Distribution pipes send water to the sprinkler heads.

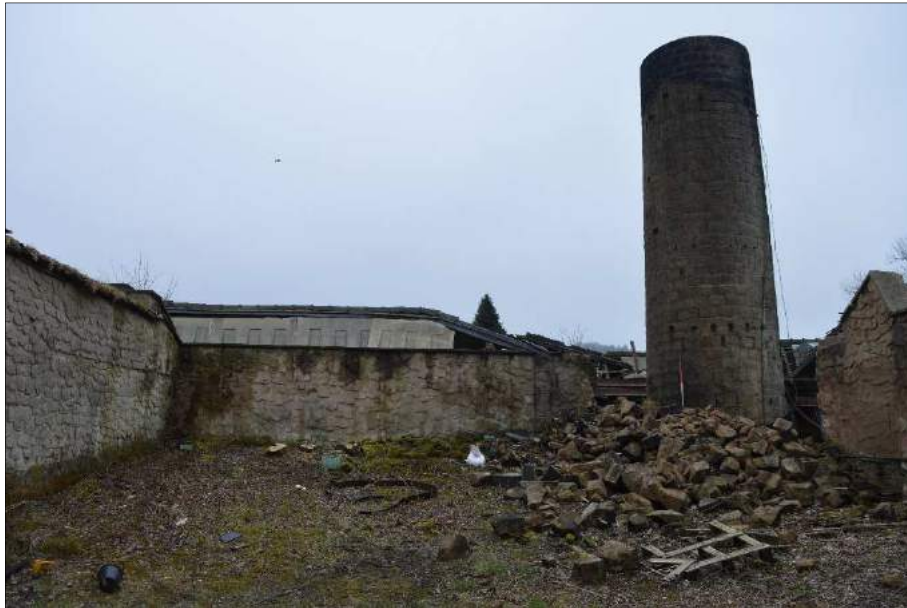
Plate 94 (shot 40): General view of the partly demolished chimney, remains of a flue situated below the scale, hidden by debris. Looking southeast, 1m scale

- 7.67 The chimney is located towards the northeast end of building F (Plate 94). It has been partially demolished for safety reasons with abundant debris surrounding it. It is built of dressed, square cut stone and measures approximately 3m in base circumference and is extant to approximately 10m in height. What would appear to be an opening for an above ground flue is located on the northeast-side surrounded by refractory bricks. As previously mentioned, historical records suggests the existence of four flues associated with the 1870s boilers.

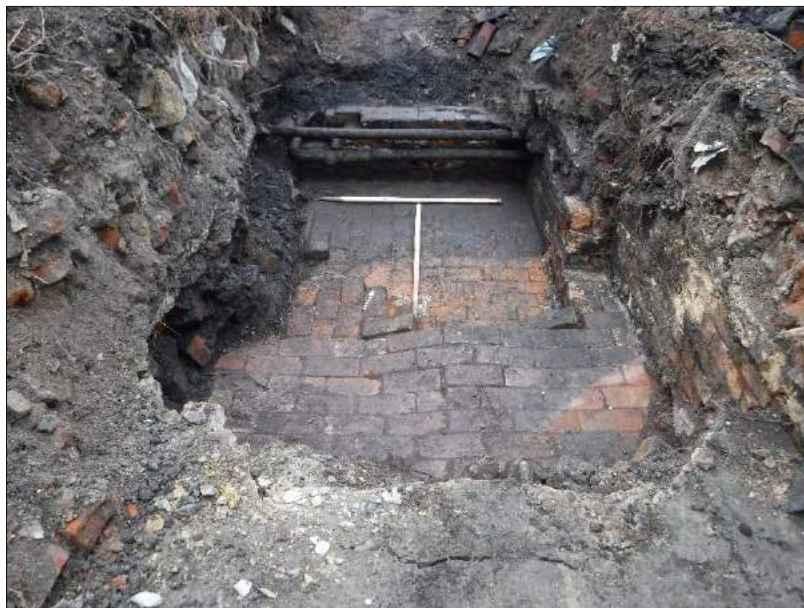
Plate 95: North end of Trench 1 showing wall 111 to the right, floor 116, pipework 110 in front of wall 109. Looking north, scales 1m

- 7.69 Trench 1 was aligned north-northwest to south-southeast and located c.3m northeast of the mill chimney (Figure 17). Most features were uncovered in the north end of the trench before the excavation had to be aborted due to the presence of asbestos (Plate 95).

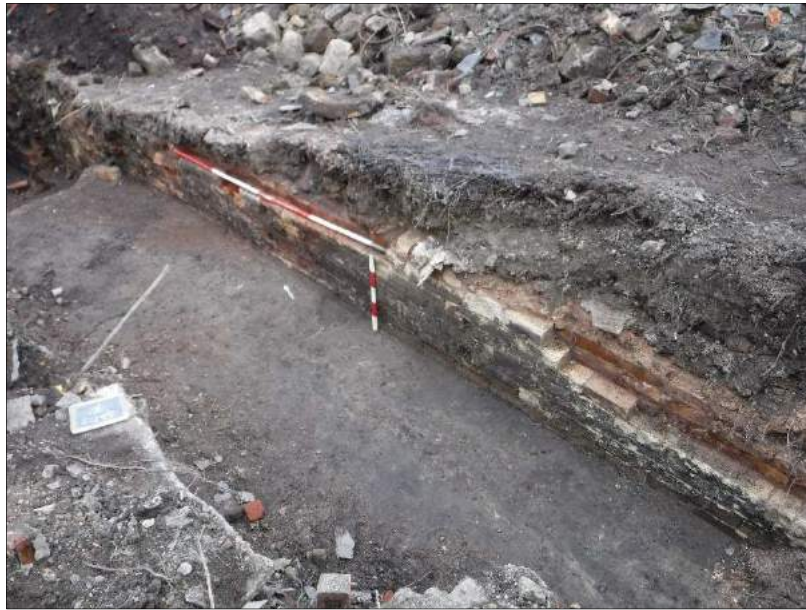
Plate 96: West-Southwest facing wall 107. Looking north-northeast, scales 2m and 0.5m

- 7.70 The earliest feature was a brick wall, 107, exposed running along the northeast edge of the trench. The wall survived to a maximum height of eight courses, and was faced with cream coloured bricks that had the appearance of firebricks commonly used in structures subjected to heat, with red bricks to the rear. The brickwork appeared to follow an English Garden Wall bond, jointed by lime mortar (Plate 96).

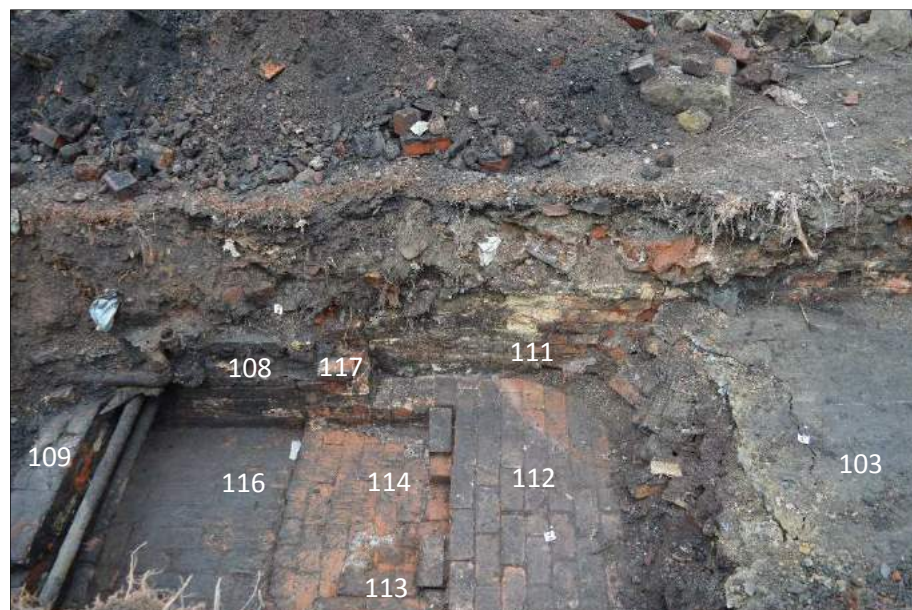
Plate 97: Floor surfaces 116 to the left, 114, disturbed surface 113 and 112 to the right

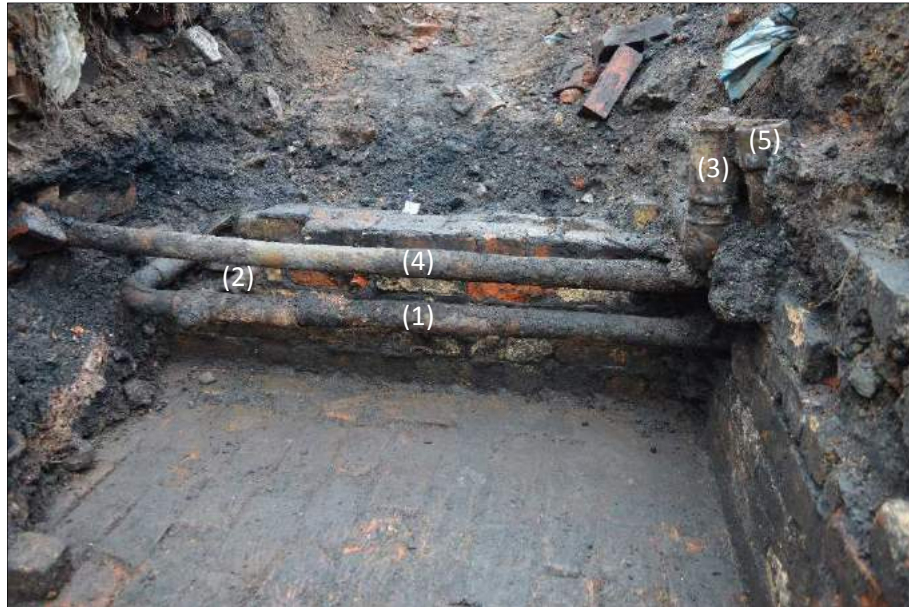
- 7.73 Abutting wall 108 to the west and situated above floor 116, was a later east-northeast to west-southwest aligned wall, 109, in 19th-20th century cream and red brick. It measured two bricks wide and five courses high with traces of both cement and lime mortar, suggesting repair work. The wall continued beyond the limit of excavation to the west. The purpose of the wall is uncertain, but it may have been a supporting machinery plinth or a partition wall, pipe work 110 (pipes 1-5, Appendix 3) surrounded the wall in all direction although the extent to the north remains unknown due to the limit of excavation.

Plate 98: Brick wall 109, surrounded by pipework 110. Looking northwest

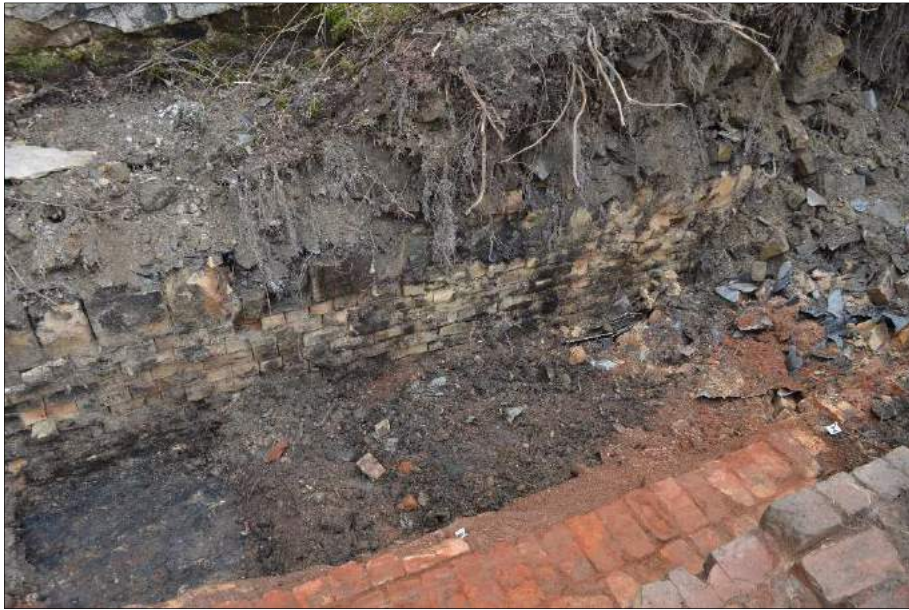
- 7.76 Trench 2 was located approximately 4m east of Trench 1 (Figure 18). Once again most of the features were uncovered towards the north end of the trench before the excavation had to be terminated.
- 7.77 Wall 209 followed the alignment of the east edge of the trench and consisted of both cream coloured facing bricks and red 19th-20th century machine pressed bricks laid in an irregular bond. Eight courses were exposed, on top of which there was a course of large, square cut stones, 208, which had caused the bricks below to subside.

Plate 99: East wall showing facing firebricks 209 and cut stone 208. Looking east-southeast

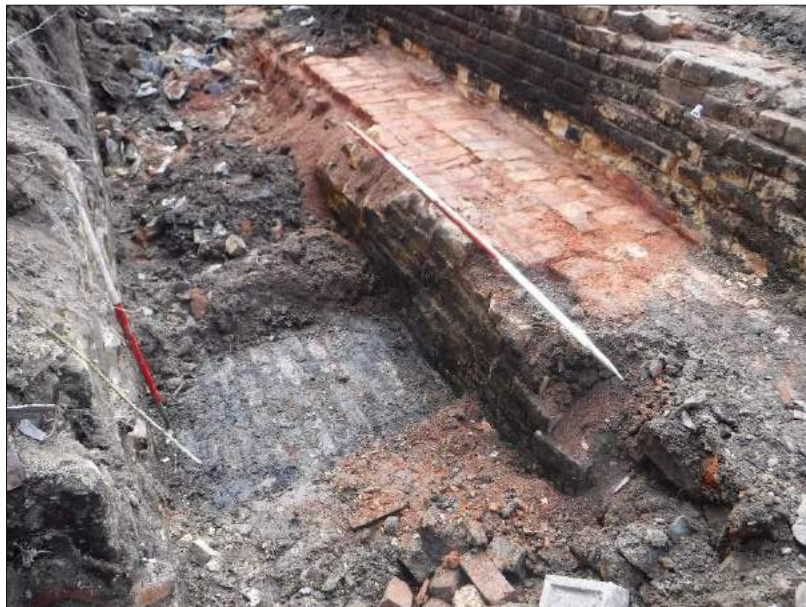
Plate 100: Trench 2 showing floor 207 with brick plinth 206 and 205 as well as wall 204 to the right. Looking south-southwest, scales 1 and 2m

- 7.78 Wall, 206, on the opposite side of the trench followed the same alignment and again consisted of 19th-20th century cream coloured machine made firebricks (Plate 100). The east face was discoloured by perhaps heat or ferrous material and the bricks had been laid offset causing a stepped effect. These were used as facing bricks for what appeared to be a 0.6m wide plinth. The upper surface, 205, was constructed with a mix of cream coloured and red machine made bricks. The edge closest to the facing bricks 206, were half bats laid on bed, followed by two lengths of stretchers on bed with occasional frog exposed. The final and fourth stretch abutted wall, 204.
- 7.79 A partially uncovered brick floor, 207, abutted the wall 209 and the presumed plinth. The bricks were laid on edge in a northwest to southeast direction.

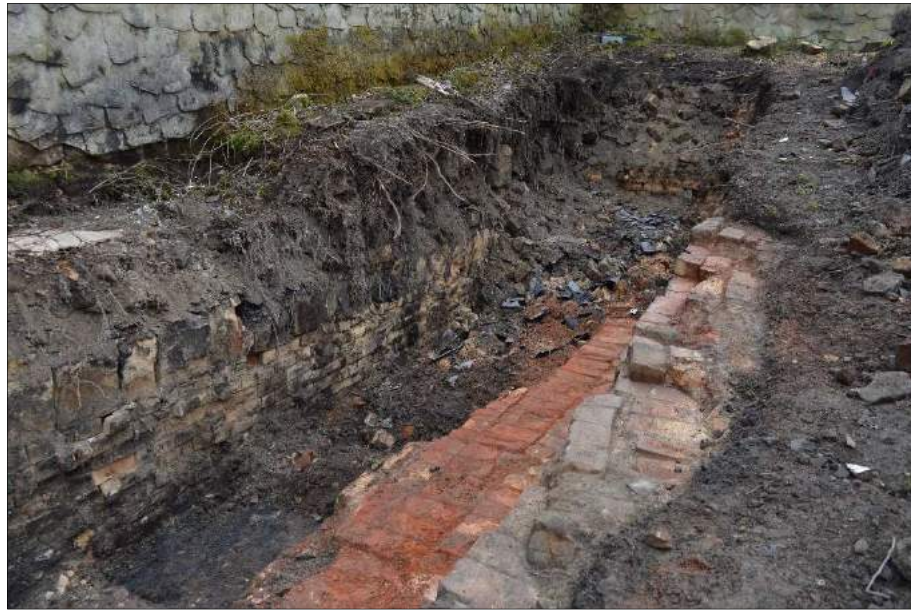
Plate 101: Wall 204 showing an offset bricks in the upper course. Looking southeast

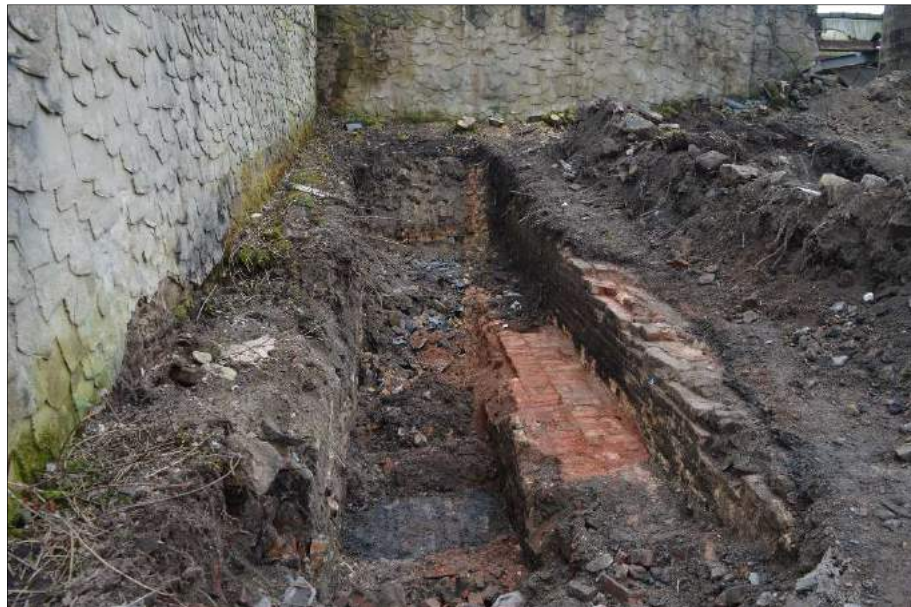
Plate 102: General trench shot looking south

- 7.81 At the south end of the trench was a further wall running in a west-southwest to east-northeast orientation, obscured by tumbling deposits and not possible to fully record due to health and safety. The relationship with plinth and wall 204 could not be established (Plate 101 and Plate 102).

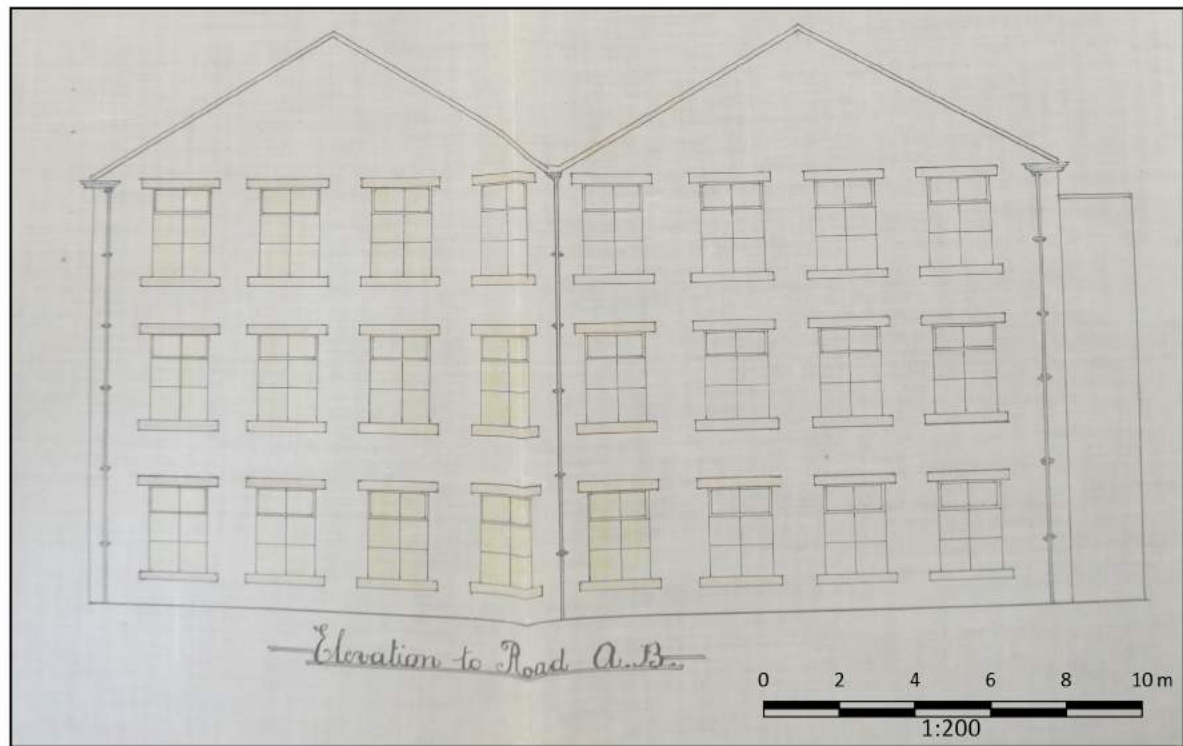
East elevation of proposed mill 1894 (Lancashire Archive, RDBU/7/2/43)

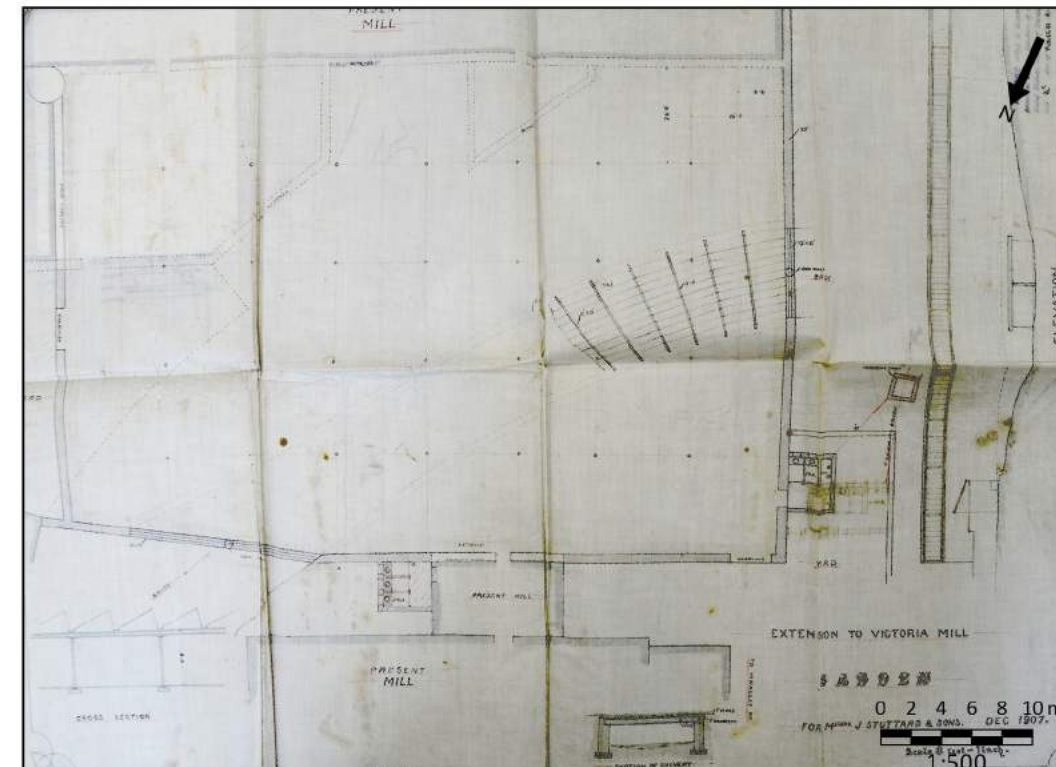
New extension 1908, detailed plan (Lancashire Archive, RDBU/7/2/129)

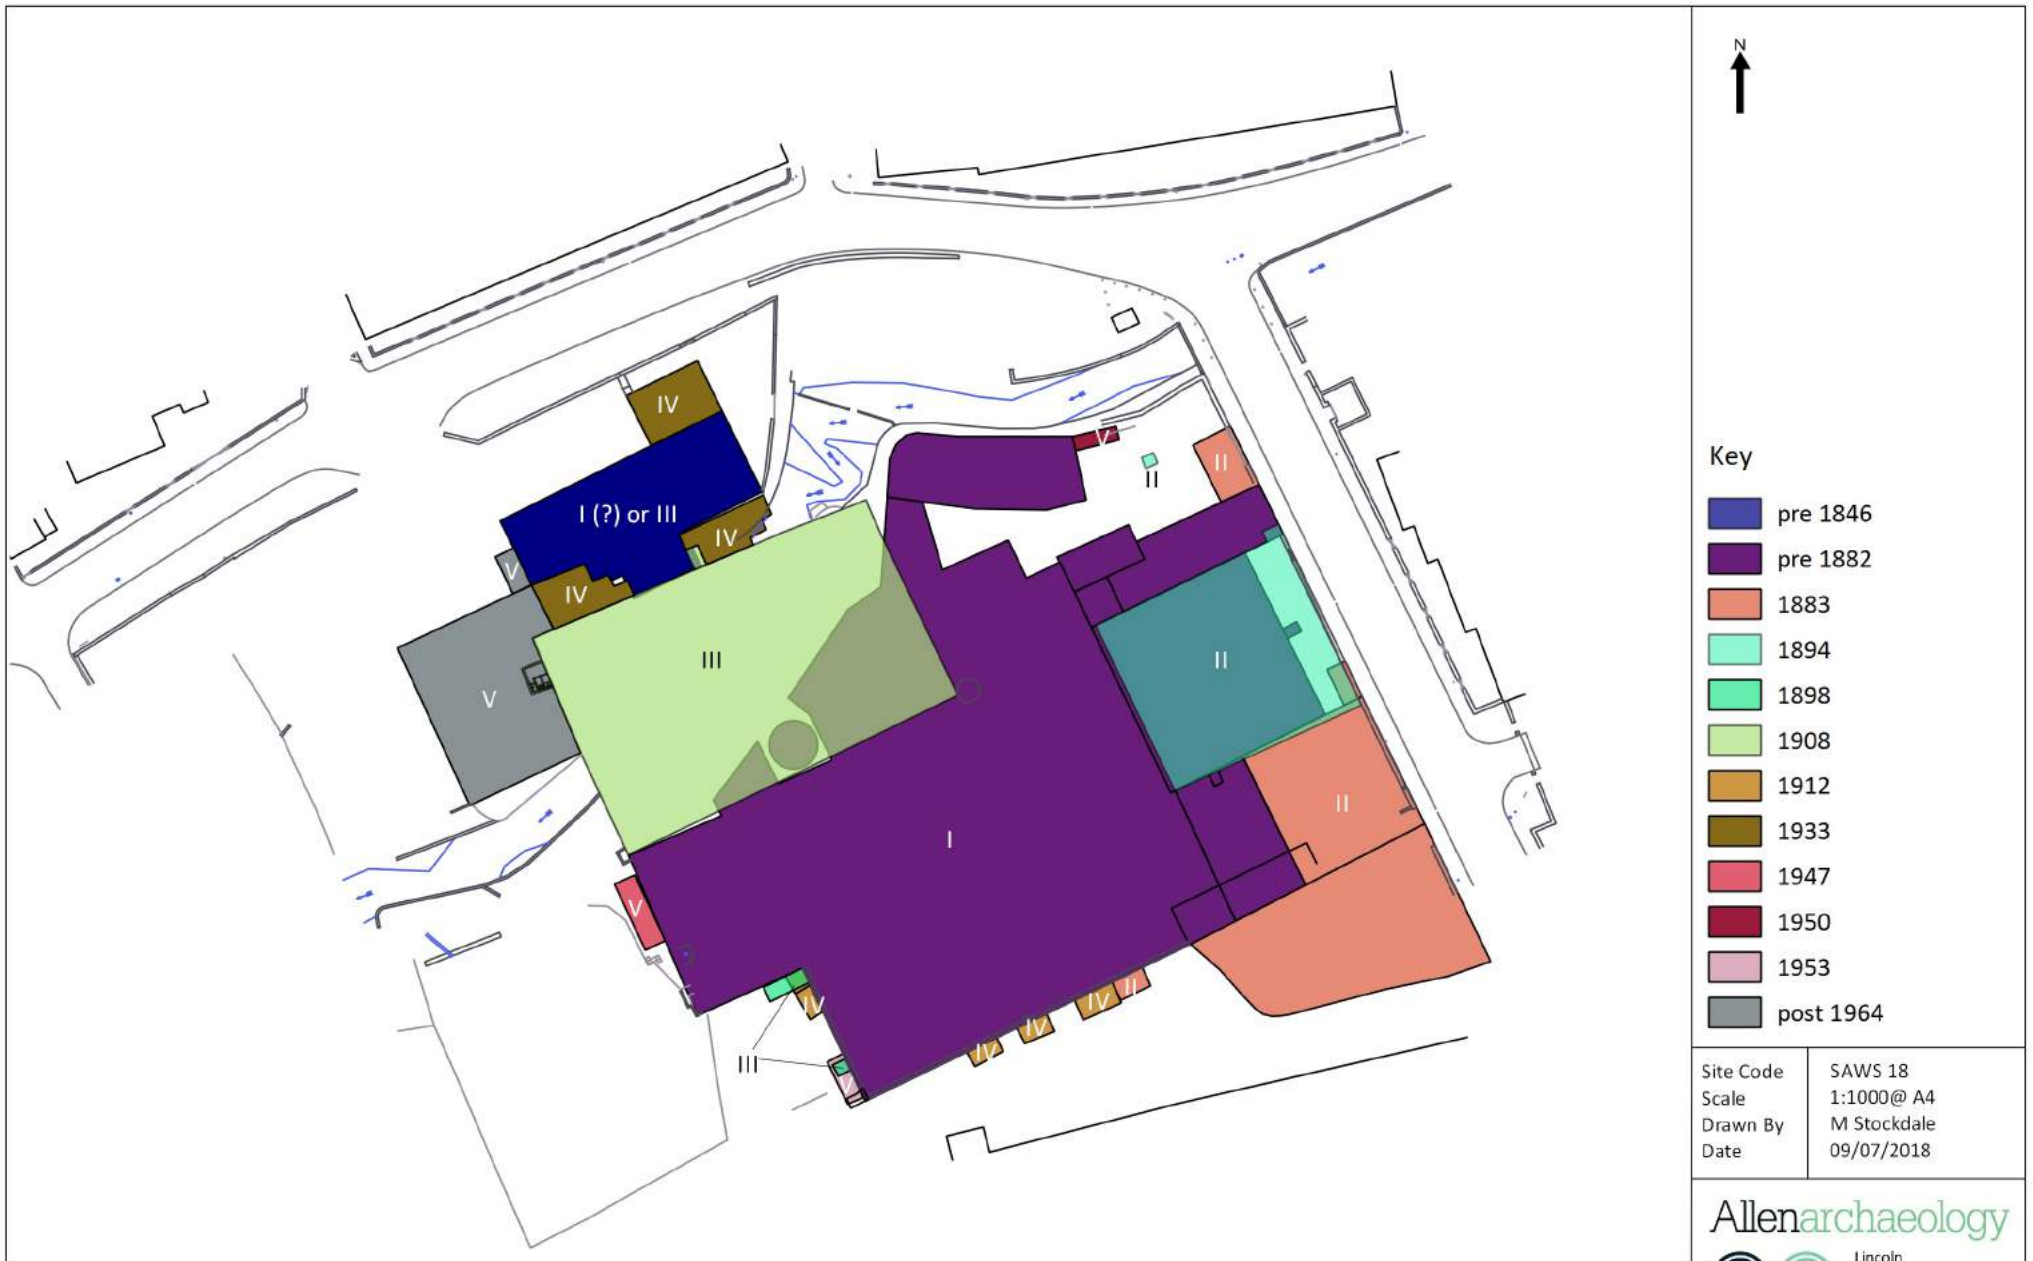
Figure 16: Phased block plan of Victoria Mill
