PHOTOGRAPHIC BUILDING SURVEY REPORT:
GARSTANG BUSINESS AND COMMUNITY CENTRE, 96 HIGH STREET, GARSTANG, PRESTON,
LANCASHIRE

Planning Reference: 16/00550/FULMAJ
NGR: SD 49291 45453
AAL Site Code: GAHS18
OASIS Reference Number: allenarc1-333340

Report prepared for Keyworker Homes Limited

By
Allen Archaeology Ltd
Report Number AAL 2018164

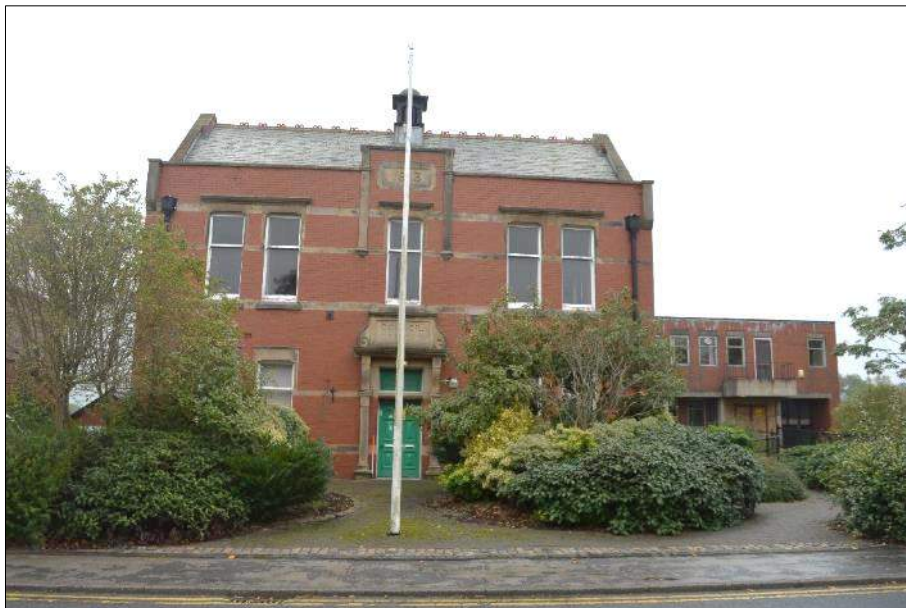
Plate 2 (shot 3): West elevation looking east, scale 1m

- 6.2 The west elevation has two pairs of tall vertical horned sashes below a stone hood mould, corresponding with paired sashes on the ground floor, with moulded stone surrounds. Another first floor sash sits above the central doorway.

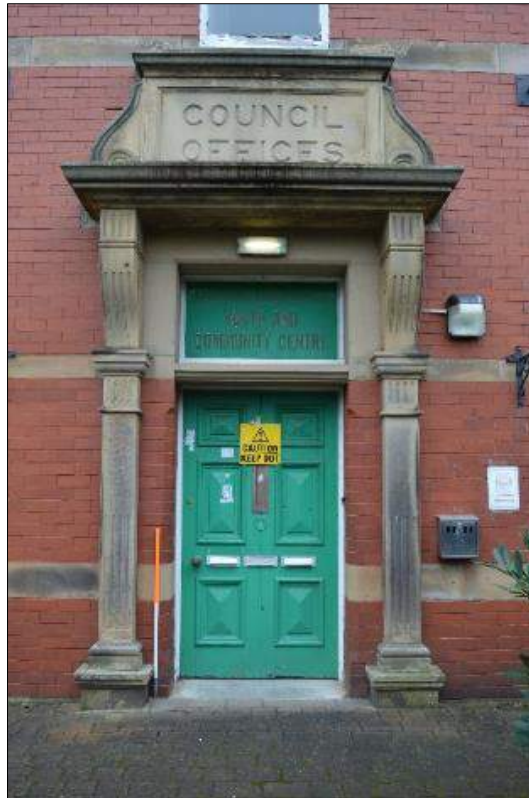
Plate 3 (shot 7): Main entrance looking east, 1m scale

- 6.3 The portico around the front entrance has classical fluted pillars on either side, with fluted and quatrefoil decorated consoles, topped by an entablature and scroll decorated hood engraved with '*Council Offices*' (Plate 3, Plate 5). Above the entrance and first floor window is a raised parapet with elongated label stops surrounding a date stone reading '1913' (Plate 4). Two cast iron down pipes have been fixed at either end of the front façade (Plate 7).

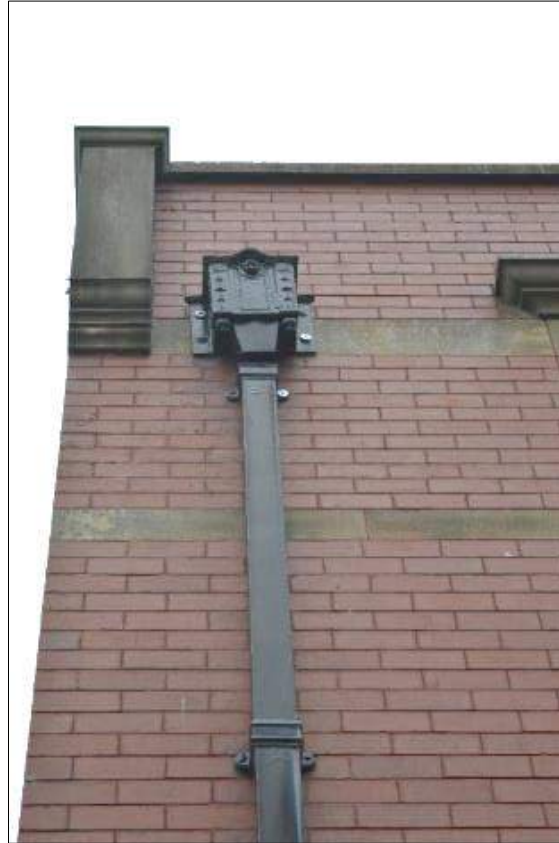
Plate 7 (shot 6): Cast iron hopper and downpipe on west facing elevation, looking east

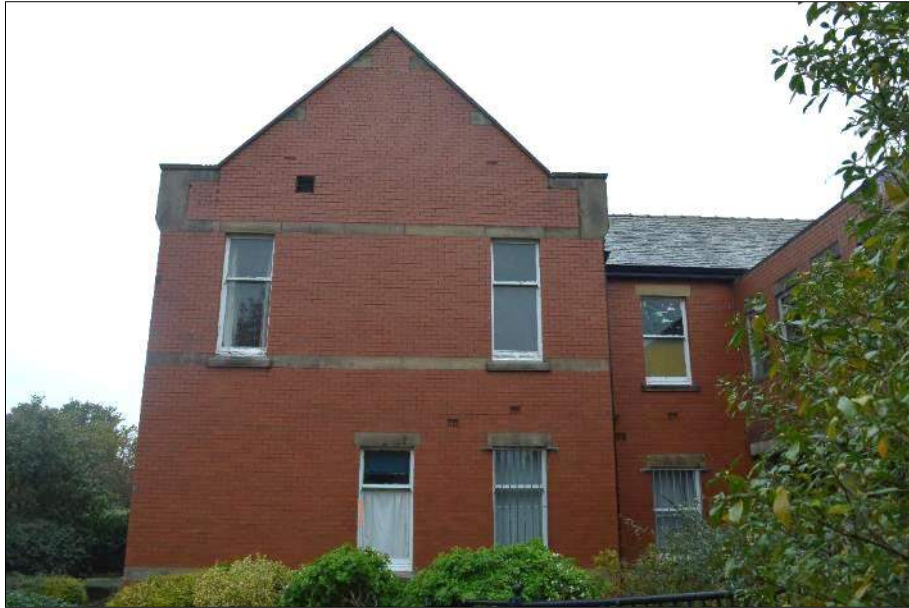
Plate 8 (shot 13): South elevation of original building looking north, scale 1m

- 6.4 The north and south elevations also have tall sash windows, two at first floor level and two at ground floor level. The first floor windows are positioned at either end of the elevation, the ground floor windows are to the centre and east (Plate 8, Plate 9).

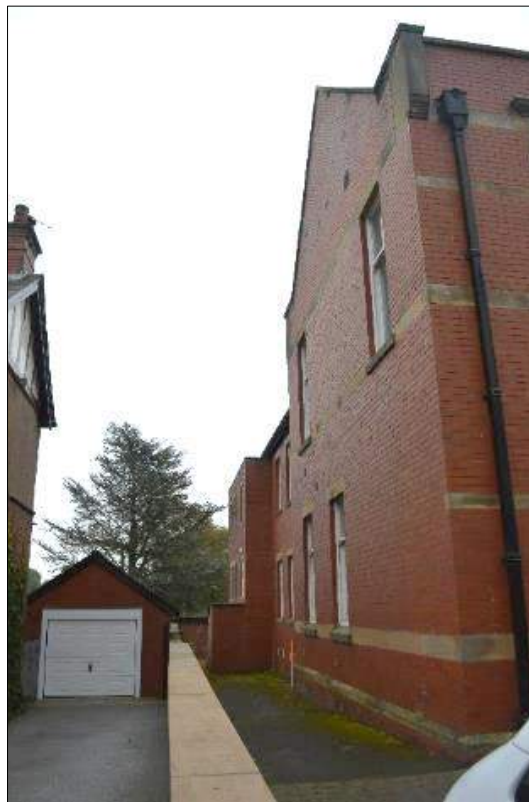
Plate 9 (shot 57): Oblique view of north elevation looking east, scale 1m

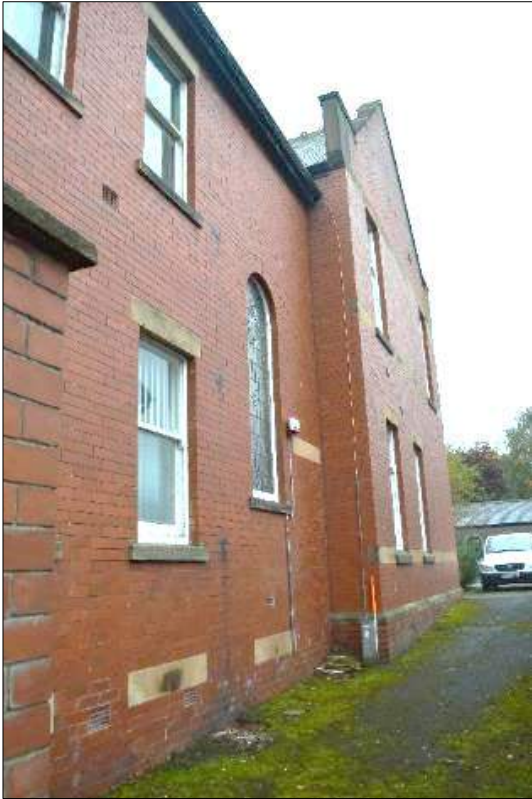
Plate 10 (shot 52): Oblique view of north elevation looking west, scale 1m

- 6.5 The east wing, with M-shaped slate roof, adjoins the east elevation of the original building (Plate 10, Plate 20). It is present on historic mapping from 1930 and could therefore only have been added within the first two decades of the Council Offices having been opened (Flaherty 2016, Figure 4). It follows the same polite style as the main building, built in the same red brick stretcher bond, and is two storeys plus a basement. It is without string courses and a plinth but, a fascia board and cornice in matching mouldings to that of the main house have been applied. A segmental arched leaded window decorates the north elevation (Plate 11). Below this two cellar windows have been blocked up of later date, but their stone lintels remain in situ (Plate 12).

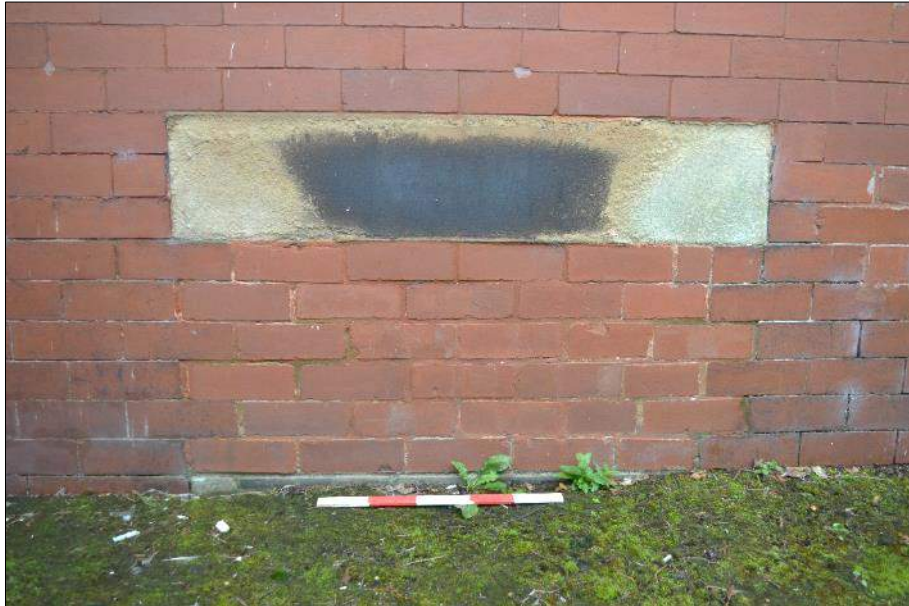
Plate 12 (shot 55): Sandstone lintel in original buildings north elevation looking south, scale 0.5m

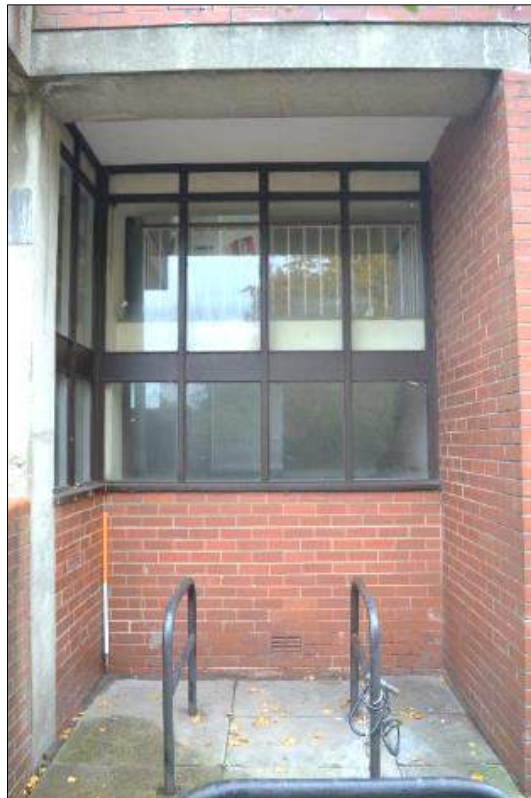
Plate 19 (shot 25): Bicycle parking bay in west elevation of 1960's extension looking east, 1m scale

- 6.6 The latest extension, extending east from the early 20th century east wing was added in the 1960s. It is two storey high, with basement, and a flat roof, and once again is in red brick stretcher bond (Plate 13). The windows are generally steel framed casements with concrete lintels. The main entrance is towards the south end of the west elevation and is accessed by a raised walkway with brick walls and steel fencing (Plate 14). A concrete and steel balcony is situated above the main entrance on the same elevation. To the north of the entrance, there is a decorative panel of grey brick below each window, below which are a series of boarded up basement windows (Plate 15, Plate 16). To the south of the main entrance is a bicycle parking bay (Plate 19).

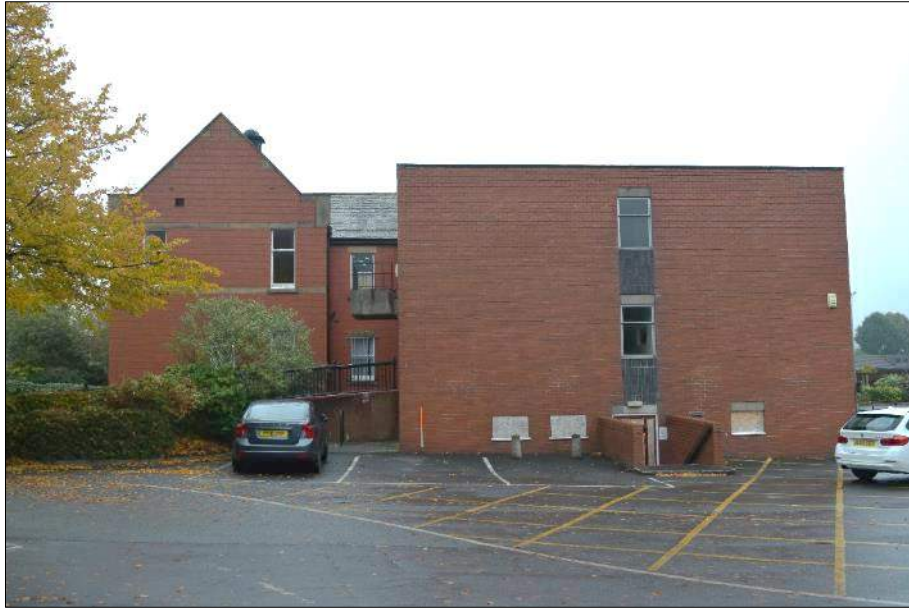
Plate 20 (shot 28): South elevation looking north, scale 1m

- 6.7 The basement is accessible from a brick framed stairway on the south elevation, which also has added ventilation (Plate 20 - Plate 22). Brick repairs have been made to the south elevation

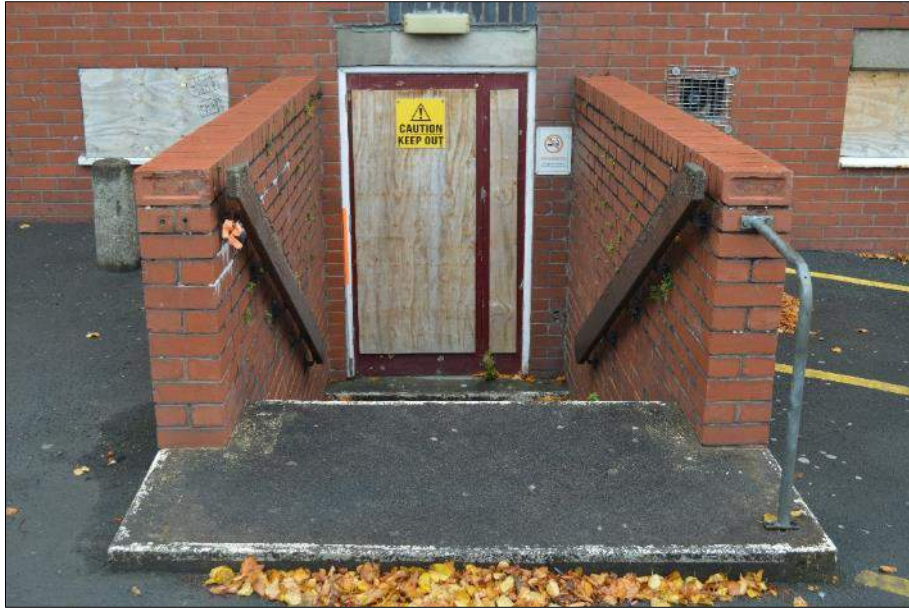
Plate 22 (shot 32): Side entrance of 1960's extension looking north, scale 1m

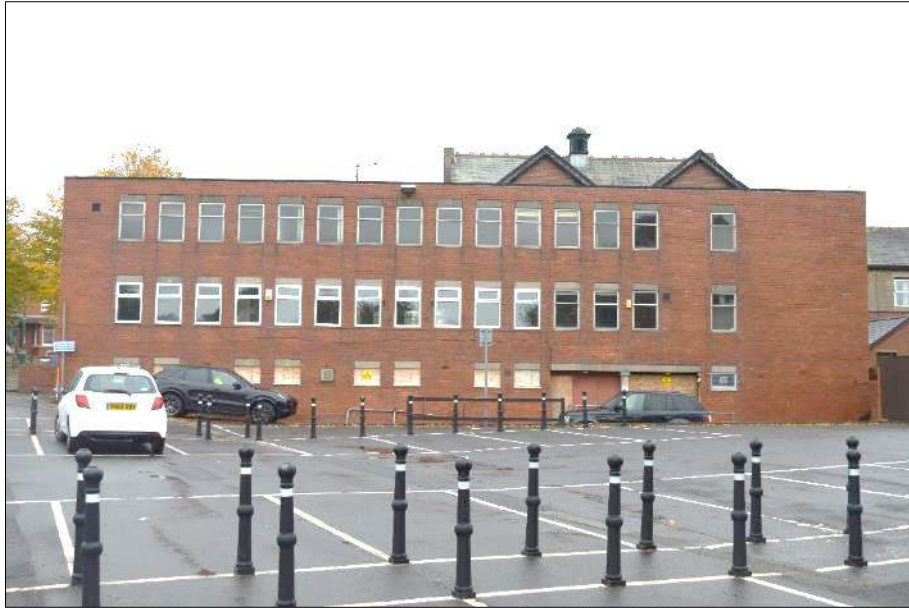
Plate 24 (shot 40): East elevation looking west, scale 1m

after removing four of the ground floor windows. Water stains on the brickwork correspond with a similar pattern seen below the windows on the east elevation (Plate 24).

- 6.8 The basement is also accessible via the east elevation. This elevation has a series of steel framed casements, with some later uPVC replacements (Plate 24 - Plate 26), as well as a doorway with access ramp.
- 6.9 On the north elevation is a single flight of stairs, which probably led to a doorway that has since been partially bricked up and replaced with a window, as well as boarded up basement windows and steel frame windows on ground floor and first floor level (Plate 27).

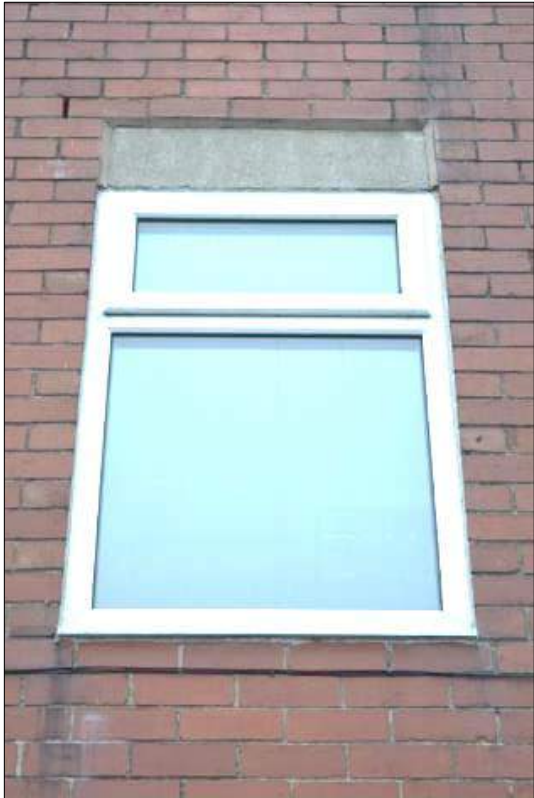
Plate 26 (shot 44): Ground floor uPVC window within east elevation of 1960's extension, looking west

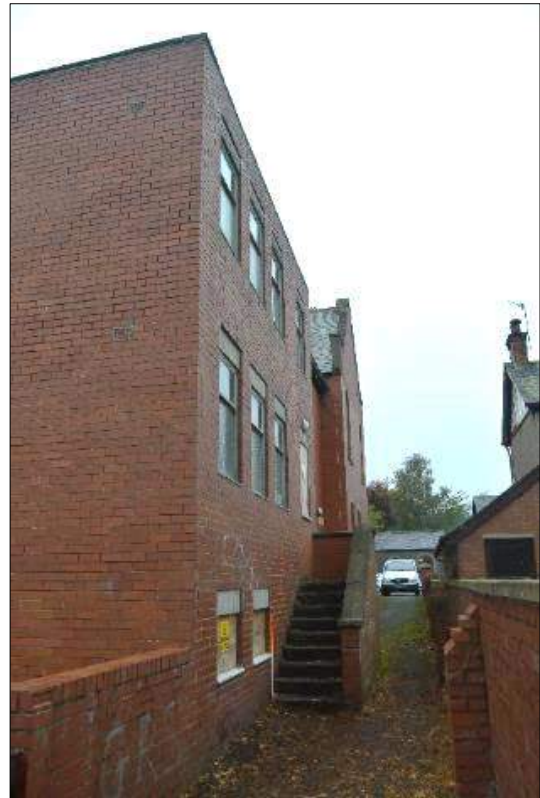
Plate 27 (shot 47): Oblique view of 1960's extension's north elevation looking west, scale 1m

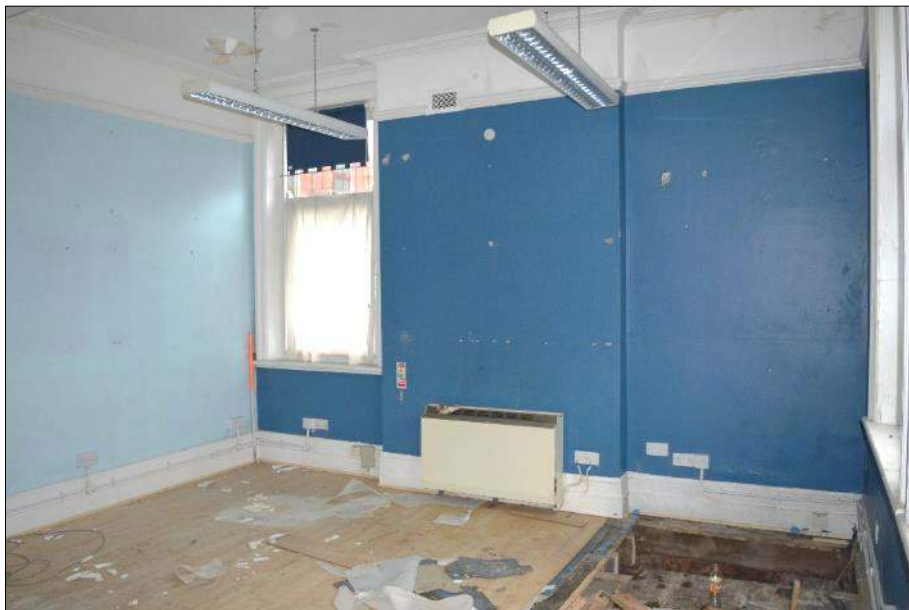
Plate 30 (shot 59): General view of room G17 showing blocked-in fireplace looking southwest, scale 1m

- 6.10 The oldest part of the council office resembles a double pile house with a ground floor plan consisting of a main corridor running from the vestibule in the west to an arched opening into the east wing with two rooms to either side, comprising two large reception rooms to the west and two smaller rooms to the east. Apart from the smaller northeast room, the rooms and the corridor appear to have retained most of the original architraves, cornices, picture rails and skirting boards, however any fireplaces have been removed or blocked up (Plate 28 - Plate 31).
