HISTORIC BUILDING SURVEY REPORT:

15 STATION ROAD, MARCH, CAMBRIDGESHIRE

Planning Reference: F/YR18/1108/FDL
NGR: TL 41751 96857
AAL Site Code: MASR 20
CHER Event Number: ECB 6191
OASIS Reference Number: allenarc1-393419

By
Allen Archaeology Ltd
Report Number AAL 2020055

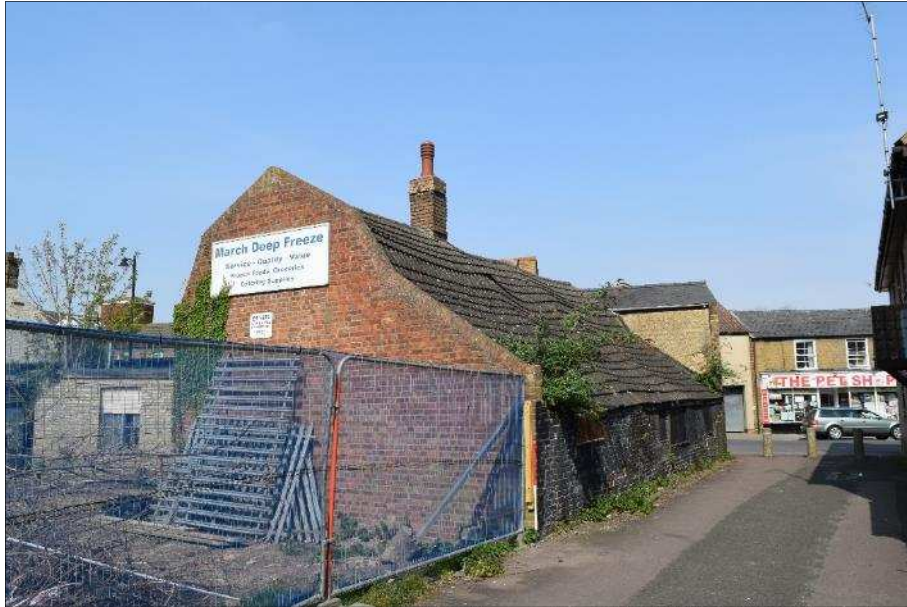
Plate 2 (Plate 77): General view of south gable and east elevation. Looking north-northwest, 1m scale

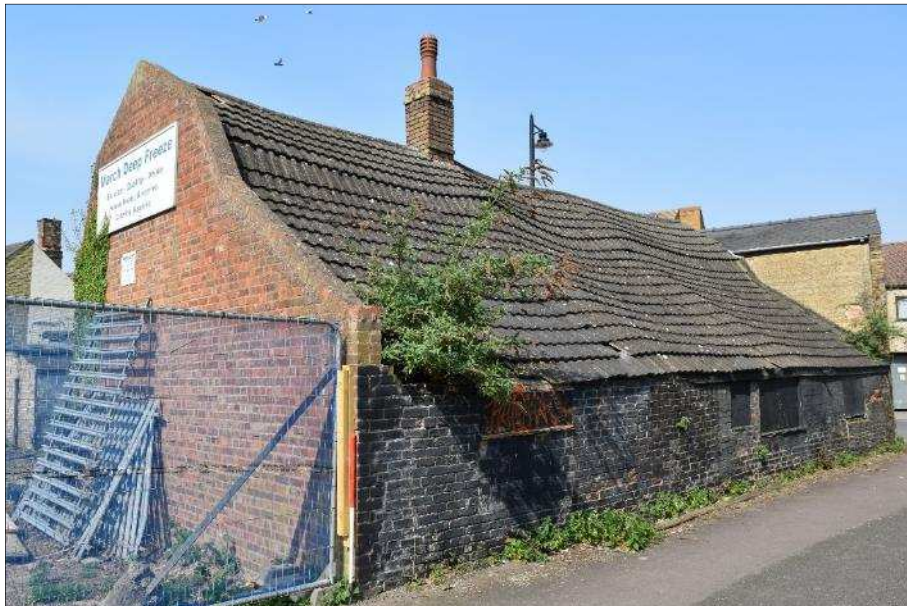
Plate 3 (shot 78): View of east elevation showing sagging roof. Looking northwest, 1m scale

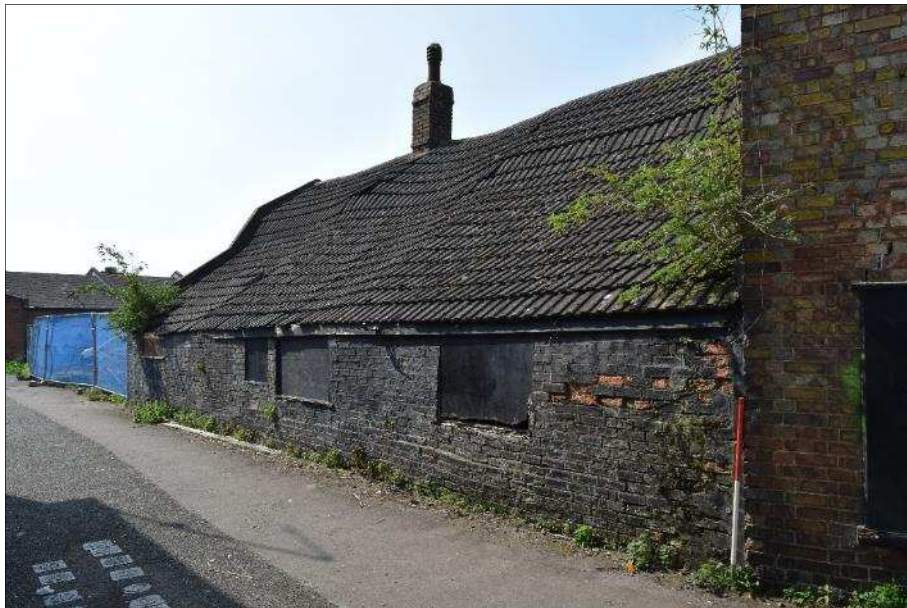
Plate 4 (Plate 80): East elevation, showing four boarded up openings on extension B. Looking southwest, 1m scale

- 7.3 There are four large and square former openings on the east elevation of Structure B, all of them have been boarded up and the southeast window is partially bricked up (Plate 4).

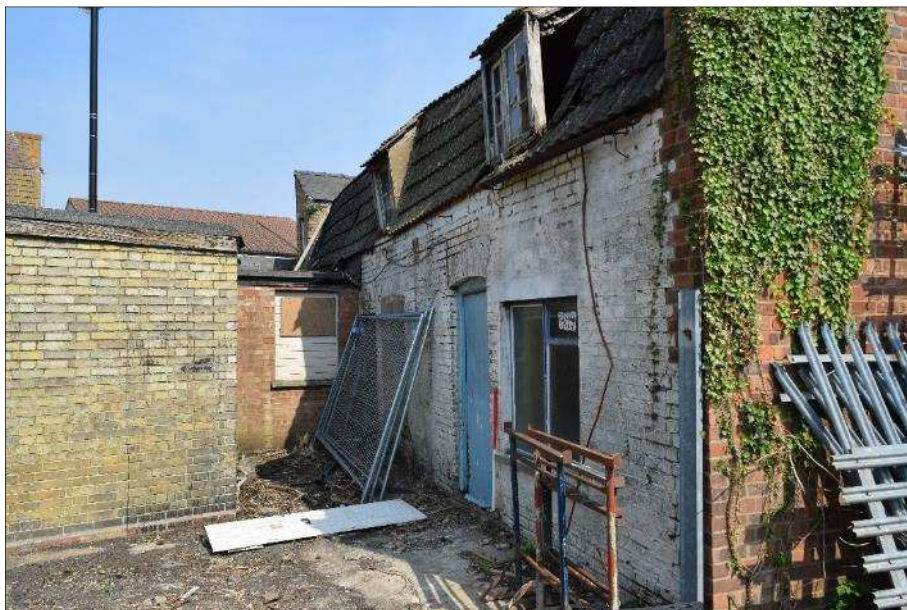
Plate 5 (shot 66): West elevation, abutted by later extension, two dormers on first floor. Structure A is abutted by Structure D. Yellow brick Extension E is visible to the left. Looking southeast, 2m scale

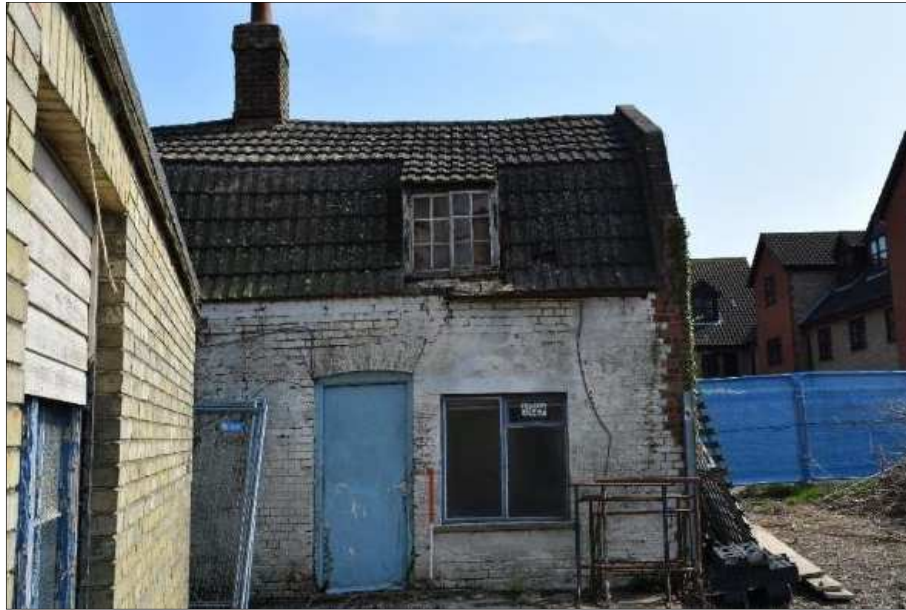
- 7.5 On the first floor are two dormer windows, probably original features of the former row of cottages. Dormers on the roof slope are common from the early 18th century (Hall 2005), and although casement windows were more regularly fitted, sash windows were also used. The southernmost has a horizontal sliding (Yorkshire) sash, usually dating between the 18th-early 19th century, and the northern dormer has a bottom sliding vertical sash without horns, with a single sheet of glass to the top and bottom (Plate 5-Plate 7). The vertical sash again could fit an 18th to early 19th century date, but the glass is likely to be of a slightly later date, as sash horns are generally mid-19th century or later and were added to support the

Plate 6 (shot 67): East elevation and representative view of doors and windows. Looking east, 1m scale

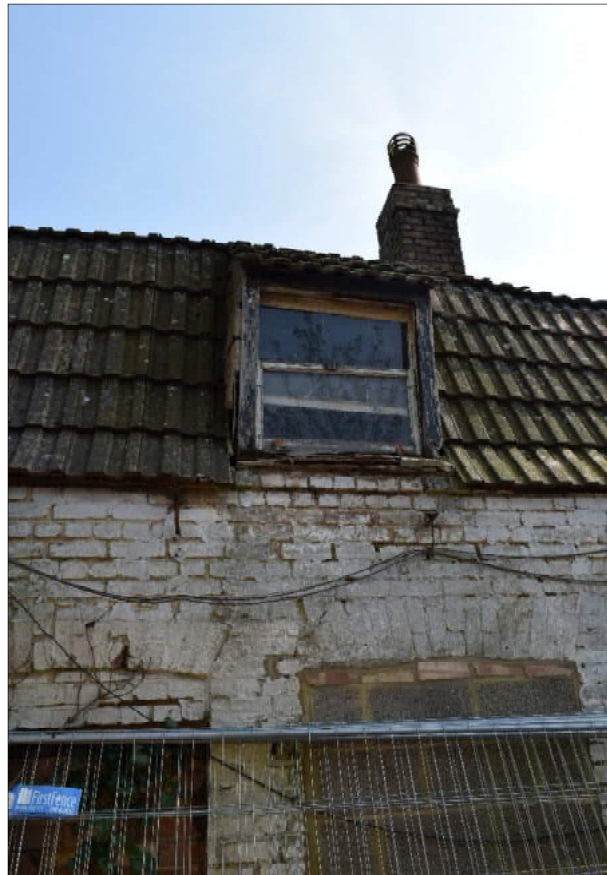
Plate 7 (shot 89): General view of the north dormer. Looking southeast

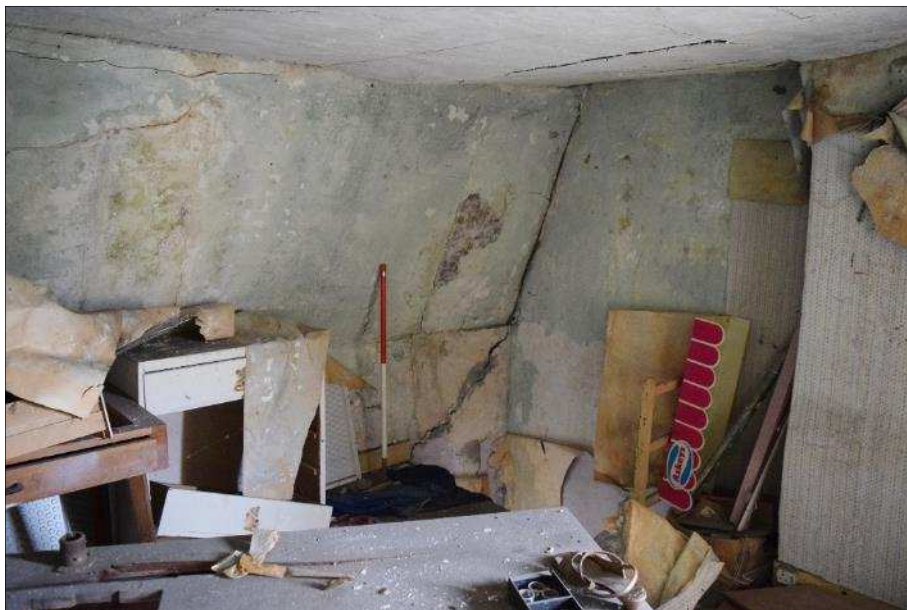
Plate 8 (shot 9): General view towards the stairs in southern room. Looking southeast, 1m scale

- 7.7 The first floor is split into two rooms separated by a partition wall and each accessed by an individual winder staircase, with no access between the two rooms. The southernmost room is accessed via a winder staircase positioned in the southeast corner next to the chimneybreast (Plate 8 and Plate 9). The room is currently used for storage.

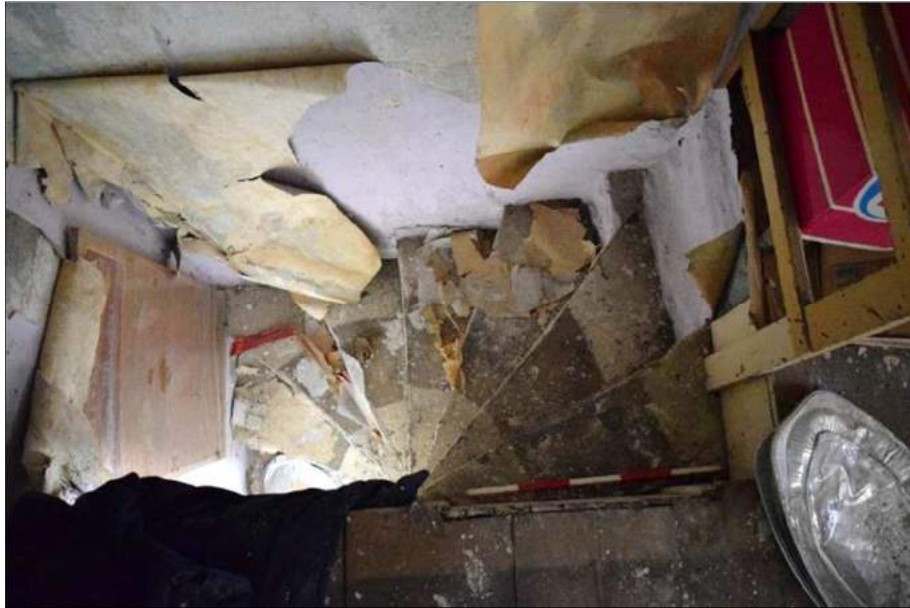
Plate 9 (shot 11): General view of winder staircase next to the chimneybreast. Looking south-southwest, 0.5m scale

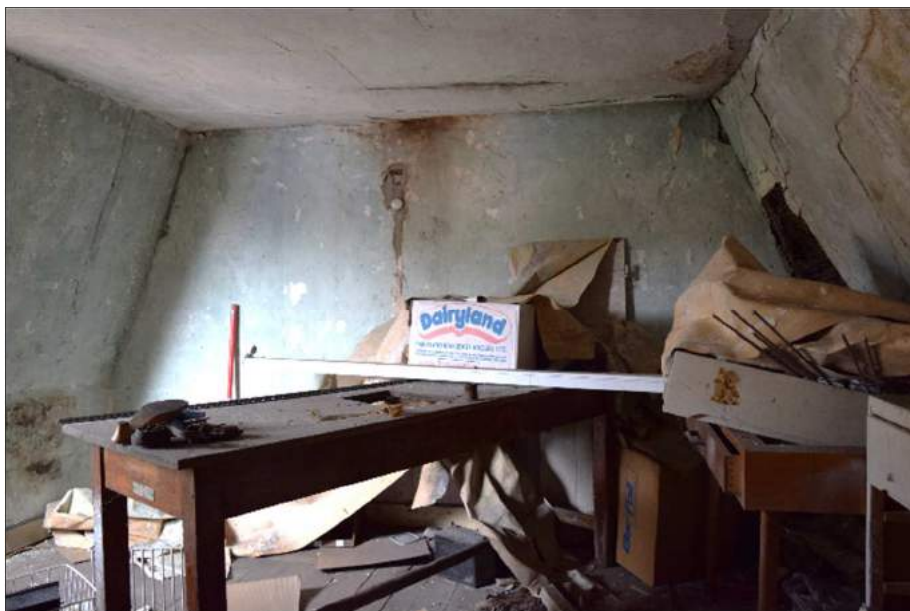
- 7.8 Both the ceiling and walls are plastered and painted. Reeds with laths were visible through an inspection hole in the northeast corner of the ceiling and by the dormer window to the southwest. The plaster has been applied directly onto these rather than to timber laths. Both materials are likely to be original and of 19th century date (Plate 10-Plate 12).

Plate 10 (shot 1): General view of first floor. Looking northeast, 1m scale

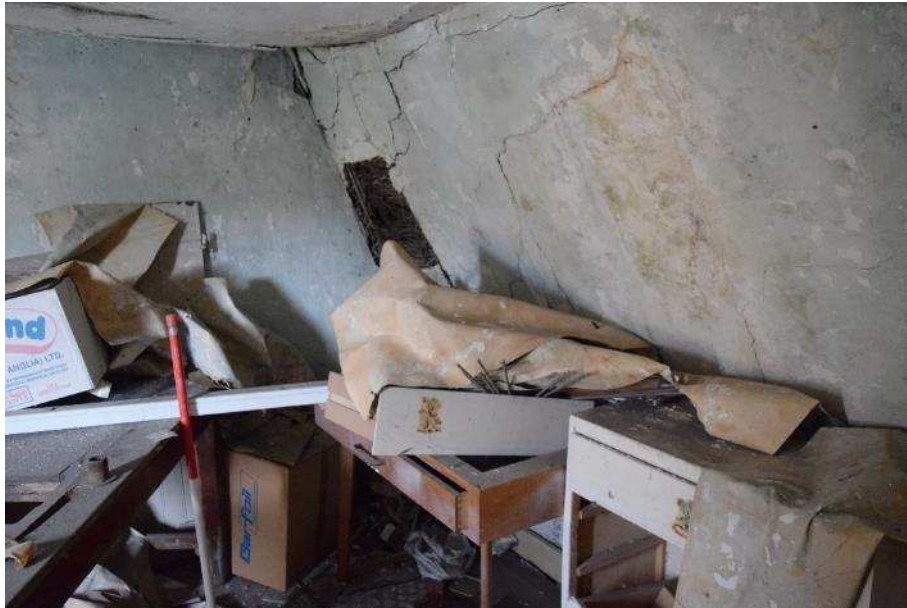
Plate 11 (shot 8): View of plastered ceiling and walls, an inspection hole revealing reeds behind the plaster. Looking southeast, scale 1m

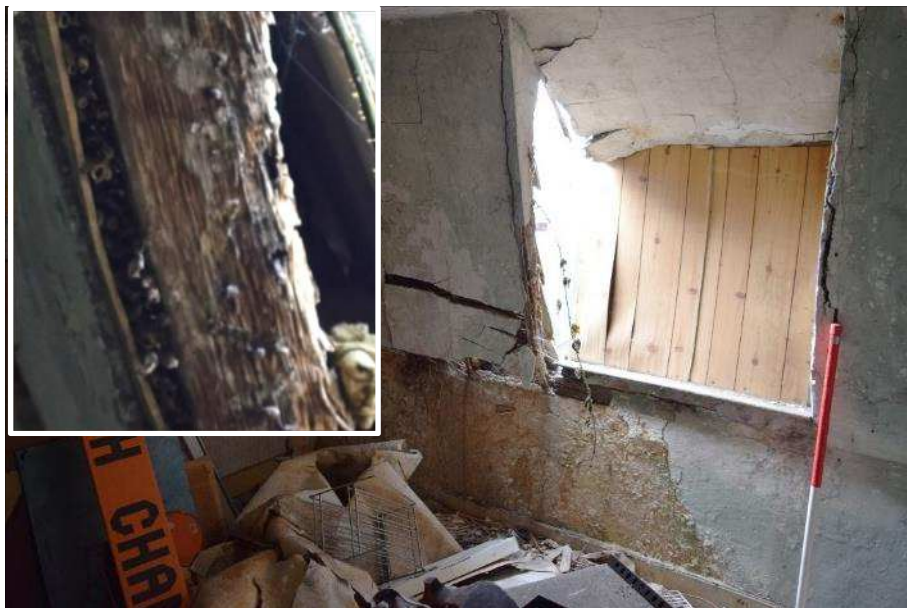
Plate 12 (shot 2): General view of boarded up dormer. Looking southeast, scale 1m. Inset shows reeds in situ adjacent to window

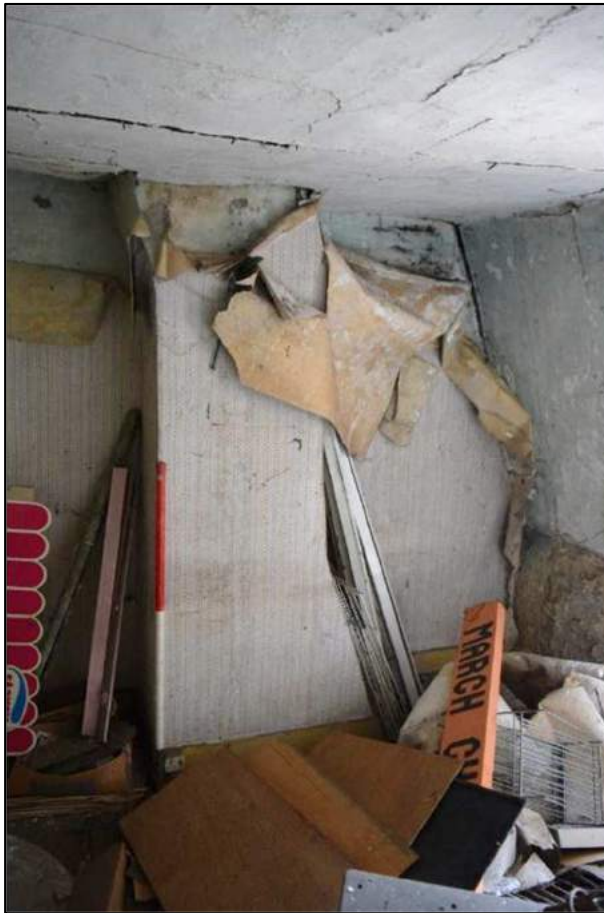
Plate 13 (shot 6): General view of chimney breast in south room. Looking south-southwest, 1m scale

- 7.9 The chimney breast on the south wall has been plastered and covered in wallpaper, and there is no gap in the skirting (Plate 13). It seems likely the room would have had a fireplace; however, the uninterrupted skirting and the lack of a hearth may suggest otherwise.

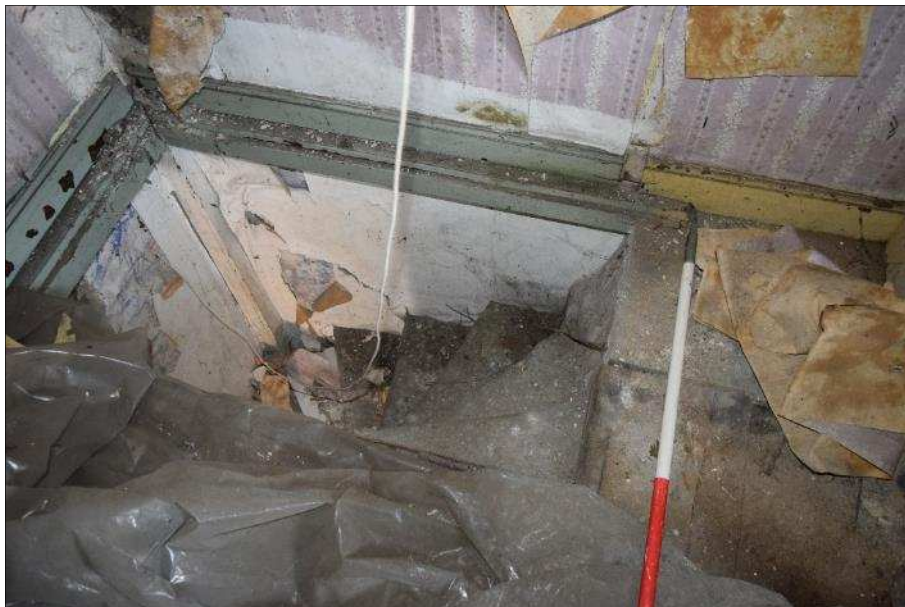
Plate 14 (shot 33): General view of the winder staircase to the north room. Looking west-southwest, 1m scale

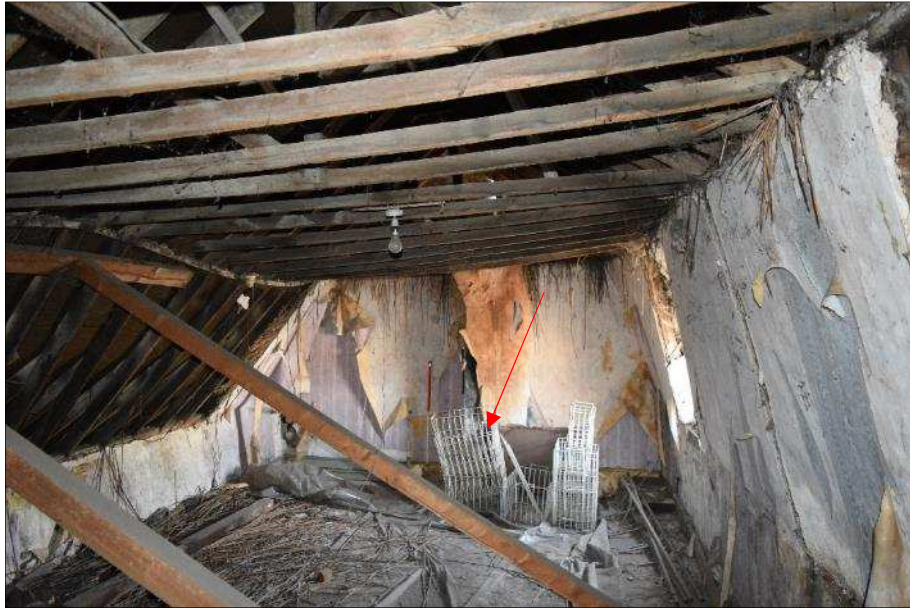
Plate 15 (shot 28): General view towards the partition wall, arrow points to a boarded-up fireplace. Looking south-southeast, 1m scale

- 7.10 The northern room is also accessible via a winder staircase in the southeast corner and positioned east of the chimney-breast (Plate 15). The north room appears to have a boarded-up fireplace (Plate 18).

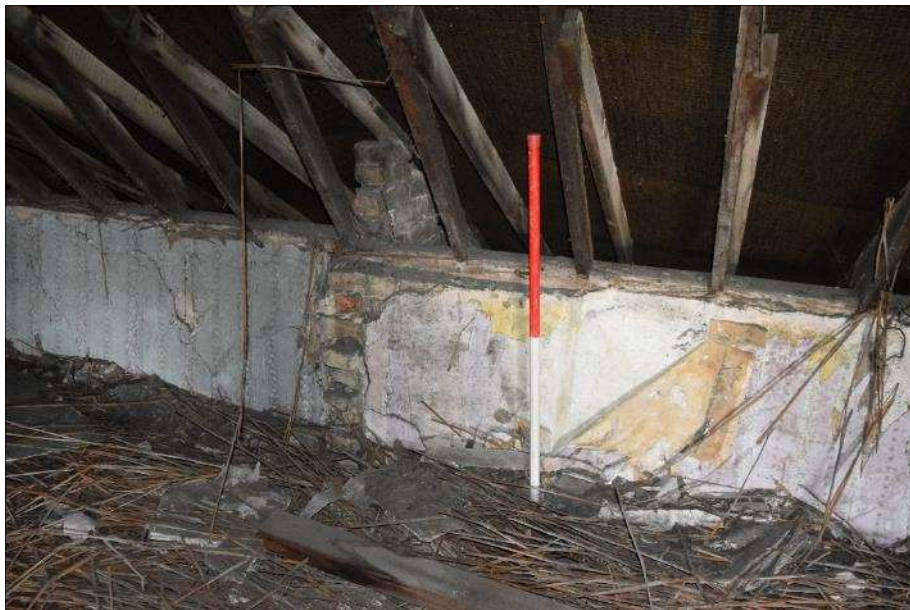
Plate 16 (shot 92): Stump of removed brick partition. Looking south, 1m scale

- 7.11 A partition has been removed in this room, and is likely to have separated two earlier cottages. There were no signs of a former chimney stack or staircase to what would have been the northernmost cottage, closest to Structure C. It is likely that these would have been located along the removed north gable, now a partition to C (Plate 16 and Plate 17).

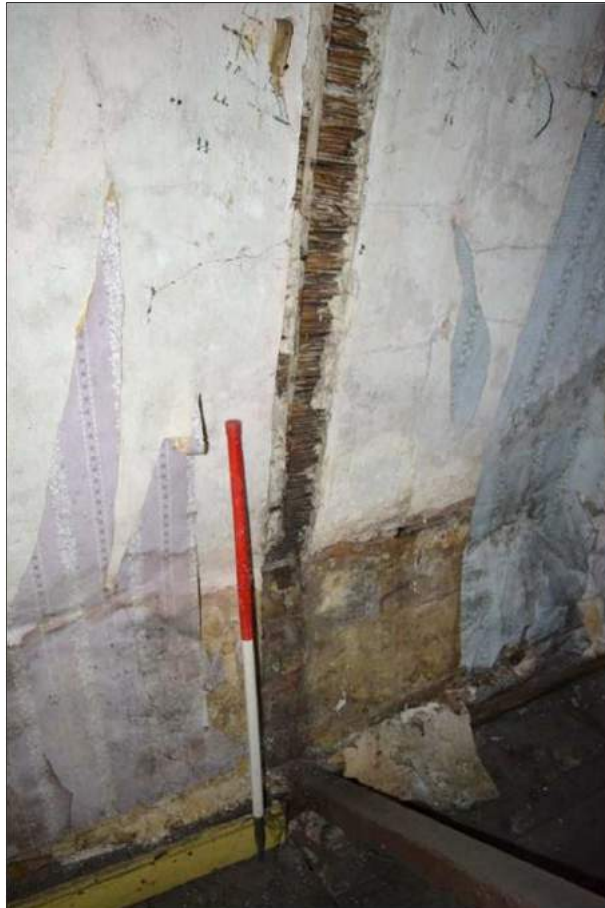
Plate 17 (shot 93): Scar from removed partition, exposing reeds behind the plaster. Looking west-southwest, 1m scale

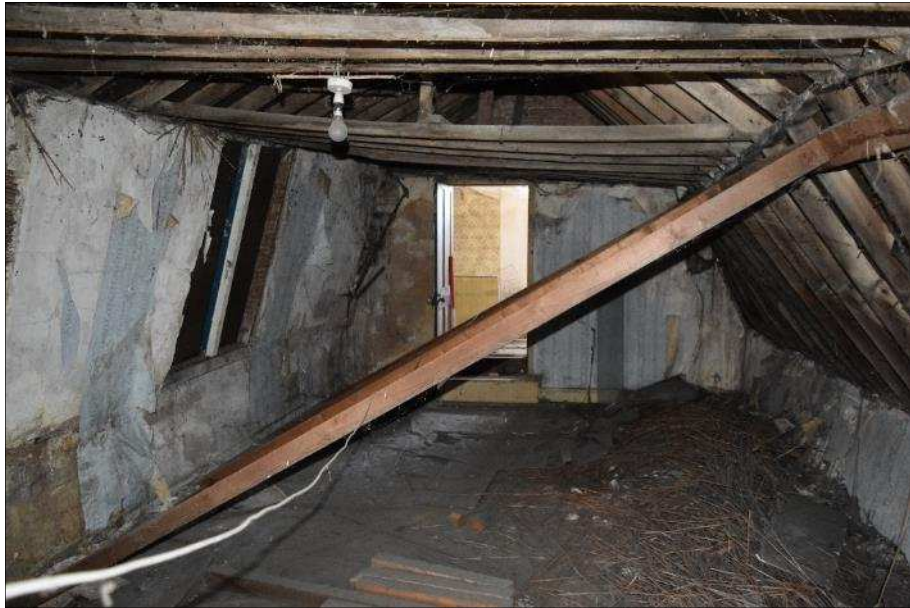
- 7.6 A third dormer was once present to the north, this is obscured by the later roof tiles but the opening is visible from the inside (Plate 18). This means that each of three surviving cottages each had a single dormer on this elevation, and they are likely to be original features.

- 7.14 The dormer window is boarded up and little internal light is provided. The roof purlin appears fragile in comparison to the rafters that it supports. Modern diagonal timber supports have been added to prevent the roof from moving any further (Plate 18-Plate 20). The concrete roof tiles are modern and are likely to have replaced an earlier, and lighter, thatched roof that would have been better suited for the thinner timbers. This hypothesis was also put forward in Jennifer Lawler's recent article, suggesting the cottages were originally thatched, then covered in plain clay tiles, before the current 20th century concrete tiles (Lawler 2017). The timbers appeared to be regular in size and shape, some with visible kerf marks. The marks were parallel with no apparent signs of overlapping/crossing to suggest a manual two-handed pit saw. Instead these appear to have been cut with a

Plate 18 (shot 22): General view of the northern room, first floor. Looking north-northwest, 1m scale

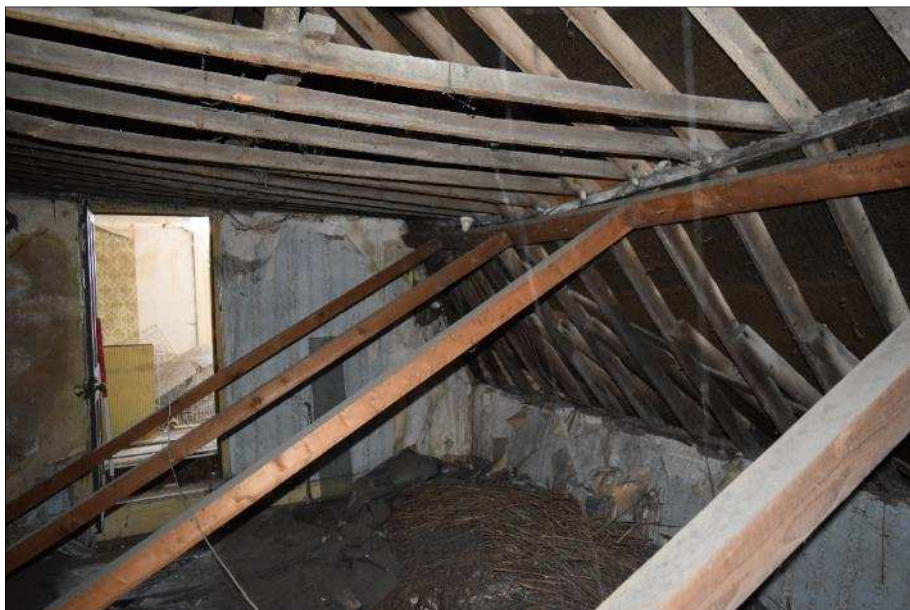
Plate 19 (shot 23): General view of later supports. Looking north-northeast, scale 1m

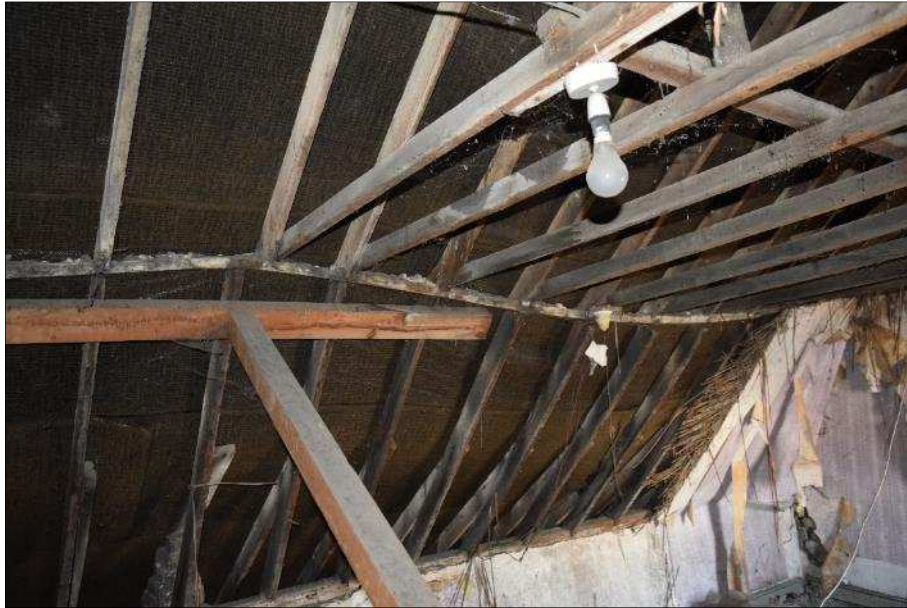
Plate 20 (shot 29): General view of poorly constructed roof. Looking south-southeast

mechanical saw, suggesting a date from the mid-19th century onwards when steam powered mechanical saws became widely available.

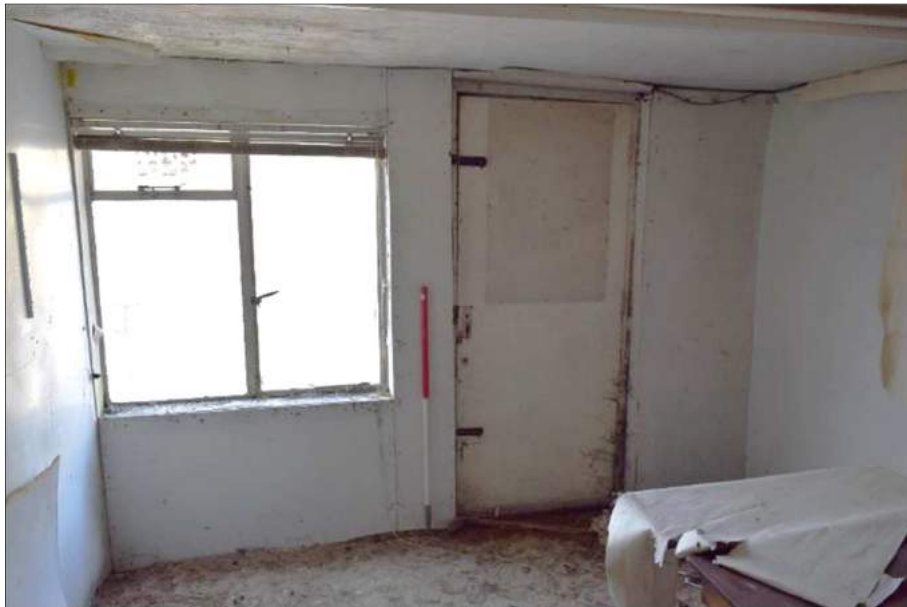
- 7.15 The ground floor is divided into two rooms of similar proportions to the first floor, with a smaller unit to the south and a larger unit to the north, again indicating that two units are likely to have been combined by removing partitions. The southernmost room has modern stud walls with a doorway to the east between A and B (Plate 21-Plate 23).

Plate 21 (shot 16): General view of the ground floor southern room. Looking west-northwest, 1m scale

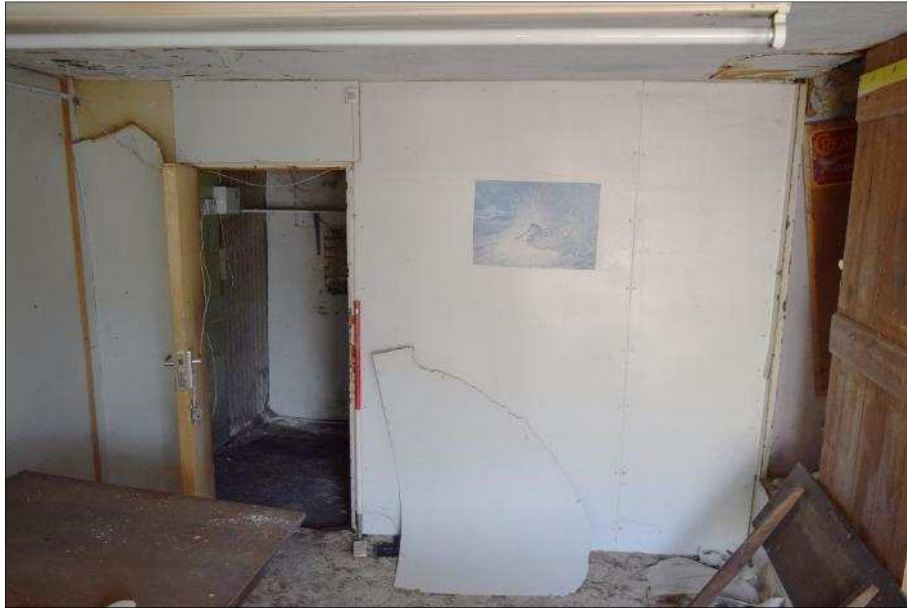
Plate 22 (shot 18): Modern stud wall and door. Looking east-southeast, 1m scale

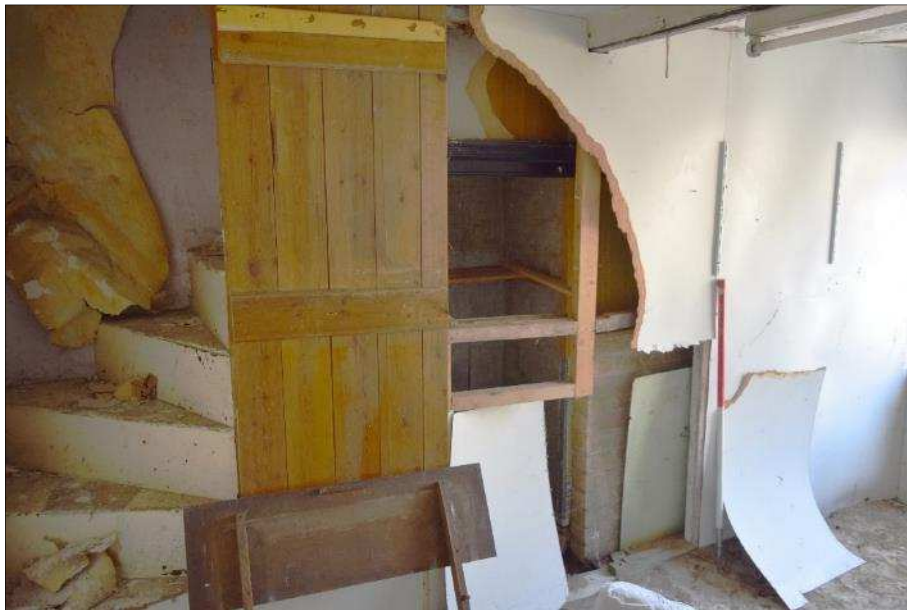
Plate 23 (shot 14): Staircase to first floor south room, fireplace behind modern stud and boards. Looking south, 1m scale

- 7.16 Along the south wall is the winder staircase with under-stairs cupboard. The modern stud wall has been partially removed and this has exposed a modern brick fireplace surround (Plate 23).

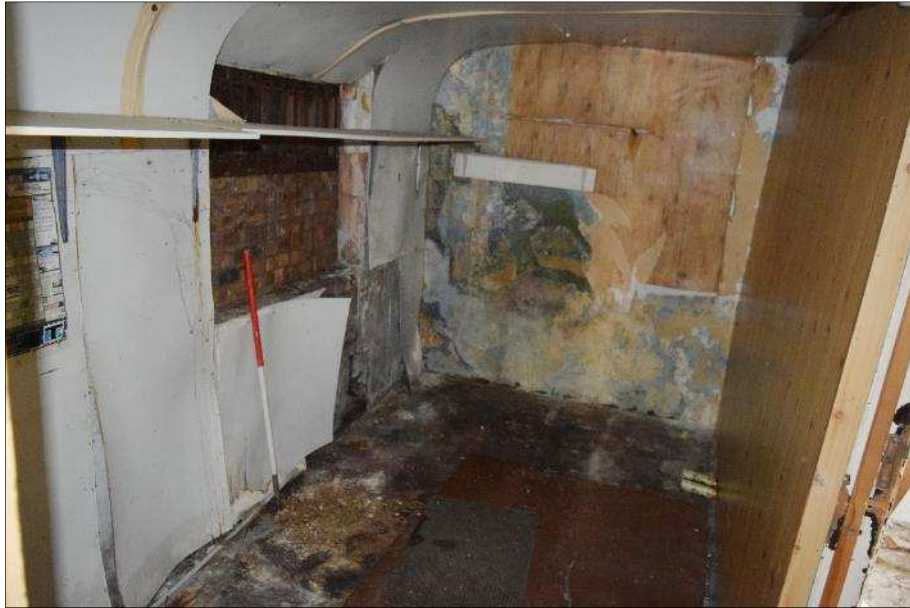
- 7.17 Structure B is accessible from the southern room of Structure A. The southern part consists of a room that has been adapted into a storage room or office with curved plyboards masking the original ceiling. The extension originally housed a kitchen and at a later date, a bathroom (Lawler 2017). The original plaster appears to be present beneath the modern wallpaper. The window to the east has been bricked up, and there is a partition with doorway into the northern part of B. This is the only access between Structures A and B (Plate 24-Plate 26). The opening is in all likelihood a later addition, after the property fell under the same ownership.

Plate 24 (shot 19): General view of southern room of Structure B. Looking south, 1m scale

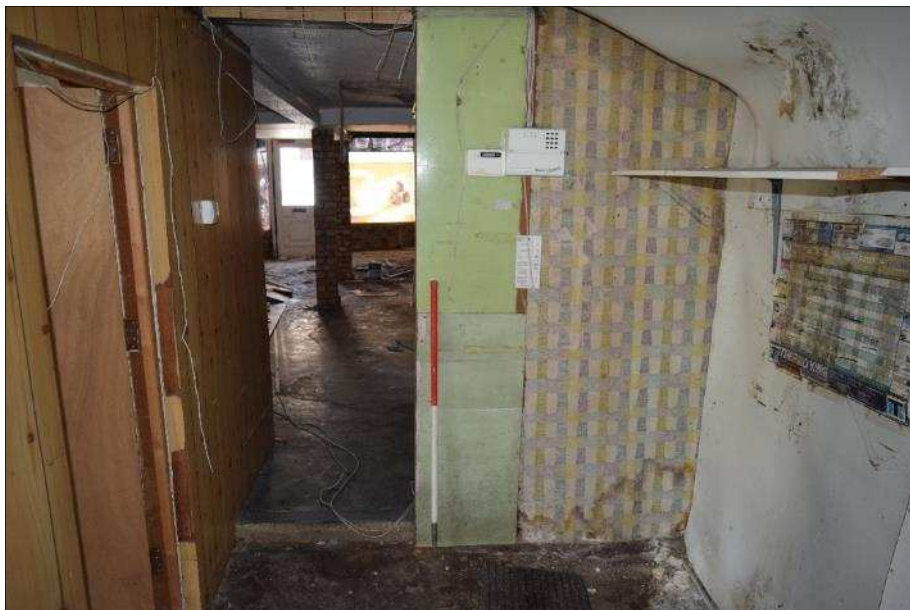
Plate 25 (shot 21): View of Structure B ground floor, looking north-northeast, 1m scale

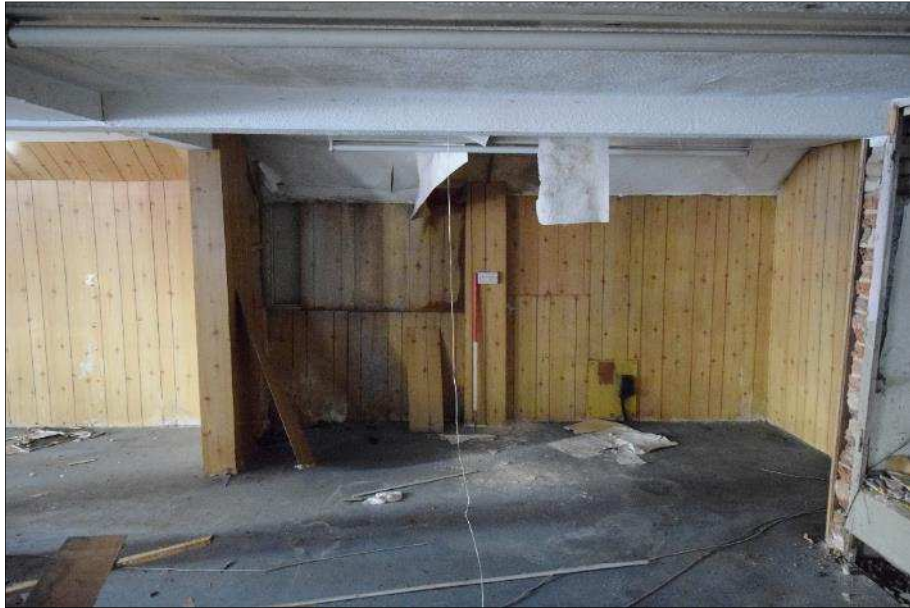
Plate 26 (shot 45): General view of north part of extension B. Looking east-southeast, 1m scale

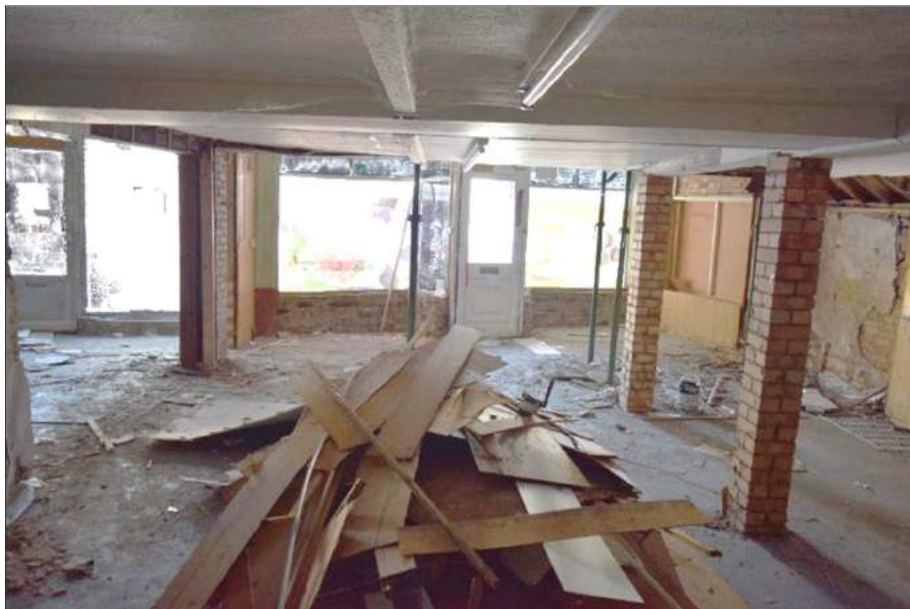
- 7.18 To the north, the ground floor of A and B forms a single open plan space, and the original layout has been entirely eradicated (Plate 27-Plate 30). It has been merged with Structure C to the north, and Structure D to the west. Most of the original west brick wall is extant, despite a large opening to the north which allows access into Structure D (Plate 28). The east wall of A has been replaced by two square brick pillars that support the first-floor girder. The ceiling is a modern replacement.

Plate 27 (shot 43): General view of north room merged with Structure C in the background and opening to Structure D to the left. Looking north-northeast, 1m scale

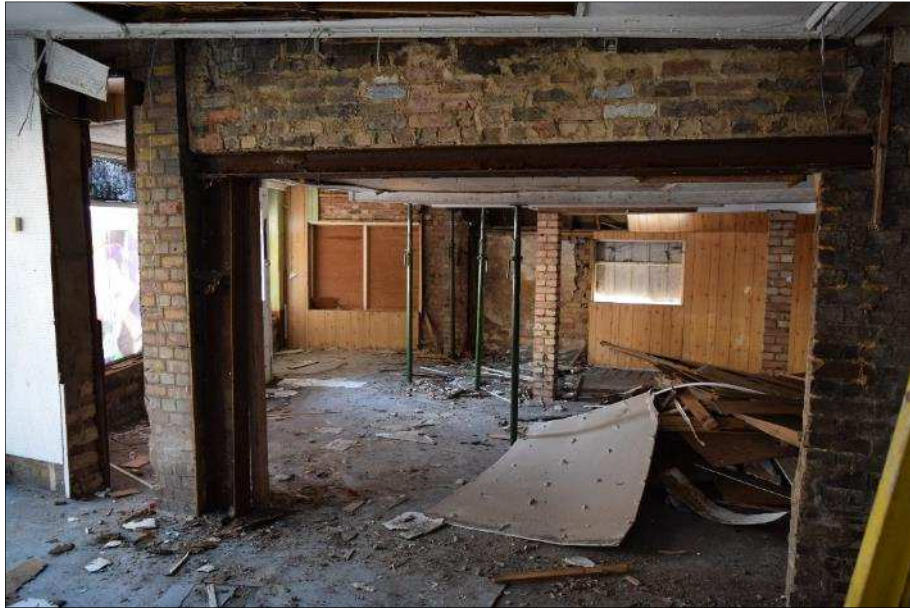
Plate 28 (shot 38): Large and later opening in the former west elevation of A. Looking northwest, 1m scale

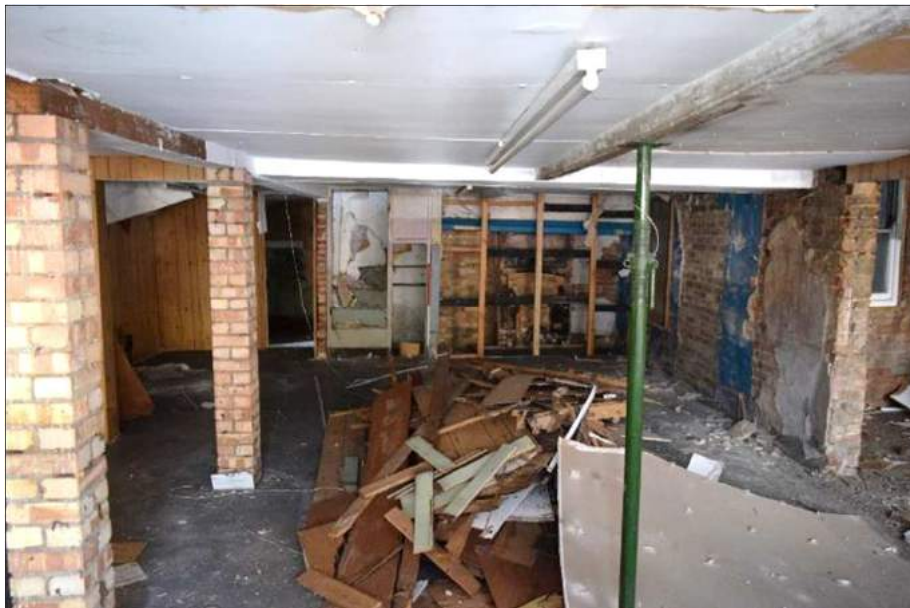
Plate 29 (shot 44): General view of the north room of A showing original west wall to the right. Looking south-southwest, 1m scale

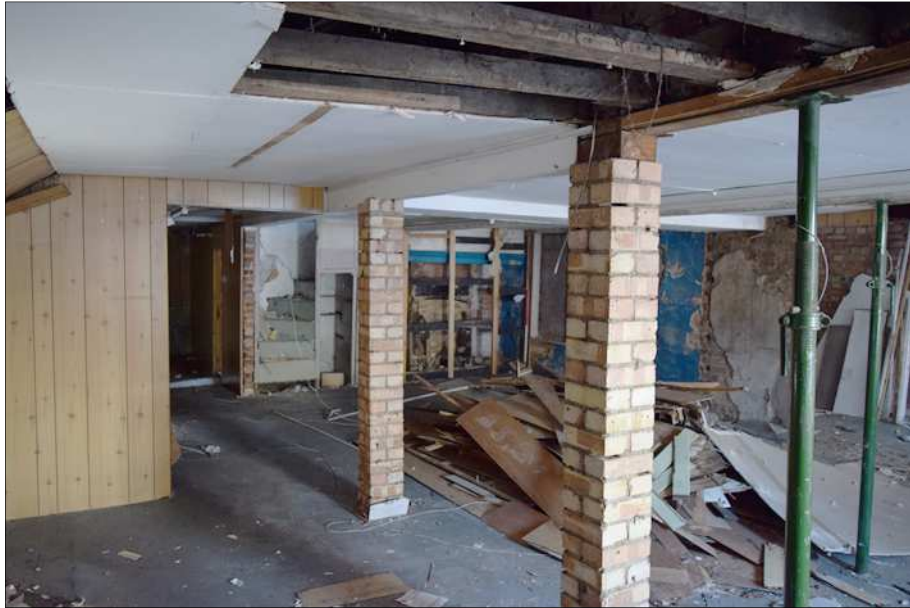
Plate 30 (shot 36): General view of northern part of Structure A and B, taken from Structure C. Looking southwest, scale 1m

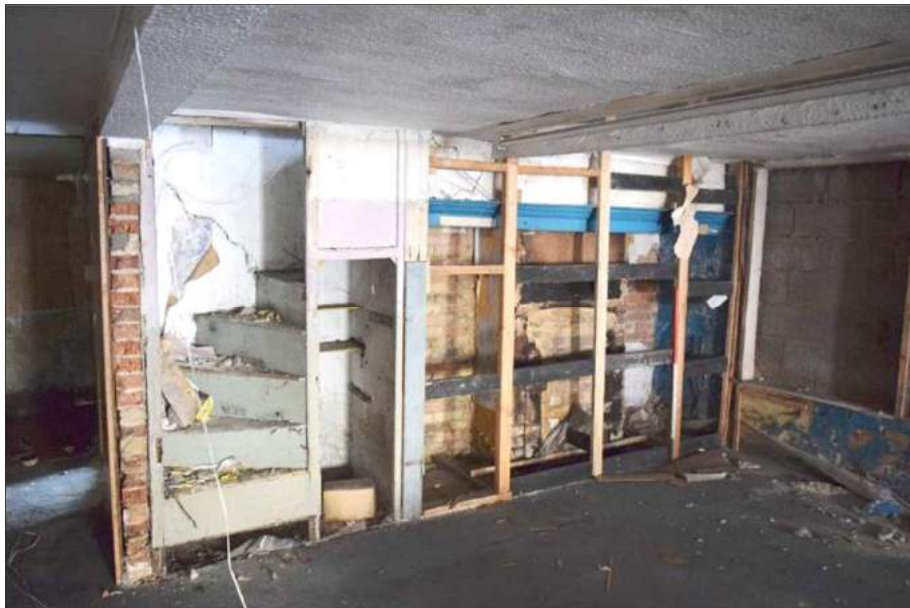
Plate 31 (shot 35): South partition wall showing original staircase, under-stairs cupboard and bricked-up fireplace behind modern stud wall. Looking southwest, 1m scale

- 7.19 The only original features that have partially survived are the staircase and fireplace along the partition wall to the south (Plate 31). The fireplace shows a shadow of a former segmental arch. The large, moulded blue painted mantelpiece is of later date.

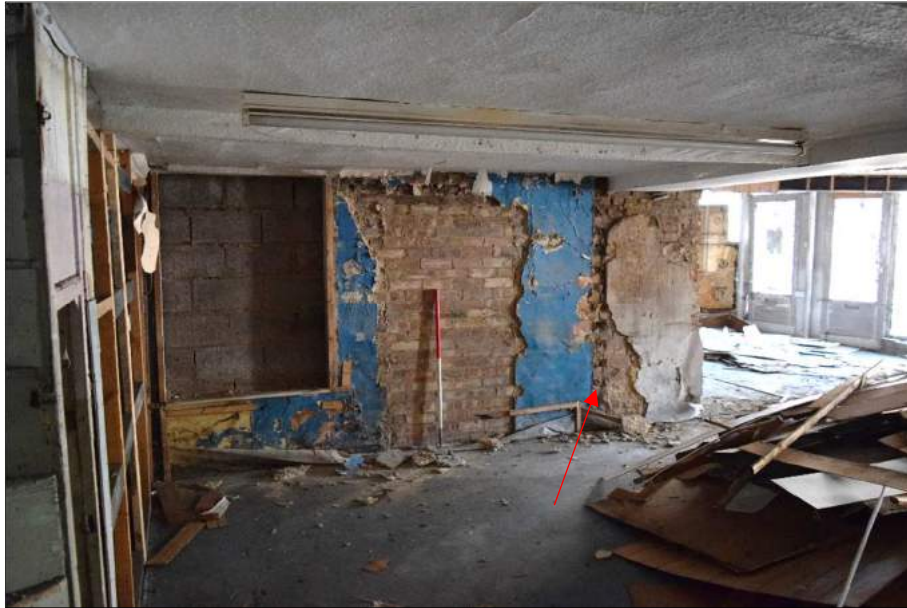
Plate 32 (shot 37): Blocked window next to a blocked doorway, behind the scale on the west wall, the arrow points to a removed partition where the blue painted plaster ends. Looking northwest, 1m scale

- 7.20 Adjacent to the fireplace on the west wall is a later, enlarged window, blocked with breezeblocks (Plate 32). Directly adjacent to this is the blocked-up doorway which once offered access into this part of the structure. To the north of this is a scar from a removed brick partition wall (Plate 32). The scar aligns with the short partition on the opposing wall. It has been masked by modern boarding and wallpaper, so it is not possible to tell whether this is part of the original partition, but the position corresponds closely with the scar of the removed partition on the floor above (Plate 26).

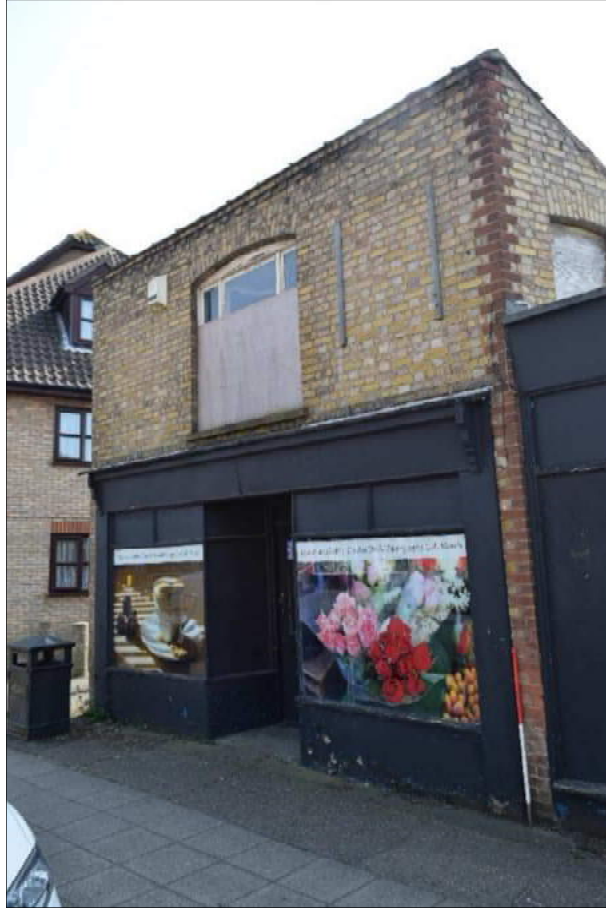
- 7.21 Structure C is a two-storey yellow brick structure with a 19th century style shopfront with part glazed central doorway and large flanking windows, facing Station Road to the north (Plate 33 and Plate 34). It measures approximately 5.5m x 3m. The brickwork is laid in a Flemish bond and the roof is mono-pitched and covered with slate, sloping down to the south.
- 7.22 The north elevation has a partially boarded-up window with segmental arch on the first floor, with a dentil course below the roof line and red brick quoins to the west.
- 7.23 The west elevation has another window with segmental arch, and on the ground floor of the east elevation is a large window. Both are also boarded-up.

Plate 33 (shot 85): General view of north elevation. Looking southeast, 1m scale

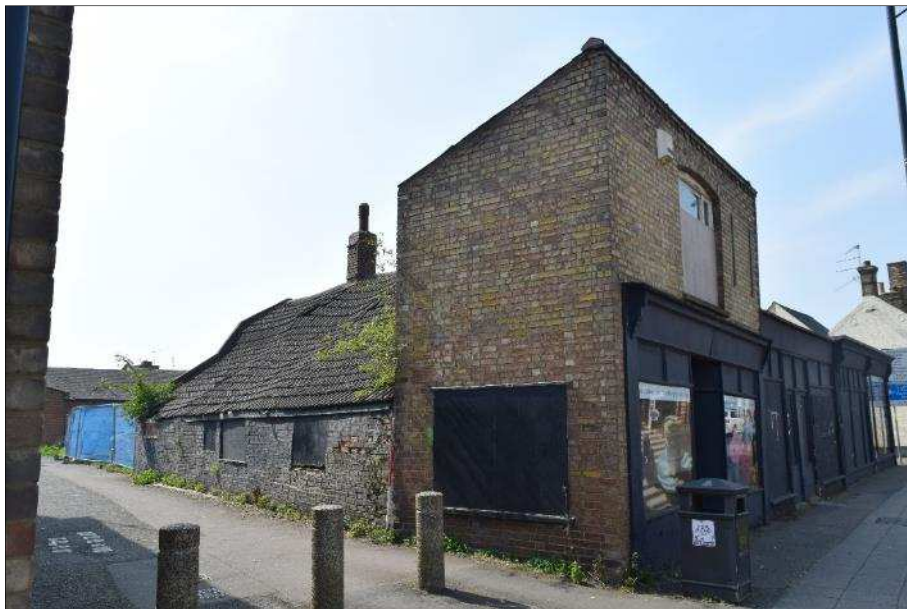
Plate 34 (shot 79): General view of Structure C with Structures A/B to the left and D to the right. Looking south-southwest, 1m scale

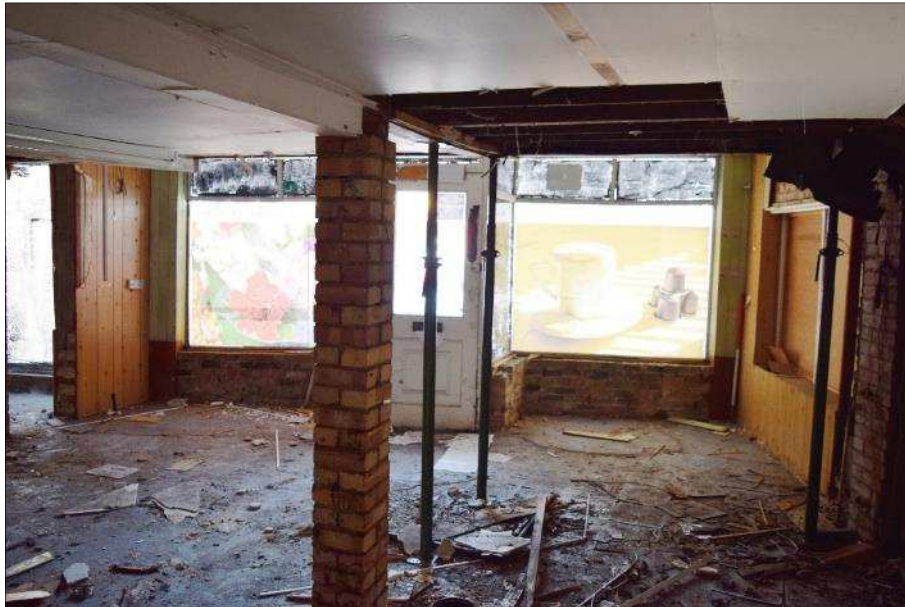
- 7.24 Structure C has two, large, shop windows facing north and positioned on either side of the main entrance. The interior forms part of the open plan space together with parts of Structures A and B (Plate 35).

Plate 35 (shot 41): General view of Structure C ground floor. Looking north-northeast, 1m scale

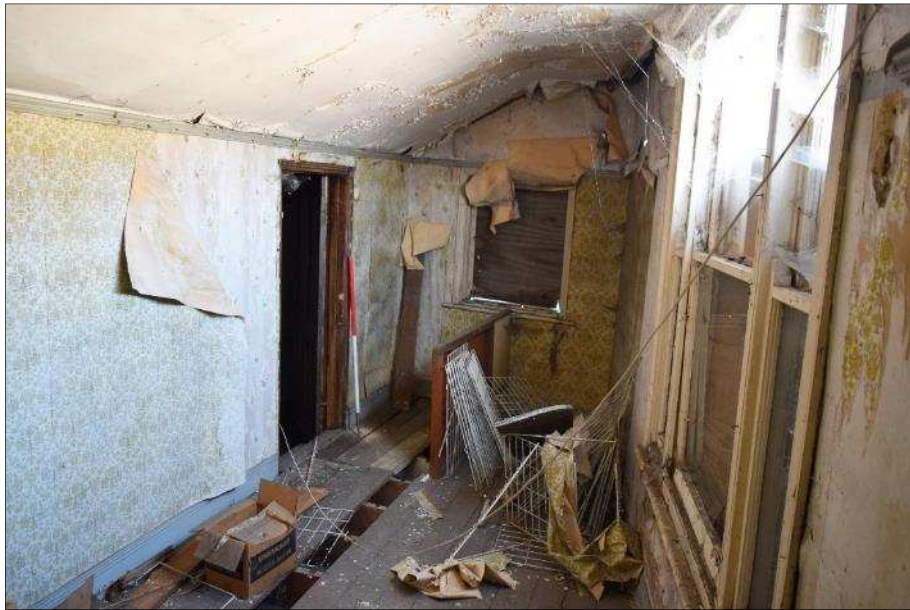
- 7.25 The first floor presumably served as an office for the shop below (Plate 36-Plate 38). An east-west orientated handrail protruding from the west wall would suggest a staircase has recently been removed. Currently, the only way of accessing this room is via the northern first floor room of Structure A.
- 7.26 The room has a large, three-light vertical sash window with typical late 19th century sash horns, facing Station Road, and a smaller boarded up window to the west. There is a tongue and groove plank floor as well as moulded skirting boards and picture rails, all features typical of a 19th century house.

Plate 36 (shot 24): General view of Structure C first floor. Looking west, 1m scale
