HISTORIC BUILDING SURVEY REPORT:

15 STATION ROAD, MARCH, CAMBRIDGESHIRE

Planning Reference: F/YR18/1108/FDL
NGR: TL 41751 96857
AAL Site Code: MASR 20
CHER Event Number: ECB 6191
OASIS Reference Number: allenarc1-393419

By
Allen Archaeology Ltd
Report Number AAL 2020055

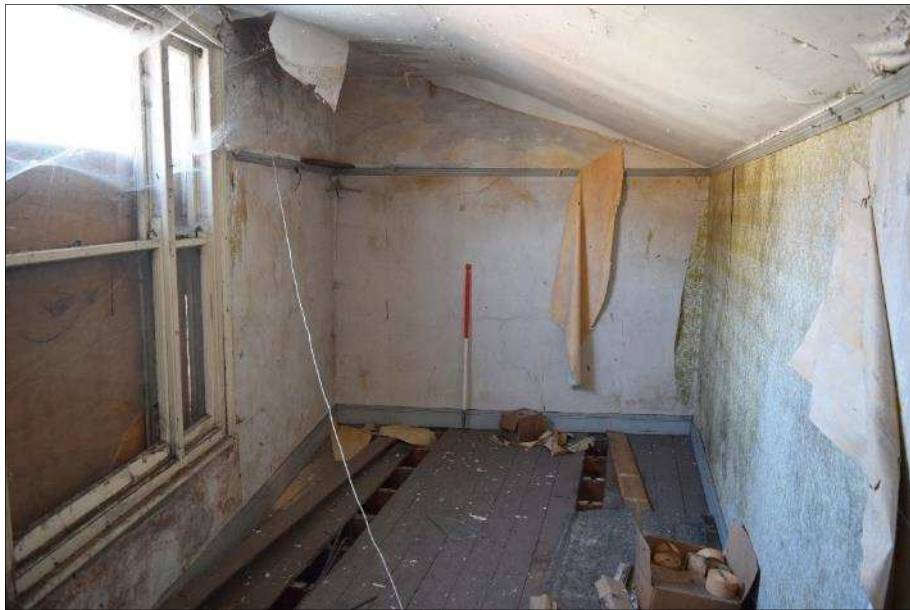
Plate 37 (shot 27): General view of Structure C first floor. Looking east, 1m scale

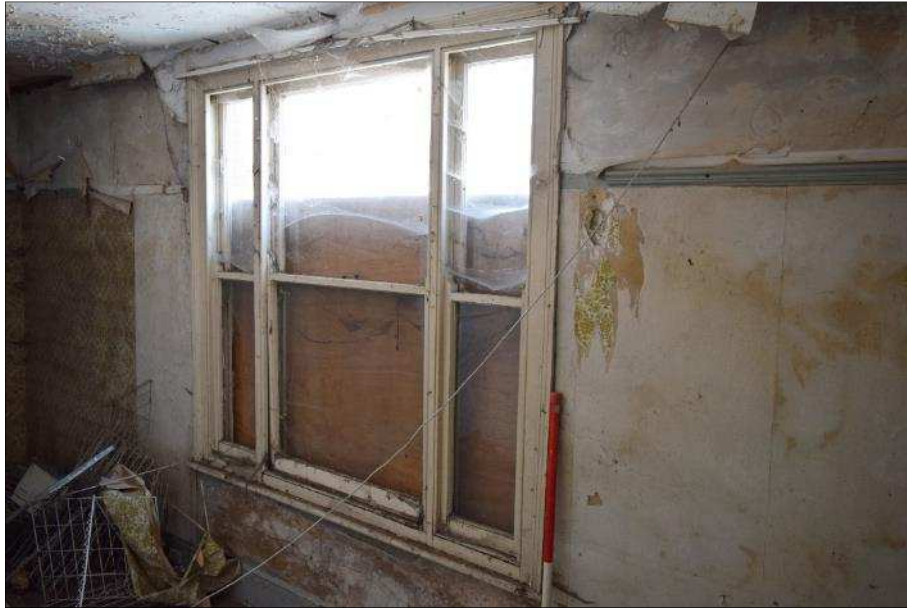
Plate 38 (shot 26): Original sash window in Structure C. Looking northwest, 1m scale

- 7.25 The first floor presumably served as an office for the shop below (Plate 36-Plate 38). An east-west orientated handrail protruding from the west wall would suggest a staircase has recently been removed. Currently, the only way of accessing this room is via the northern first floor room of Structure A.
- 7.26 The room has a large, three-light vertical sash window with typical late 19th century sash horns, facing Station Road, and a smaller boarded up window to the west. There is a tongue and groove plank floor as well as moulded skirting boards and picture rails, all features typical of a 19th century house.

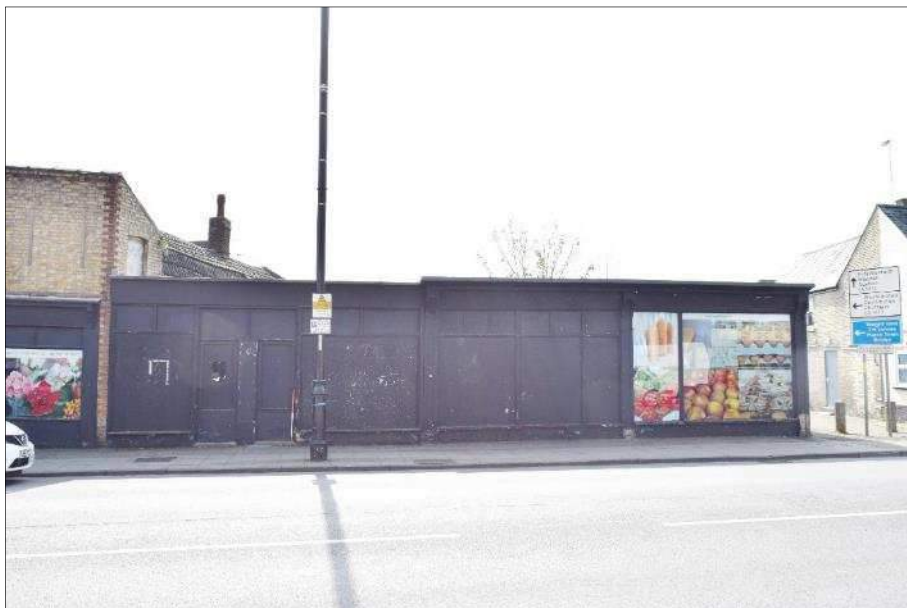
- 7.27 Structure D is a single-storey structure and abuts Structure C to the west. It measures c.16m x 7m and is an extension to the original shop. The 19th century style frontage matches that on Structure C, but the entire frontage, including the glass, has recently been painted black (Plate 39). It has simple pilasters and console mouldings. The windows vary in size but all have the common large panes with smaller lights at the top. There are two openings towards the west. The roof is flat and felted. The west elevation consists of a brick wall in Monk Bond painted black and white (Plate 40). This structure has two adjoining extensions, E and F, to the rear.

Plate 39 (shot 84): North elevation, shop frontage with black painted fenestration. Looking south, 1m scale

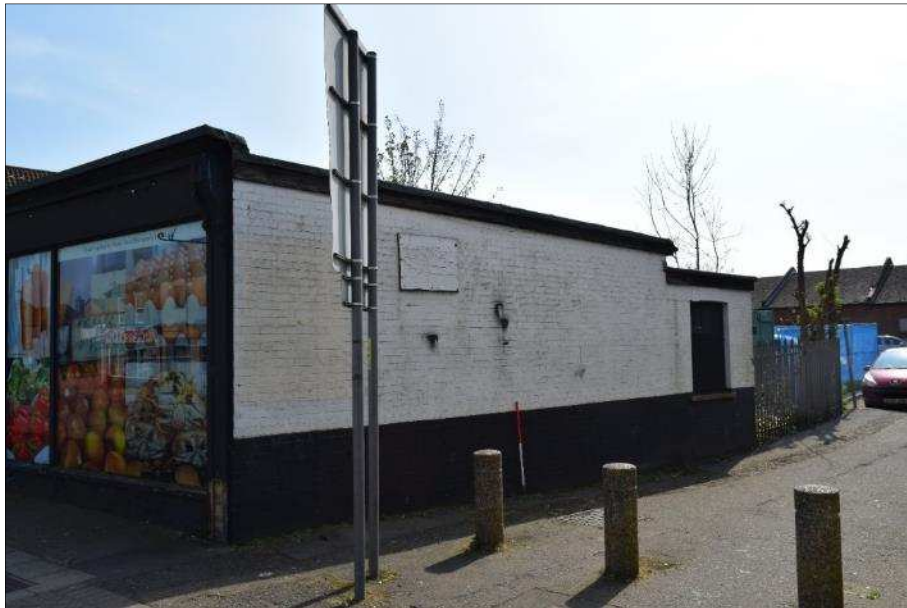
Plate 40 (shot 86): West elevation with extension E visible to the right. Looking south, 1m scale

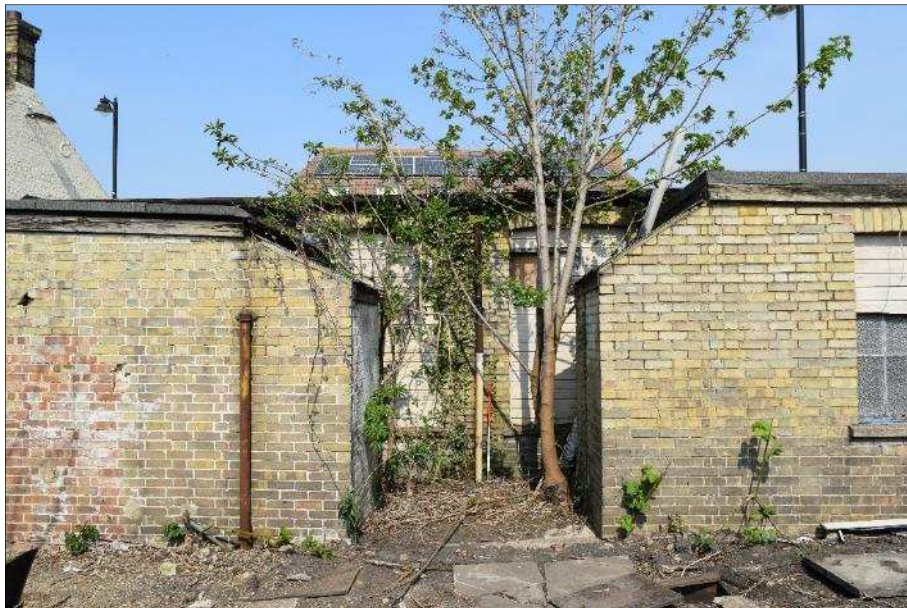
Plate 41 (shot 73): Largely obscured view of the south elevation of Structure D showing large blocked up segmental arched windows behind the tree. Looking north, 1m scale

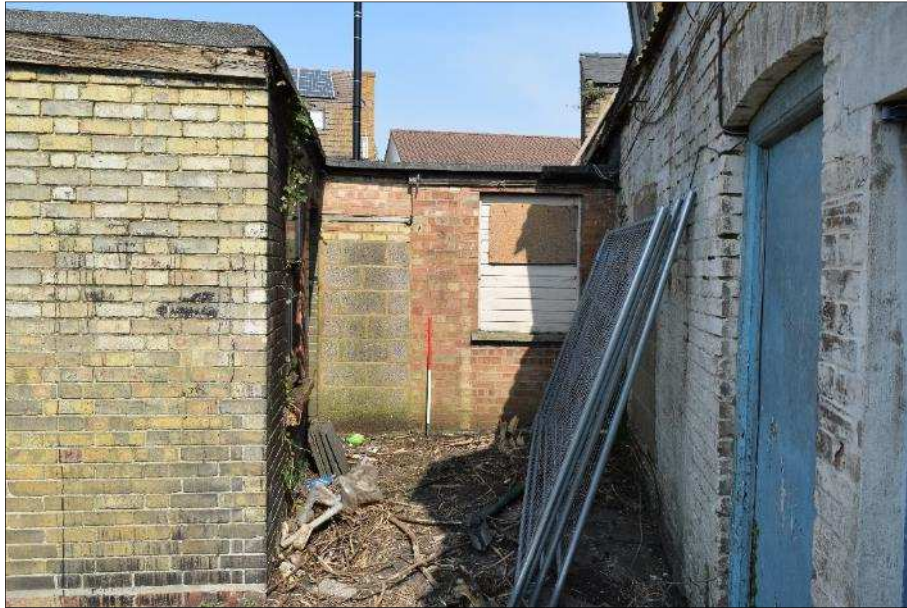
Plate 42 (shot 71): Blocked window and doorway on the south elevation. Looking north-northeast, 1m scale

- 7.29 Another, smaller window and a doorway have been blocked on the southeast corner (Plate 42). The brick stock matches that of the interior and also the bricks used on the south elevation of A.

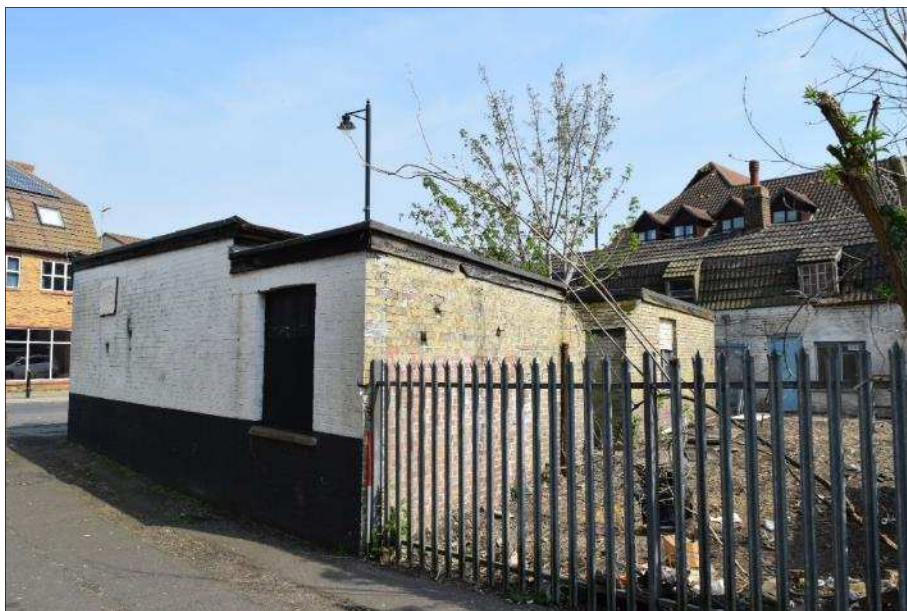
Plate 43 (shot 87): General view of Structures D, E and F in the background. Looking northeast, 1m scale

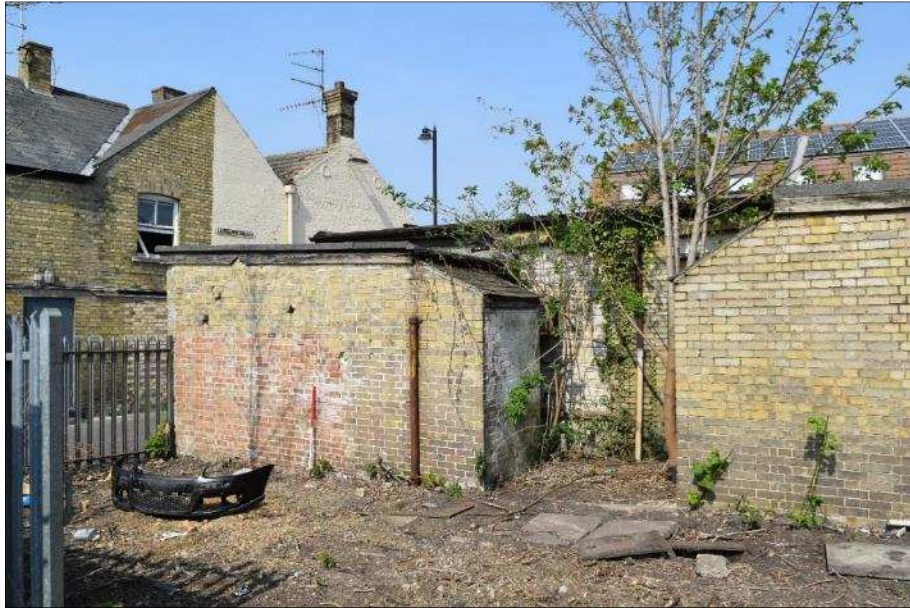
Plate 44 (shot 76): South and east-facing elevations of Structure E to the left. Looking north-northwest, 1m scale

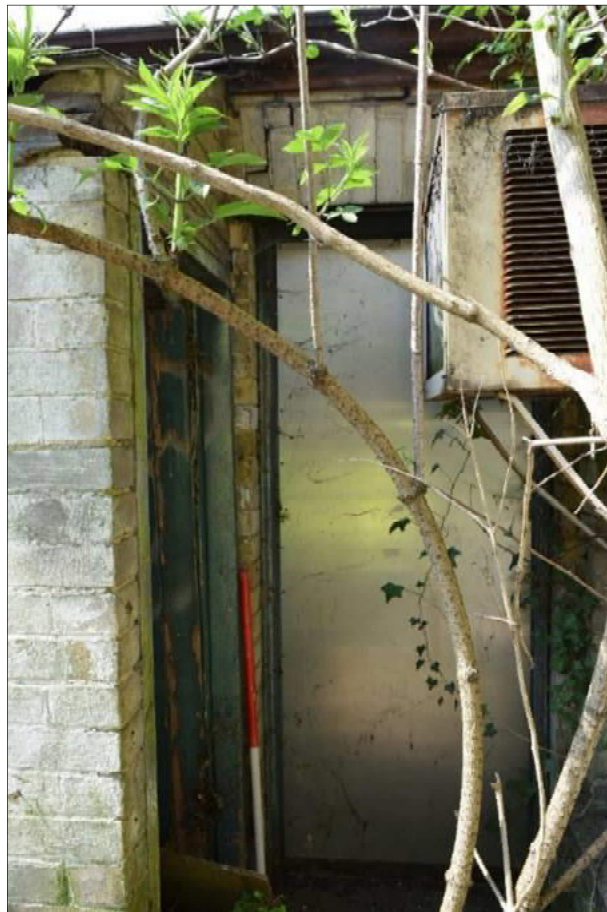
- 7.30 Extension E has a west-facing window with segmental arch (Plate 40), and is also built in Monk Bond. The south elevation has no openings (Plate 43-Plate 44). There are two openings into this structure on the east side, one facing east and another facing north (Plate 45).

Plate 45 (shot 75): Openings facing north and east on Extension E. Looking west, 1m scale

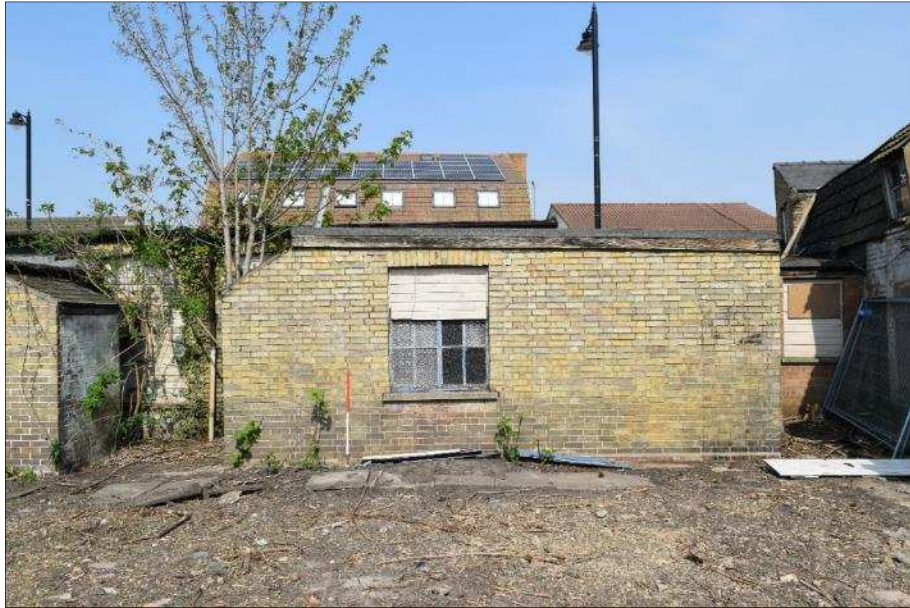
- 7.31 Extension F follows the same style as Structures D and E, built in Monk Bond with a flat roof. There is a window on the east elevation and on the south elevation where the top opening casements have been boarded over. The steel-door entrance is located on the west elevation, but is largely obscured (Plate 47).

Plate 46 (shot 72): Extension F, south elevation. Looking north, 1m scale

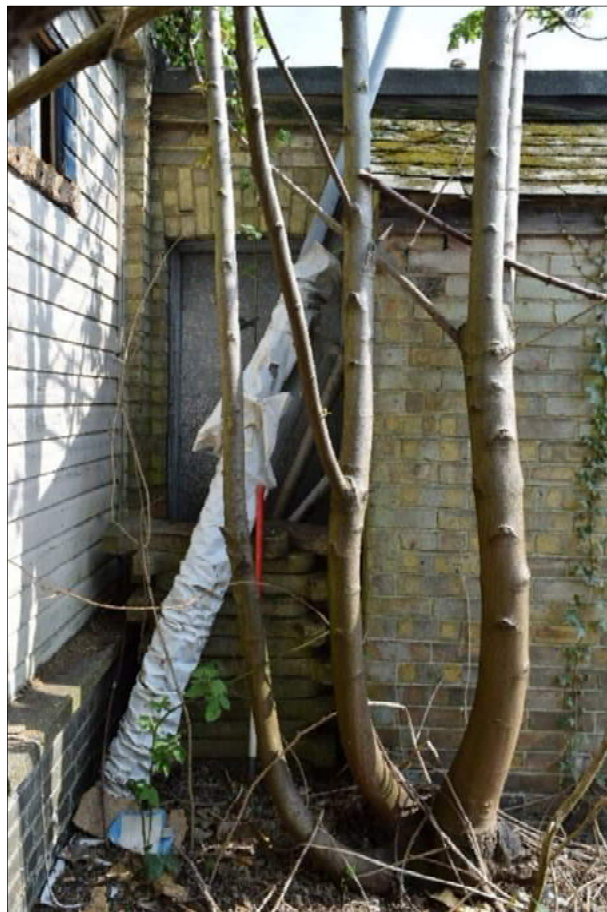
Plate 47 (shot 74): Obscured doorway on west elevation of extension F. Looking east, 1m scale

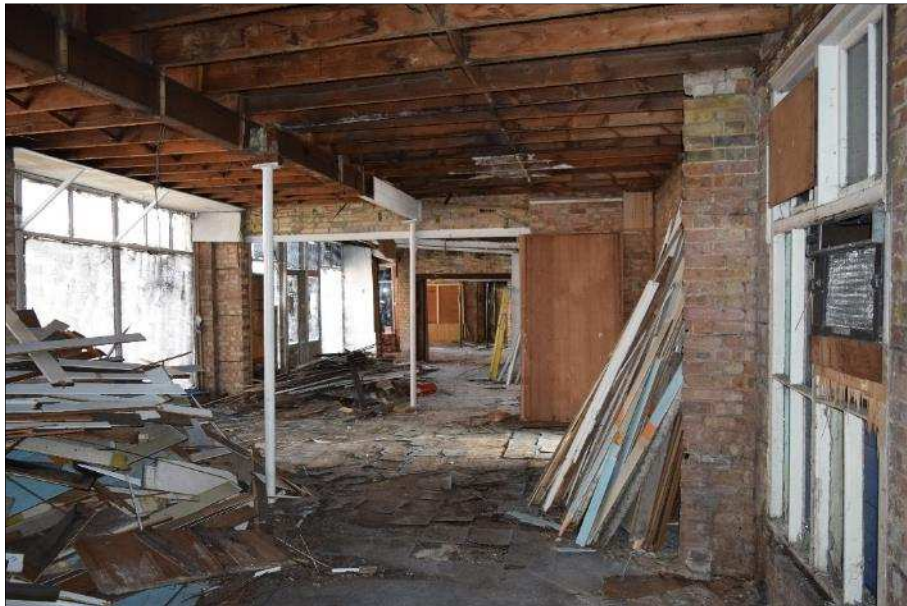
- 7.34 The large opening in the brick wall partition midway through the room (Plate 48) is likely to be a later modification of a smaller opening. An uneven break in the brickwork on the southwest buttress (Plate 49), is an indication that the original structure had a further north-south partition, in total Structure D originally comprised three units.

Plate 48 (shot 62): General view of D. Looking east

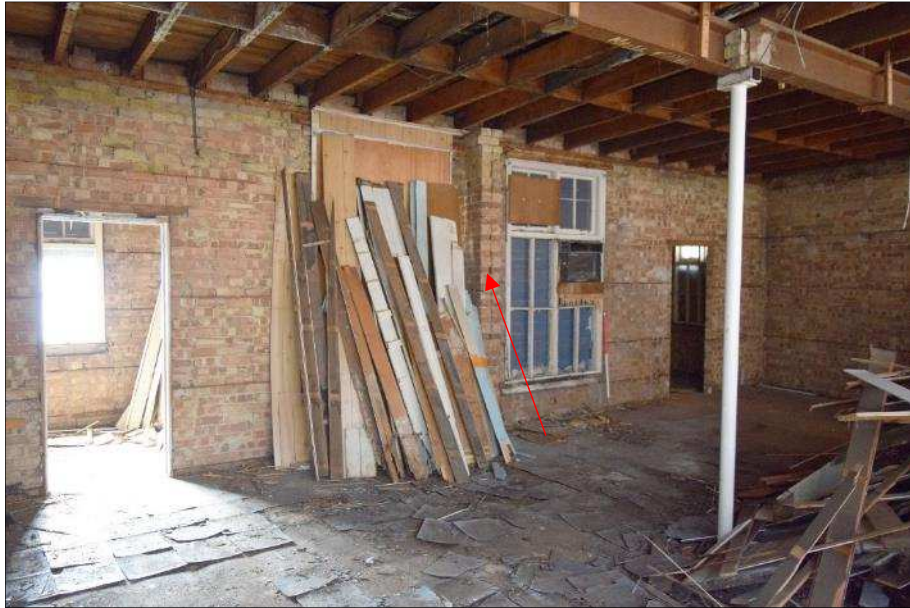
Plate 49 (shot 57): South wall of D, showing original window to the centre right and access to Extension F to the far right. Arrow points to former partition. Looking west, 1m scale

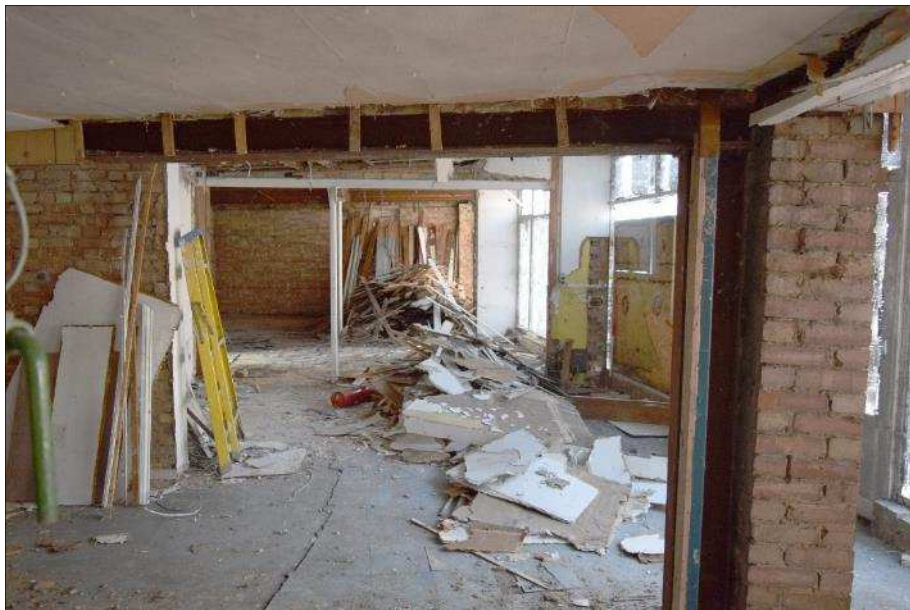
Plate 50 (shot 48): General view from A/B into D. Looking west, 1m scale

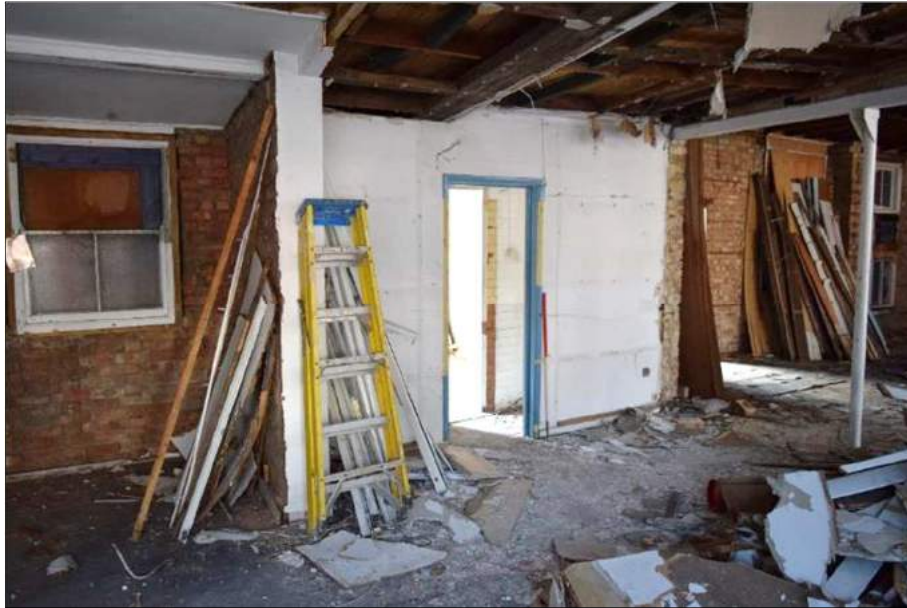
Plate 51 (shot 49): General view of the south wall and entrance to the toilet block and extension F. Looking south-southwest, 1m scale

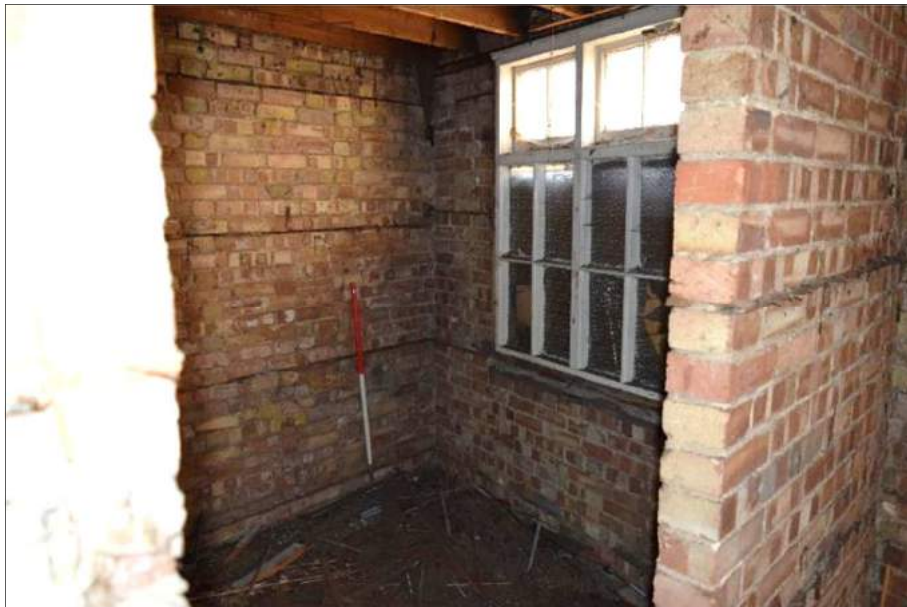
- 7.35 The access to Extension E is located in the southwest corner of D. It is a small space with bare walls and no evidence of its former use (Plate 52). It has a casement window following the style seen on the south wall. The two top casements open outwards (Plate 53). On the east wall is a doorway leading out to the yard. There is a single toilet abutting this extension to the east, accessed from the yard.

Plate 52 (shot 59): General view of extension E. Looking southwest, 1m scale

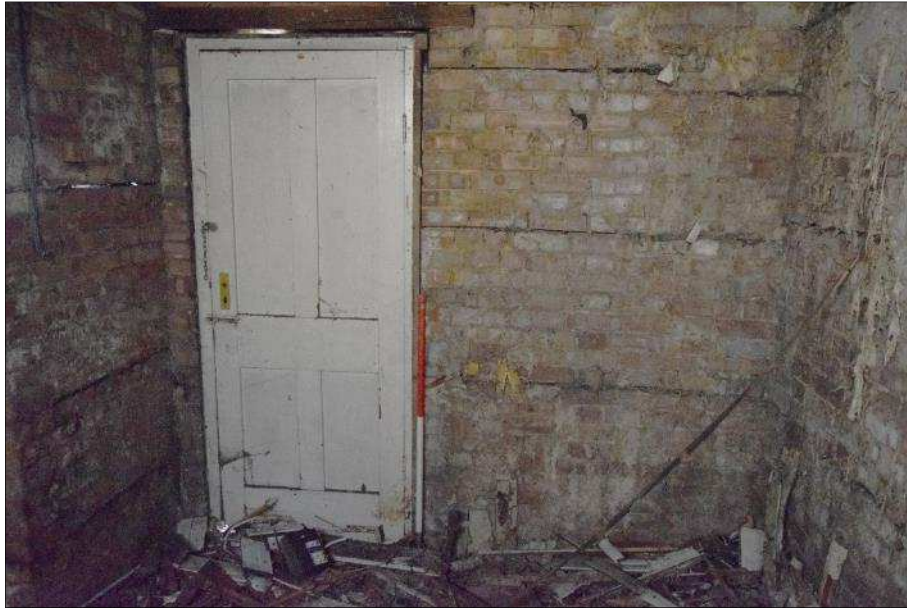
Plate 53 (shot 61): Extension E, general view. Looking east, 1m scale

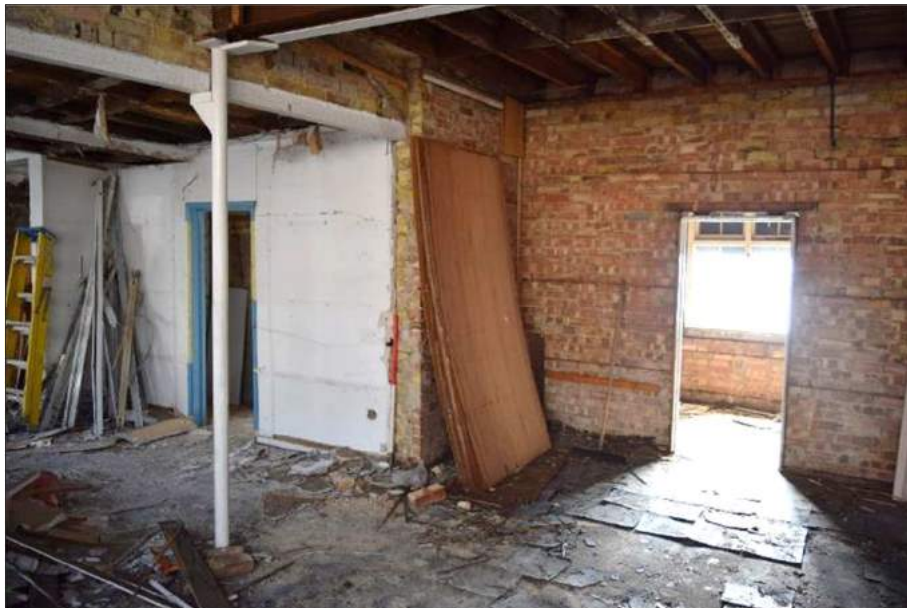
- 7.36 Extension F is accessed from two doorways into two rooms (Plate 54), measuring approximately 3x3m each, both stripped of interior features indicating a former use (Plate 55-Plate 56). The room to the east has a large casement window with fixed four lights below two top casements, opening outwards. A four-leaf door leads out to the yard to the west.

Plate 54 (shot 56): General view of the south wall with access to F and modified north-south partition. Looking south-southeast, 1m scale

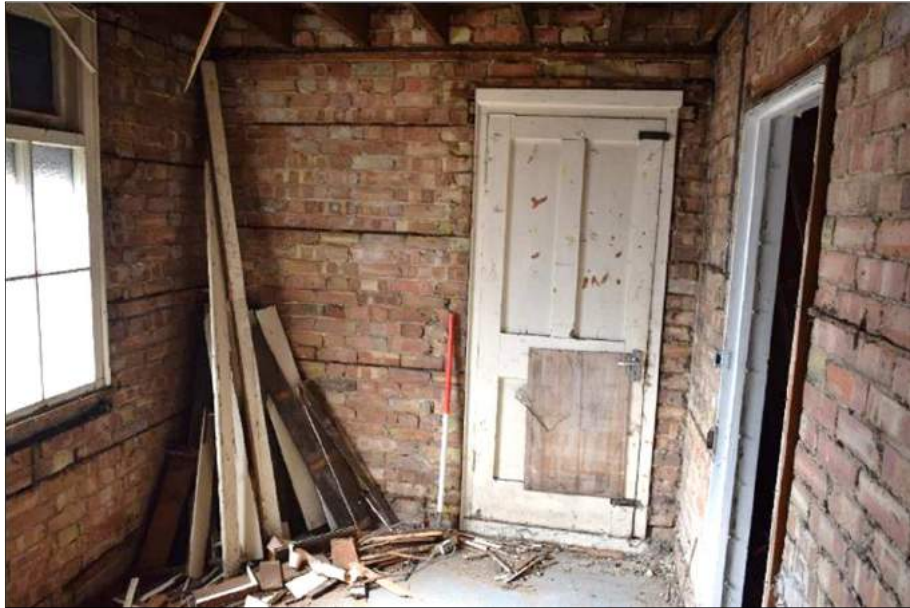
Plate 55 (shot 55): General view of Extension F looking west at the doorway leading to the yard. 1m scale

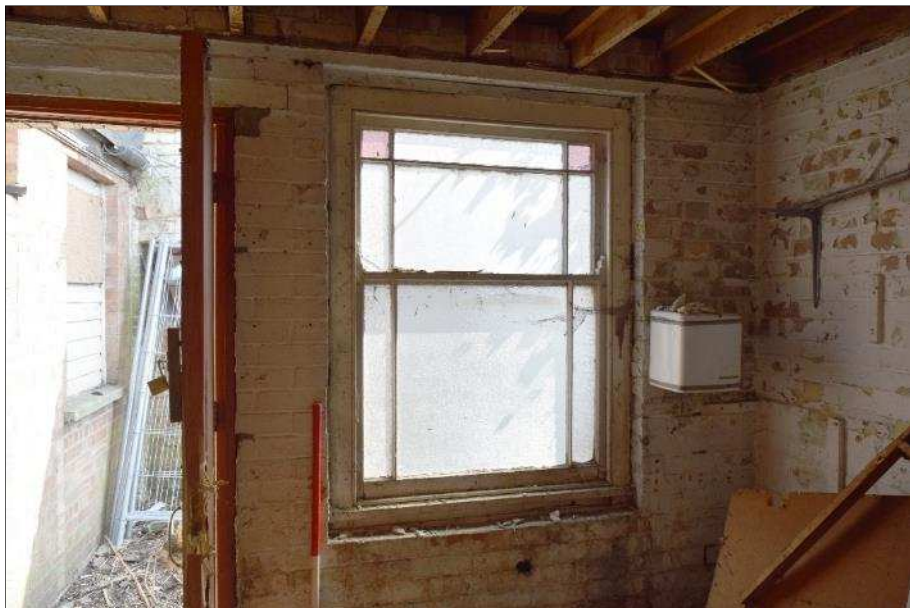
- 7.37 There is a doorway linking the east and west room. In the latter room the brickwork is painted white and on the east wall there is a vertical sash window with horns, and a door leading to the yard (Plate 56).

Plate 56 (shot 54): General view of east room in F. Looking southeast, 1m scale
