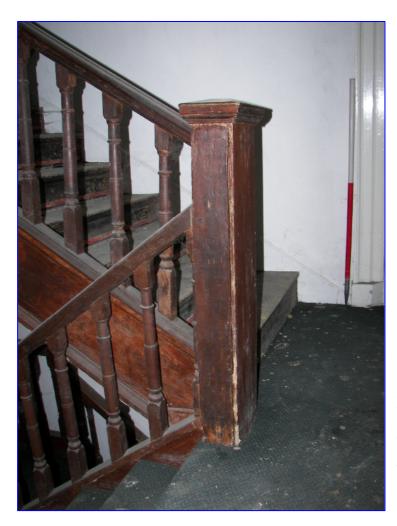
**Plate 17:** (167) The Western Range staircase, later 17<sup>th</sup>/early 18<sup>th</sup> century style, closed string construction with simple turned spells, heavy plain handrail and balusters. Looking north.

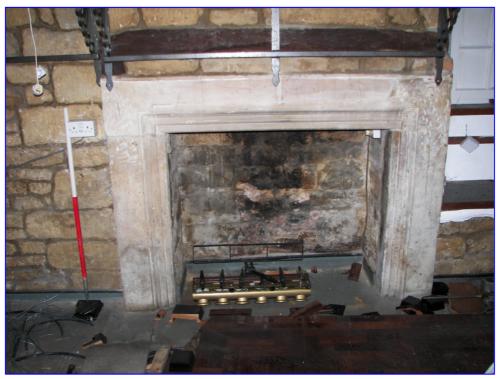
**Plate 18:** (056) Room 6 in the Western Range, 17<sup>th</sup> century open fireplace with a stone surround. Looking west.

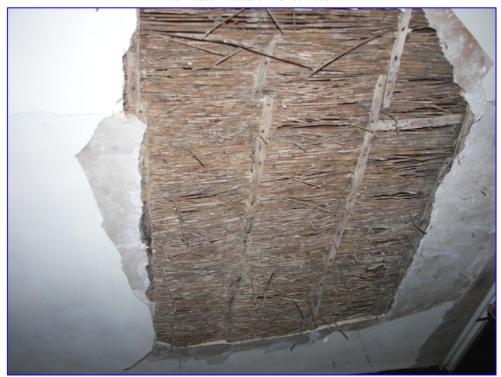
**Plate 19:** (057) The reeded ceiling exposed in Room 6.

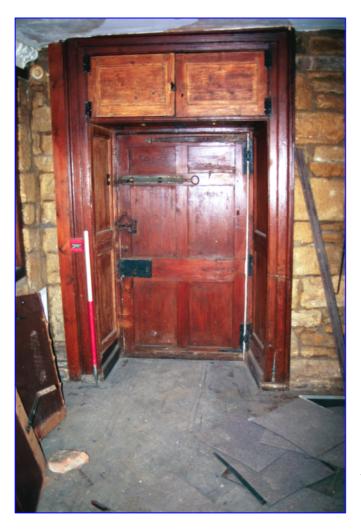
**Plate 20:** (055) Room 6, mid 18<sup>th</sup> century style six panelled door with L shaped hinge and contemporary iron work. The door is set within panelled jambs below a built in cupboard. Looking east.

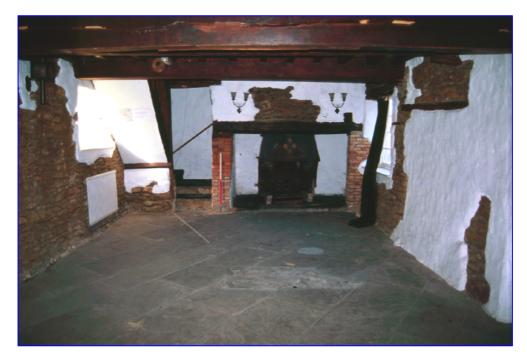
**Plate 21:** (047) Room 8, in the Western Range. At the northern end of the room is a broad 17<sup>th</sup> century style fireplace with a heavy timber bressumer supported on 2<sup>1/4</sup> inch brick piers. Adjacent to the fireplace is the staircase to the garret room above. Large timber cross beams support the joists for the garret floor. Looking north.

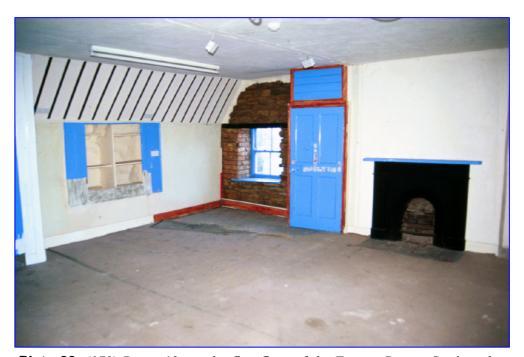
**Plate 22:** (079) Room 13, on the first floor of the Eastern Range. Set into the chimney breast on the northern wall is a 19<sup>th</sup> century cast iron arched bath grate with a plain stone mantel and pillars. The door leads to Room 14 down a short flight of stairs. Looking north-west.

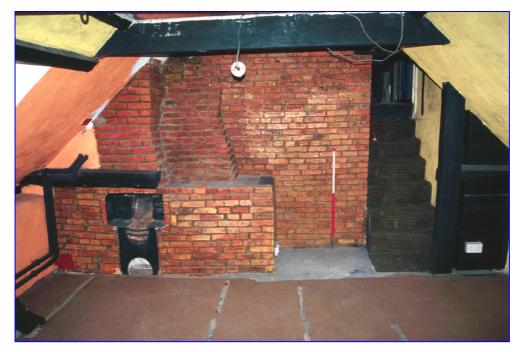
**Plate 23:** (083) Room 14. The southern wall is dominated by a large brick chimney breast that has a small hob grate built onto its eastern side. This structure also supports the stub end of a cross beam that has been cut to accommodate the insertion of stairs from Room 13. A timber stanchion at the foot of the stairs supports the opposing beam stub. Looking south.

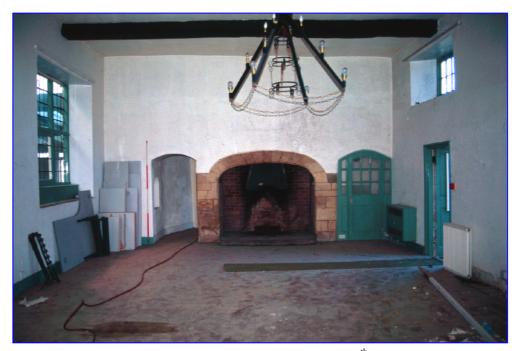
**Plate 24:** (038) Room 2. In the north wall is a large 18<sup>th</sup> century basket arched fireplace with integral moulded stone surround and buttresses over an integral stone slab. There is an arched recess to the east of the fireplace with a half glazed nine pane door flanked by narrow three light sashes. The arch to the west passes through a former oven set into the corner of the building with an external curved wall. Looking north.

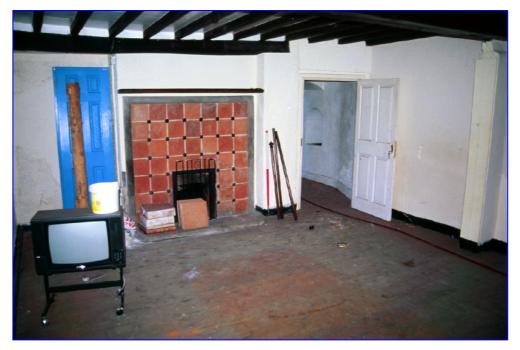
**Plate 25:** (041) Room 3 has a beamed ceiling with a large cross beam supporting squared timber joists, with a further beam set into the chimney breast crossing a recess on its eastern side. There is a tile backed modern retro fireplace incorporating iron studs and a small grate fitted to the chimney breast on the south wall. The floorboards are also a relatively recent addition to the building and the internal doors are modern replacements. Looking south-east.

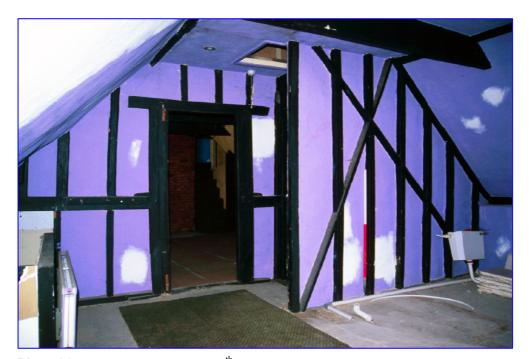
**Plate 26:** (085) Room 15. The 18<sup>th</sup> century type doorframe in the southern wall of this room is constructed in heavy timbers that form part of the roof superstructure. It has an expanded lintel that is secured to the jambs with pegged mortice and tenon joints supporting timber studding to the apex of the roof. An original latch hoop is still attached to the north side of the frame. A partition wall of timber uprights with cross bracing may have enclosed what may have been the original internal staircase access. Looking south-east.
