**ARCHAEOLOGICAL MONITORING AND RECORDING REPORT:  
MANOR WORKS, MAIN STREET, FLECKNEY, LEICESTERSHIRE**

Planning Reference: 20/00091/FUL  
NGR: SP 64802 93464  
AAL Site Code: FLMS 20  
Museum Accession Number: X.A80.2019  
OASIS Reference Number: allenarc1-406725

By  
Allen Archaeology Limited  
Report Number AAL2020011

November 2020

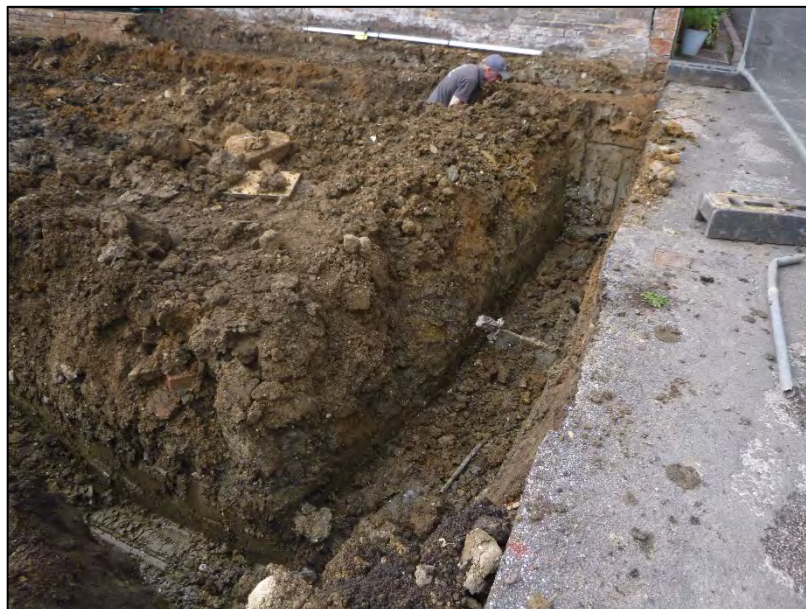
*Plate 1: Unit 1, representative section, looking southwest*

- 7.3 The earliest deposit in Unit 1 was the natural geology of glacial till, 101, a mid-brown silty clay. Sealing this was 100, made ground, up to 0.60m thick in places, and containing whole bricks (Plate 1).

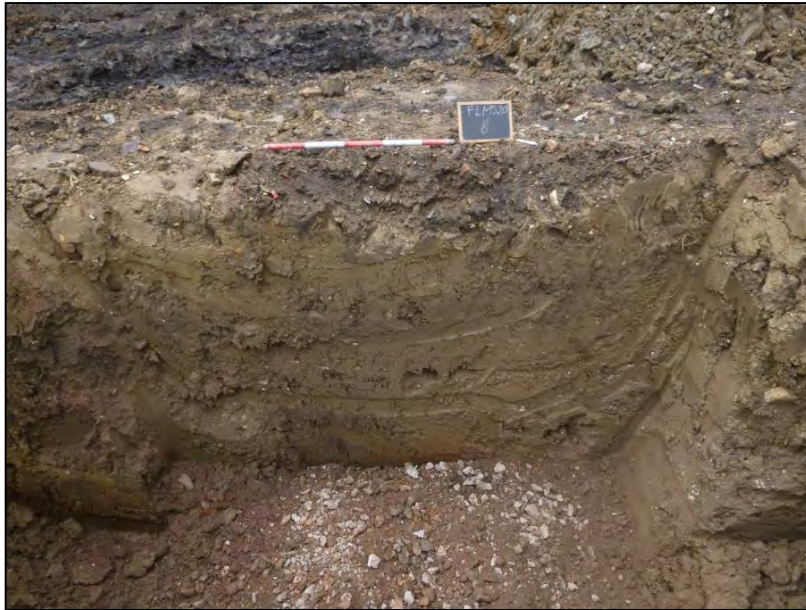
*Plate 2: Garages between Units 1 and 2, pit [007], looking southwest. Scale 1m*

- 7.4 Demolition layers 001 and 008, measuring 0.40m thick, sealed a large pit, [007], revealed in almost the entire length of the garage footings, and extending to the west beyond the limit of excavation. The pit was only apparent in the westernmost footing of the garage.
- 7.5 Pit [007] had a steep sloping northern edge, its base was not visible in section. It had a depth of 2m and was filled by 003, 004, 005 and 006, all of which were undated (Figure 4, Plate 2).
- 7.6 Pit 007 cut a mid-grey blue clay till, 002.

- 8.1 Monitoring of foundation trenches for the buildings and garages revealed one large undated pit. The 1886 and 1902 Ordnance Survey maps shows a track across where the pit is located, suggesting the pit predates 1886, but no dating evidence was recovered to confirm this.
- 8.2 Modern demolition layers sealed the natural geology across the site suggesting that there may have been significant truncation of deposits, possibly as a result of the construction and subsequent demolition of former buildings on the site.

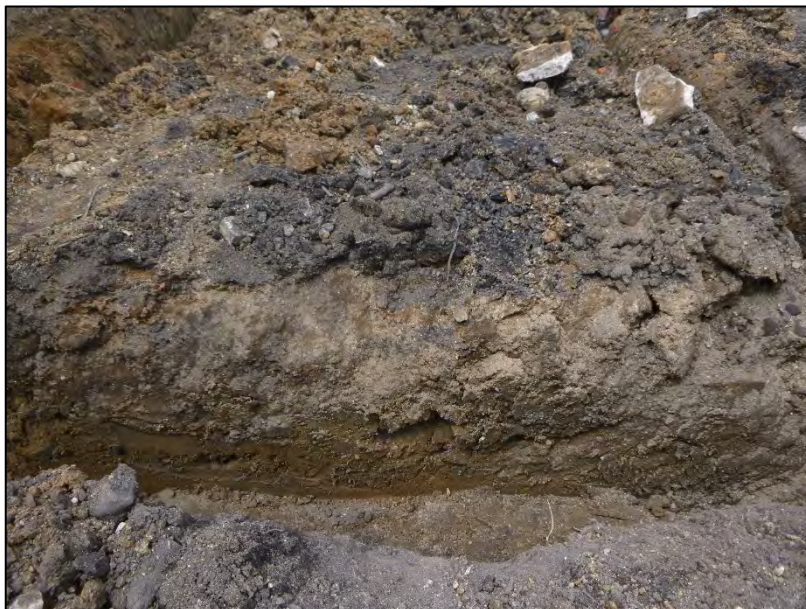
*Plate 3: Unit 2, representative section, looking northwest*

- 7.7 In the building plot and garages of Unit 2 a similar sequence of deposits was encountered to that of Unit 1. Mudstone 202 was overlain by glacial till, 201 which was sealed by modern demolition, 200 (Plate 3).

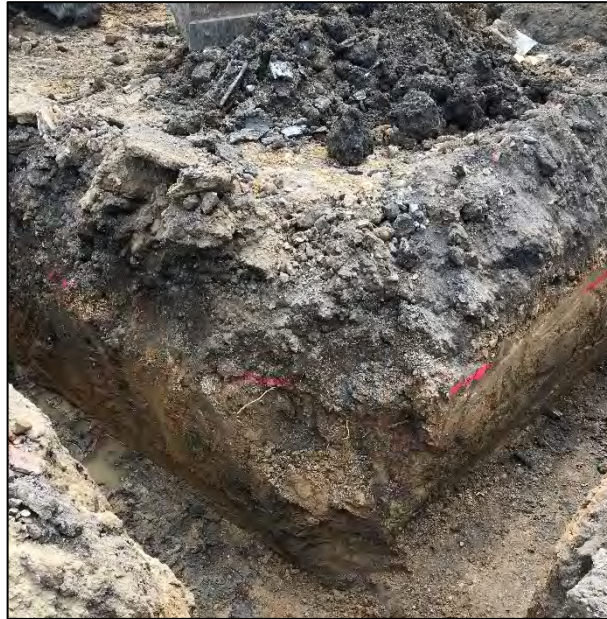
*Plate 4: Unit 3, representative section, looking south*

- 7.8 In the building plot and garages of Unit 3 the sequence of deposits comprised modern demolition material, 300, above natural mudstone 301 (Plate 4).

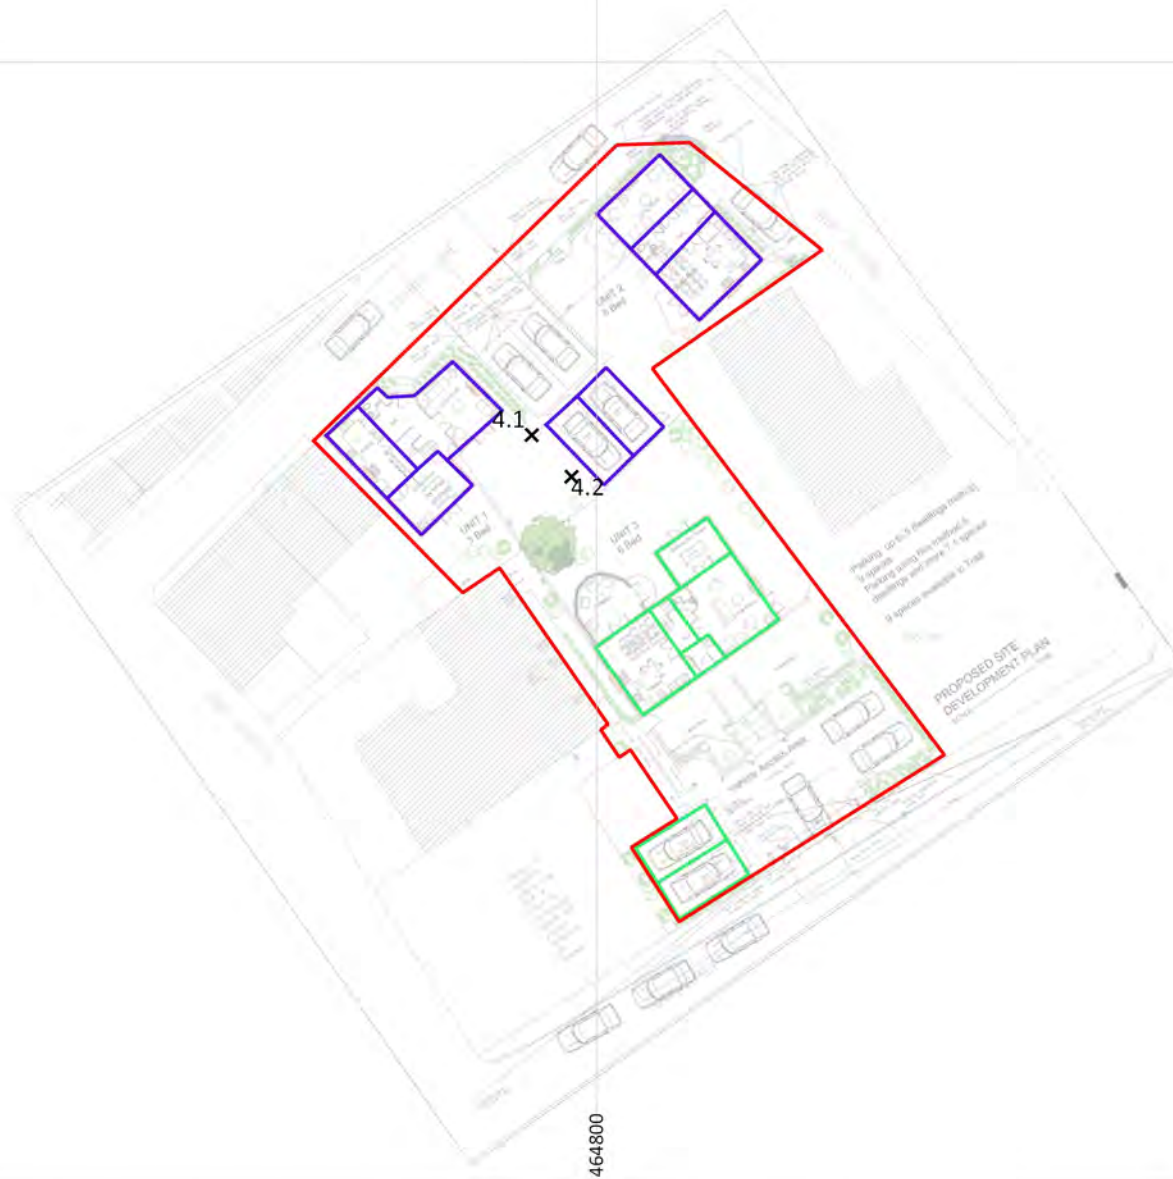
Figure 3: Unit locations showing areas monitored and not monitored

- 7.1 The initial visit was to monitor the demolition of the existing building on the site and grubbing out of foundations (Figure 2, cover image), recorded during a building survey in 2019 (AAL 2020b). A second visit in June was made to monitor groundworks for the new dwellings.
- 7.2 The works monitored in June 2020 extended across 3 Units; Unit 1 was located at the west end of the site, contained a 'T' shaped residential plot with further parking to the northeast. Unit 2 comprised a rectangular residential plot and was northeast of Plot 1. Between Units 1 and 2 were garages. Unit 3 was to the southeast of Unit 1. It comprised a housing plot and two garages, with parking for a further three vehicles (Figure 3).
