**REPORT ON AN ARCHAEOLOGICAL SCHEME OF WORKS:  
THOMAS COWLEY SCHOOL, DONINGTON, LINCOLNSHIRE**

Planning Reference: H04/1402/07  
NGR: TF 2123 3574  
AAA Site Code: DTCS 08  
LCCM Accession Number: 2008.18  
OASIS reference: allenarc1-43288

Allen Archaeological Associates  
Report Number 2008/034

June 2008

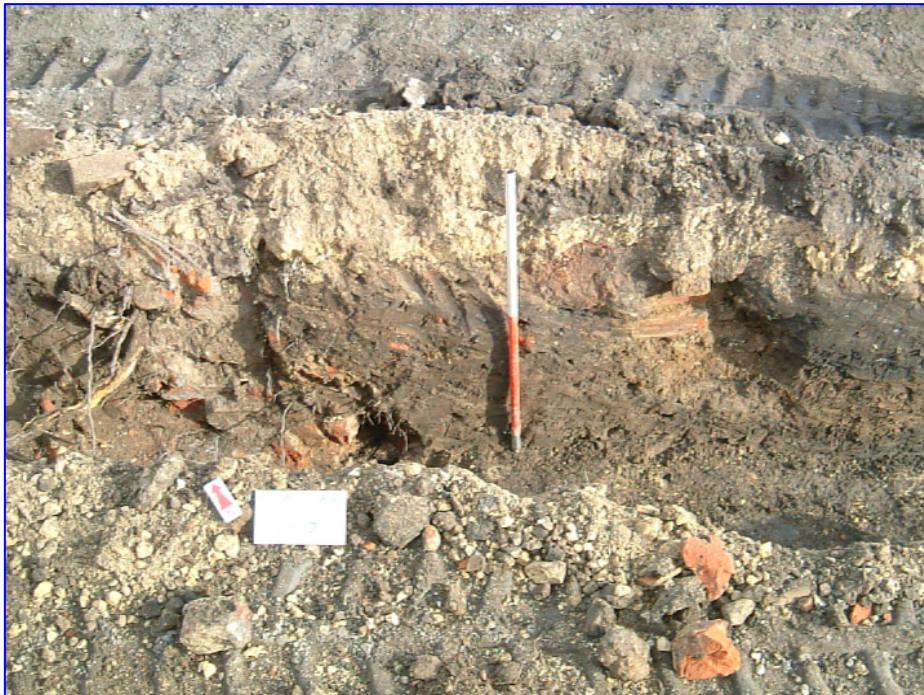
**Plate 2:** South-south-west facing section, showing tree bole [116], culvert [103] and walls [106] and [107]. To the right of the scale can be seen the collapsed section exposing the face of wall [107]. Looking north-north-east.

- 6.5 The dumped deposits were cut by two parallel walls of a brick structure, running on a north-north-east to south-south-west alignment. Both walls comprised a construction cut, [107], which was filled by a 0.18m thick deposit of lime based cement with frequent inclusions of fragmented brick. The wall constructed onto this base, 109, was of roughly coursed hard faced wire cut 3 x 9 x 4 ½ inch red bricks bonded with a lime based mortar, which were dated to the mid 19<sup>th</sup> – 20<sup>th</sup> century. The walls did not continue into the service trench to the north, and a collapsed section of the north face of the foundation trench exposed part of the west-north-west to east-south-east aligned component of the structure (see Figures 3 and 4, Plate 2).

- 6.6 Another wall, in a construction cut [106] was recorded to the north-west of [107]. At the base of the cut was a two course width brick foundation, 104, constructed in 2 ½ x 8 ⅝ x 4 ¼ inch soft faced mould-formed bricks of 18<sup>th</sup> – 19<sup>th</sup> century date. Overlying 104 was a more irregular foundation, 105, comprising randomly coursed full and part bricks bonded with a lime based mortar that extended to within 0.08m of the current ground surface. There was no evidence for a return in the wall which extended into and beyond the service trench to the north. To the north-west of the wall was a large modern tree bole, [116], which obscured the stratigraphic relationship between construction cut [106] and the dumped deposits 110 and 111. However, as cut [106] contained only the foundation courses, with no evidence for a superstructure, it seems likely that [106] is cut through the dumped deposits.

- 6.7 Abutting [106] to the south-east, and sealed by dumped deposit 111, was a brick built vaulted drainage culvert [103], constructed in late 17<sup>th</sup> to mid 18<sup>th</sup> century hand made red soft faced 2 ¾ x 8 ½ x 4 ½ inch bricks bonded with a lime based mortar. The culvert followed a north-north-east to south-south-west orientation extending beyond the limits of excavation in both directions. It was not possible to establish the full construction depth of the culvert during the groundworks.

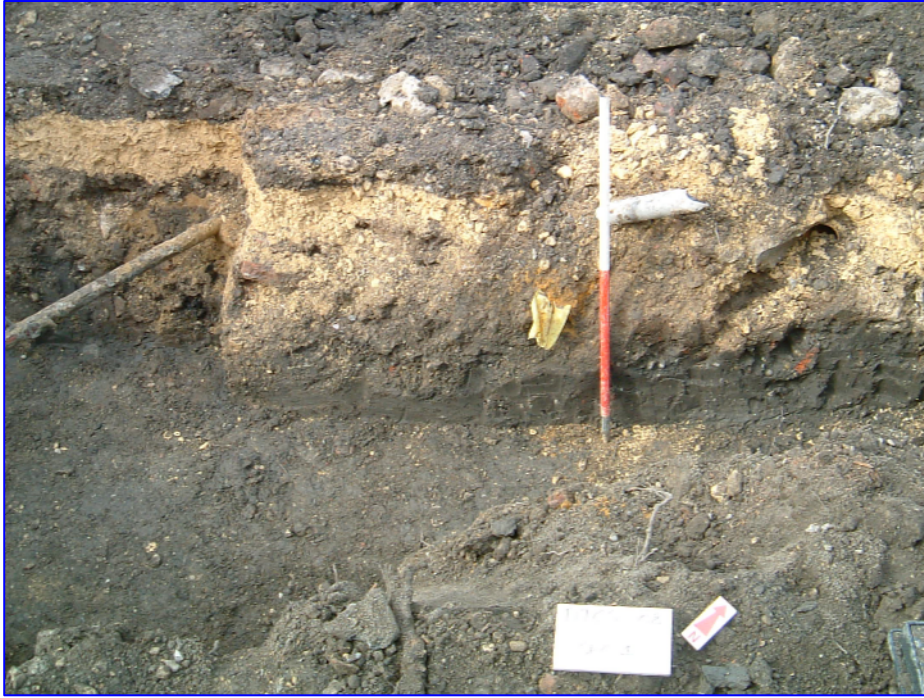
**Plate 3:** Stratigraphic sequence at south-east side of development area, looking west-north-west.

- 6.2 On the south-eastern side of the site the uppermost layer comprised a limestone aggregate 100, laid down to support the tarmac car park surface that was removed before excavation commenced. This sealed a dark brown silty clay 101, interspersed with frequent inclusions of modern rubble, interpreted as a demolition deposit associated with the construction of the car park and the nearby school buildings. Below this was layer 102, a grey brown clay/silt, which was similar in character to layer 114 but included occasional fragments of brick and small stones within its matrix. This deposit extended beyond the limit of excavation.

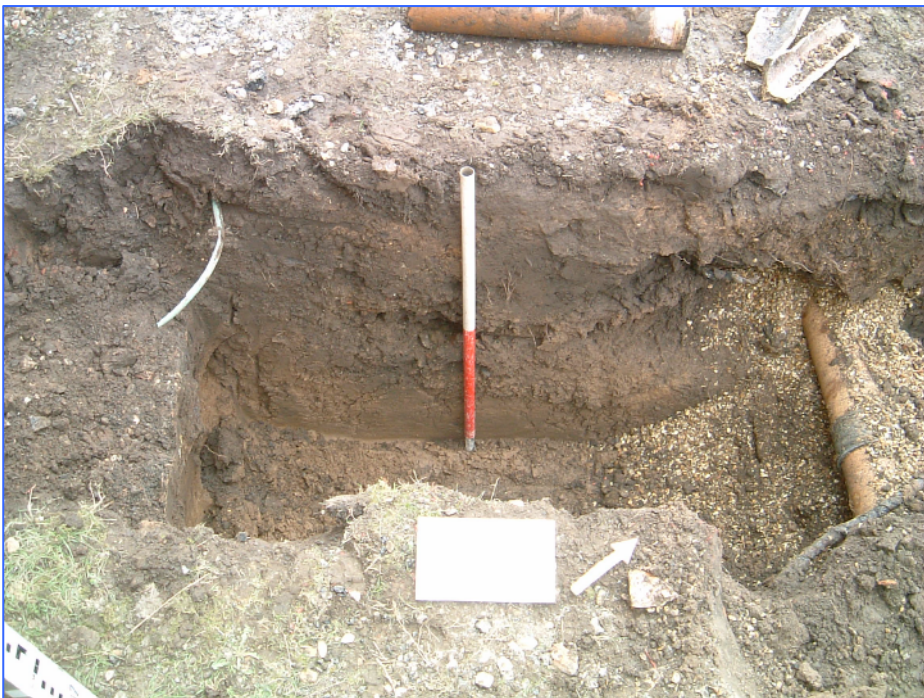
**Plate 4:** Stratigraphic sequence at north-west side of development area, looking west-north-west.

- 6.1 At the north-west side of the site, the uppermost deposit was a 0.2m deep dark brown clay silt topsoil 113, which sealed a 0.40m deep deposit of grey brown clay/silt 114, representing a probable subsoil horizon. The underlying natural geological deposit on the site consisted of mid brown clay silt 115, which extended below the limit of excavation.

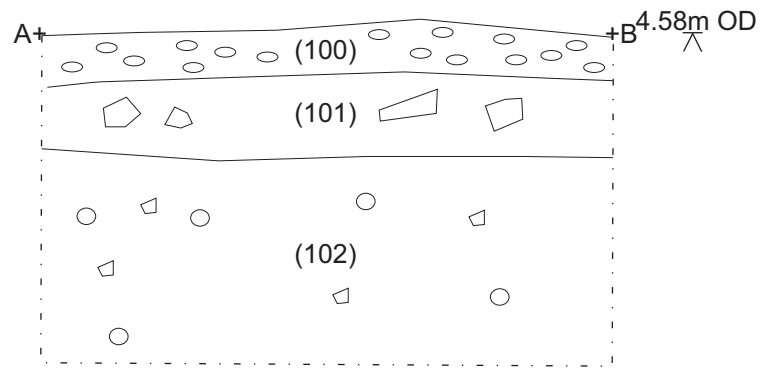
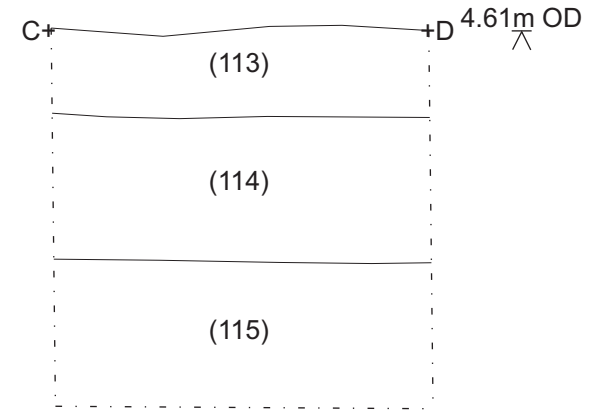
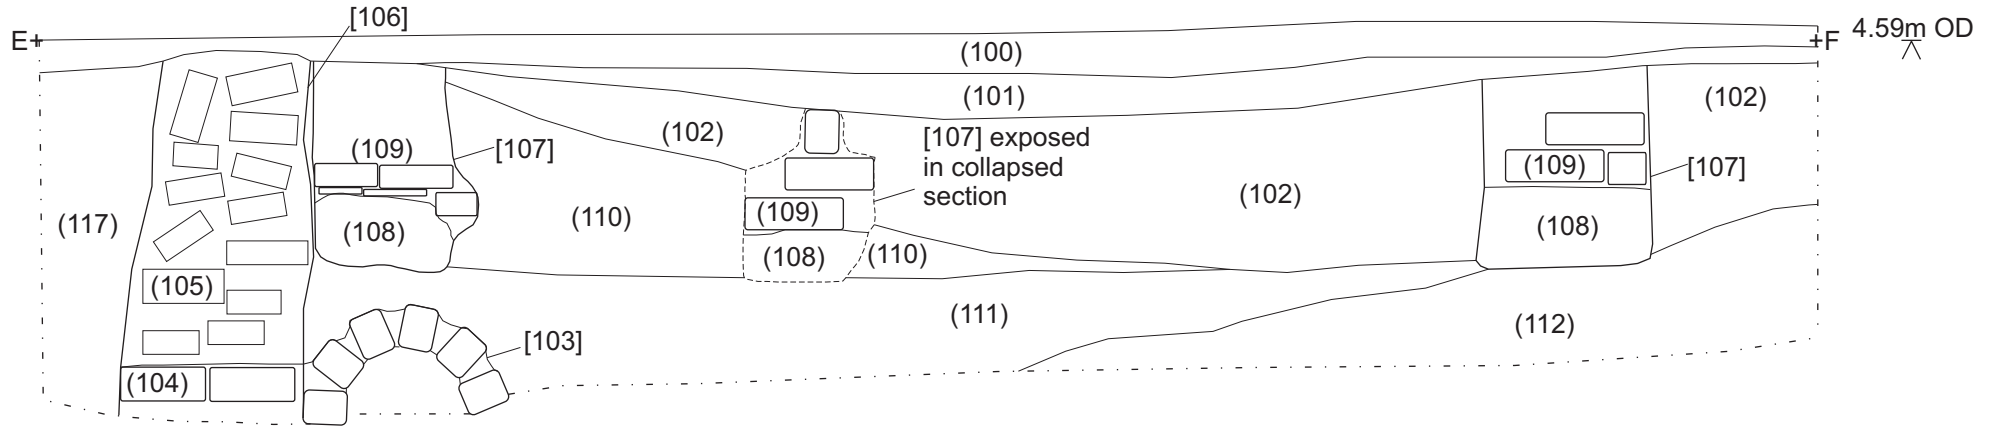
**Figure 3:** Section drawings A - B, C - D and E - F at scale 1:20. Located on Figure 4
