ARCHAEOLOGICAL EXCAVATION REPORT:
LAND AT MOSS HEY STREET, SHAW, OLDHAM, GREATER MANCHESTER

NGR: SD 94153 08576
AAL Site Code: SHMH 20
Planning Reference: PA/344572/20
OASIS Reference Number: allenarc1-433595

Report prepared for Mulbury Homes

By
Allen Archaeology Limited
Report Number AAL2021140

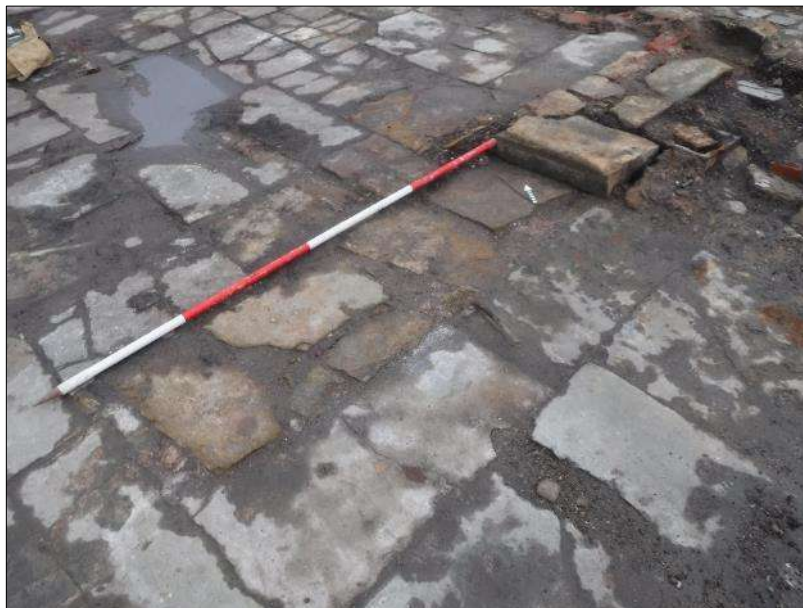
- 7.6 A northeast-southwest aligned internal partition wall 212 was recorded in plan abutting the southwestern face of wall 210. The wall was also of sandstone construction, but was not tied into the northeastern external wall of the building, and so may represent a later alteration.

Plate 2: Partition wall 212, looking north, 2m scale

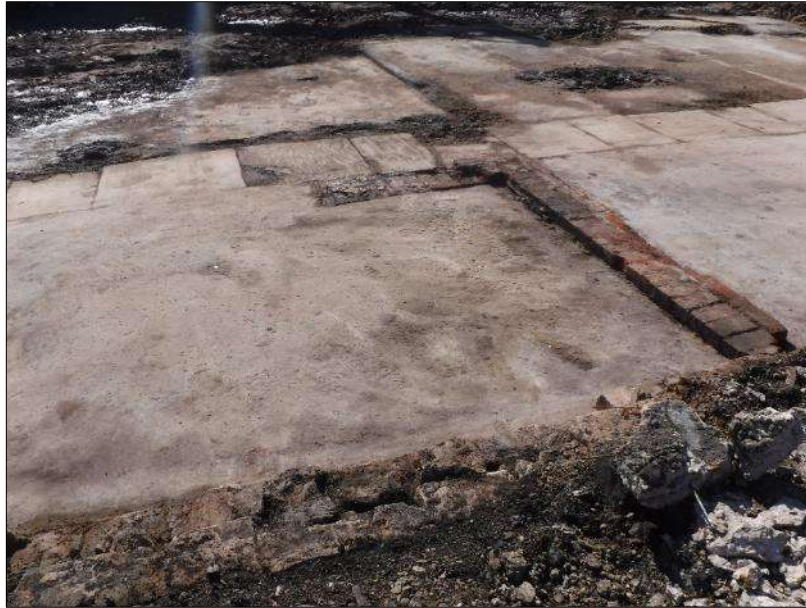
- 7.7 Another internal partition 236 bonded to the southwestern face of wall 234 was recorded towards the southeast end of the range. The wall was built from hand pressed red brick measuring 220mm x 110mm x 80mm, bonded with lime mortar, and may represent a later alteration to the original structure. The construction materials of the wall were very similar in character to those used in the construction of the main spinning block to the northeast, and the partition may indicate a change of function in the southwestern range associated with the construction of the main spinning block in the early 19th century.

Plate 3: Brick partition wall 236 with sandstone wall 234 in foreground, showing central flagged surface 215 and later concrete floors, looking southwest, no scales

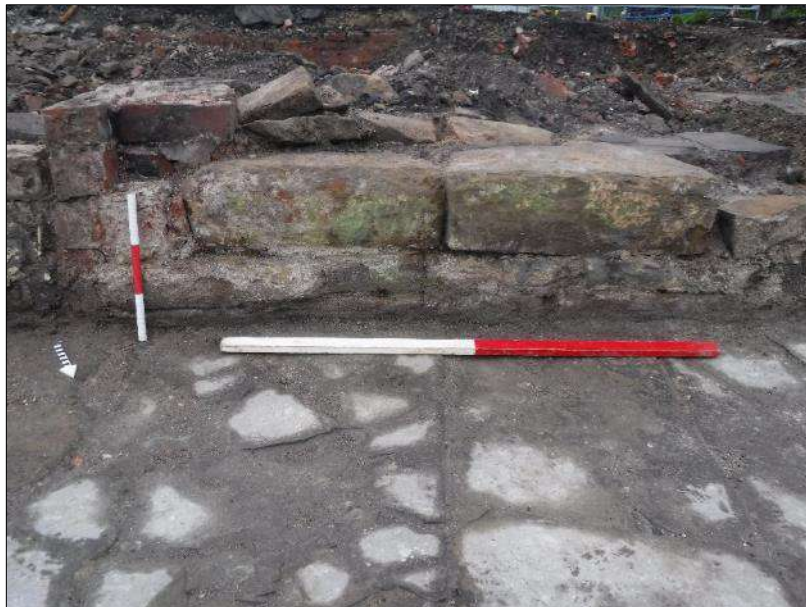
- 7.8 To the southwest a series of walls (206, 209 and 211) created a partition on the long axis of the building to designate a number of rooms on the southwest side of the road. To the northwest wall 209 was of sandstone construction and probably contemporary with the external walls of the range. Built into the wall was a worn sandstone threshold 208 measuring 1.27m x 0.33m x 0.08m, indicating the position of a doorway within wall 209.

Plate 4: Northeast facing elevation of wall 209, looking southwest, 1m and 0.30m scales

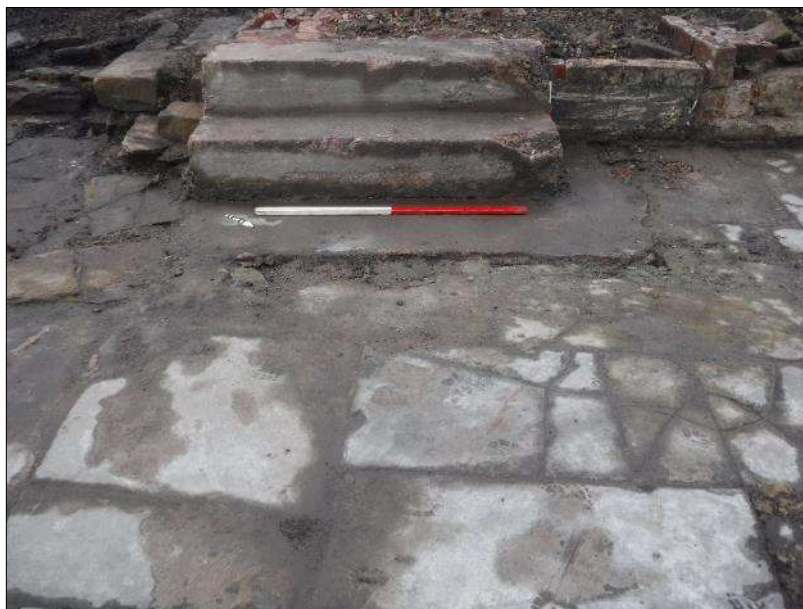
- 7.9 To the southeast of wall 209 the partition was formed by a brick built wall 206 which survived to a maximum height of 5 courses (0.45m) and was bonded with lime mortar and limewashed on the faces. The brick wall abutted wall 209 to the northwest and to the southeast it abutted a pair of concrete steps 207, with which the brickwork was probably associated. The steps were made of poured concrete on a concrete base and were 1.40m wide with a tread width of 0.30m and a riser height of 0.20m. The steps and associated brick wall represented a later alteration to the original structure.

Plate 6: Concrete steps 207 and brick wall 206 to the right, looking southwest, 1m and 0.30m scales

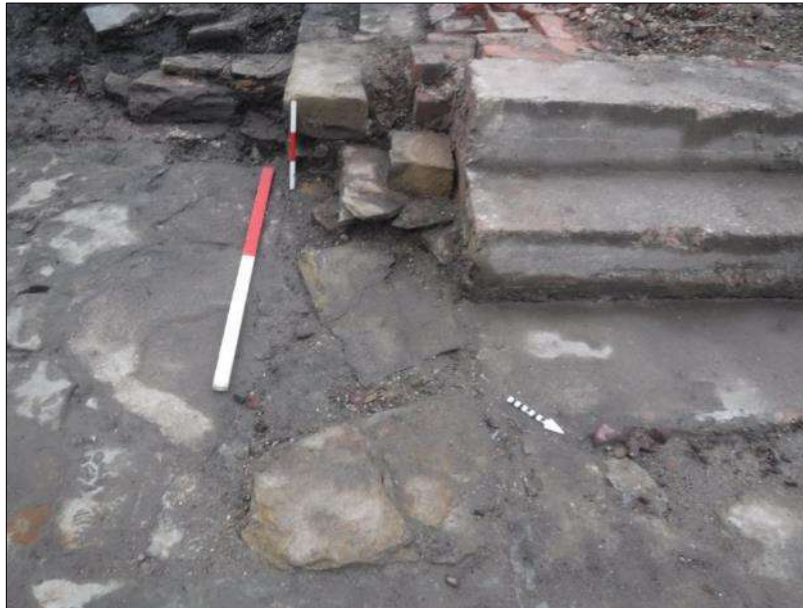
Plate 7: Sandstone partition wall 213 to the southeast of concrete steps 207, looking southwest, 1m and 0.30m scales

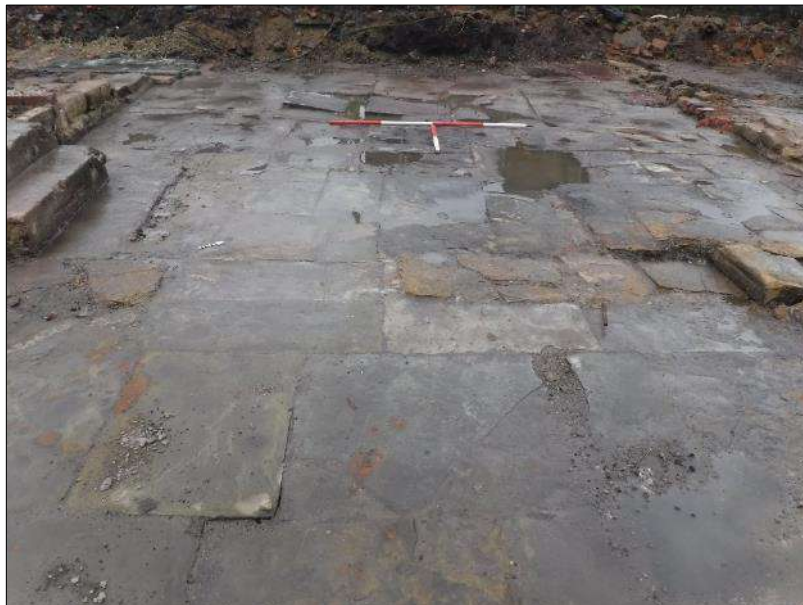
- 7.11 The earliest floor surface within the room defined by walls 210 to the northeast, 209 to the southwest and 212 and 213 to the southeast comprised a flagged floor 215, consisting of rectangular flags of local Lancashire stone, smaller and less regular than the flagging used in the main spinning block to the northeast. The floor surface was in poor condition with many of the flags broken and evidence in places of subsidence of the floor.

Plate 8: Flagged floor surface 215 at northwestern end of southwestern range of mill buildings, looking northwest, 2m and 1m scales

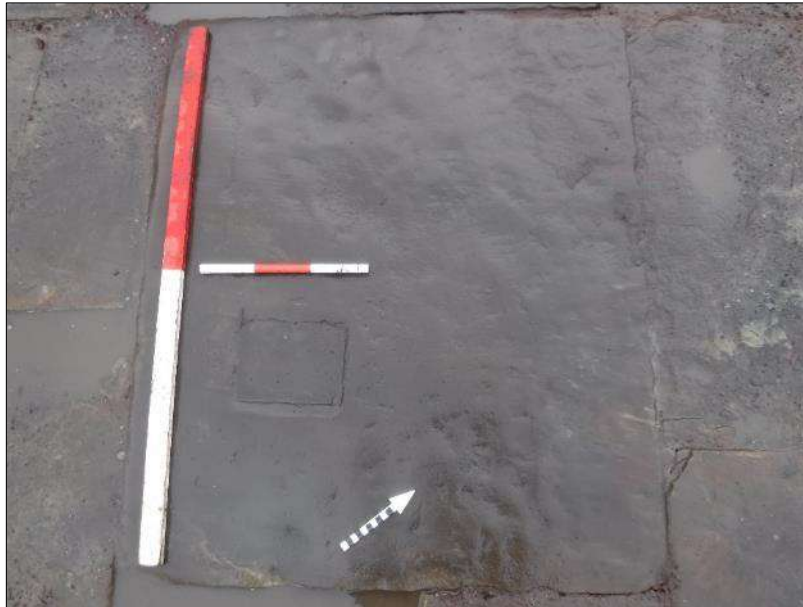
- 7.12 There was some evidence for machinery having been housed in the flagged area of the building. One of the flagstones 216 making up the floor had an incised square notch which may indicate the former presence of a machine base (Plate 9).

Plate 9: Flagstone 216 with shallow square notch, 1m and 0.30m scales

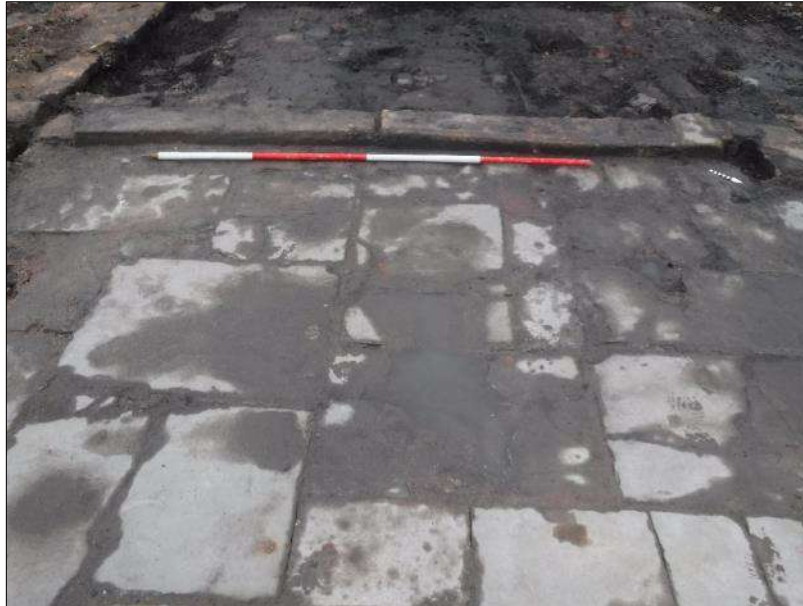
- 7.14 To the southeast of partition wall 213, flagging 215 abutted a threshold comprising two green sandstone blocks each measuring 1.37m x 0.28m x 0.07m, to form a threshold 214 with an overall length of 2.74m. At either end of the threshold stones, sockets measuring 0.28m x 0.11m were recorded and interpreted as the sockets for timber door or gates posts for a double leaf door. At the junction of the two threshold stones bolt holes were recorded cut into flagging 215. The threshold was built into wall 211, which represented a continuation of wall 209, although cartographic evidence suggests that at the location of threshold 214 wall 211 represents the external wall of the southwestern range of mill buildings, whereas to the northwest it represents a partition wall within the range.

Plate 10: Flagging 215 and threshold 214, looking southwest, 2m scale

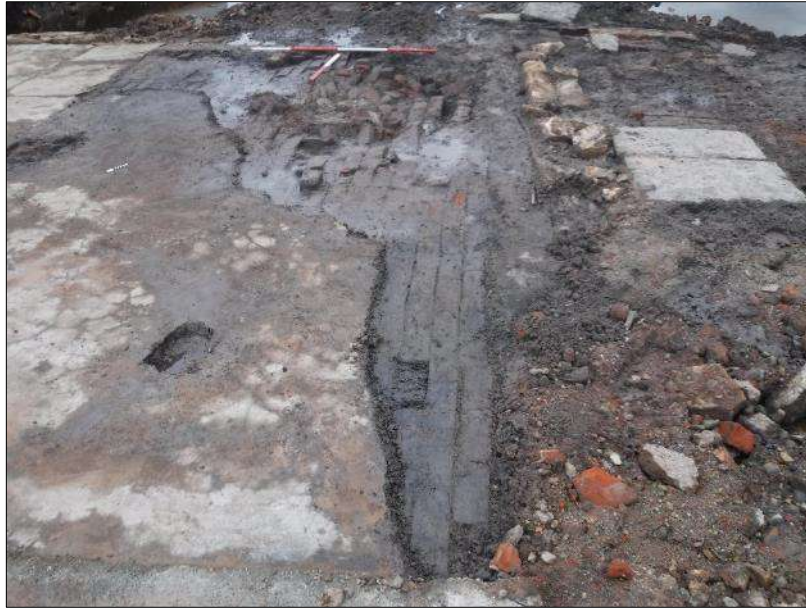
- 7.17 Opposite concrete floor 244 to the southwest of the strip of flagstones 215, the earliest floor surface revealed comprised a single 5.88m x 3.12m layer of unmortared bed-laid hand pressed bricks 247 laid on a sub-base of orange coarse sand (Plate 11). It is possible that this represents the original floor of this part of the southwestern range and that the flagging did not formerly extend across the width of the building. The brick surface abutted the flagging to the northeast and was heavily disturbed in some areas and was overlain by a 0.08m thick deposit of concrete 240, the upper surface of which was higher than the surface of the flagstones to the northeast.

Plate 11: Brick floor surface 247 below concrete surface 240, looking southeast, 2m and 1m scales

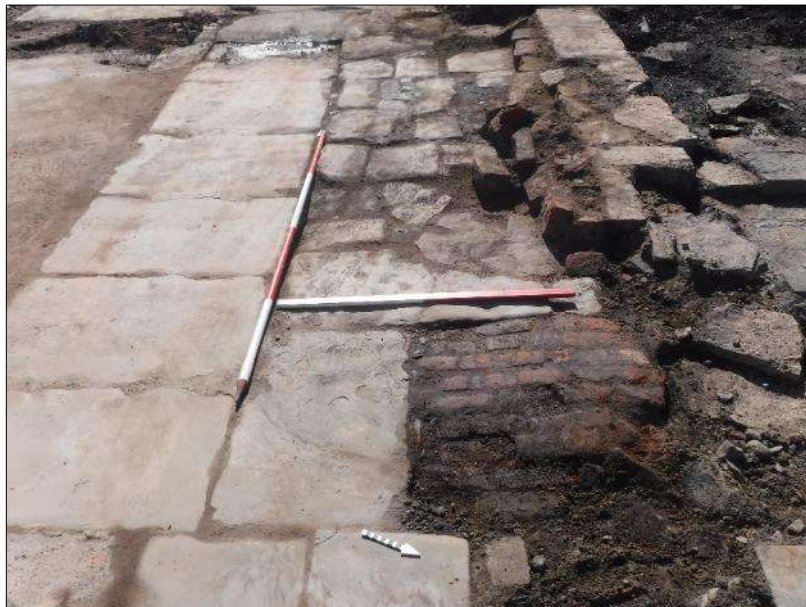
- 7.18 To the northwest of brick surface 247 was another concrete floor surface 239 measuring 7.35m x 4.22m. This surface was similar in character to 243 and 244, and probably contemporary with those deposits and had a ceramic drain 246 built into the surface.
- 7.19 At the north-western extent of concrete surface 239 surface 237 comprised a mixture of brick and flagstones, measuring 4.14m northeast-southwest by 1.25m northwest-southeast. This surface is very likely to pre-date the concrete surface to the southeast but may represent an area of repairs to the original flagging 215 of the southwestern range.

Plate 12: Mixed flagstone and brick floor surface 237 and wall 233 to right, looking southwest, 2m and 1m scales

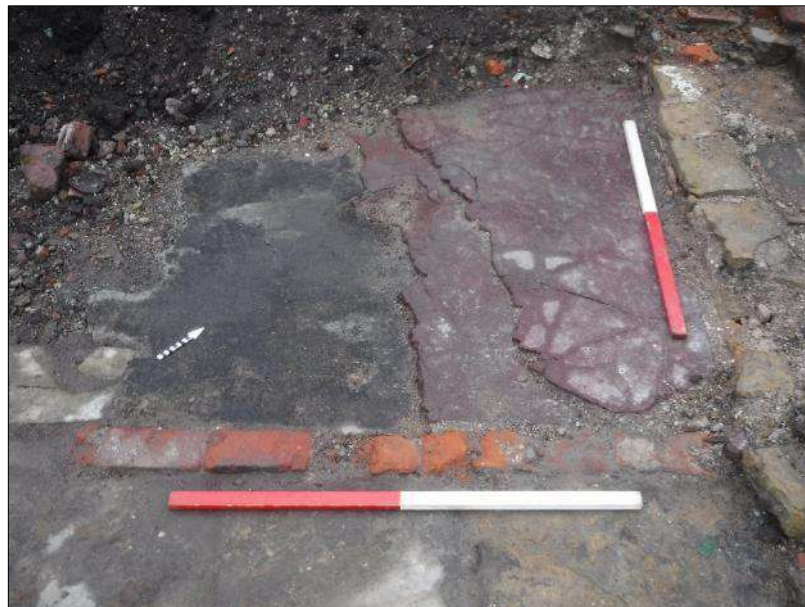
Plate 13: Example of late floor surface 221 and wall 210 to right, looking northwest 1m scales

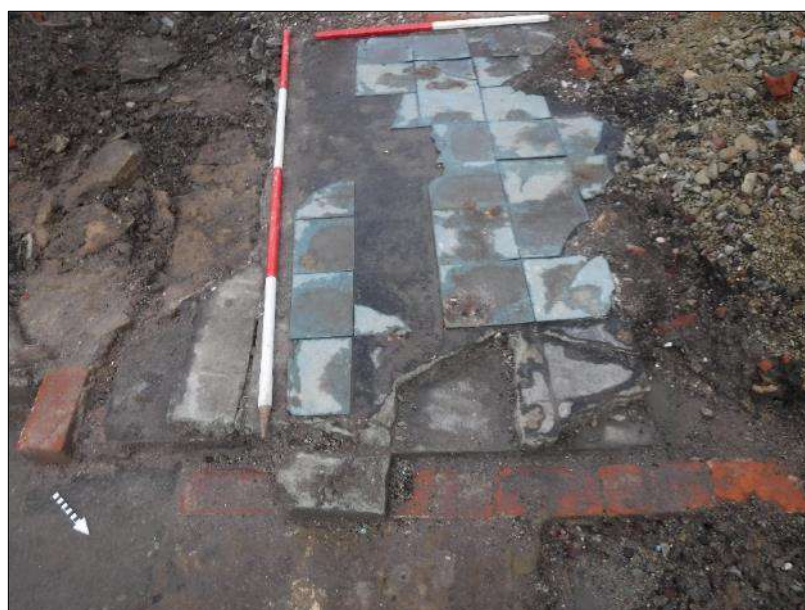
Plate 14: Example of late floor surface 202, looking southwest, 2m and 1m scales

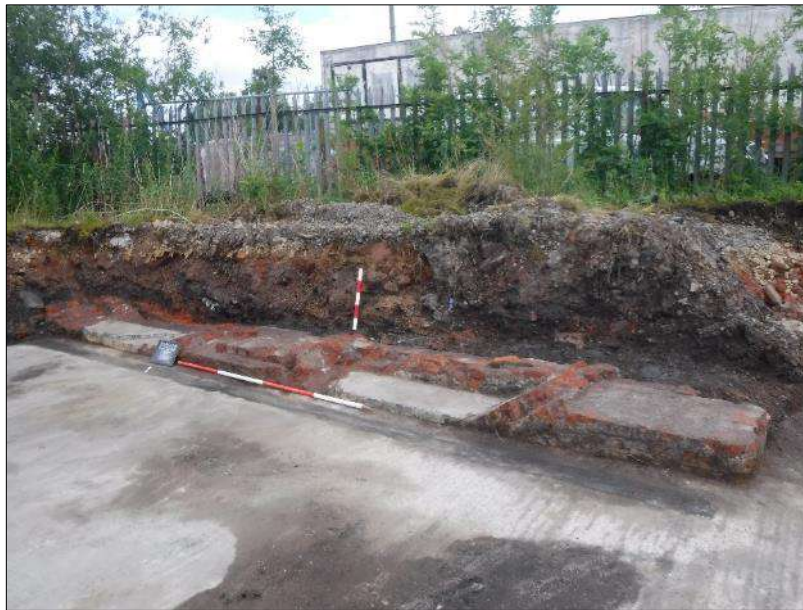
Plate 15: Wall 116, looking north, 2m and 1m scales

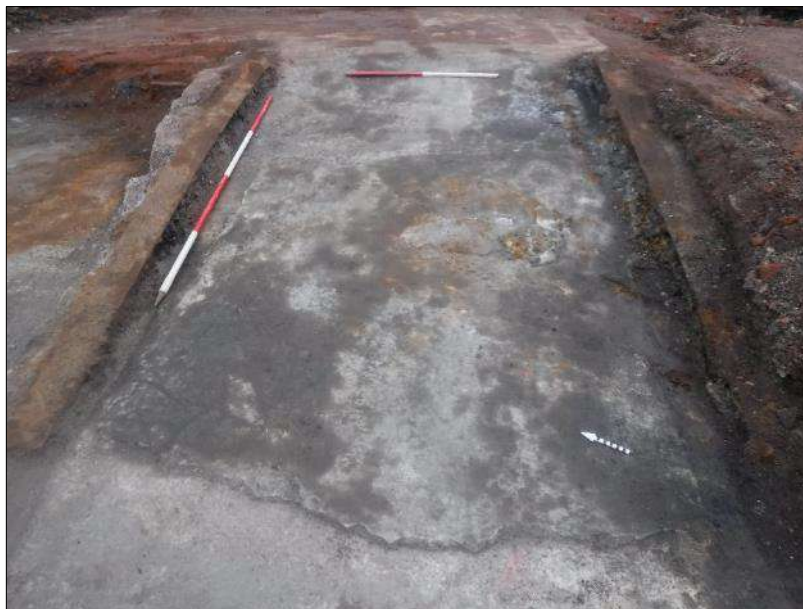
Plate 18: Entrance ramp 153, looking northeast, 2m and 1m scales

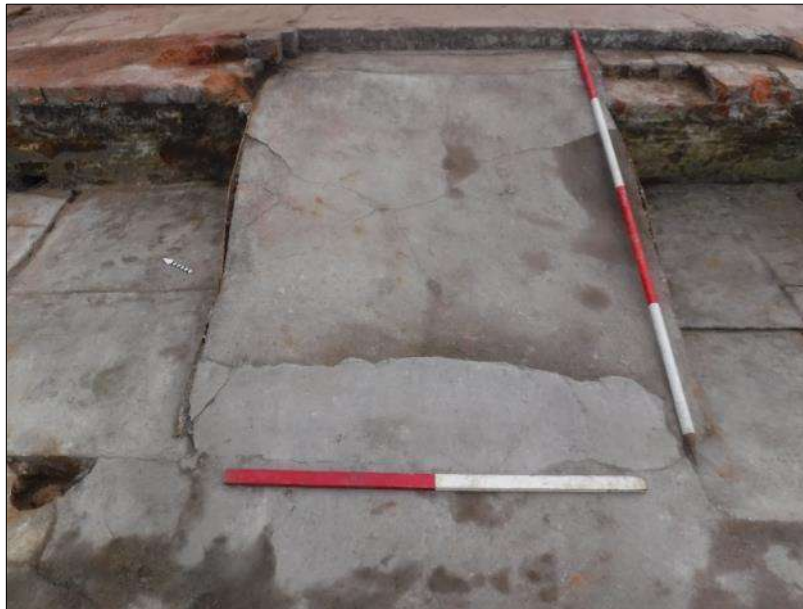
- 7.28 Ramp 153 was interpreted as a 20th century alteration to the spinning block. It replaced an earlier ramp 192, which was probably also inserted in the 20th century to facilitate vehicular access. Ramp 192 measured 1.88m northeast – southwest and was 1.35m in width.

Plate 19: Entrance ramp 192, looking northeast, 2m and 1m scales

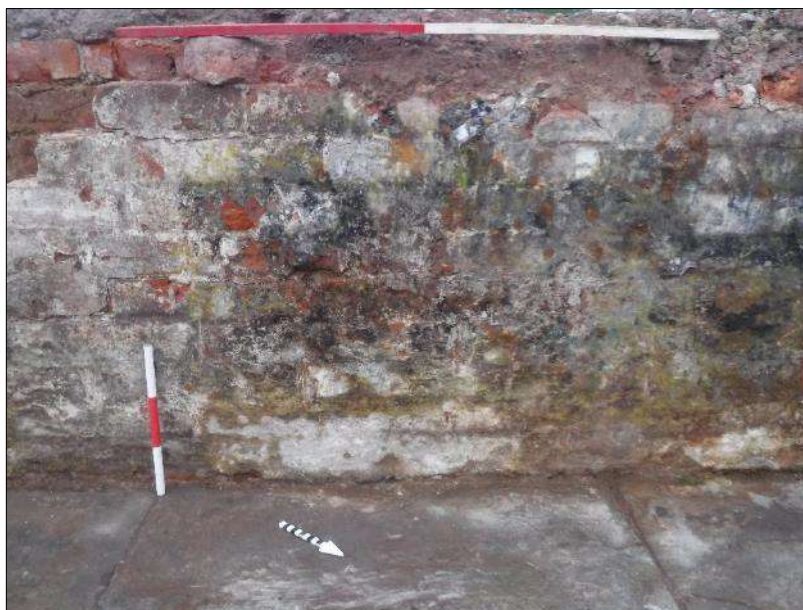
- 7.29 The southwestern extent of the main spinning block was defined by wall 156, which was very similar in form to the northeastern wall, and probably of contemporary construction date. The wall had a maximum width of 0.57m and survived to a maximum height of >0.85m (Plate 4)

Plate 20: Elevation of Wall 156, looking southwest, 1m and 0.30m scales

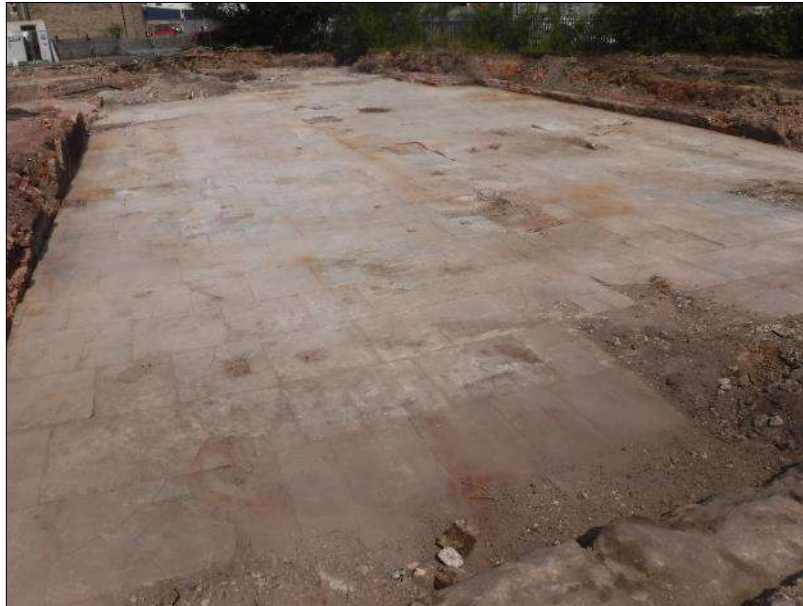
- 7.30 To the northwest of ramp 132 on the southwestern side of the main spinning block, the mill building was defined by wall 138, a continuation of brick wall 156. An 8.12m length of this wall was recorded, to a point where it was truncated by the foundation cut for the modern PD Northern Steels building to the northwest. As with the other walls of the main spinning block, the construction of the wall was of hand pressed red brick bonded with light whitish grey lime mortar.
- 7.31 The original floor surface 158 within the main spinning block comprised large rectangular flags of green laminated Lancashire sandstone (Plates 21-23). The average size of the flags was c.0.90m² although there was some variation in the size of the flags, which were not uniform.

Plate 21: General shot of flagged floor surface 158, 2m and 1m scales

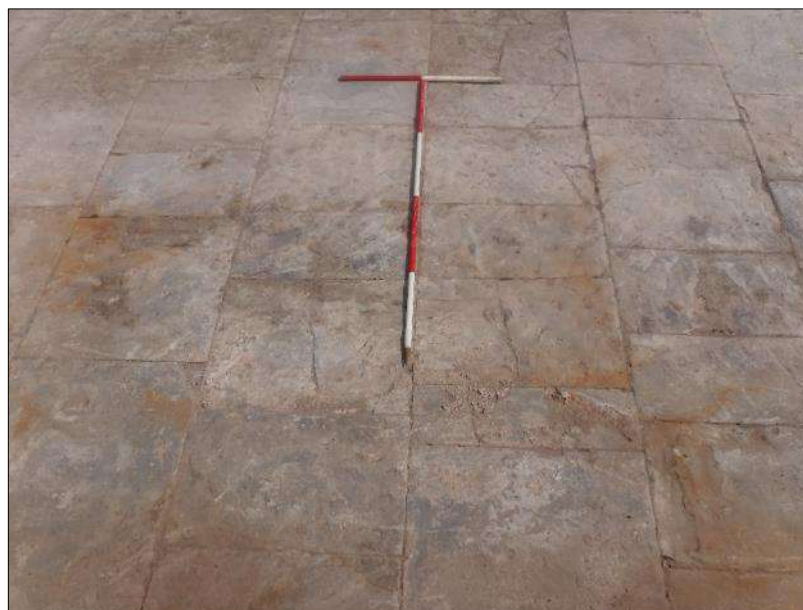
Plate 22: Detail shot of flagged floor surface 158, 2m and 1m scales

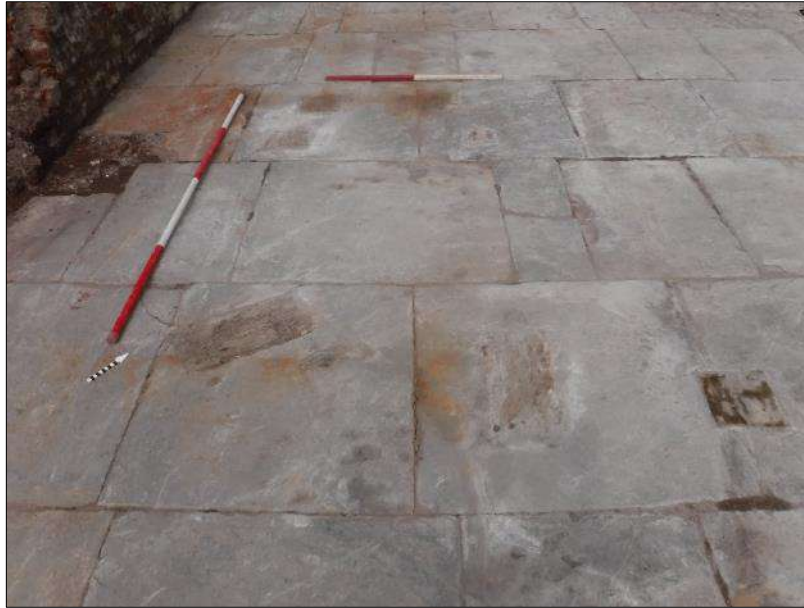
Plate 23: Detail shot of flagged floor surface 158 showing timber inserts, 2m and 1m scales

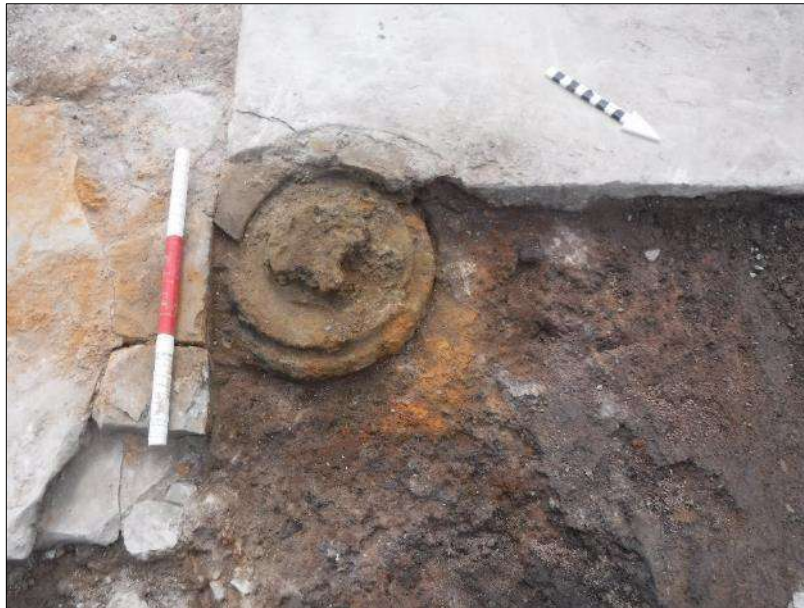
- 7.33 The form of the column bases was the same in all recorded cases, comprising a circular cast iron base plate 0.20m in diameter, with a raised cruciform flange on the upper surface acting as a tenon for the column proper, the purpose of which is described thus: *'a raised cross is formed on the top of the plate fitting into the socket of the column, and turned on the ends of its arms to size, so that the column is kept quite steady, being practically fixed'* (Nasmith, 1895) (Plate 24). The cast iron base plates were set into cement (174) with a shallow concave depression on the upper surface in which the base was set. The concrete deposits overlay large rectangular sandstone foundation stones (eg. 349) measuring c. 1.02m x 0.95m to bear the weight of the mill superstructure. There was no evidence of tie-beams or joists between the stone piers.

Plate 24: Column base plate 175, 0.30m scale

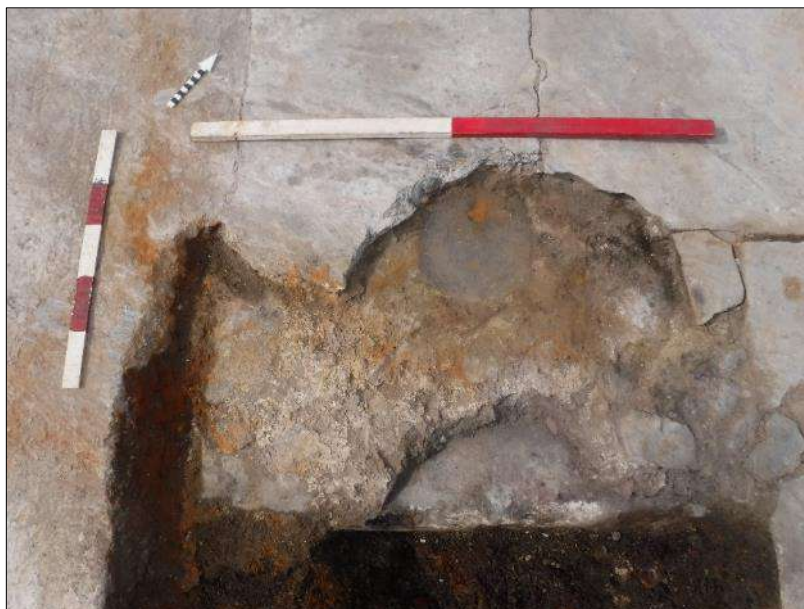
Plate 25: Concrete base 174 and stone pier 349, 1m and 0.50m scales

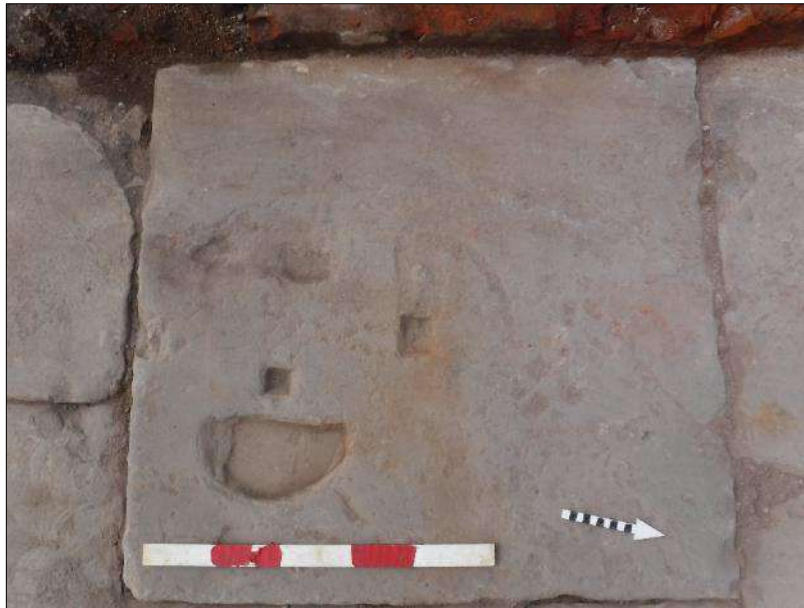
- 7.34 Throughout its extent, flagged floor surface 158 was pierced by frequent cut and drilled holes associated with fixing machinery to the floor. In some cases the fixing holes were open and in other cases still either retained parts of iron fixing bolts/rods or were plugged with timber inserts, presumably indicating that they were no longer in use. Also present were depressions cut into the surface of the flags, either rectangular or semi-circular in plan that did not pierce the flag (Plate26).

Plate 26: Example of features associated with machine bases, cut into flagged floor 158, 0.50m scale

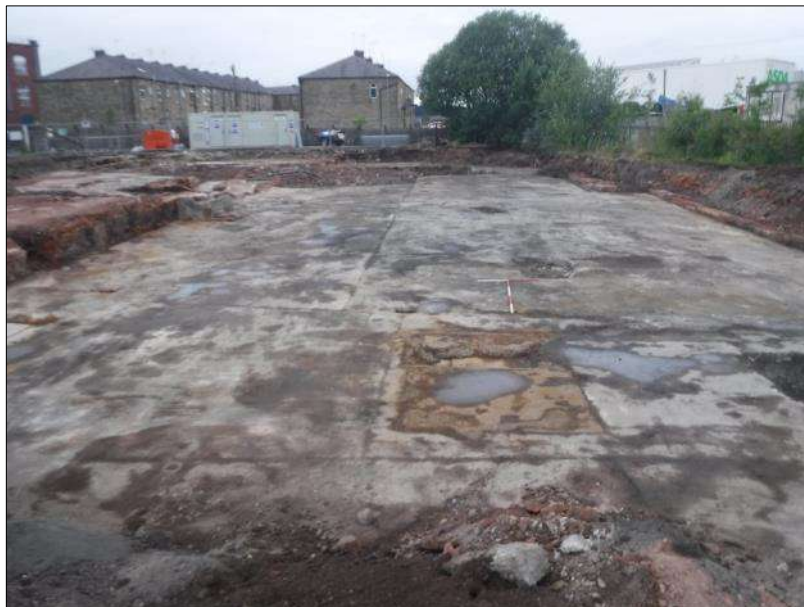
7.35 The flagged floor was overlain by concrete floor surface 118 reinforced with steel rebar at the base (Plate 27). As the concrete floor surface sealed the features cut into the flagged floor below that were associated with the ground floor machinery of the mill, it is reasonable to assume that the insertion of the concrete floor surface coincided with a change to the layout and function of the ground floor of the main spinning block. The floor, which comprised very hard light whitish grey concrete with an average thickness of 0.23m may be associated with the introduction of mechanical handling plant such as forklift trucks to the mill in the 20th century.

Plate 27: General shot of concrete floor surface 118, 2m and 1m scales

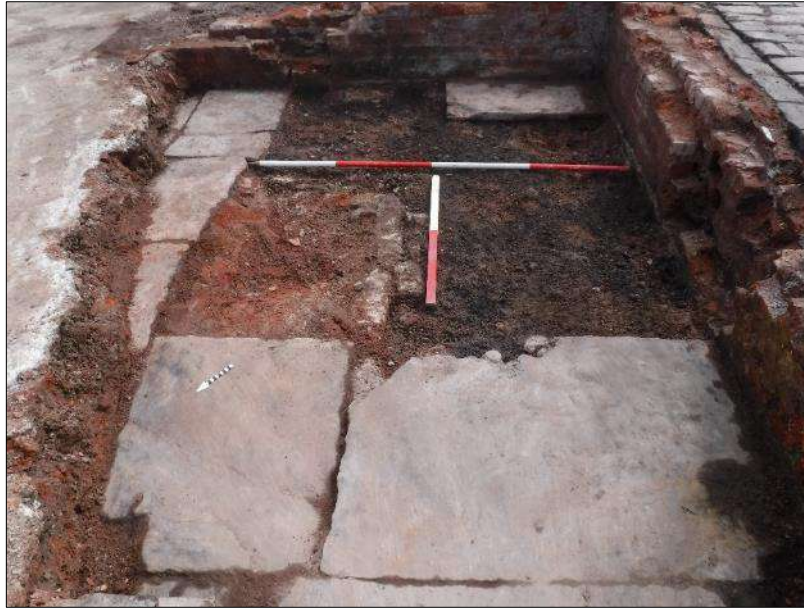
- 7.39 Attached to the southwestern side of the main spinning block, a structure measuring c.3.5m x 3m internally was recorded (Plate 31). The structure represents the stair tower that is clearly visible in aerial photographs of the mill.
- 7.40 The external wall 126 of the structure was built from hand pressed red brick laid in running bond and bonded with light grey lime mortar. The wall was 0.35m in width and survived to a maximum height of 0.52m (7 courses). Wall 126 defined the southeastern and southwestern sides of the structure, the northeastern side being defined by the southwestern wall 138 of the main spinning block, and the northwestern side by wall 128.

Plate 31: General shot of interior of stair tower showing wall 126 and flagging 125, 2m and 1m scales

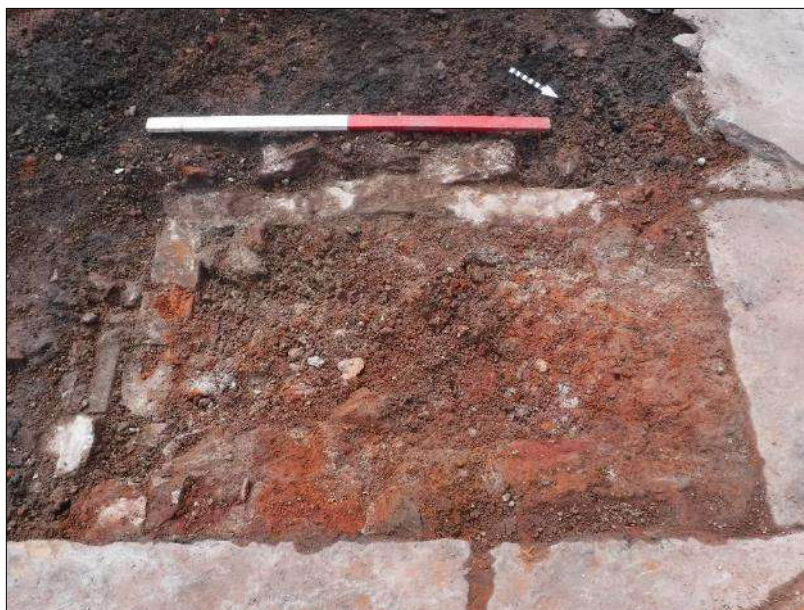
7.41 The interior of the stair tower was paved with substantial flagging 125 very similar to that used in the main spinning block, and probably laid as part of the same constructional phase. The flagging survived partially, and it is possible that it was partly removed during later alterations to the structure. The flagging abutted the exterior wall 126 and also the outer brickwork 129 of a 1.36m x 0.96m rectangular feature situated centrally within the stair tower (Plate 32). The feature comprised a half brick thick outer wall 129, infilled with a mixture of crushed brick and mortar 130. The structure is likely to represent the foundation for the newel within the stair tower. There was no evidence of the form of the newel above foundation level, or of the staircase itself. In particular there was no evidence for stone steps within the interior of the stair tower, perhaps suggesting that the staircase may have been of cast iron construction.

Plate 32: Foundation 129, 130 of newel within stair tower, 1m scale

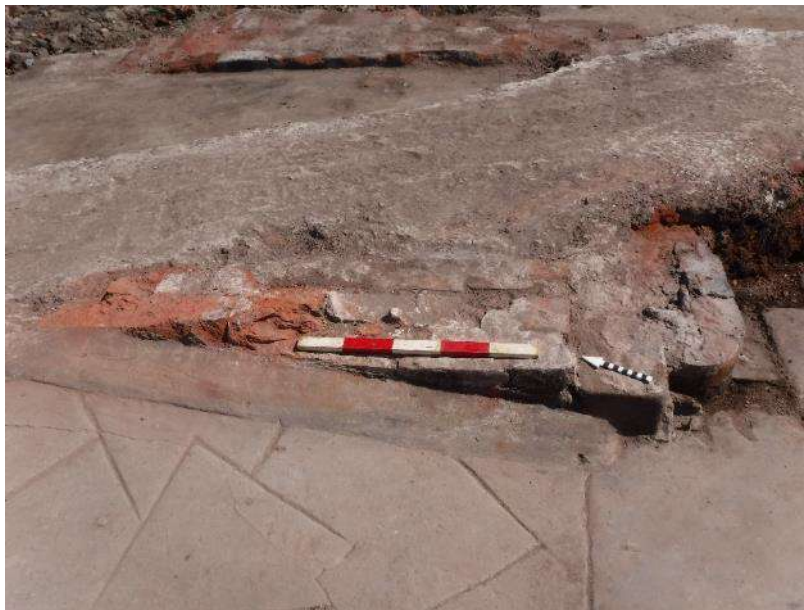
7.42 Access to the stair tower was from the northwest side. At its northwestern end the southwestern wall 126 of the stair tower makes a slight return to the northeast before terminating in a jamb for the entrance with a curve formed on the interior side by bullnose bricks (Plate 34). Another similar jamb forms the terminal of the part of wall 128 forming the northwestern side of the stair tower, which is bonded into the wall of the main spinning block at its northeast end (Plate 33). The entrance thus formed is 0.95m in width. Abutting the northwestern faces of both brick jamps were sandstone inserts also forming part of the door jamps. The sandstone elements extended beyond the brick walls by c.0.10m, and in the angle between the stone and brick elements on the northeastern side of the entrance there was an iron fixing set into mortar which is likely to represent the base of a hanging post for a door. No fixing was recorded on the opposite side of the entrance, suggesting the door was single leaf.

Plate 33: Detail of door jamb, northeastern side of entrance to stair tower, 0.5m scale

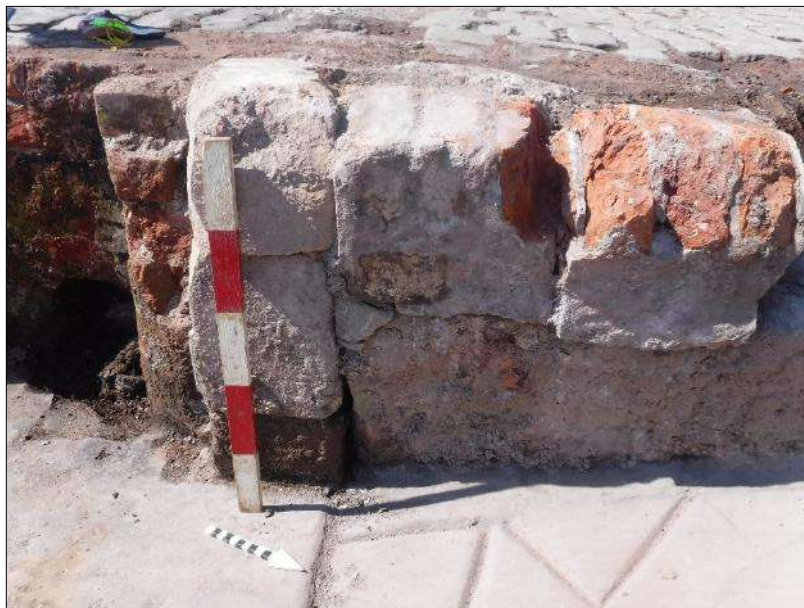
Plate 34: Detail of door jamb, southwestern side of entrance to stair tower, 0.5m scale

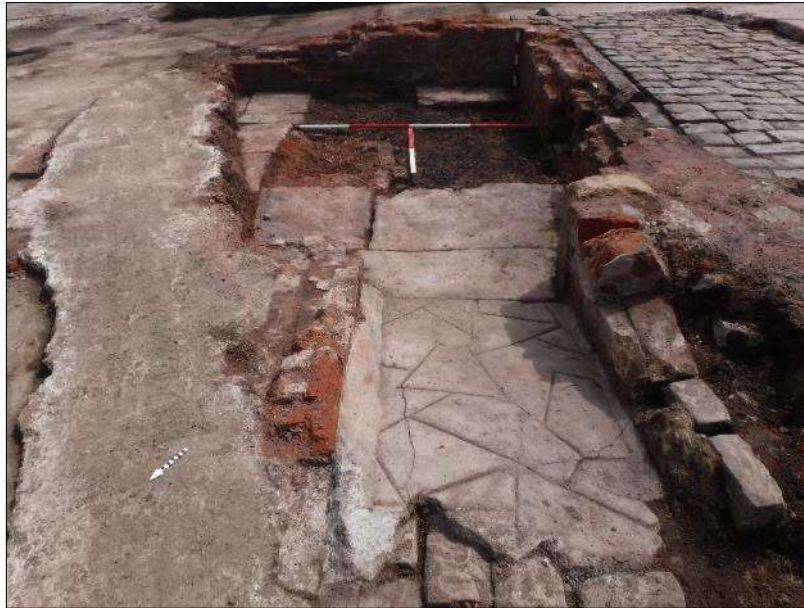
Plate 35 Entrance to stair tower showing ramp 123 and concrete capped service trench 127, 2m and 1m scales

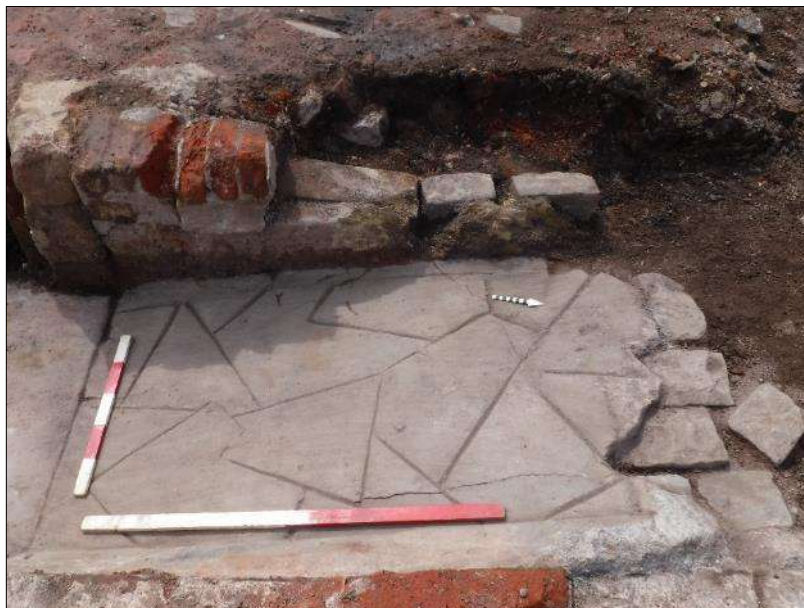
Plate 36 Entrance to stair tower showing ramp 123, 1m and 0.5m scales

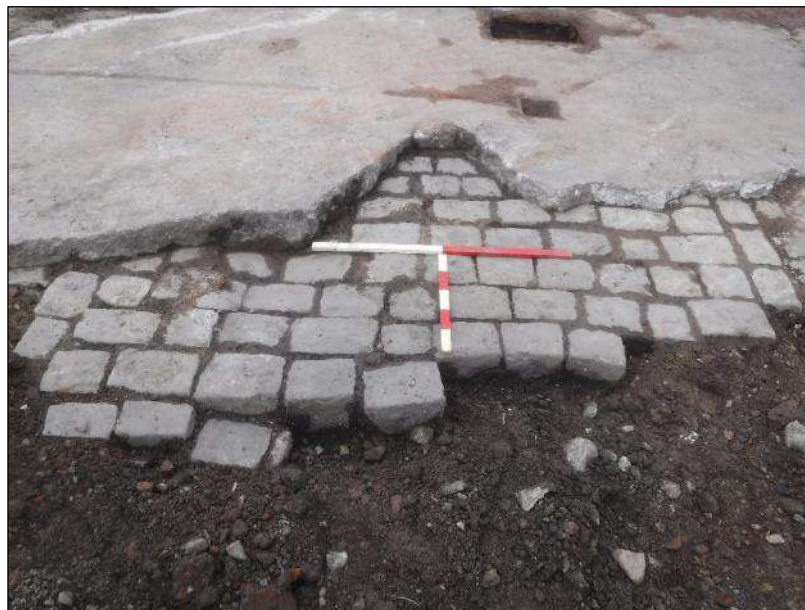
7.46 Directly above the natural clay 110 was a deposit 139 of dark grey ash, sand and clinker that served as a bedding layer for a cobbled road surface 106=120, comprising roughly squared, tightly packed basalt setts measuring c. 250mm x 150mm x 170mm, but with considerable variation (Plates 37, 38). The largest area of setts recorded measured 6.65m NW-SE by 2.13m NE-SW. This part of the road surface was truncated to the NW by the foundation cut for the modern building associated with P & D Northern Steels Ltd. The northeastern and southwestern extents of the road surface were defined by the walls 138, 210, 234 of the two main ranges of mill buildings, and the southeastern extent by the concrete ramp 132 leading into the main spinning block.

Plate 37: Road surface 106, looking northwest, 1m and 0.50m scales

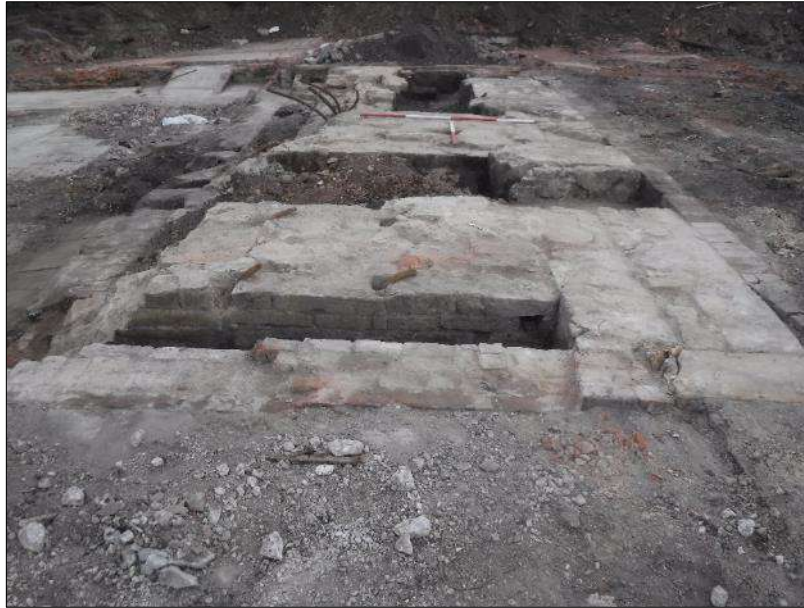
Plate 39: Pre-excavation shot of engine house, 2m and 1m scales

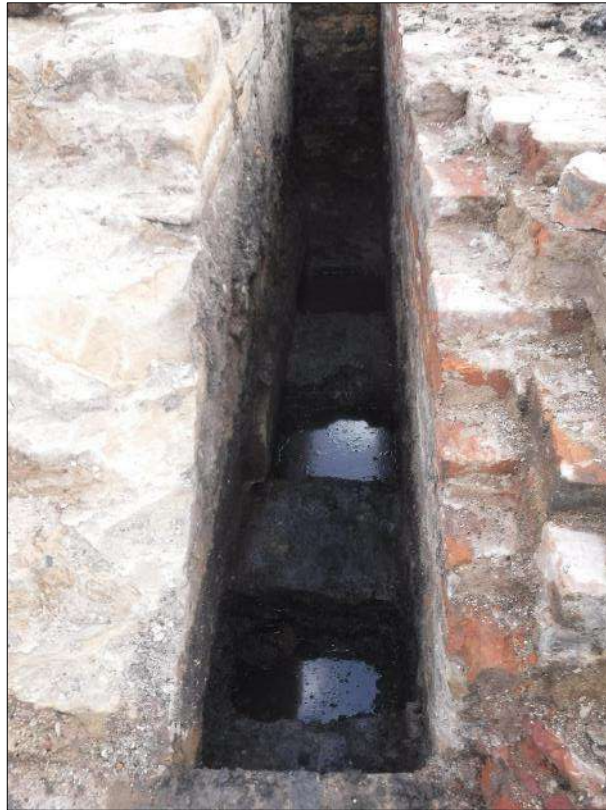
Plate 40: Post excavation shot of pit with masonry 178 to the left and wall 176 to the right, looking southeast

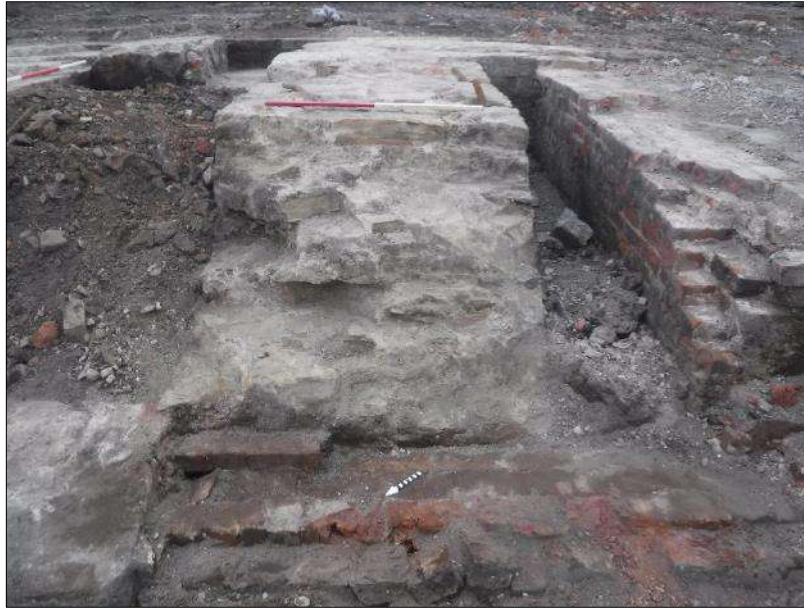
Plate 41: Masonry 178 within engine house showing fixing bolts in upper surface and wall 176 to the right, 1m scale

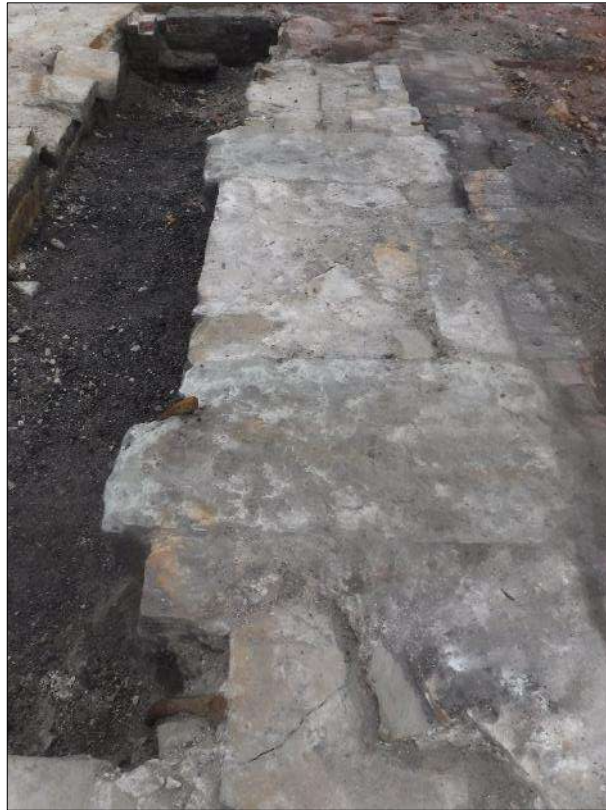
Plate 42: Masonry 181 within engine house showing sandstone slabs 184 and 185, looking northwest

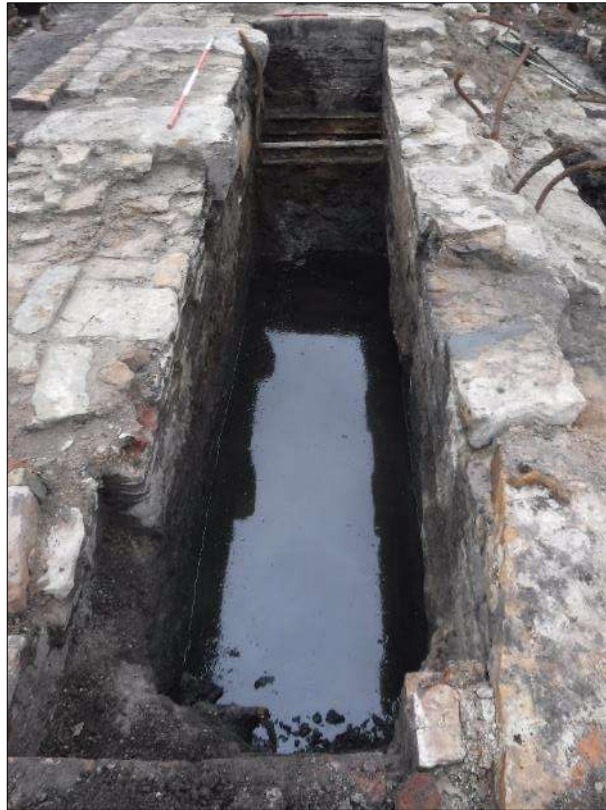
Plate 43: Pit between masonry 181 to the left and 183, 184 and 186 to the right, showing wrought iron joists and anchor bolts at southwestern end, looking southwest, 2m and 1m scales

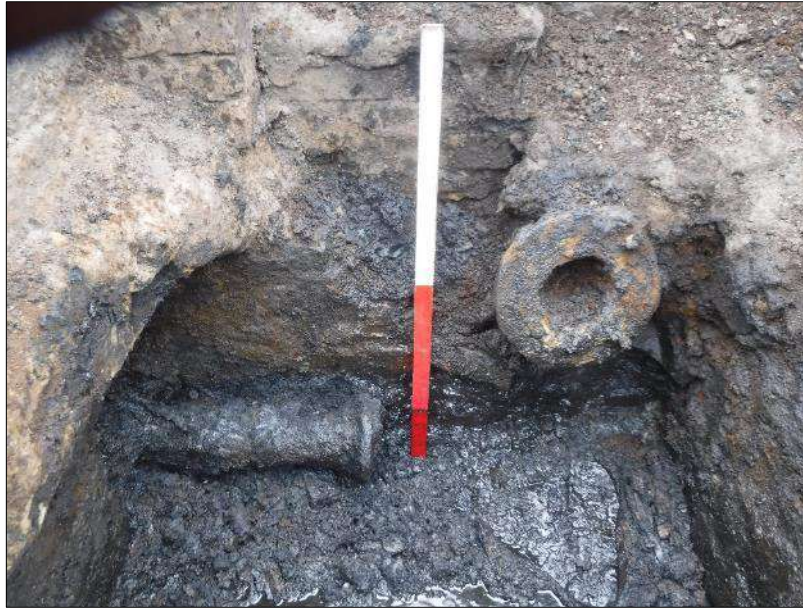
Plate 44: Detail of pipework at northeastern end of cold well, looking northeast, 1m scale

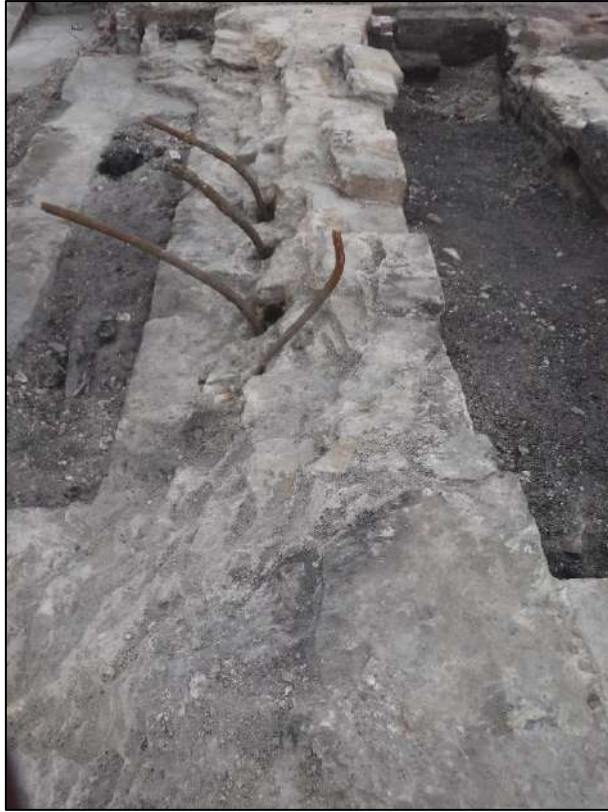
Plate 45: Masonry 183 within engine house showing fixing bolts in upper surface, no scale

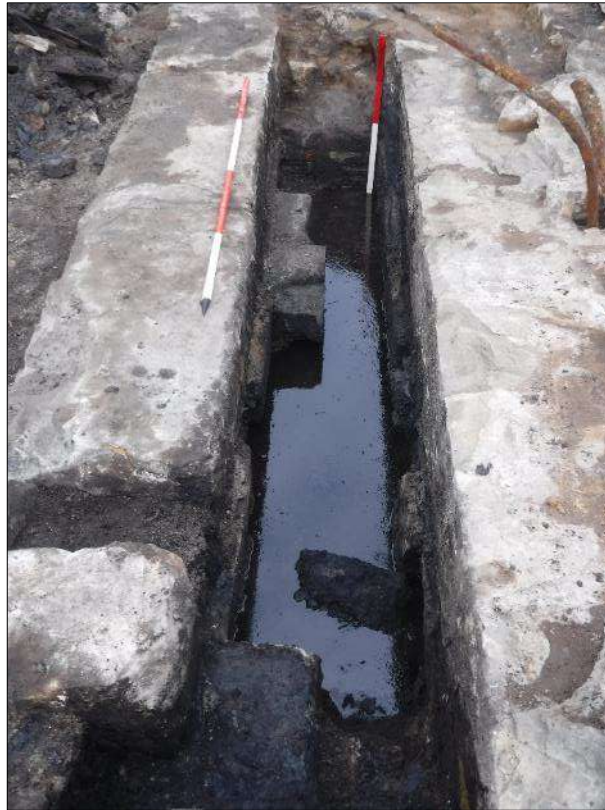
Plate 46: Post excavation shot of flywheel pit, 2m and 1m scales
