ARCHAEOLOGICAL EXCAVATION REPORT:
LAND AT MOSS HEY STREET, SHAW, OLDHAM, GREATER MANCHESTER

NGR: SD 94153 08576
AAL Site Code: SHMH 20
Planning Reference: PA/344572/20
OASIS Reference Number: allenarc1-433595

Report prepared for Mulbury Homes

By
Allen Archaeology Limited
Report Number AAL2021140

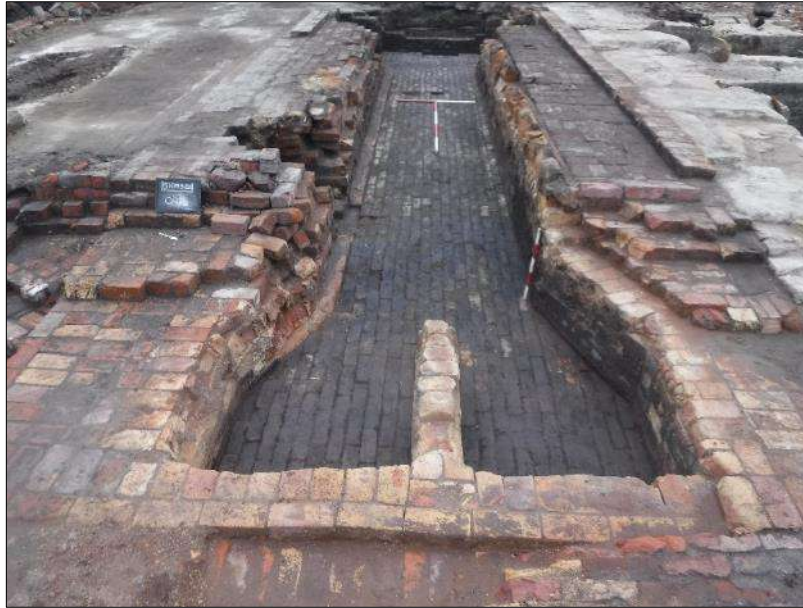
- 7.65 The bricks used in the construction of the Lancashire boiler house to the northwest comprised a mixture of common bricks and firebricks with firebrick predominating, averaging 230mm x 110mm x 75mm in size. The brickwork was all mortar bonded generally with hard dark grey sandy mortar, although some variation was observed. None of the variation in mortar type could be definitely linked to different constructional phases of the structure.

Plate 47: General view of Lancashire boiler base, looking southwest, 2m and 1m scales

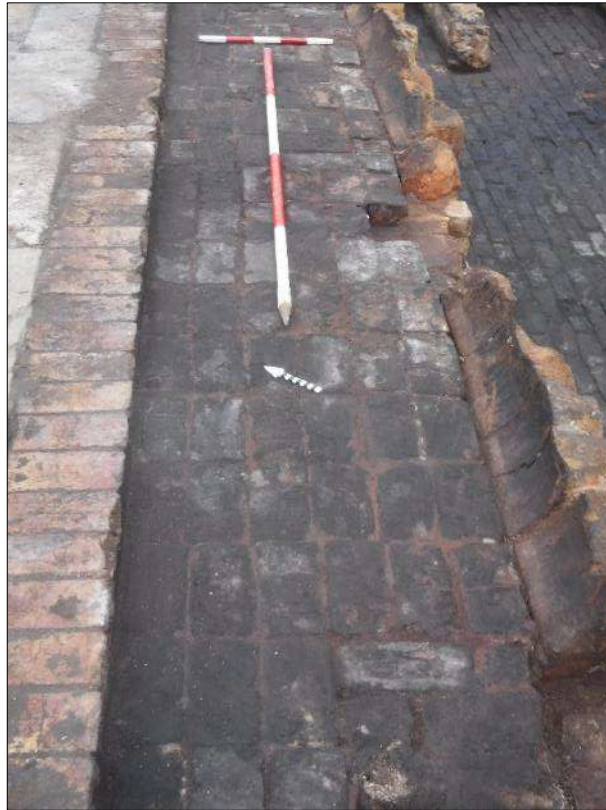
7.67 The floor 290 of the boiler base comprised edge set firebrick which was unbonded, although any original mortar bonding may have become degraded. To the northwest and southeast the floor abutted brick built benches 298 to the northwest and 300 to the southeast, built from common brick but with a facing course of firebrick, much of which had collapsed on bench 300. The benches measured 8.39m in length by c. 0.90m in width, and were 1.40m in height. The uppermost course on the internal face of the northwestern bench 298 comprised a single course 299 of refractory boiler mounting blocks, most of which were incomplete. On the southeastern side of the boiler base the boiler mounting blocks were absent due to the collapse of the inner face of the bench, although many fragmentary and some complete blocks were recovered from the fill 355 between the benches. The mounting blocks measured 430mm x 300mm x 220mm and were stamped ACME and SHORT and also with batch numbers. The stamp suggests that the boiler supports were products of the Acme brick company, founded as the Acme Pressed Brick Company in Texas, USA in 1891. If this is the case it would suggest that the boiler mounting blocks represent a late, probably 20th century, alteration to the boiler house, although it would be standard practise to replace elements of the structure subject to deterioration at regular intervals.

Plate 48: Bench 298 showing boiler mounting blocks 299 to the right, looking northeast, 2m and 0.5m scales

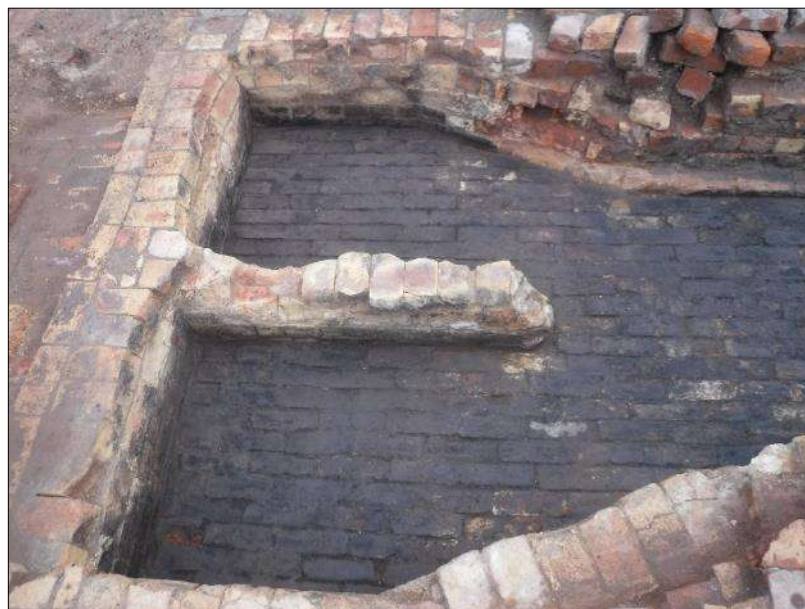
Plate 49: Detail of twin flues at northeastern end of boiler base, showing spine wall 228, looking southeast

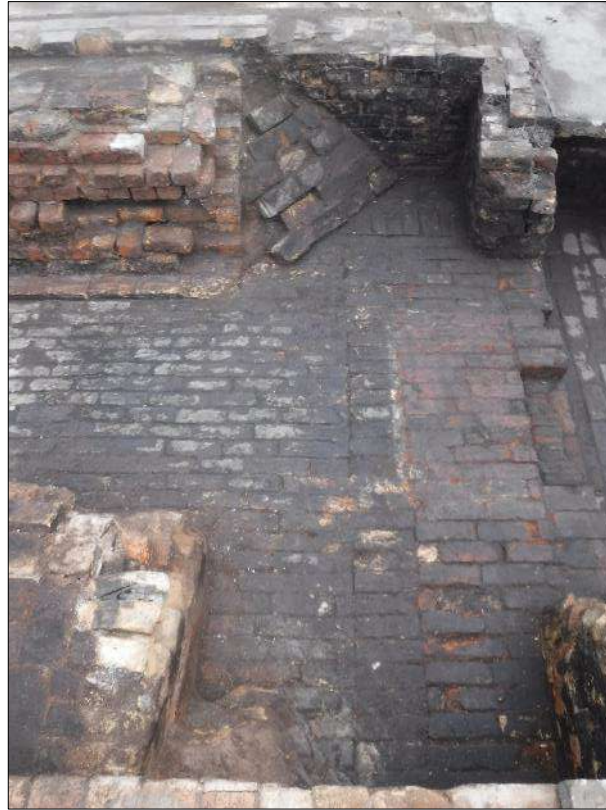
Plate 50: Detail of inclined brick masonry 288 at southwestern end of boiler base, no scales

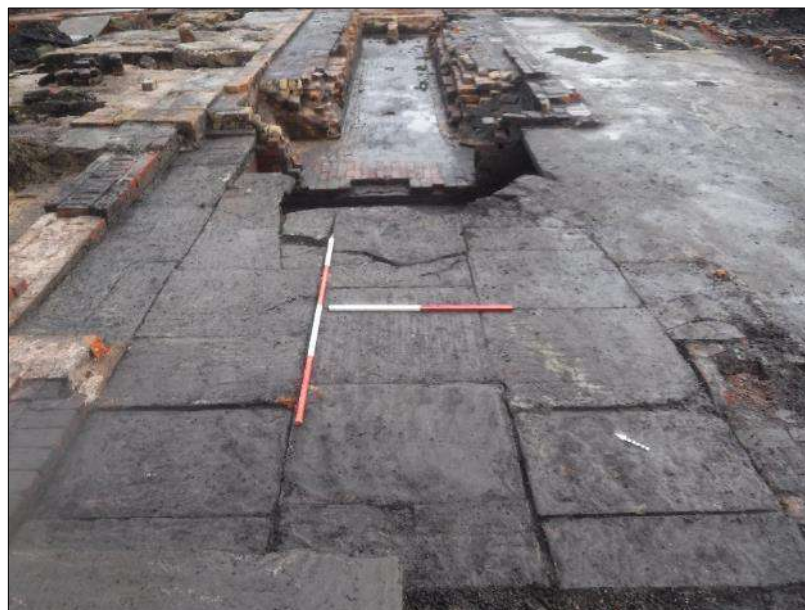
Plate 51: Flagged floor 301 of charging platform at southwestern end of boiler base, looking northeast, 2m and 1m scales

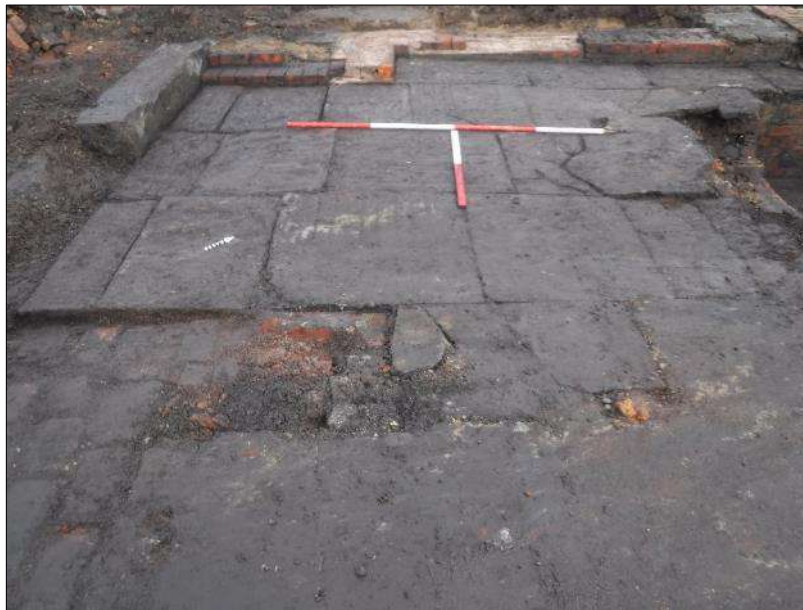
Plate 52: Flagged floor 301 of charging platform at southwestern end of boiler base showing kerb 308 and walls 306, 305 and 304 from left to right, and concrete surface 268 in foreground, looking northwest, 2m and 1m scales

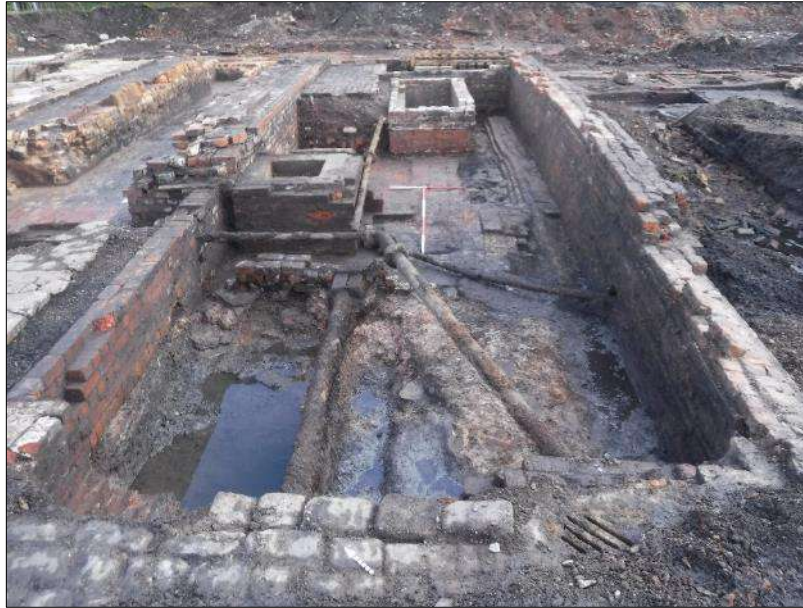
Plate 53: General post-excavation shot of southeastern bay of boiler house, looking northeast, 2m and 1m scales

- 8.10 The southeastern bay of the boiler house is likely to originally have housed a second Lancashire boiler, as it was very unusual for spinning mills to operate with a single boiler, as failure would have halted production until repairs to the boiler had taken place. This interpretation is perhaps supported by historical evidence for the sale of a Lancashire boiler by the owners of the mill in 1882, as the boiler was offered for sale in working order, and it is therefore unlikely that the sale related to the replacement of a decommissioned boiler. It is possible that the Lancashire boiler offered for sale was one of a pair, and the sale may relate to the later alteration of the southeastern bay of the boiler house. Alterations in the southeastern bay to the southwest of the Green's economiser had removed most of the masonry associated with the original Lancashire boiler base, and pipework and masonry structures of uncertain function were installed. It was apparent that the economiser also went out of use at the time the alterations were carried out, as the outlet pipe from the bottom boxes was cut during the installation of the pipework. Interpretation of the change in function of the southeastern bay of the boiler house was not straightforward, as it presumably represented the substructure of plant that had since been removed. It is possible that the Lancashire boiler in the southeastern half of the boiler house was replaced with a boiler of a different type such as a Babcock or similar water tube boiler, which would have had little in terms of substructure and would also have not required the economiser to improve fuel economy. Alternatively, the alterations to the southeastern bay of the boiler house may not have taken place until the mill had been converted to electric power in the first half of the 20th century.

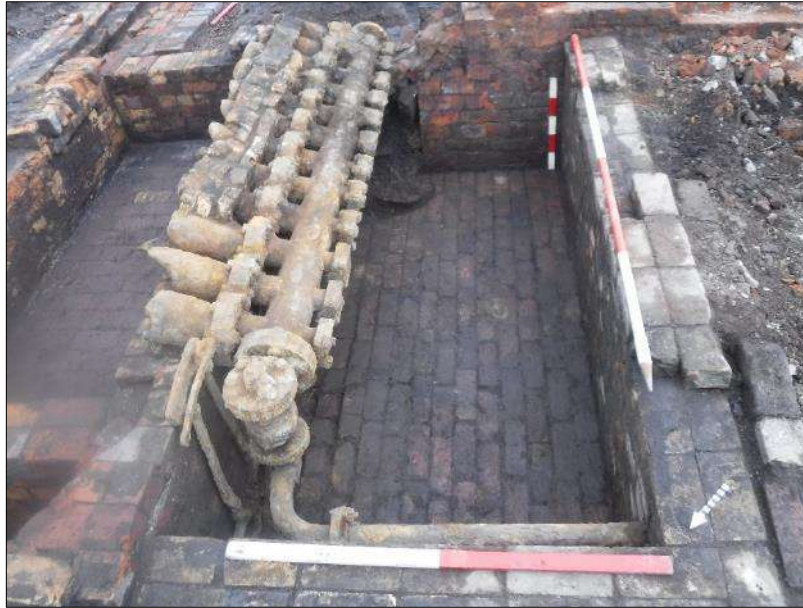
Plate 54: Bottom header pipe and cut off bottom boxes of fuel economiser 230, looking southeast, 2m, 1m and 0.5m scales

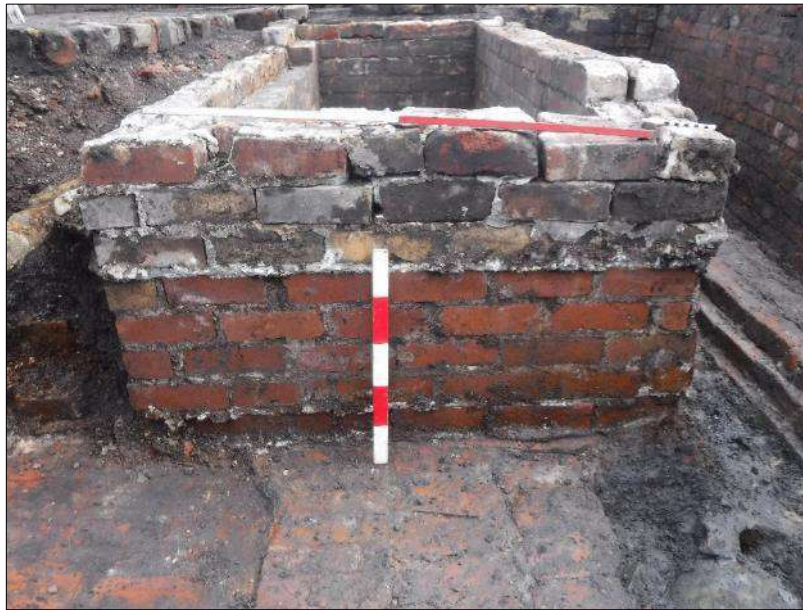
Plate 56: southwest facing elevation of structure 315, showing distinct construction phases, 1m and 0.5m scales

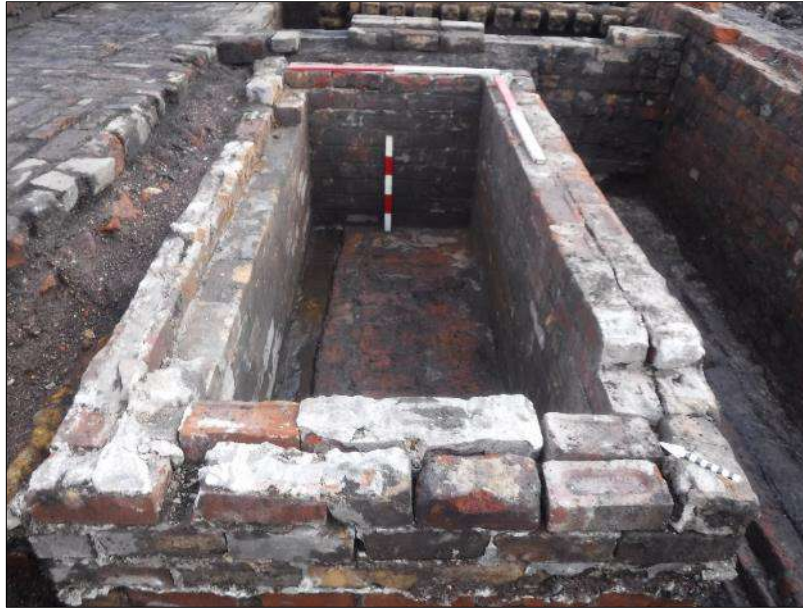
Plate 57: Post excavation shot of structure 315, 1m and 0.5m scales

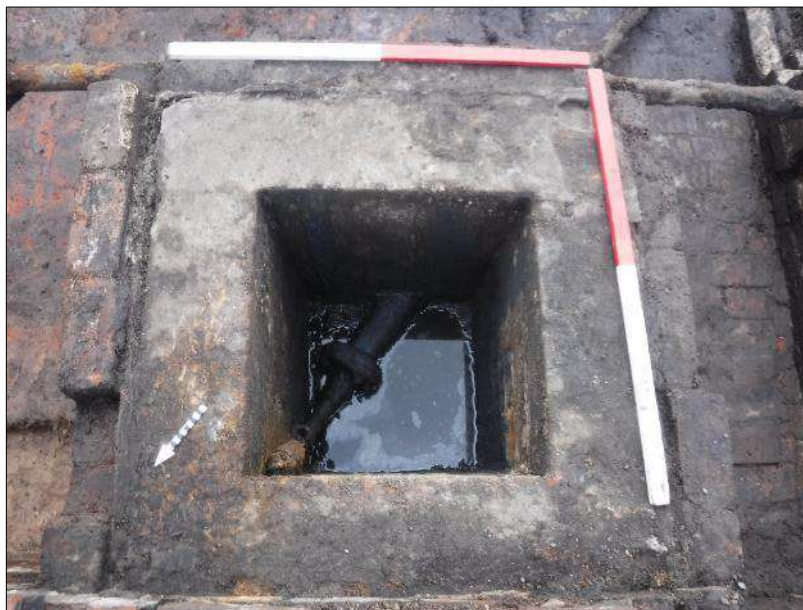
Plate 58: Post excavation shot of structure 319, showing pipe 335, 1m scales

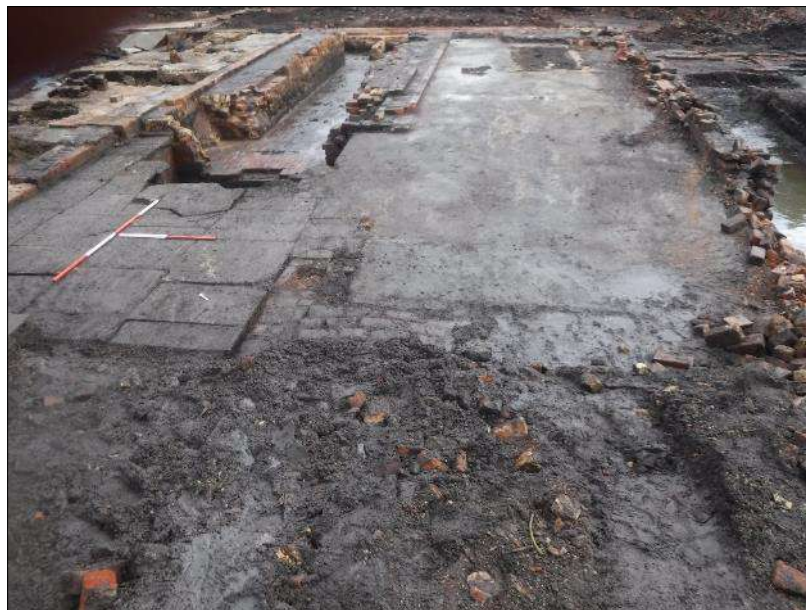
Plate 59: Boiler house showing concrete floor surface 328 within southeastern bay, 2m and 1m scales

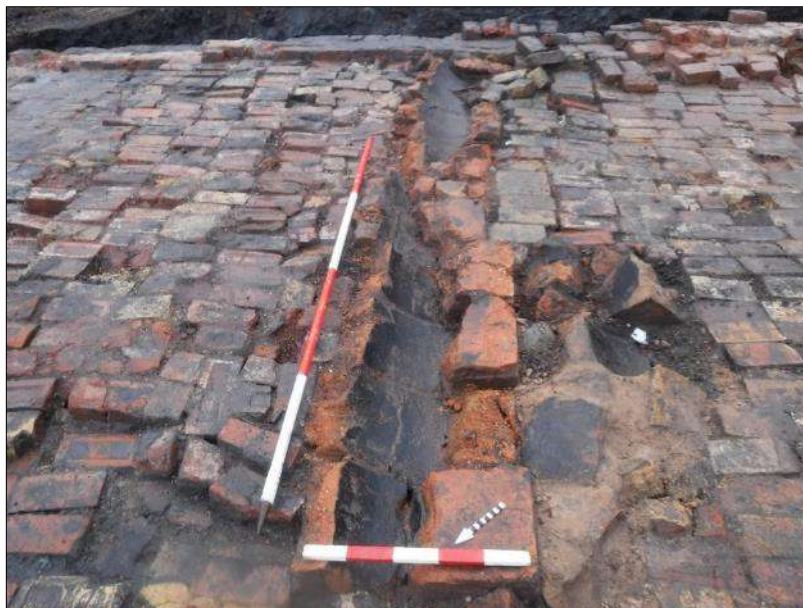
Plate 61: Detail shot of reused boiler mounting blocks 281 within unbonded brick surface 269, looking southeast, 2m and 0.5m scales

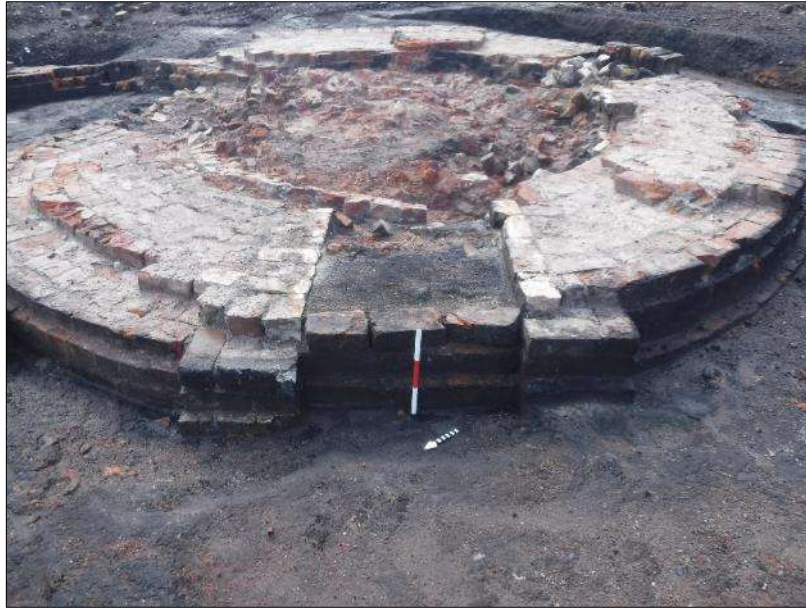
Plate 63: Detail shot of blocking of northwestern flue of chimney, 0.3m scale

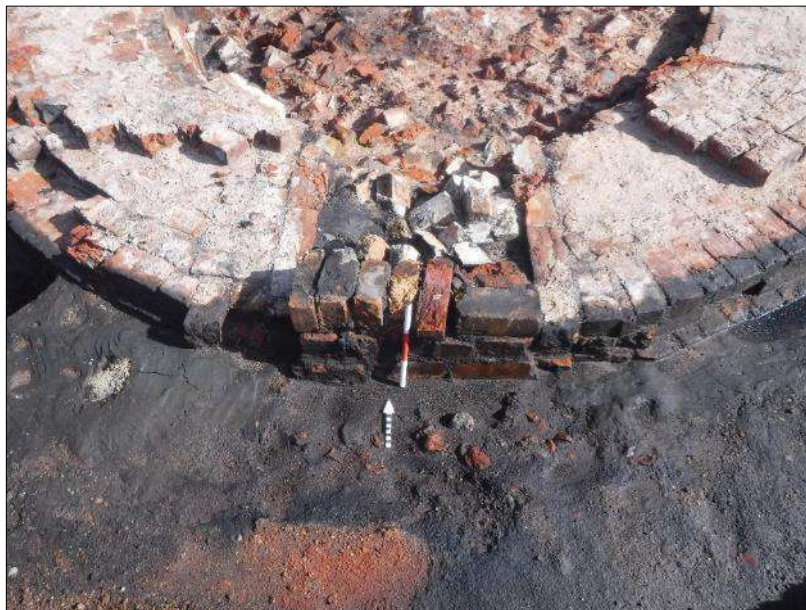
Plate 64: Detail shot of blocking of southwestern flue of chimney, 0.3m scale

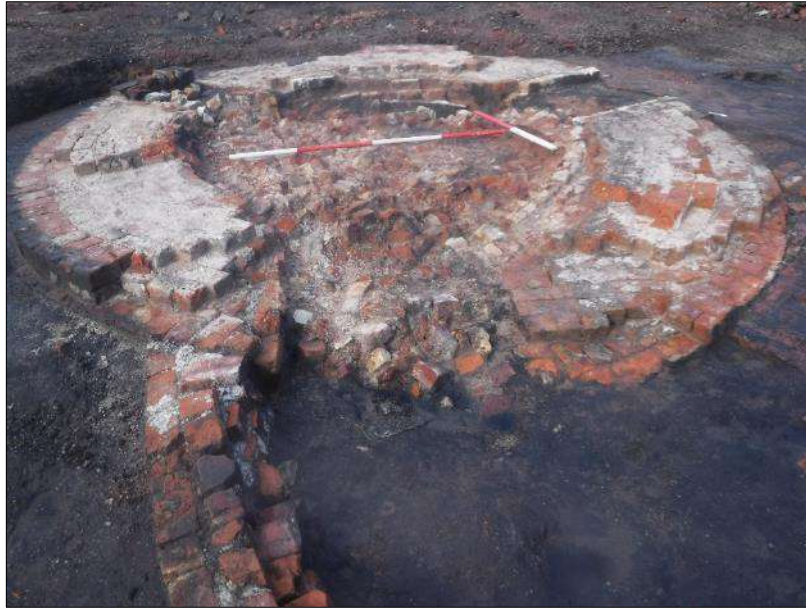
Plate 65: Chimney base 249 showing straight joint with northeastern flue wall 250, 2m and 1m scales

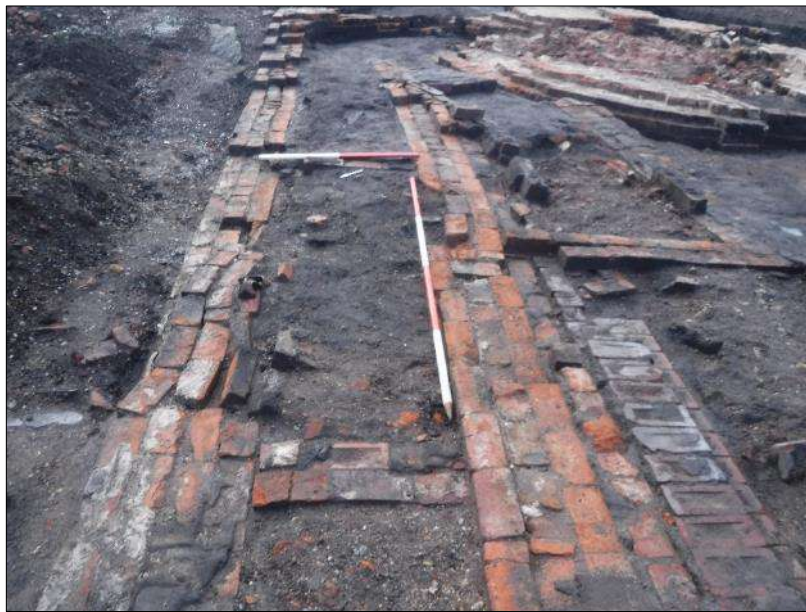
Plate 66: Overall view of flue system connected to chimney 249, 2m and 1m scales

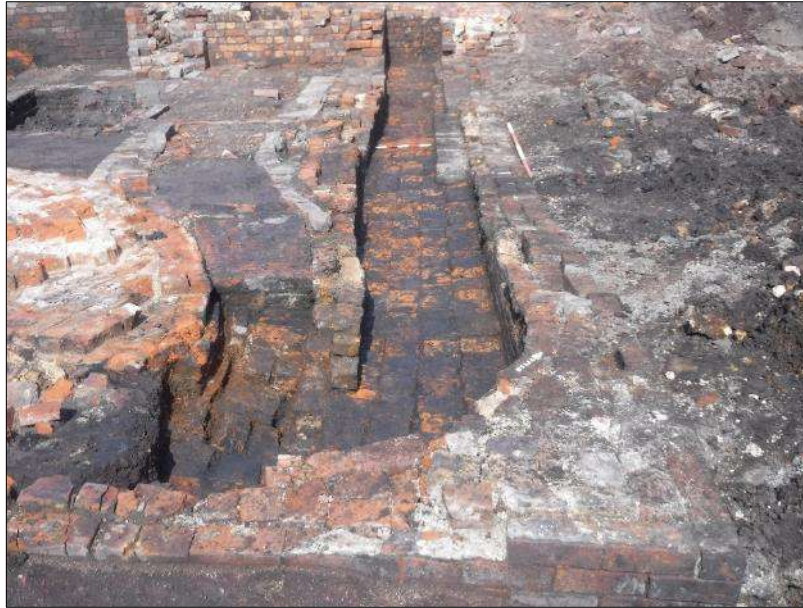
Plate 67: Post-excavation shot of flues connected to chimney 249, 2m and 1m scales

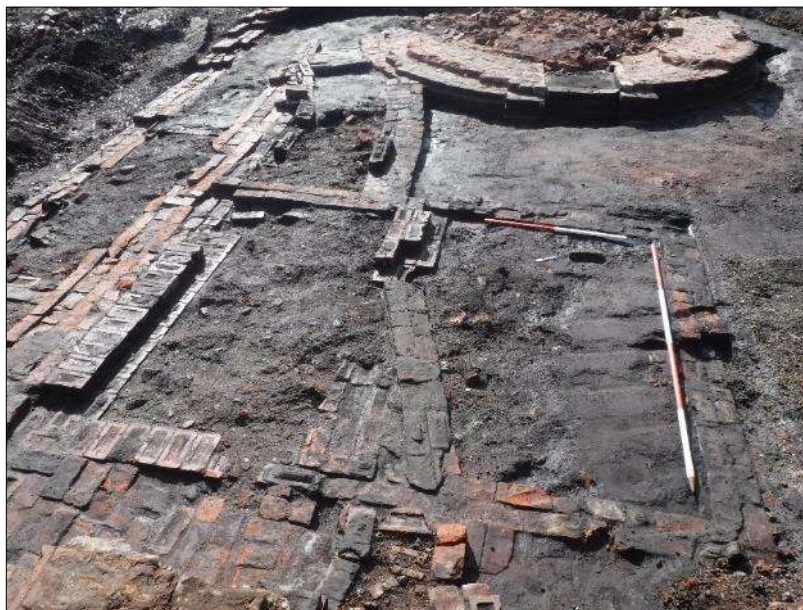
Plate 68: Pre-excavation shot of structure 255, looking southeast, 2m and 1m scales

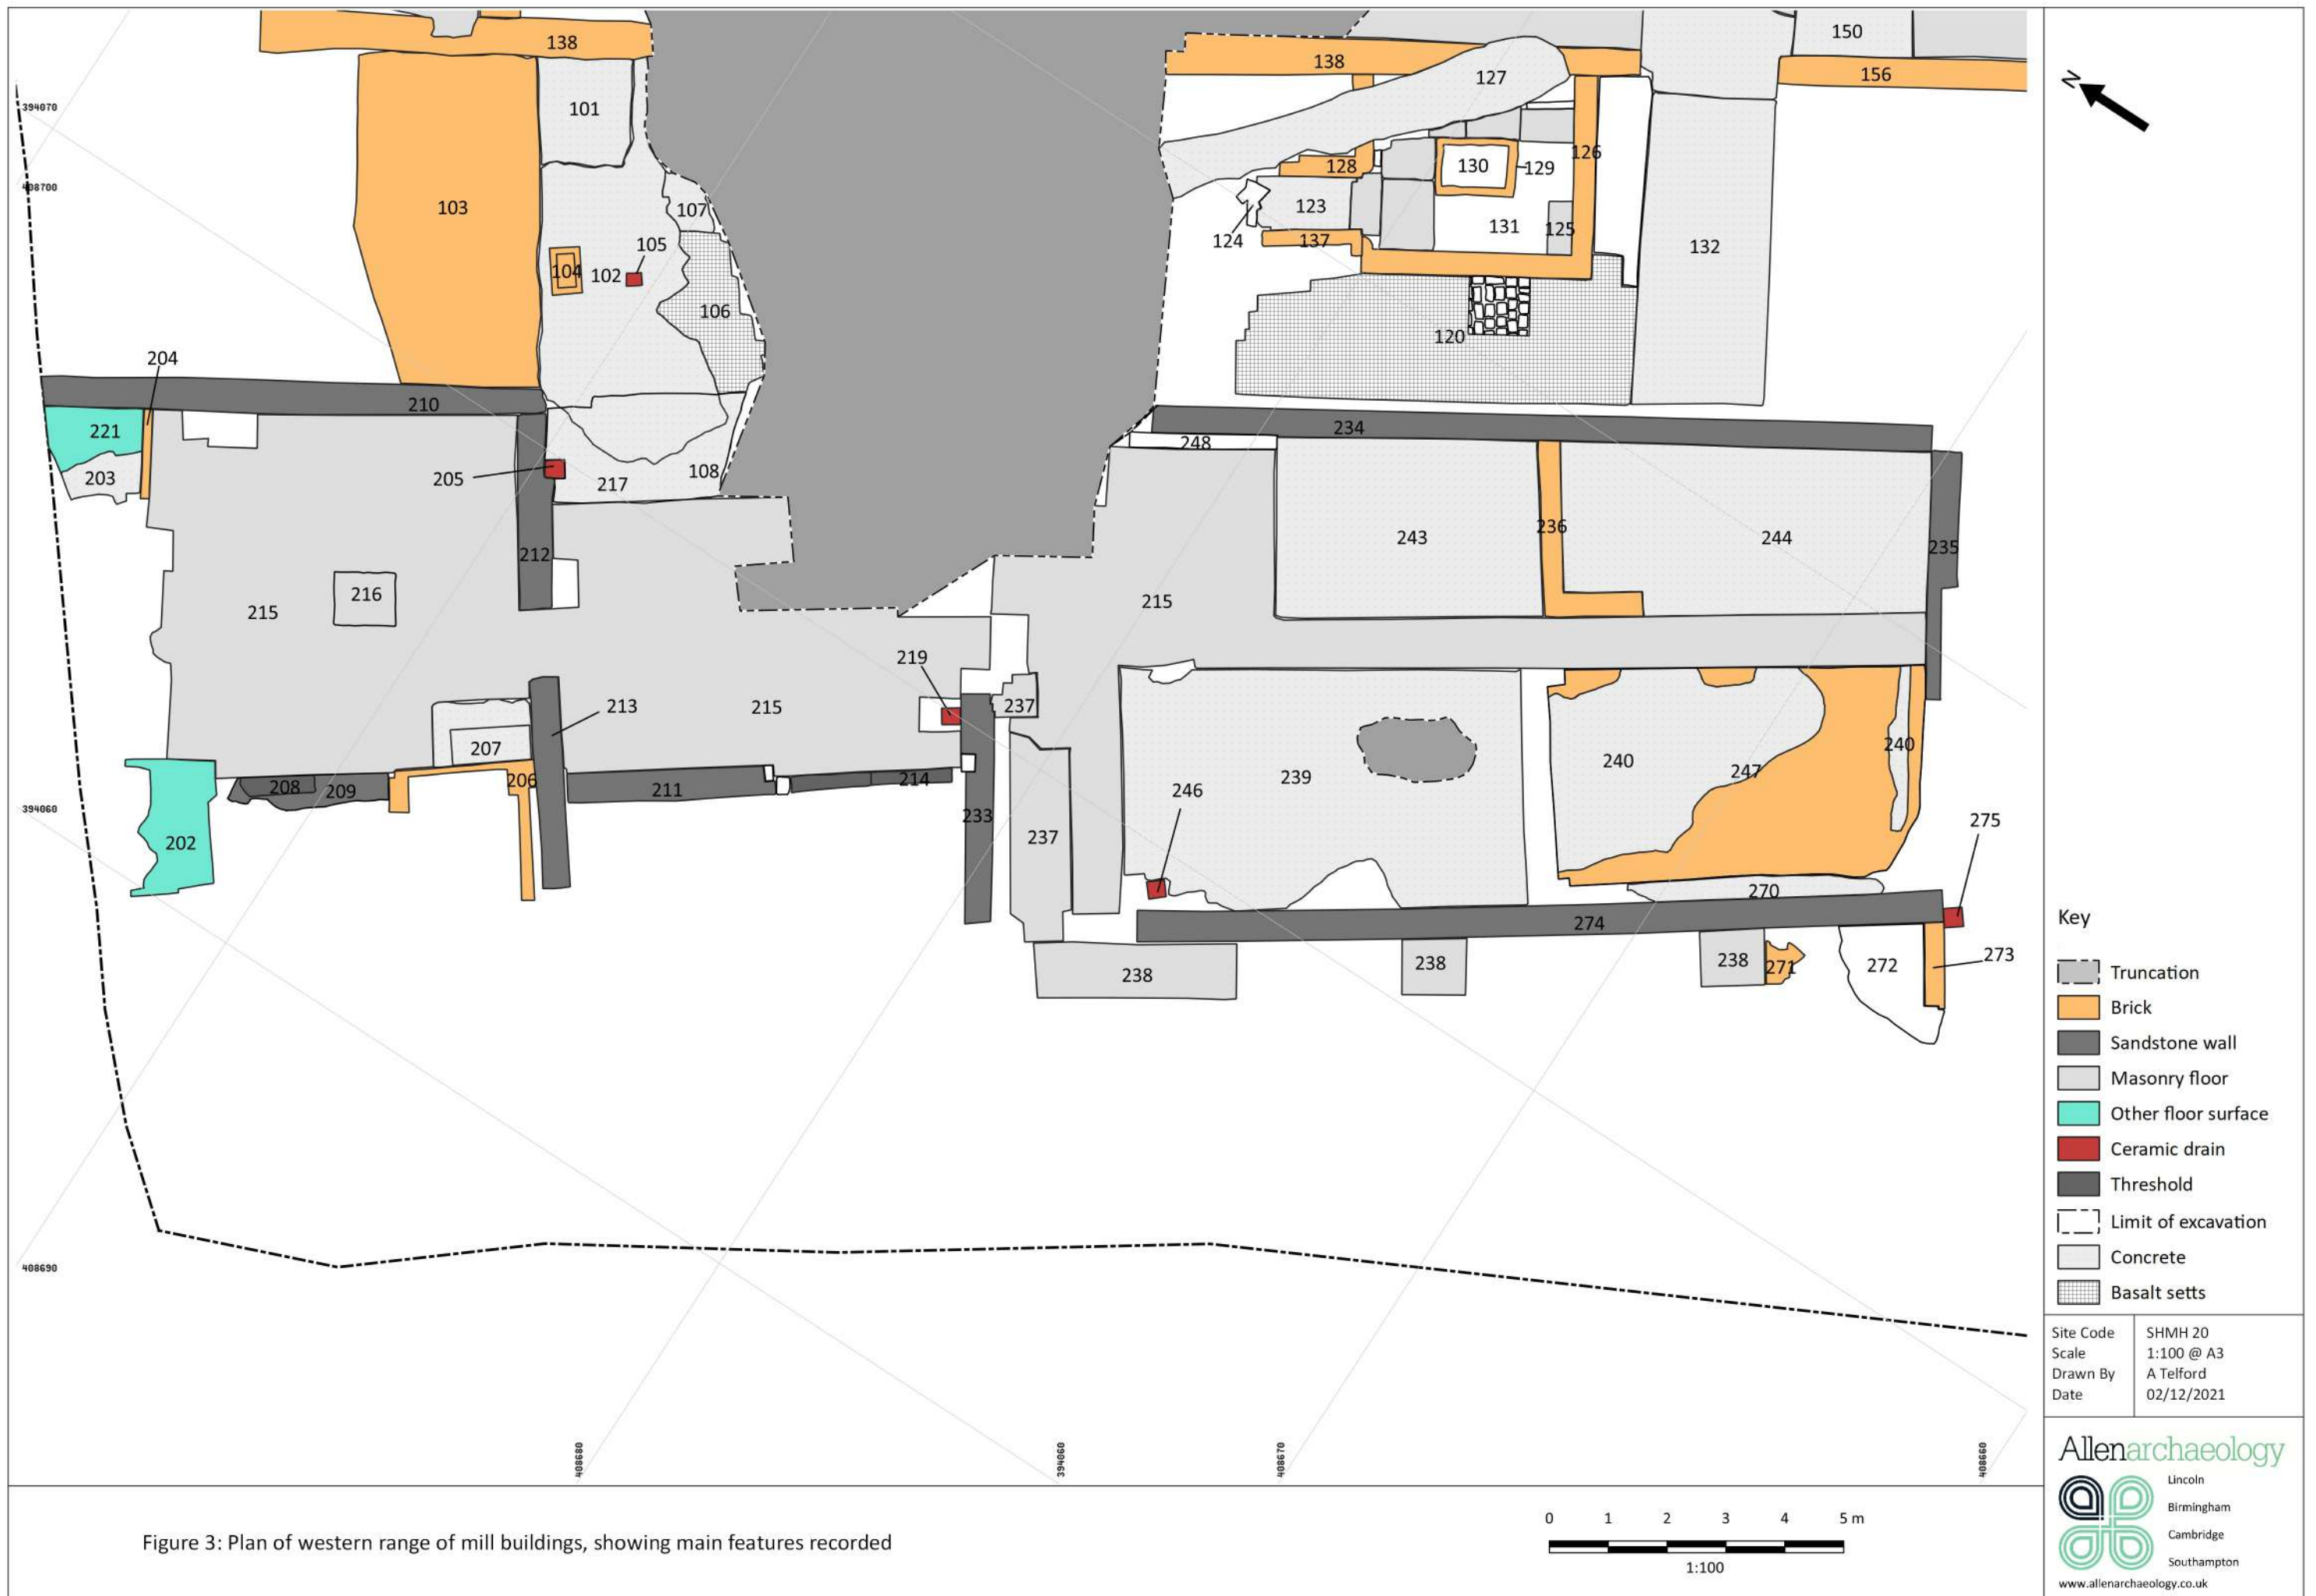
Figure 3: Plan of western range of mill buildings, showing main features recorded

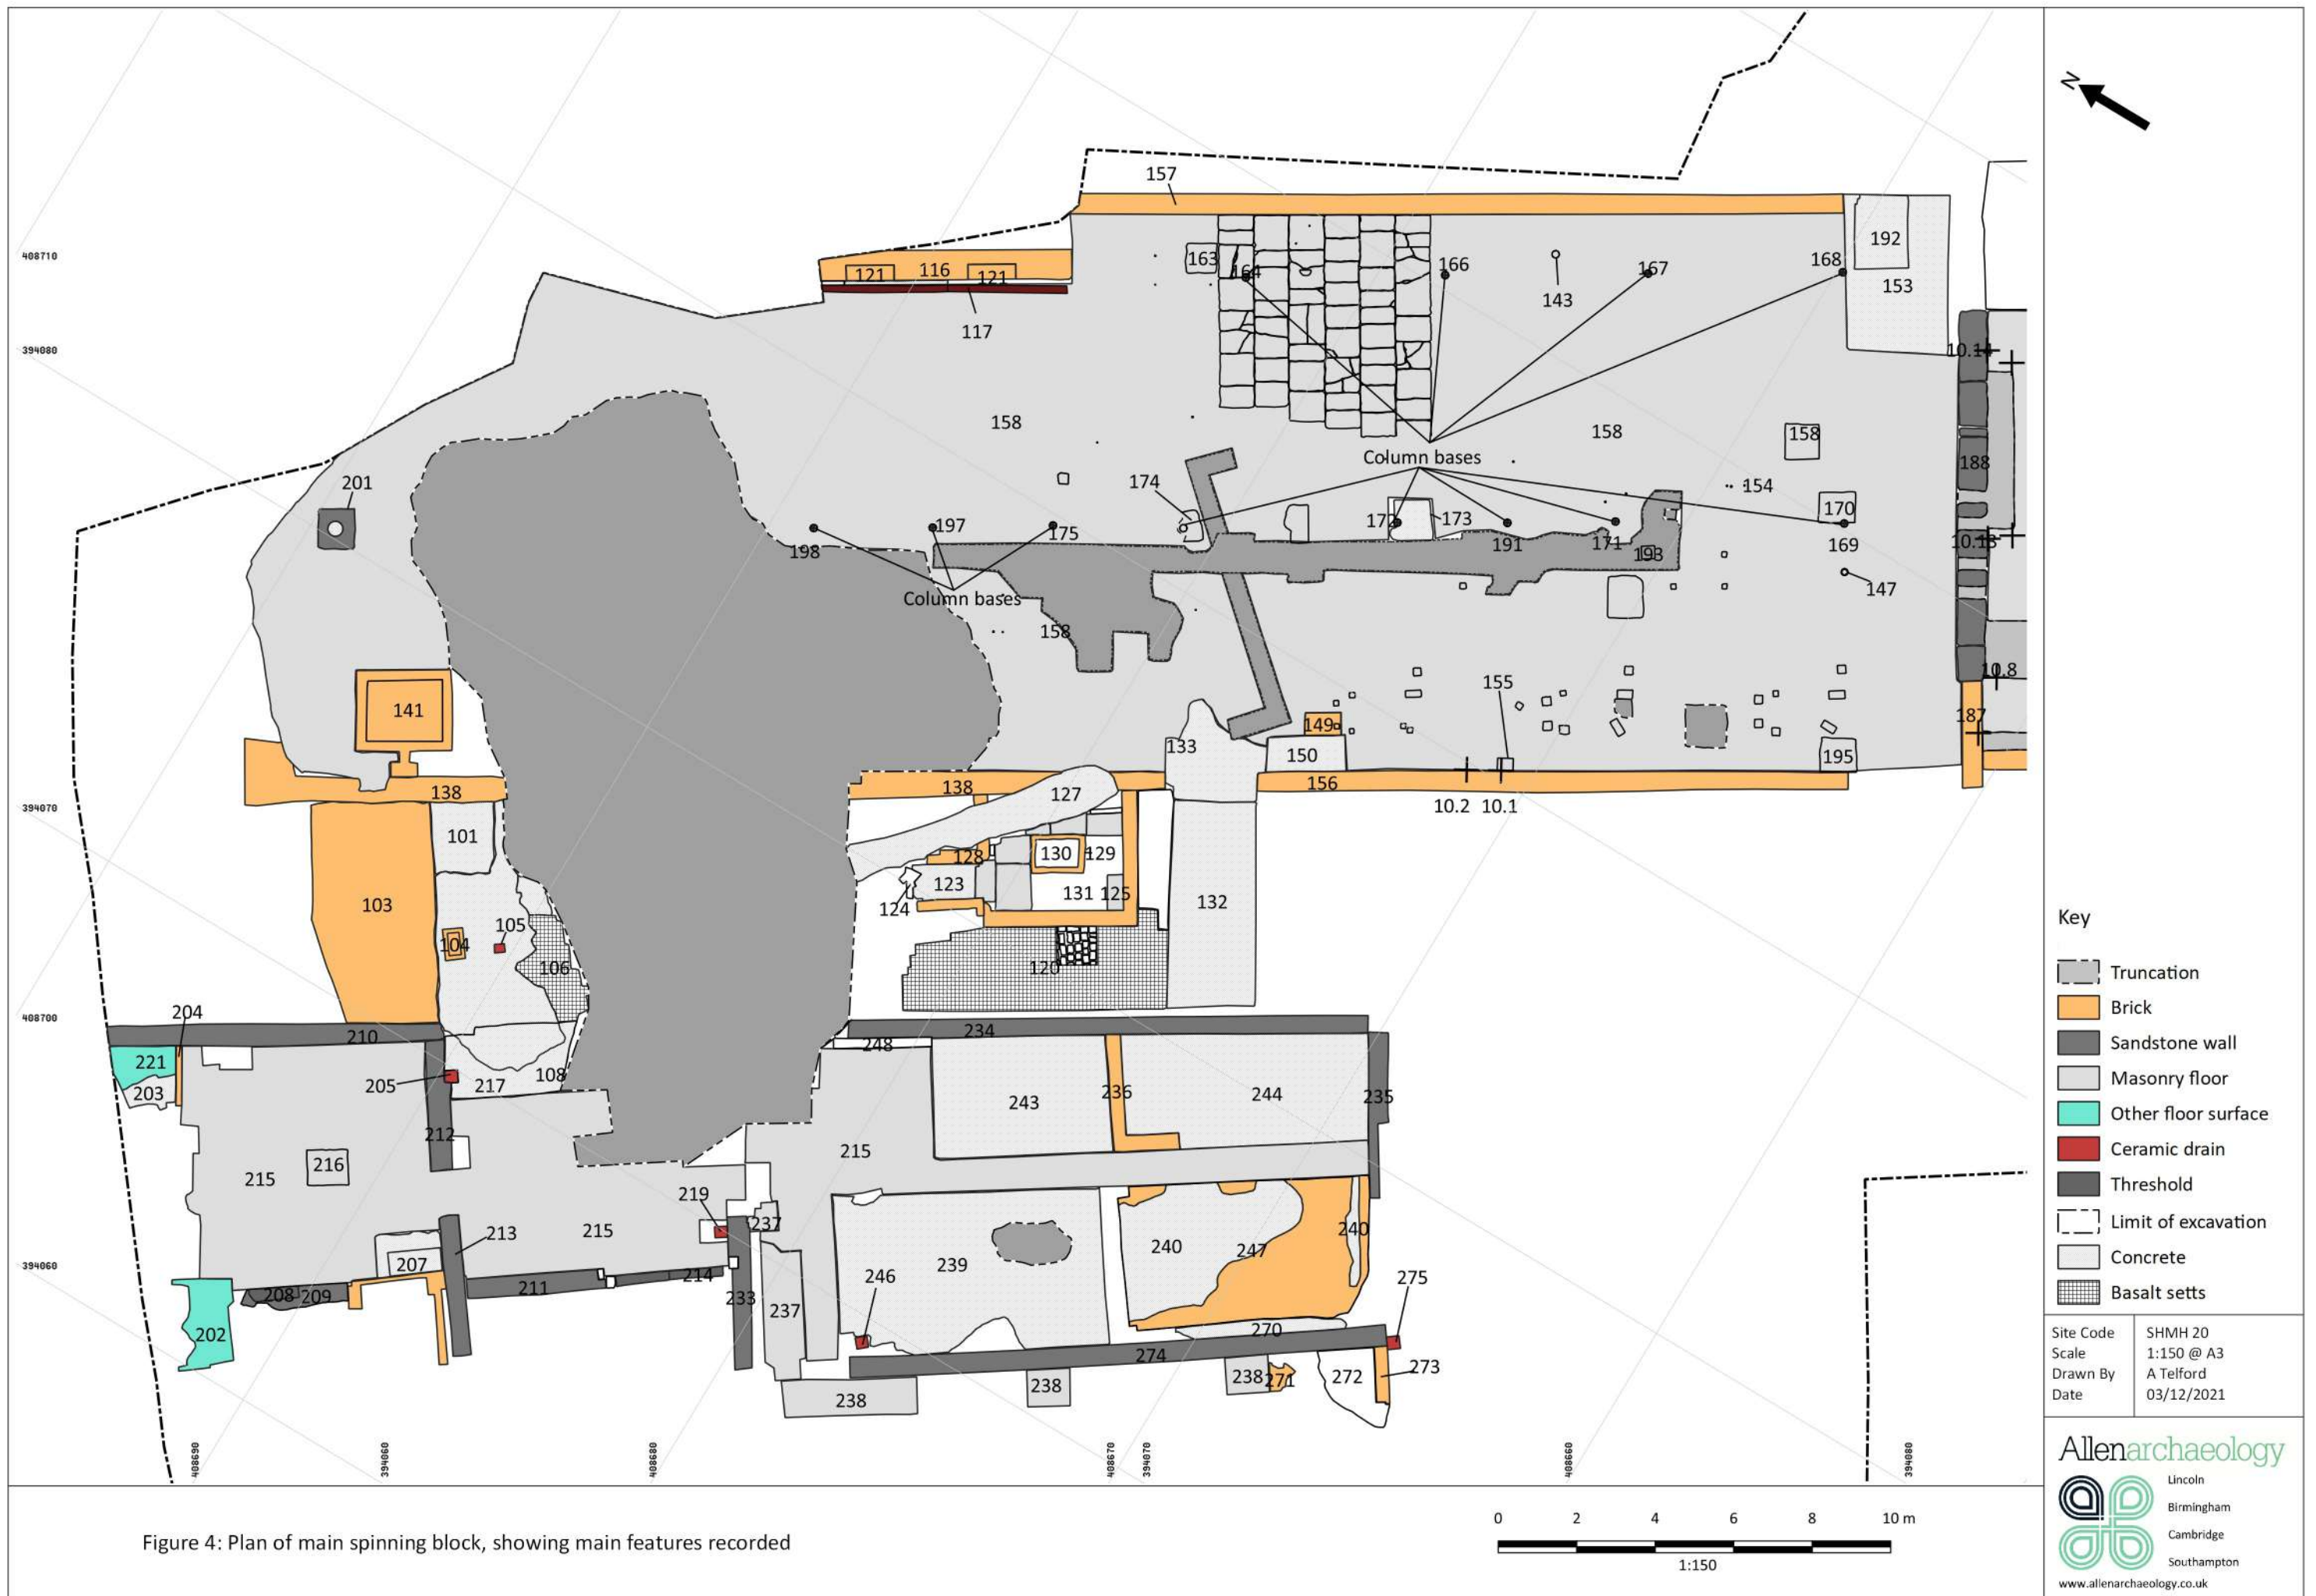
Figure 4: Plan of main spinning block, showing main features recorded
