**ARCHAEOLOGICAL SCHEME OF WORKS:  
LAND AT 2 CHURCH STREET, CAISTOR, LINCOLNSHIRE**

Planning Reference: 142476 and 142477  
NGR: TA 1172 0136  
AAL Site Code: CACS 21  
Scheduled Monument Consent: S00242029  
Museum Accession Number: LCNCC: 2022.32  
OASIS Reference Number: allenarc1-504698

By  
Allen Archaeology Ltd  
Report Number AAL2022025

February 2022

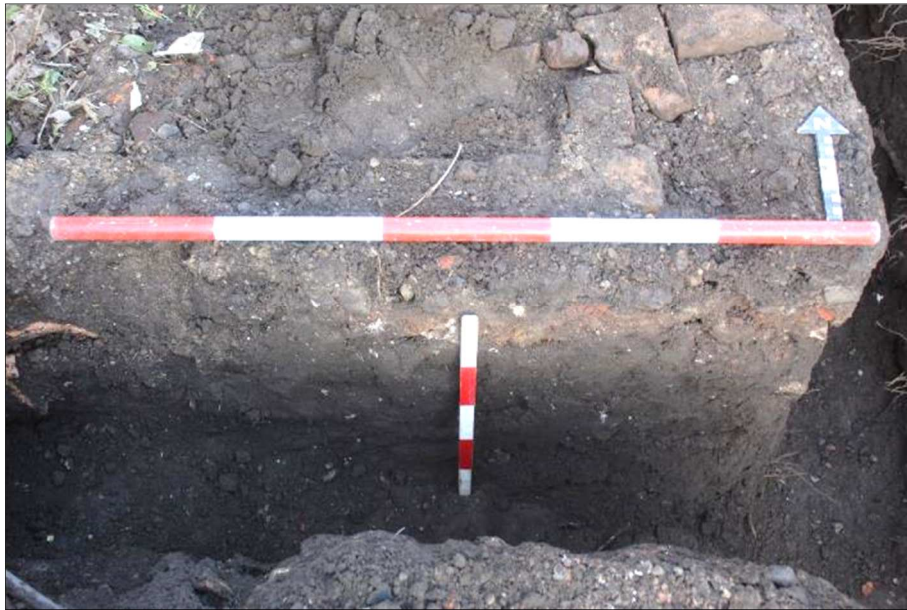
- 6.2 The uppermost layer was a mid-grey gravel yard surface 100 approximately 0.45m thick. This layer was visible across the entire site and also recorded as 200, 300, 400, 500 and 600. This sealed a greyish brown silty sand 101, which was also visible in Trenches 2, 3, 5 and 6; 201, 301, 502 and 601. 101 etc likely represented a former made ground/levelling layer associated with the surrounding buildings.

- 6.3 Approximately 1m from the eastern end of Trench 1 was a cut [102], which represented the cut for the existing drain that was being replaced. This cut had near vertical sides with a concave base. It was filled with a mid-greyish brown silty sand 103 with occasional CBM (ceramic building material) flecks, and the former drainage pipe.

- 6.4 At the eastern end of Trench 1 below the gravel yard surface 100, was a single course of brick paving 104, 0.06m thick, which lay above a light brown sandy hardcore bedding layer 105, 0.10m thick.

*Plate 1: South-facing section of Trench 1, scales are 1m and 0.5m*

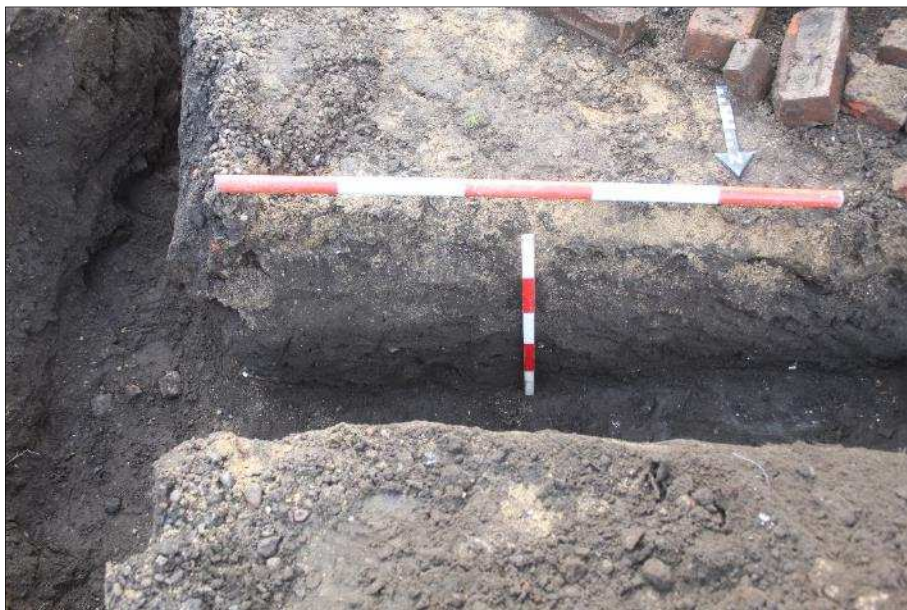
- 6.5 The gravel surface 200, 0.05m thick, sealed layer 201. The modern brick paving and bedding layers seen in Trench 1 were also visible within Trench 2, 202 and 203 respectively.

*Plate 2: North-facing section of Trench 2, scales are 1m and 0.5m*

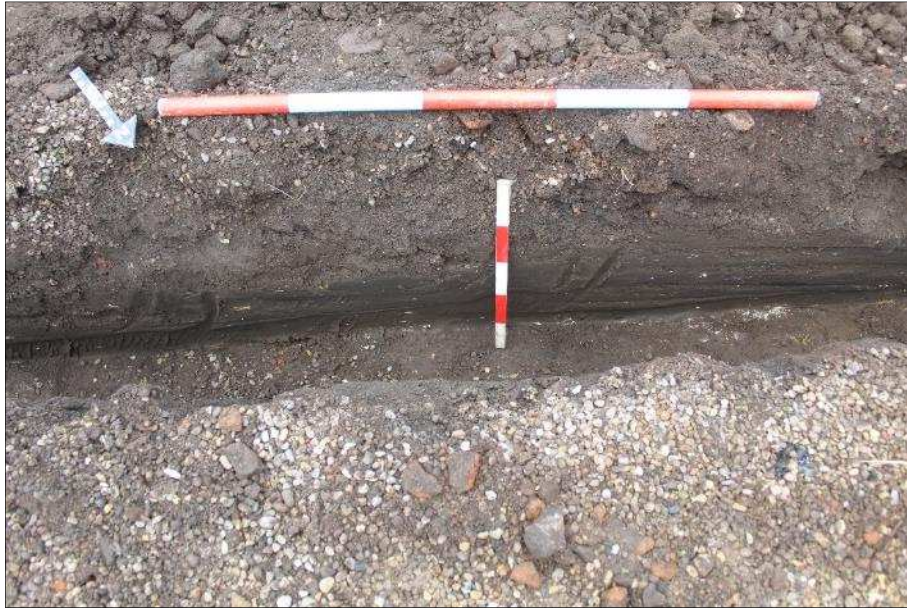
- 6.6 The gravel surface 300, 0.20m thick, sealed made ground layer 301.

*Plate 3: Northeast-facing section of Trench 3, scales are 1m and 0.5m*

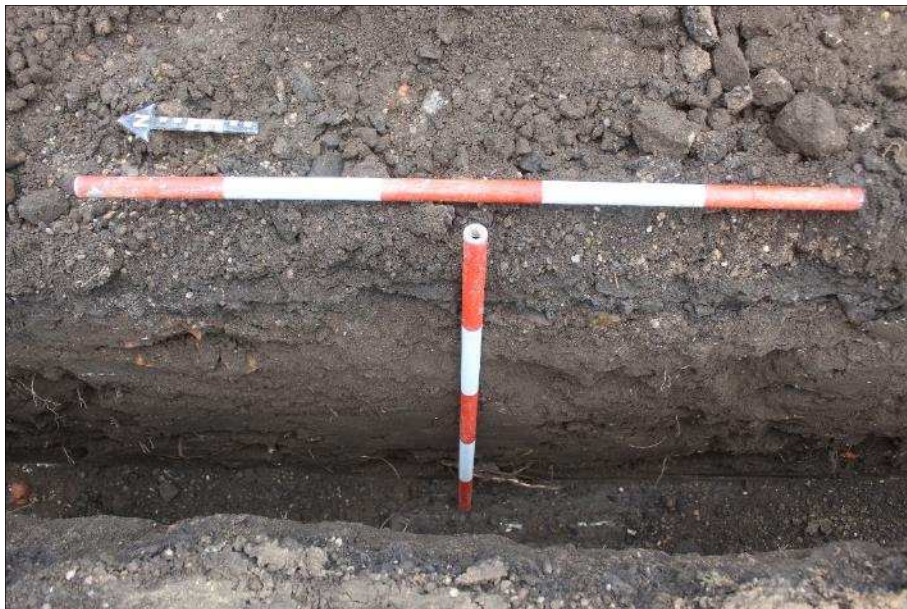
- 6.7 The uppermost deposit in Trench 4 was the gravel yard surface 400, 0.20m thick. This section of the works was entirely within the limits of the previous modern service trench, [401], filled with a mid-grey silty sand with occasional inclusions of CBM and charcoal flecks 402.

*Plate 4: West-facing section of Trench 4, scales are 2 x 1m*

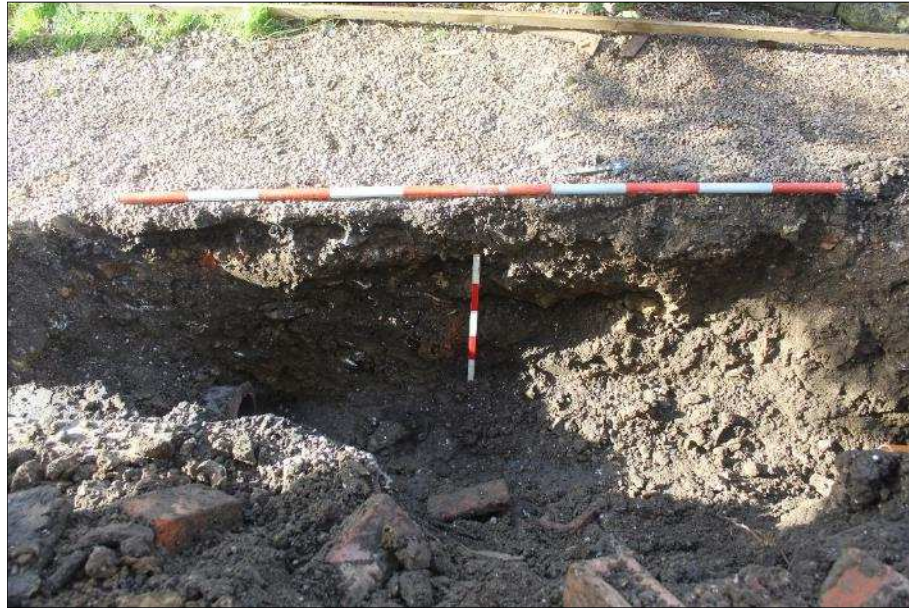
- 6.8 In Trench 5 the gravel yard surface 500, was 0.10m thick. It sealed a 0.13m thick mid brown silty sand 501, a possible former surface. This sealed a mid-greyish brown silty sand 502

with occasional inclusions of ceramic building material (e.g., brick, tile) (CBM) flecks, 0.40m representing a made ground layer corresponding with 101, 201 and 301. Below this was a light yellow silty sand levelling layer 503. Within Trench 5 was the cut of the former inspection chamber [504], 1.50m by 0.80m, which was filled by a dark grey silty sand 505.

*Plate 5: East-facing section of Trench 5, scales are 2m and 0.5m*

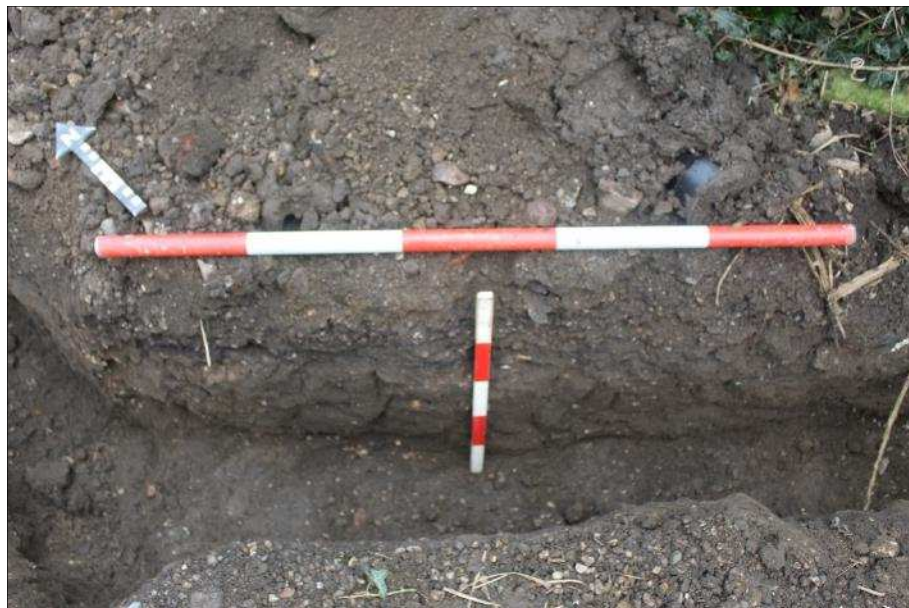
6.9 The gravel surface 600, 0.10m thick, sealed the former occupation layer 601. At the northwestern end of Trench 6 the cut for the modern service trench [401] was identified.

*Plate 6: Southeast-facing section of Trench 6, scales are 1m and 0.5m*

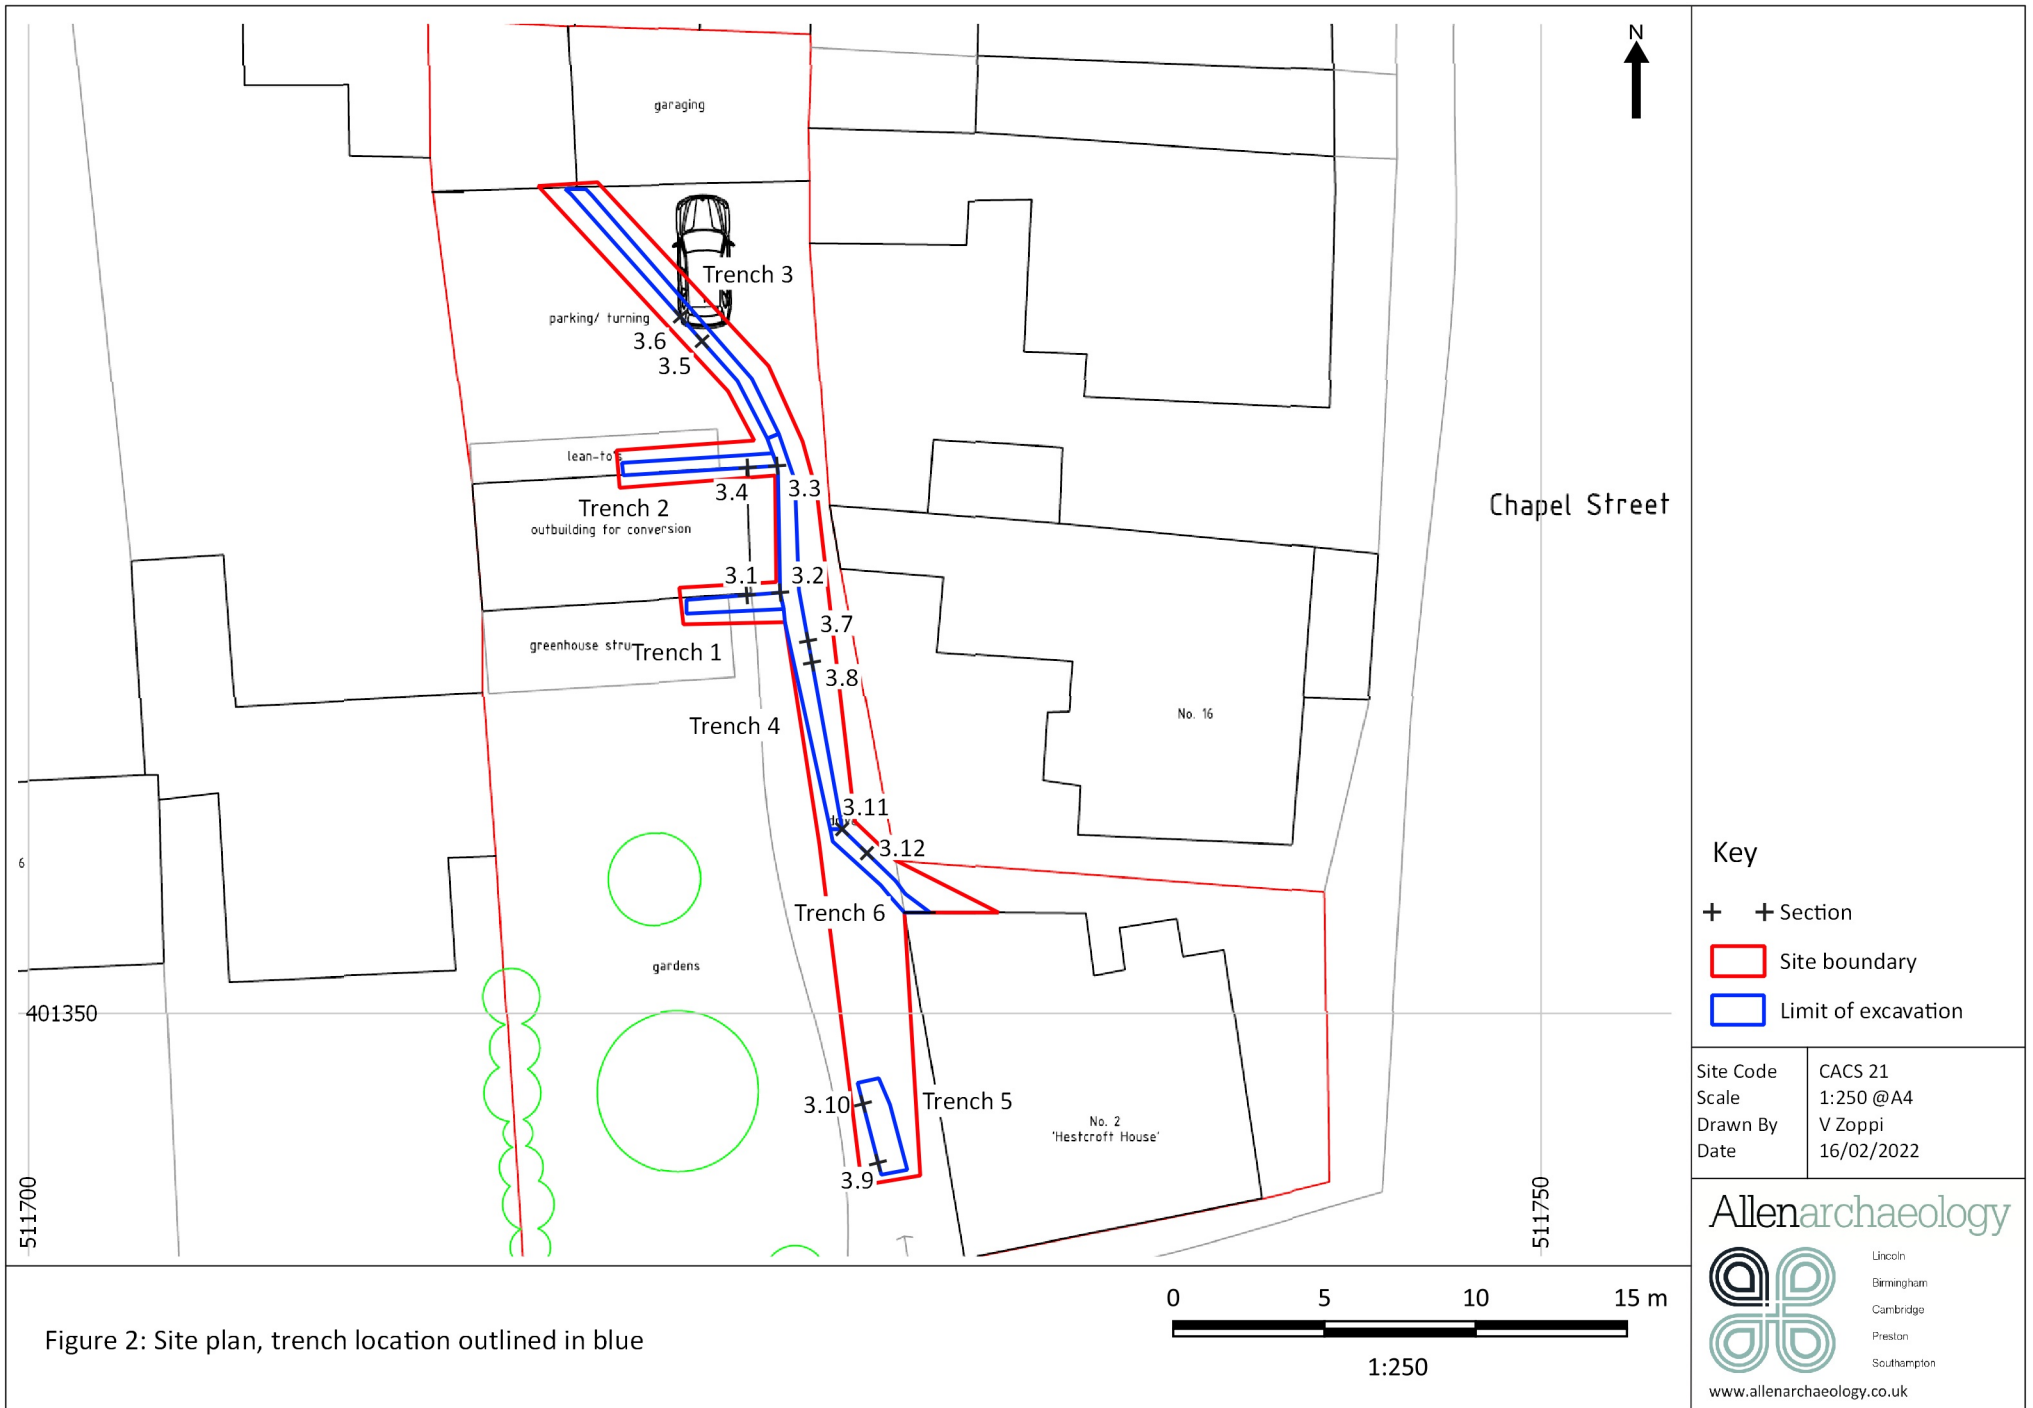
- 6.1 The drainage trenches were split into six sections for ease of recording (Figure 2).

Figure 2: Site plan, trench location outlined in blue

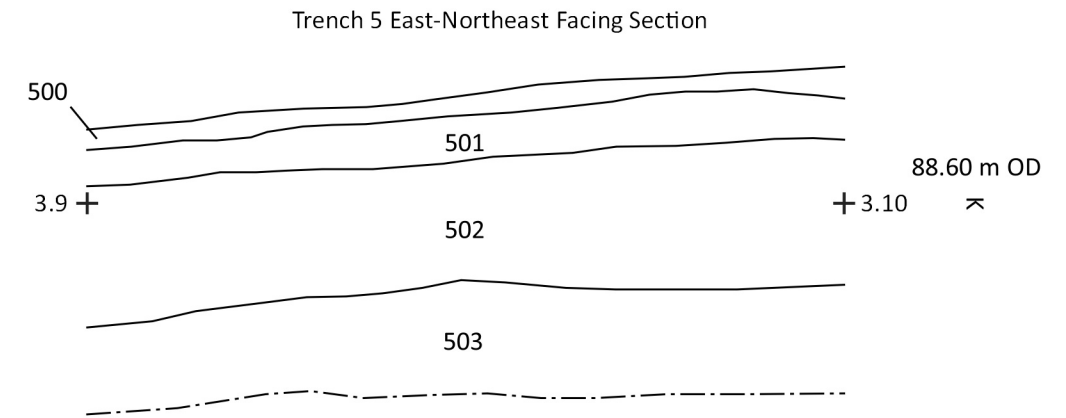
Figure 3: Representative sections, located on Figure 2
