**REPORT ON A PROGRAMME OF ARCHAEOLOGICAL MONITORING AND RECORDING:  
LAND AT MIDDLE STREET, CORRINGHAM, LINCOLNSHIRE**

Planning Reference: 142098  
NGR: SK 8710 9160  
AAL Site Code: COMS21  
Museum Accession Number: LCNCC:2021.209  
OASIS Reference Number: allenarc1-513145

By  
Allen Archaeology Ltd  
Report Number AAL2023017

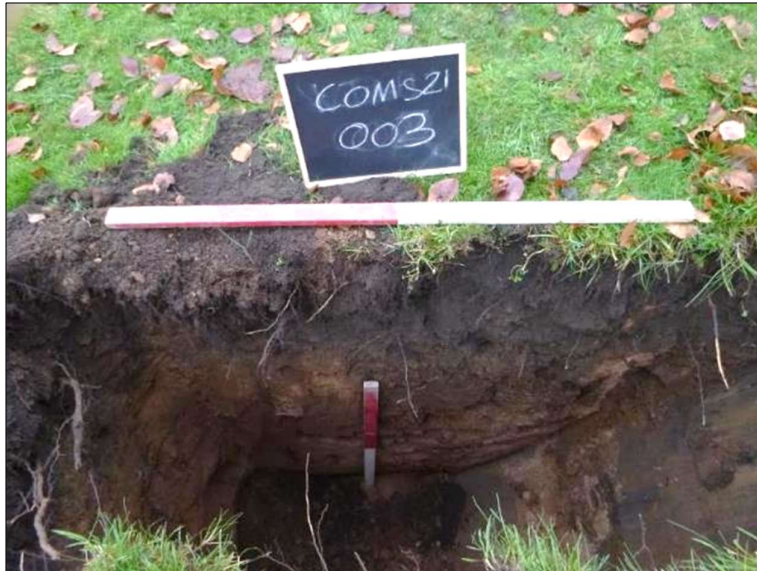
- 7.2 Test Pit 2 was located c.4m west of the northwest corner of the existing building (Figure 2). The topsoil, 100, in this test pit was also 0.35m thick and sealed a 0.10m thick made ground layer of compact red brown sand silt, 101, sealing the natural geology, 102 (Figure 3, Plate 2).

*Plate 2: Test Pit 2, north facing section. Scales 1m*

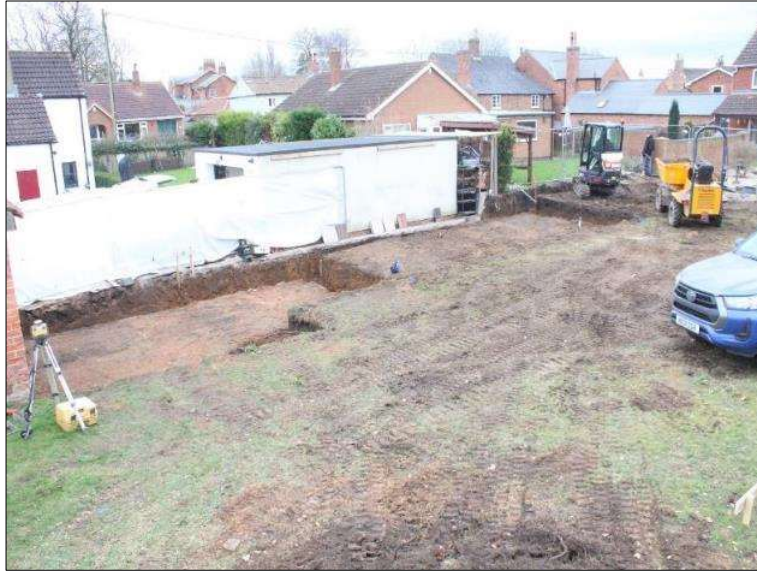
*Plate 3: Extension foundations. Looking southwest. Scale 1m*

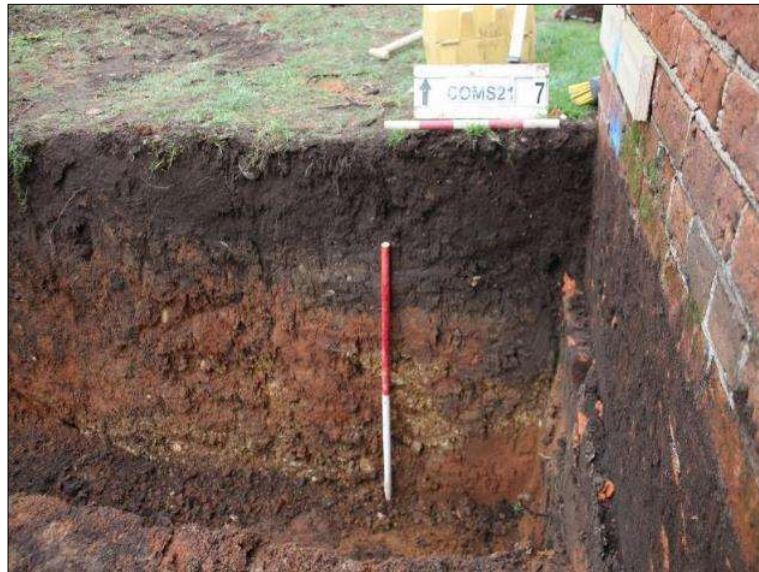
- 7.4 The foundation trenches for the extension were 0.30m wide and 1.30m deep. The eastern end exposed an identical sequence to that seen in Test Pit 2, comprising topsoil 101, over made ground 101 and natural geology 102 (Figure 3, Plate 4). However, at the western end there was no made ground as it petered out between Test Pits 1 and 2.

*Plate 4: South facing section of extension showing deposits. Scales 0.50m and 1m*
