ARCHAEOLOGICAL WATCHING BRIEF REPORT:

GARAGES AND WORKSHOPS SITE MILL LANE, LINCOLN, LINCOLNSHIRE

Planning Reference: 2007/0152/F
NGR: SK 97133 70305
AAA Site Code: LIML 08
LCCM Accession Number: 2007.206
OASIS Reference: allenarc1-51574

Allen Archaeological Associates
Report Number 2008/062

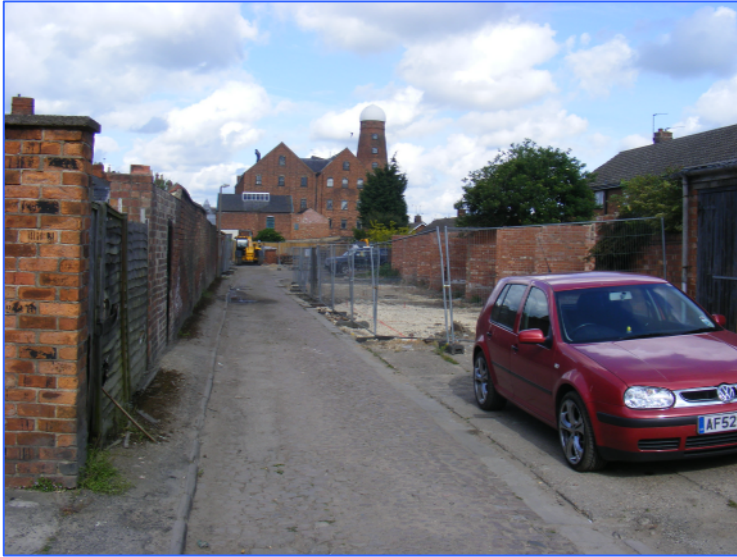
Plate 1: General site location shot looking west-north-west along Mill Lane. Plots A1 – A4 are in the fenced area to the right.

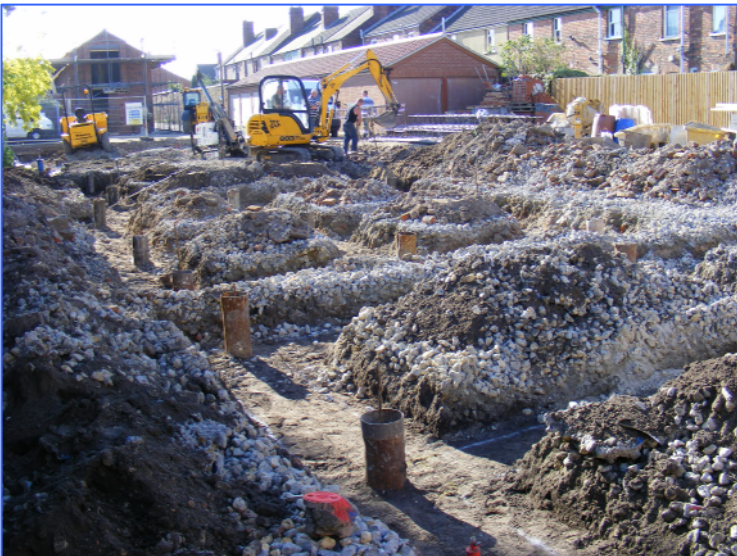
Plate 2: General view of Plots 2 – 5, showing the excavated ring beam foundations and the steel pile sleeves in situ. Looking west.

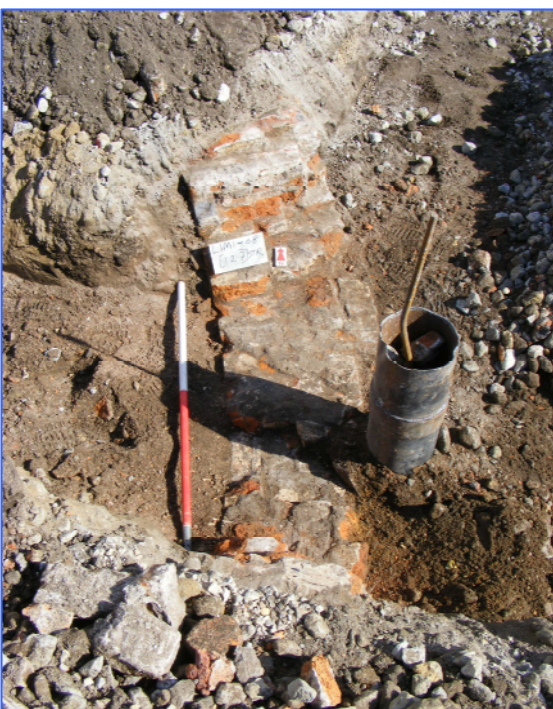
- 6.1.3 Towards the middle of the southern foundation trench of Plot 3, the groundworks exposed the remnants of the 19th century mill foundations previously identified during the evaluation of the site (see Figure 3). The exposed portion of the structure, [127], was 1.25m long and survived to a depth of six courses of brickwork running on an approximate north – south alignment. This segment of the mill foundations was located immediately to the north of the section identified in Trench 2 of the previous evaluation, and had been recorded running for c.3m north of the Trench, before being truncated by a later phase of development (Chavasse 2007). It appears therefore that the laying of the stone piling mat prior to the watching brief had sealed the remainder of this structure.

Plate 3: Remnants of the foundations of the 19th century mill exposed in Plot 3. Looking north

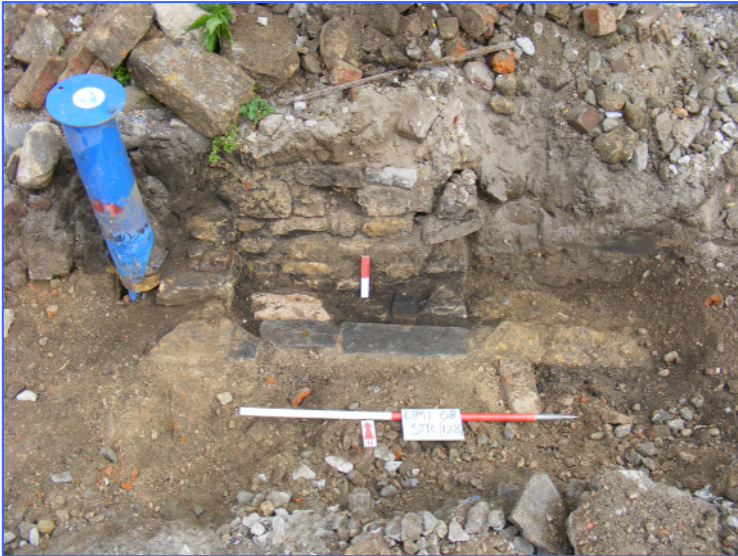
- 6.1.4 On the north side of Plot 4 layer 100 sealed the remnants of a brick and stone structure likely to represent the remains of a hearth and chimney stack, and the associated foundations of an east – west aligned wall, 130. The probable chimney stack, 128, comprised five courses of roughly-dressed limestone blocks, in a yellow/grey sandy mortar, with a width of c.1.1m. An area of soot and scorched stonework at the base of this structure represents the former hearth or fireplace. The east and west sides of the fireplace were abutted by a single brick, each possibly representing the base of a brick surround, 131, although the fragmentary nature of the remains makes this interpretation far from certain.

Plate 4: North side of Plot 4, showing chimney stack 128 and wall foundation 130, looking north-north-east. The soot staining in front of the chimney shows the location of the former fireplace.

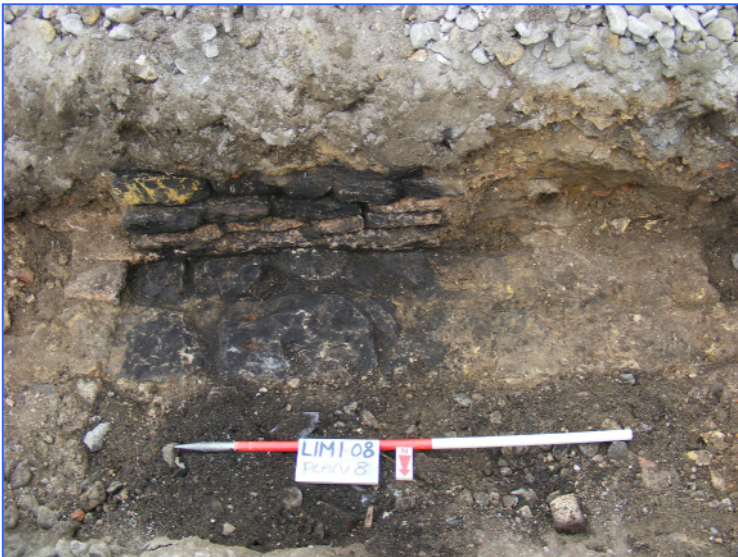
- 6.1.6 A further complex of structures, representing components of the former 19th century cottages, was identified in the southern part of the plot. Layer 100 sealed three surviving courses of a probable chimney stack, 137. The wall comprised two lower courses of artificial stone blocks with the upper course in roughly dressed limestone blocks; all of which were heavily stained by soot. The chimney stack was built off a compact foundation course of roughly dressed limestone blocks, 135, in a pale yellow/grey sandy mortar with limestone and brick rubble infill, 138. This deposit produced two fragments of 18th/19th century brick and a single residual fragment of 14th/15th century roof tile. An area of soot residue on 135 immediately to the south of the chimney stack indicated the extent of the former fireplace. To its west, a robber cut [139] was evident, suggesting the deliberate demolition of the structure. [139] contained three distinct demolition deposits, 140, 141 and 142, the latter of which produced three fragments of late

Plate 5: Chimney stack 137 and wall foundation 135 exposed along south side of Plot 4, looking south-south-west. Again, soot staining indicates location of the former fireplace.

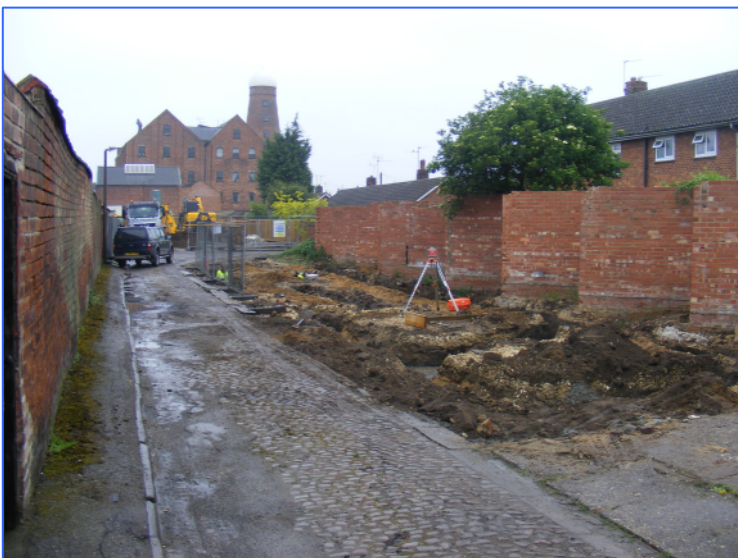
Plate 6: General view of Plots A1 – A4 following completion of the groundworks, looking north-west from Mill Lane.

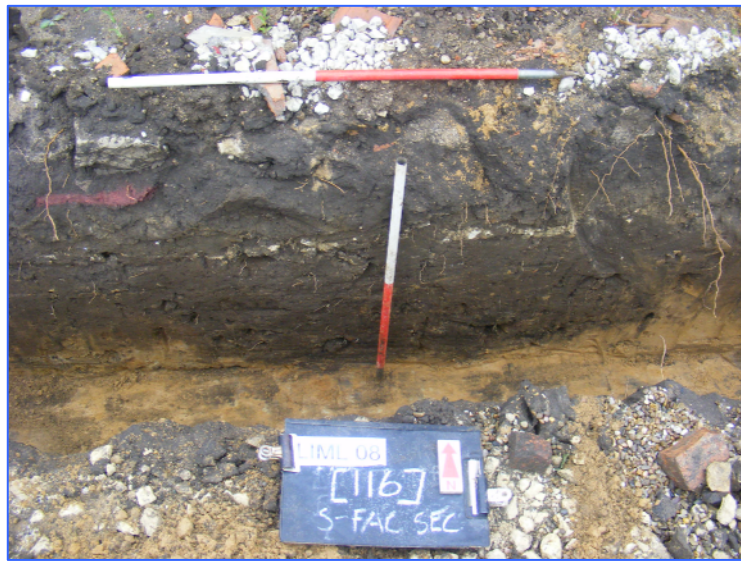
- 6.3.3 Layer 101 was cut by a number of features. At the north side of the plot, features [106] and [116] were only apparent in the south facing section, and are most likely to represent pits or possibly the termini of ditches. To the east of [106], a possible ditch, [105] was recorded running across the foundation trench on a north-north-east to south-south-west alignment, although its continuation could not be observed to the south, due to the instability and collapsing of the foundation trenches making them unsafe to enter. In the southern part of the plot, another large feature, [118] was observed in both the north and south facing sections of the foundation trench. It was however not observed in any other part of the footings, and is likely to be either a pit, or a ditch that terminates within the site.

Plate 7: Probable pit [116], on north side of Plot A1/A3, looking north-northeast. At the base of the trench is alluvial deposit 102.

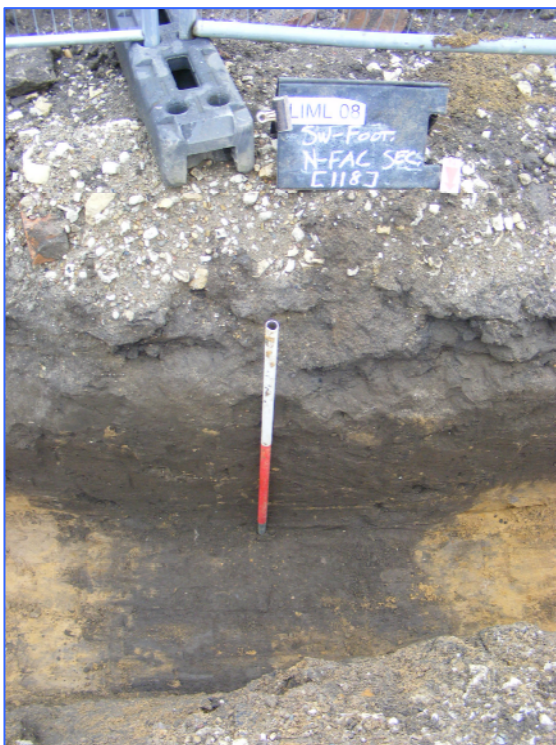
- 6.3.4 All the features discussed above (Section 6.3.3) had similar steep sided profiles and contained very similar fills, comprising very dark greyish brown silty sands, with occasional charcoal flecking. The only finds recovered from these features were three fragments of animal bone and a single sherd of 13th to 15th century roof tile from the backfill of pit [118].

Plate 8: Feature [118], exposed on south side of Plot A1/A3, looking south-south-west. At the base of the trench is alluvial deposit 126.

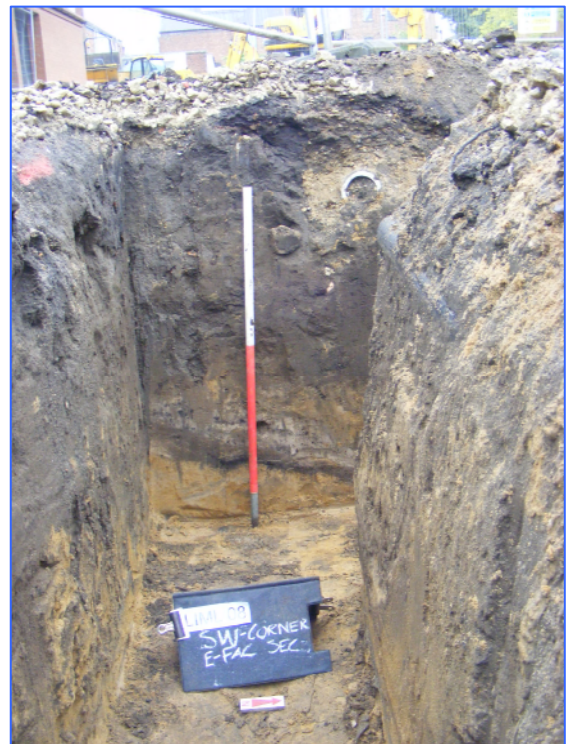
- 6.3.6 102 sealed layer 103, a thin, intermittent layer of brown/grey silty sand with occasional charcoal lenses (also recorded as 108, 111, 113 and 122). This layer was no more than 0.1m deep throughout the plot, and may be the remains of a cultivation horizon similar in its formation process to the later and much thicker deposit 101. A single sherd of Romano-British greyware of 3rd century AD date was recovered from this deposit towards the north side of the plot (context 111). In the south-west corner of the foundations, 103 sloped downwards to the north, representing the profile of the underlying ground surface. At this location, layer 103 was sealed by a lens of very pale fine grey sand, 121, possibly representing an accumulation of wind-blown sand against the natural incline of the ground, or against an object or barrier that has since disappeared or lies beyond the excavated footings.

Plate 9: South-west corner of Plot A1/A3, looking west-north-west. This shot shows layer 126 at the base of the sequence, overlain by soil horizon 103 sloping down to the north, over which is a possible wind-blown sand lens 121 and alluvial deposit 102.

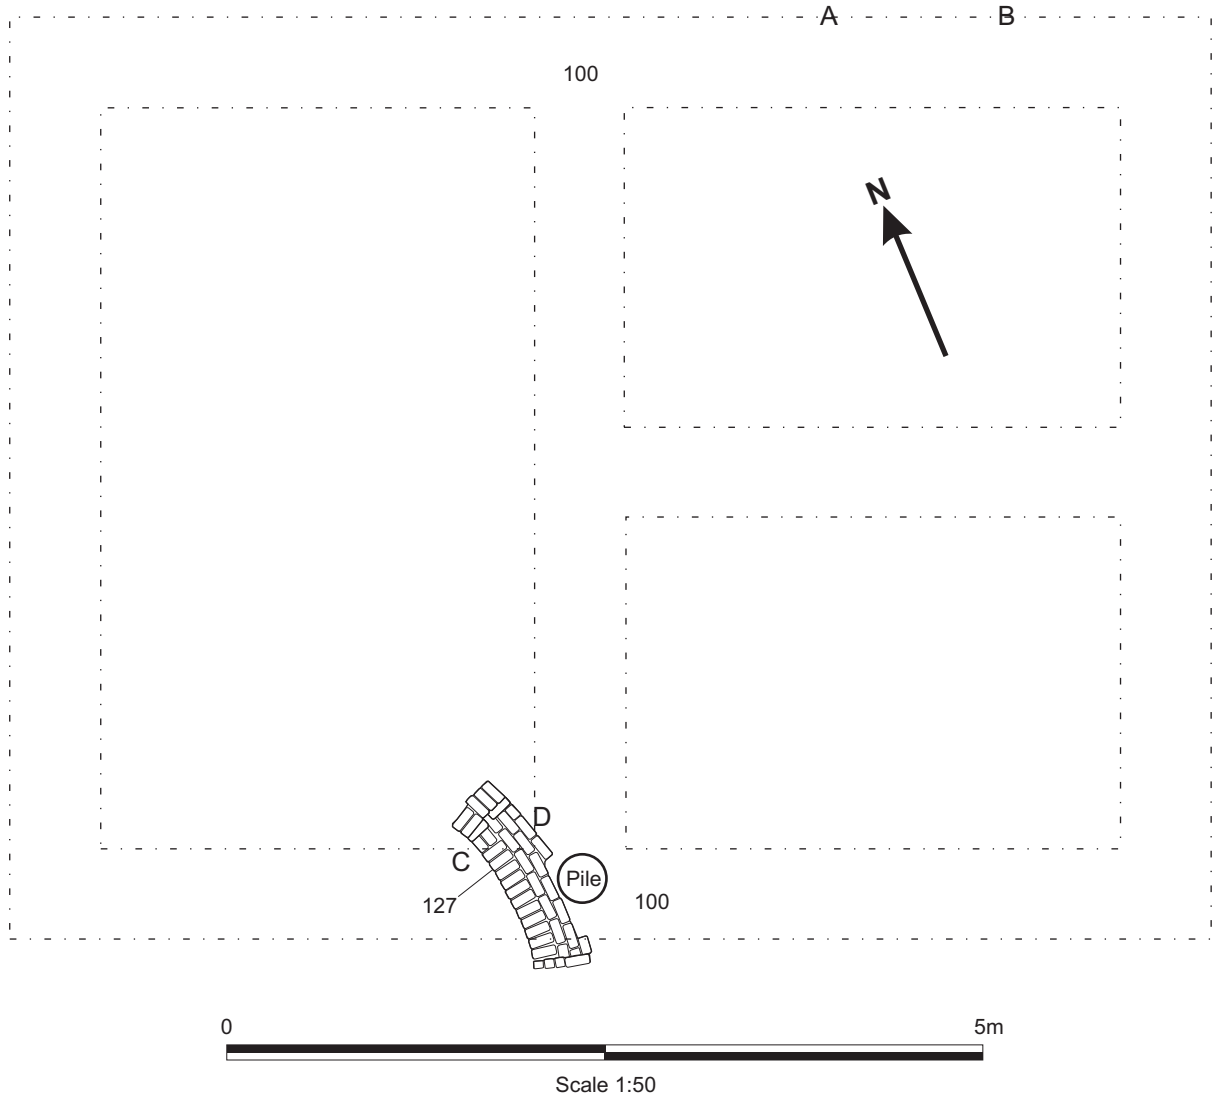
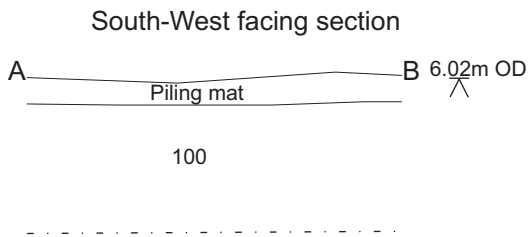
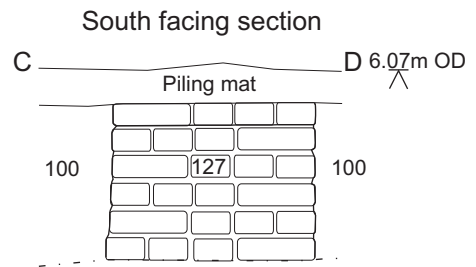
Plot 3 foundation plan, scale 1:50

Figure 3: Plot 3 foundation plan at scale 1:50 with section drawings at scale 1:20

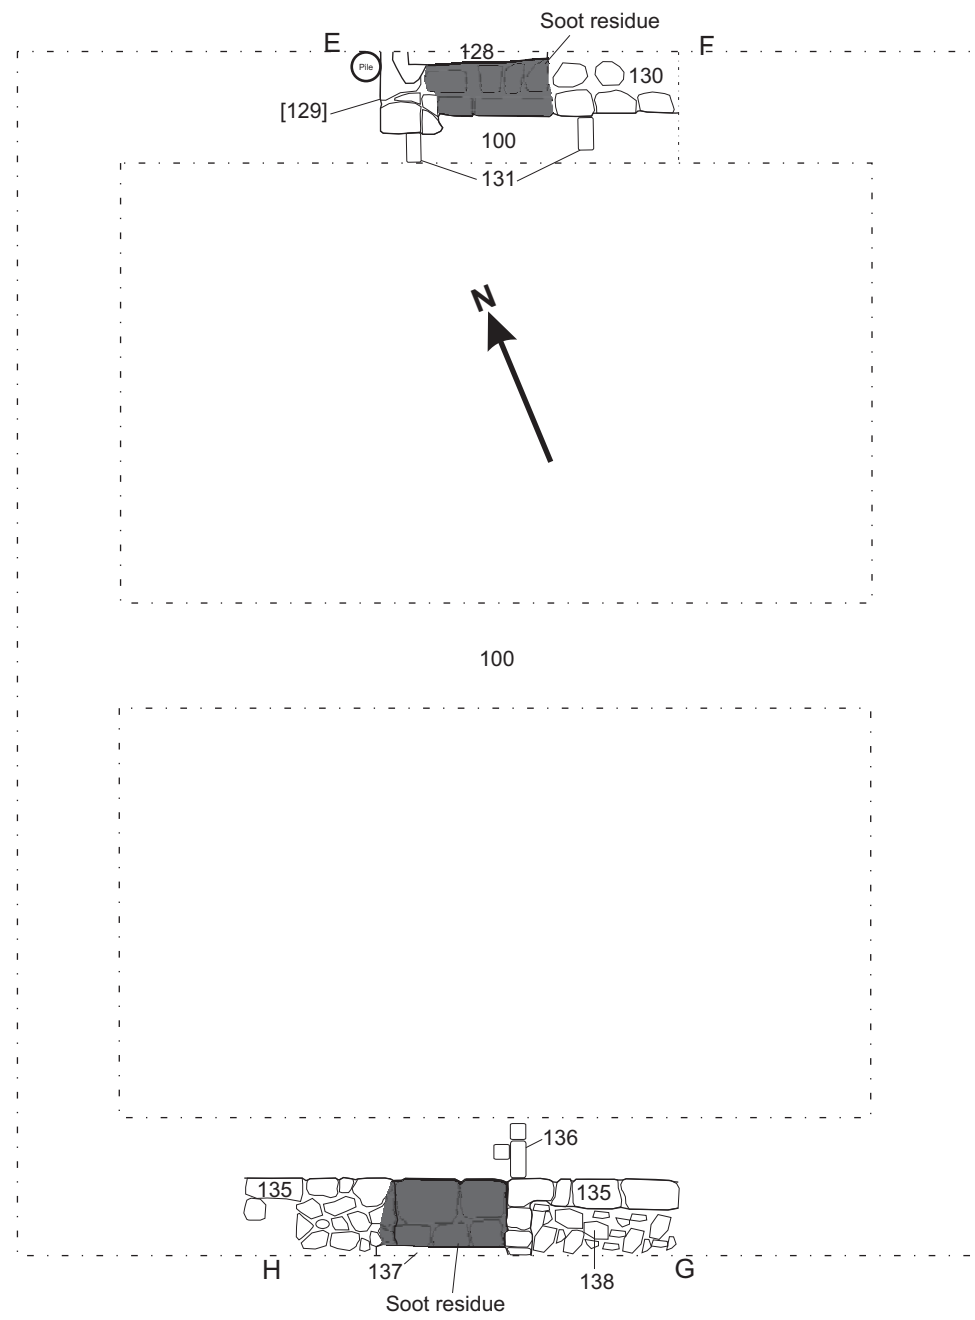
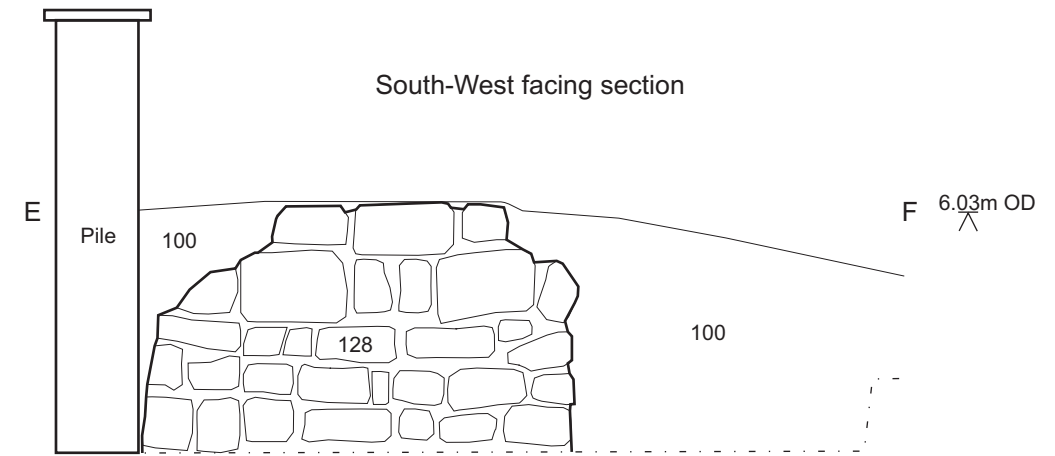
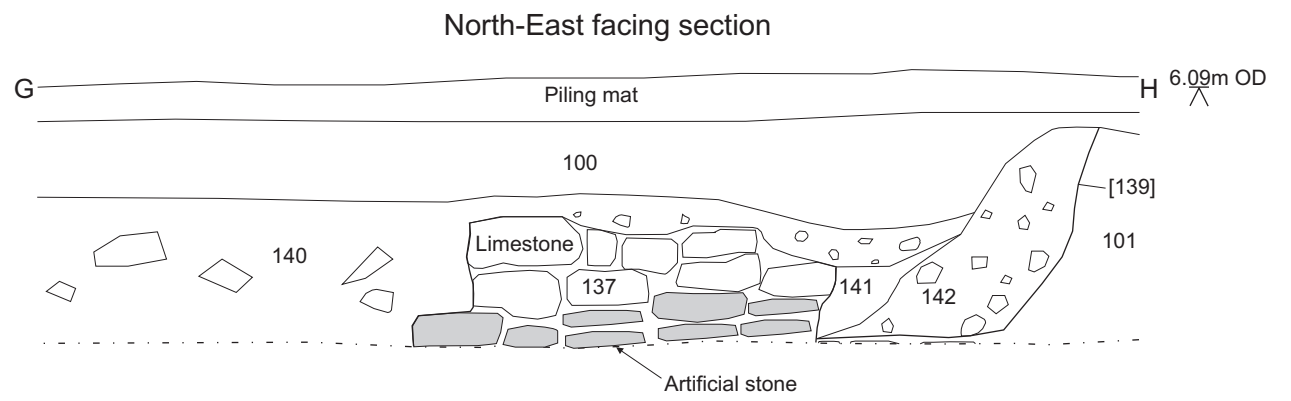
Plot 4 foundation trench plan, scale 1:50

Figure 4: Plot 4 plan and sections at scales 1:50 and 1:20
