# ARCHAEOLOGICAL WATCHING BRIEF REPORT:

## 51 MONKS ROAD, LINCOLN

Planning Reference: 2009/0032/F  
NGR: SK 9802 7139  
AAL Site Code: LIMR 09  
LCCM Accession Number: 2009.103  
OASIS Reference: allenarc1-64076

Allen Archaeology Limited  
Report Number 2009044

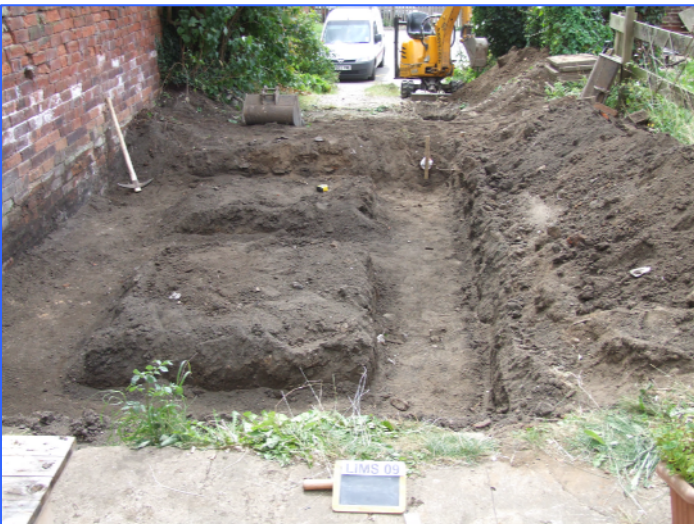
**Plate 2:** General view of the foundation trenches, looking south from the north end of the site.

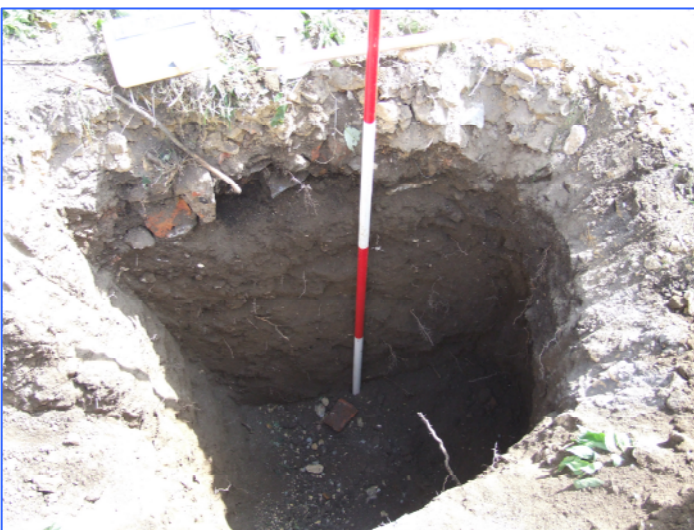
- 6.4 The excavation of the new soakaway revealed a modern demolition layer, 05 comprising dark greyish brown sandy silt containing frequent tile, brick and limestone fragments, sealed below a modern gravel surface. This deposit was 0.5m thick and sealed layer 06, a loose dark brown sandy silt with occasional limestone fragments, possibly representing the same deposit as layer 04 exposed in the foundation trenches. This deposit extended below the limit of excavation.

**Plate 3:** West facing section of soakaway, showing layers 05 and 06, looking east-south-east
