**ARCHAEOLOGICAL WATCHING BRIEF REPORT:  
OTTER'S COTTAGES, LINCOLN, LINCOLNSHIRE**

Planning Reference: 2006/0661/F  
NGR: SK 9695 6911  
AAL Site Code: LIOC 09  
OASIS Reference Number: allenarc1-73529

Report prepared for Tennyson Homes Ltd

By  
Allen Archaeology Limited  
Report Number 2010012

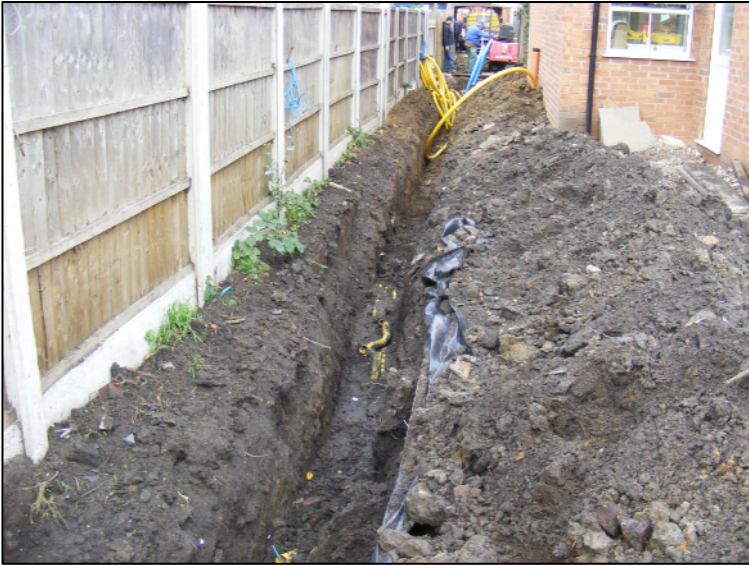
**Plate 1:** Working shot looking north along service trench towards St. Catherine's Grove

- 5.1 Prior to being commissioned to undertake the archaeological works, the foundations for the new dwelling were excavated and concreted. Following discussions between the client, AAL and the City Archaeologist, it was agreed that all services, access and drainage works should be monitored as a final mitigation. The ground works were monitored by Chris Clay and Kevin Trott of AAL between 29<sup>th</sup> September and 27<sup>th</sup> October 2009. The archaeological monitoring pertained to the inspection of an open soakaway pit to the south of the new building (Pit 1), partial monitoring of a second soakaway to the north (Pit 2), and monitoring of drainage trenches along the west side of the new building, running northwards to connect to an existing manhole in the access road towards St. Catherine's Grove.

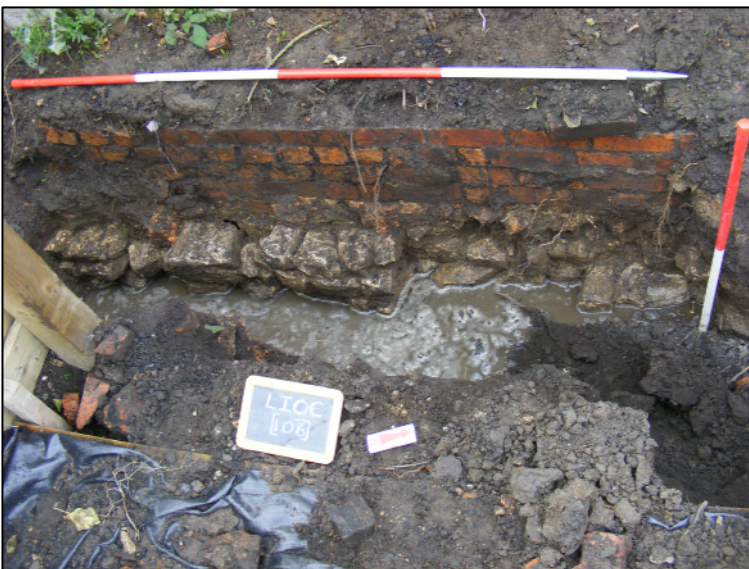
- 6.3.3 Towards the south end of the service trench, layer 102 sealed layer 108, which extended below the limit of excavation. Also recorded towards the south end of the trench was a portion of a brick and stone wall, 106/107, aligned broadly north – south. The lower portion of the structure comprised three courses of roughly dressed blocks of limestone (c.0.15m x 0.10m), bonded with a degraded grey/yellow sandy mortar. In plan the structure exhibited a slight recess, perhaps indicating a blocked entrance, approximately 0.60m wide.

- 6.3.4 Limestone wall 106 was subsequently utilised as the foundations for a brick wall, 107. Four courses of this structure survived above limestone wall 106, to a height of c.0.35m. The wall was of an irregular bond, with headers and stretchers incorporated in no obvious pattern. This suggests that the surviving portion of the brick wall represents below ground foundation courses. The bricks were regular machine made bricks suggesting a later 19<sup>th</sup> or early 20<sup>th</sup> century date for the wall.

**Plate 3:** Walls 106 and 107, at south end of service trench, looking west-south-west

- 7.2 Monitoring of the service trench also exposed an undated brick and stone structure, 106/107. The date of the stone footings is unclear, and could not be resolved either stratigraphically or artefactually, as there were no associated finds and no construction cut evident. The presence of a small recess (possibly a blocked doorway) in the stone structure suggests that it may represent a building, extending to the west, rather than a boundary wall. The later brick component of the structure comprised machine-made bricks and is likely to be of 19<sup>th</sup> or early 20<sup>th</sup> century date.
