**ARCHAEOLOGICAL EVALUATION REPORT:**  
**HOLY TRINITY COLLEGIATE CHURCH, TATTERSHALL,**  
**LINCOLNSHIRE**

Planning Reference: N/A  
NGR: TF 21215 57583  
Site Code: TAHT 10  
OASIS Reference Number: allenarc1-74253

By  
Allen Archaeology Limited  
Report Number 2010014

March 2010

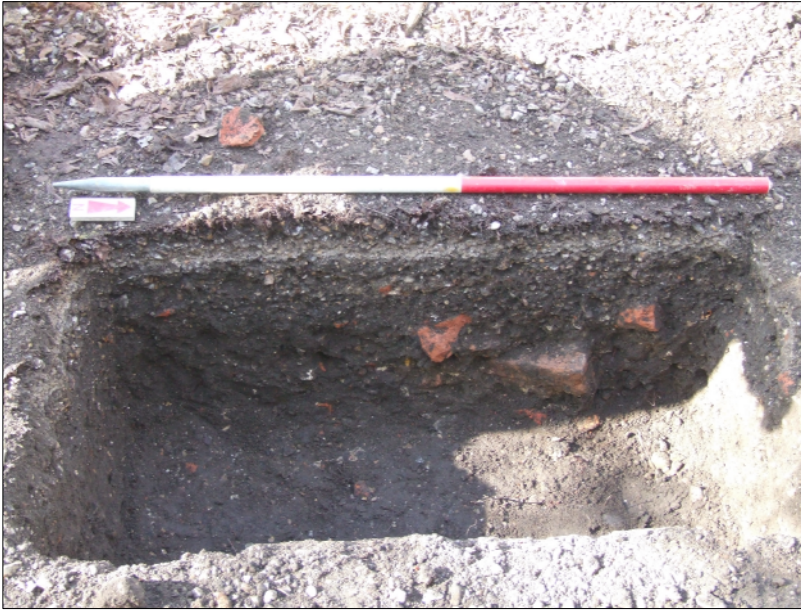
**Plate 1:** East facing section in Test Pit 1

6.1.1 Test Pit 1 was excavated to a depth of 0.43m, revealing three layers. The uppermost layer 100 comprised the modern gravel pathway, and it overlay made ground 101, a compact dark greyish brown silt. A fragmented and decorated late 18<sup>th</sup> century clay pipe was found within this context. 101 covered a build up of soil, 102, a dark greyish brown silt with occasional gravel.

6.1.2 The waste pipe was not identified within the test pit.

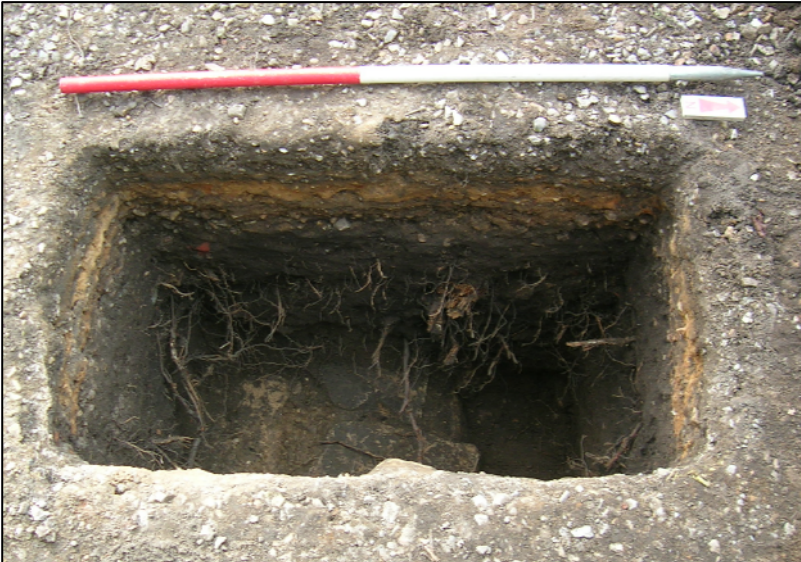
**Plate 2:** East facing section in Test Pit 2, showing probable stone wall 204, looking west

6.2.1 Test Pit 2 was excavated to a maximum depth of 0.96m. The uppermost layer 200 was the gravelled surface of the modern pathway. It sealed 201, a mix of re-deposited yellow sand and dark brown silt, identified as a bedding or levelling layer for the pathway. The underlying layer 202 consisted of a compact dark brown silt. Layer 202 sealed 203, a deposit of greyish dark brown silt with twelve fragments of bricks and tile ranging in date from the 13<sup>th</sup> to 18<sup>th</sup> century and 36 pottery sherds, most of which were dated to 17<sup>th</sup> – 18<sup>th</sup> century. The layer also contained fragments of late 18<sup>th</sup> century clay pipe, two fragments of 18<sup>th</sup> – 19<sup>th</sup> century window and bottle glass as well as a piece of window tracery made of Ancaster stone, the same material used to build the church.

6.2.2 At the base of the test pit was a stone structure, 204. This comprised several large, uncut, limestone blocks bonded with lime mortar. Due to the limited size of the trench, it was not clear whether the stone feature represented a wall or surface, although the former is perhaps the most likely due to the lack of wear on the surface of the stones. Adjacent to the stones was mid red brown silty sand with some gravel and stone inclusions, 205. This soil appeared to have formed against probable wall 204.

7.2 Test Pits 1 – 3 exhibited signs of a build up of soil in the 18<sup>th</sup> century, and in Test Pit 2 this was found to seal a stone wall running east to west at 0.84m below the modern ground surface (5.89m OD). The origin of this wall is unclear on the basis of the excavated evidence, however, historical references show that Ralph Lord Cromwell received permission to found a collegiate college in 1439, and until his death in 1456, the college used the existing parish church (OA 2009). Major construction then occurred in the years following Cromwell's death to create the college, although the chapel was not built until the 1470s. Although it has been suggested that the chapel (Holy Trinity Collegiate Church) was probably built on the foundations of the previous parish church (*ibid.*), it is possible that Holy Trinity was built adjacent, thus allowing the parish church to continue in use until its successor was completed. If this is the case then the stone wall exposed in Test Pit 2 may be associated with the earlier church. Another plausible theory is that it is the remains of a demolished building associated with the Alms Houses.

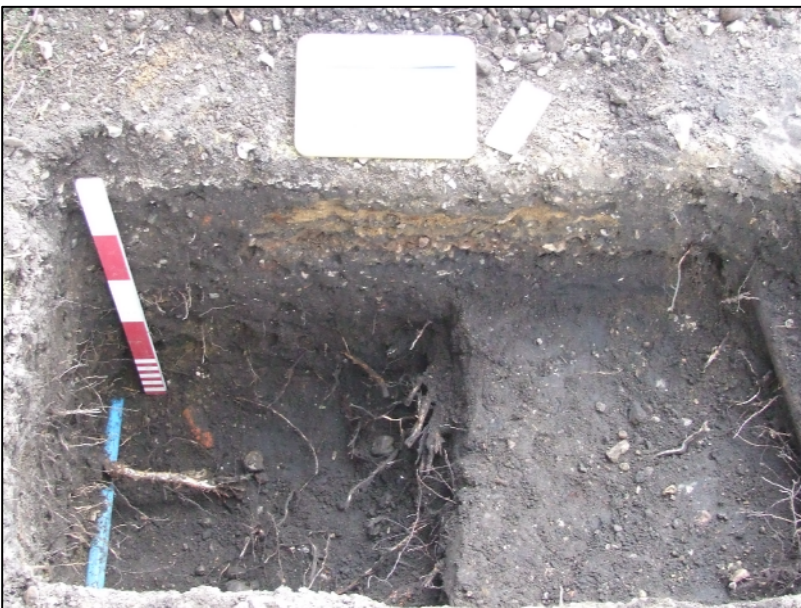
**Plate 3:** North-west facing section in Test Pit 3 showing water service [303] to the left and disused gas service [306] to the right, looking south-east

6.3.2 [303] ran north-west to south-east, with a steep edge and flat base, and contained the water pipe laid on its base, 0.48m below the modern ground surface. The pipe trench was backfilled with 304, a loose dark grey/brown silty sand with some gravel. The backfill contained intrusive post-medieval finds, comprising three fragments of brick and tile and seven pottery sherds of mid/late to late 18<sup>th</sup> century date.

6.3.3 The second linear, [306], ran north-west – south-east and contained a disused metal gas pipe within backfill 307. The backfill comprised loose dark grey/brown silty sand with occasional gravel that did not contain any artefacts.

6.3.5 Test Pit 3 did expose the water pipe running broadly north-west to south-east along the north-east edge of the excavation area. The blue plastic pipe was 0.48m below the existing ground surface (6.15m OD).

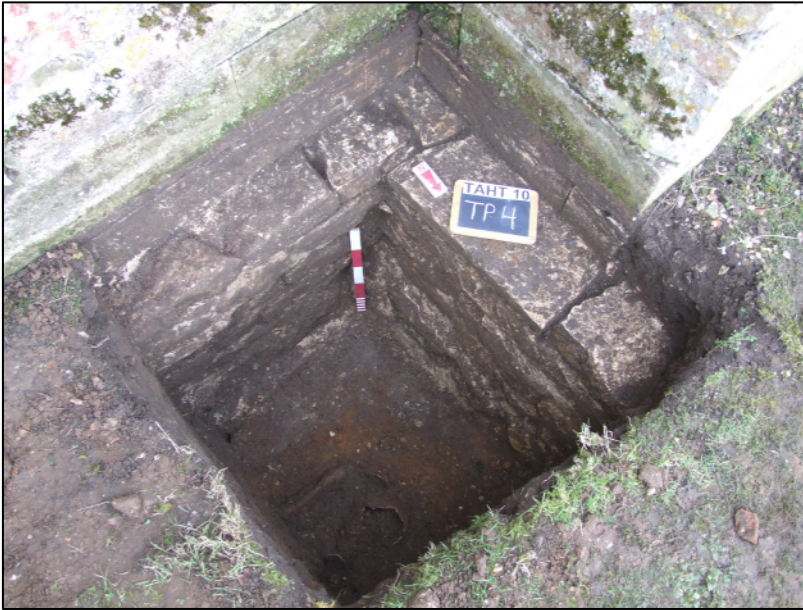
**Plate 4:** General shot of Test Pit 4 showing the church wall (top left of shot), buttress (top right of shot), foundations and burial, looking south-west

6.4.2 Cutting the graveyard soil was the foundation cut [403] for the north wall of the church. Within the cut was a protruding stone foundation 404 that followed the alignment of the northern wall and a buttress and is likely to have been constructed as a support for the wall above. Seven roughly hewn stone courses were exposed in the test pit, however the foundation continued further downwards, beyond the limit of excavation. The stones were not smooth dressed like the church wall 408 above ground level and the lime mortar bonding the stones was moist and slowly degrading. The backfill of the foundation cut, 405, was a fairly loose, slightly damp, dark greyish brown silty sand with moderate natural flint inclusions.

7.3 Test Pit 4 was excavated against the north wall of the church to examine the structure and attempt to provide information on why water is seeping into the church. This exposed natural sand and gravel geology at c.1.0m below the modern ground surface (c.5.15m OD). Overlying the natural geology was a graveyard soil which produced disarticulated human bones and ceramic building material dating to the 16<sup>th</sup> – 19<sup>th</sup> century. The soil also contained 15<sup>th</sup> century

- 7.5 In the southern and western side of Test Pit 4, a protruding rough cut stone foundation was exposed. This probably forms part of the foundation for the church north wall and an adjacent buttress, although it is noted that such foundations have not been seen elsewhere at the base of the church (Mr David Mullenger and Mr Graham Cook *pers. comm.*).

- 7.6 With regard to the issue of water entering the church, Test Pit 4 does not appear to have provided definite evidence for this. The ground level is higher than inside the church thus allowing groundwater to naturally form against the wall above the floor level. Also, it was noted during the evaluation that the foundations and where the northern wall meets the buttress were more water worn, including the lime mortar, perhaps allowing water between the stones more easily.

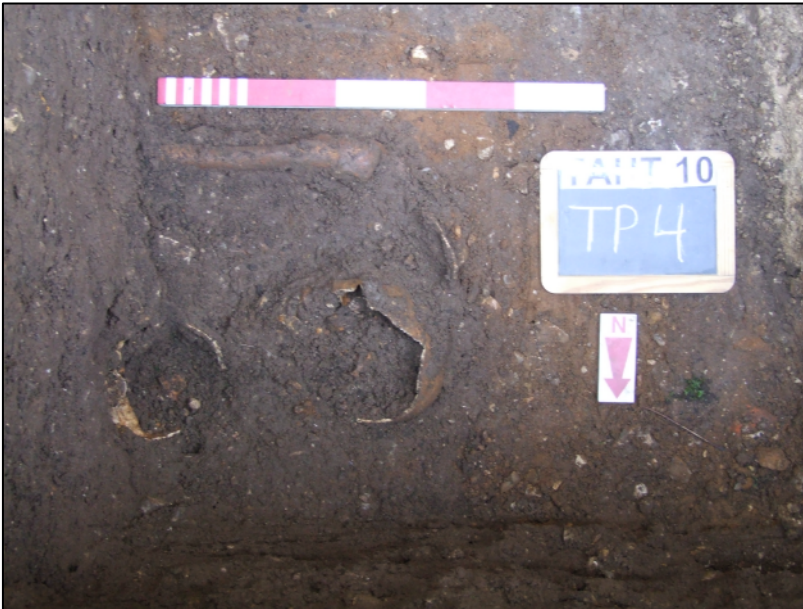
**Plate 5:** Close-up of east – west orientated inhumation [406] in Test Pit 4, looking south

6.4.3 The excavation also revealed the western end of an east – west aligned grave cut that contained at least one individual, and skull fragments from possibly two more. The grave cut was cut from an unknown depth within grave soil 401.

- 7.4 One grave was exposed at the bottom of the test pit and left in-situ. No cut for the grave was evident in section within the graveyard soil; however re-working of this soil has probably removed this evidence.

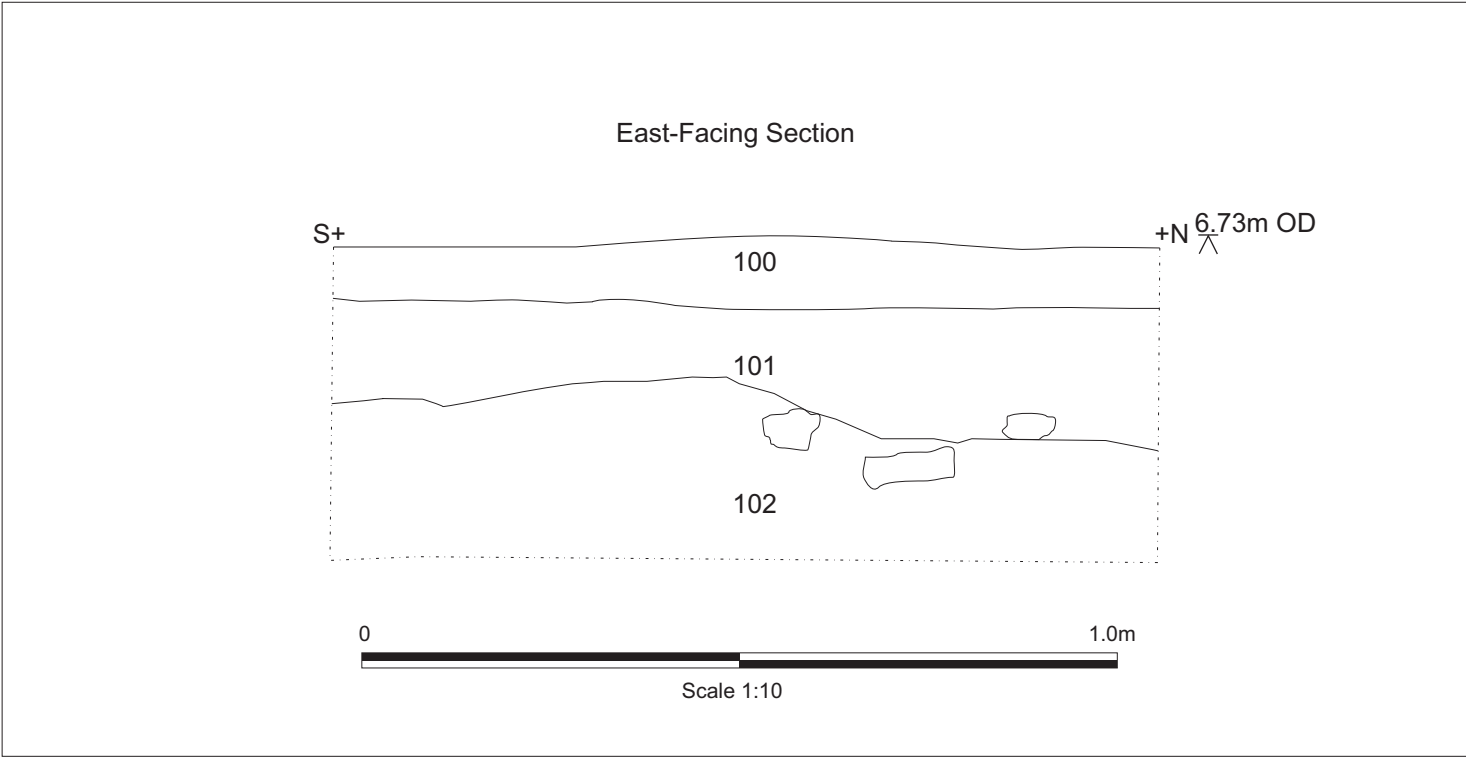
**Figure 3:** Test Pit 1 East-facing section at scale 1:10

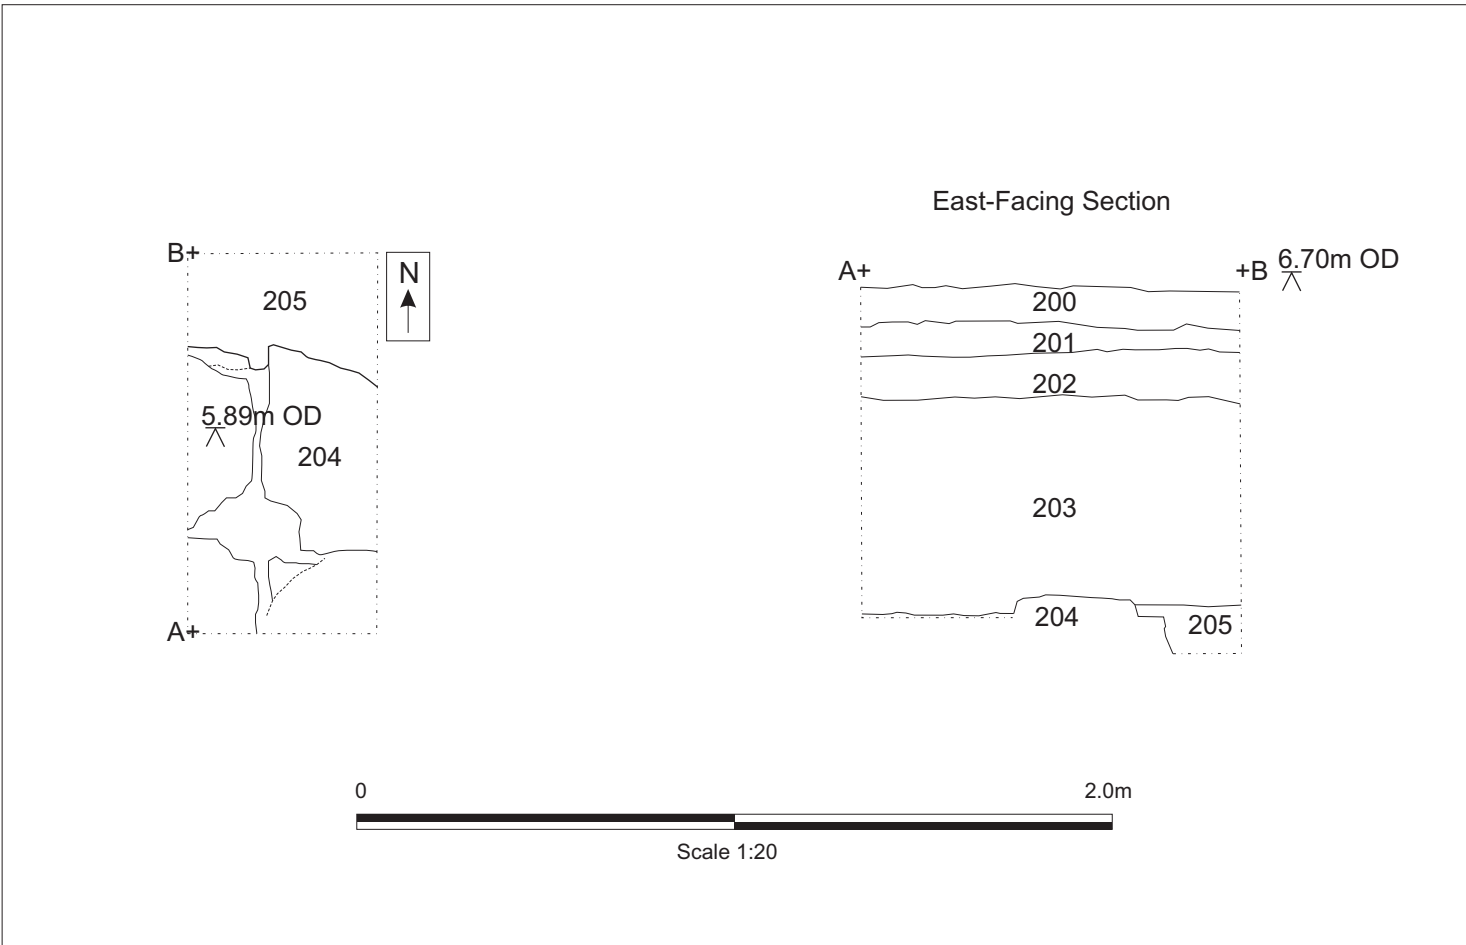
**Figure 4:** Test Pit 2 plan and sections at scale 1:20

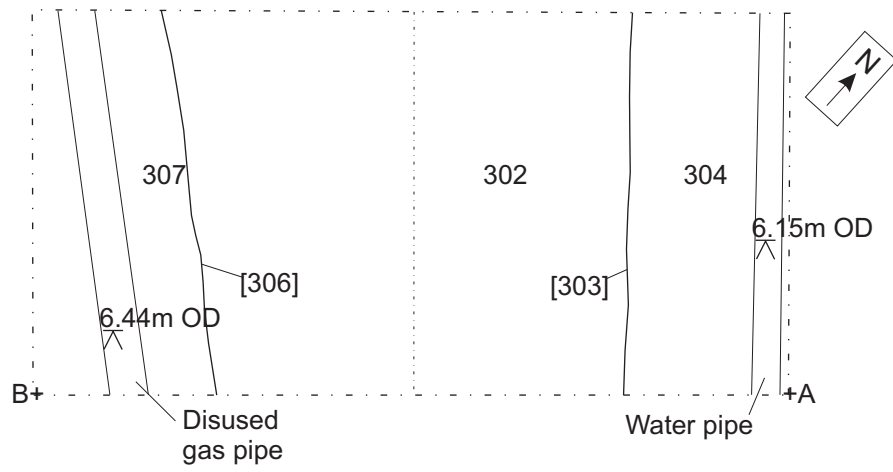
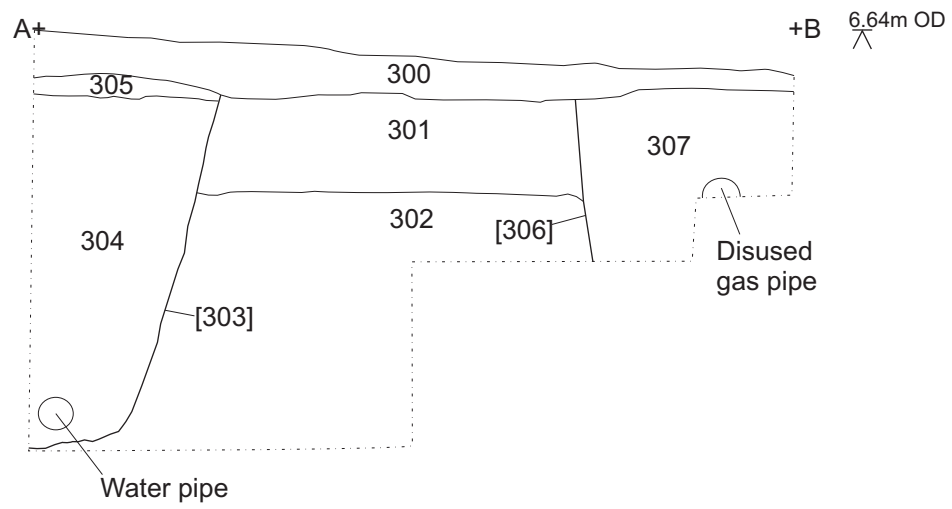
North-West Facing Section

Figure 5: Test Pit 3 plan and section at scale 1:10
