**HISTORIC BUILDING SURVEY REPORT:
STATHERN METHODIST CHAPEL, CHAPEL LANE
STATHERN, LEICESTERSHIRE**

Planning Reference: 10/00501/FUL

By
Allen Archaeology Limited
Report Number 2011001

January 2011

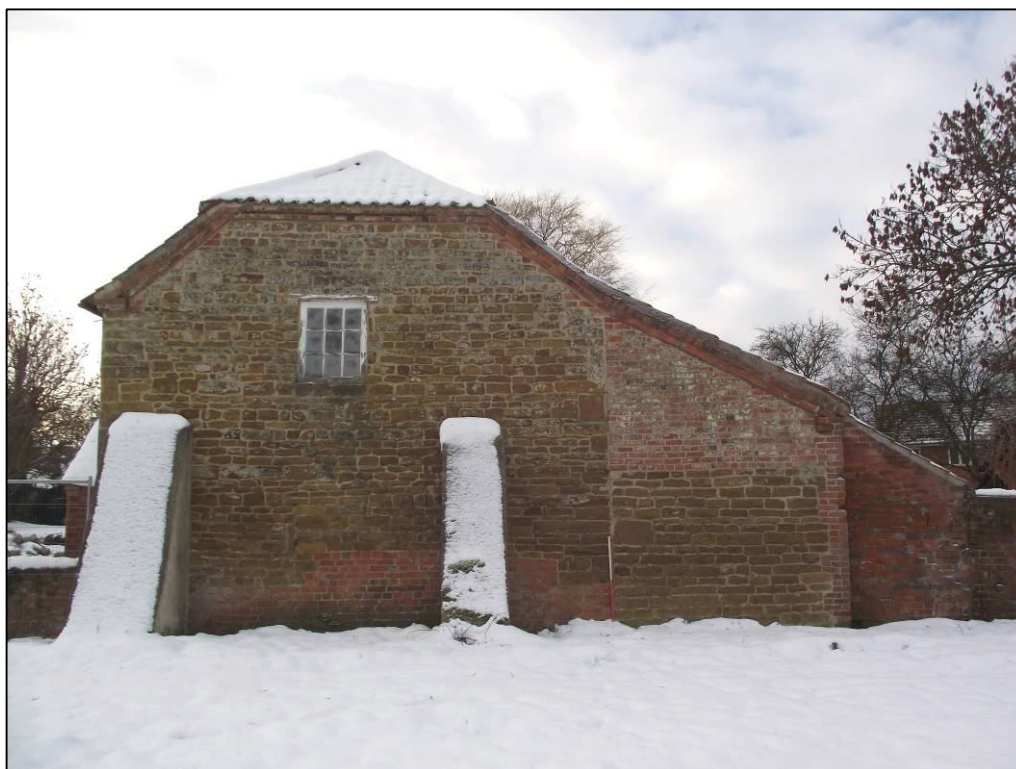
- 6.2 The north elevation is believed to be the earliest part of the building and the only surviving wall of the original dovecote. It consists of irregular, coursed ironstone blocks with thick mortar joints and large quoins, and a brick repair at the bottom of the wall. Two concrete buttresses have been added for support. To the west can be seen the north elevation of a later extension, built in coursed ironstone blocks with English Garden Wall brickwork above, and rusticated brick quoins. There is a single nine-light window with thin glazing bars in a wooden frame in this elevation (Plate 1).

Plate 1 (Shot 16): North elevation of the former chapel and brick outbuilding, looking south

- 7.1 The surviving building displays as many as five possible phases of development, beginning with the former dovecote which was used when the non-conformist preachers came to the village in the early 19th century. A conjectural plan of this phasing is shown in Figure 5.
- 7.2 The northern wall of the chapel was indicated in the heritage statement submitted in support of the planning application as the only surviving element of the original dovecote (Breslin 2010), and this is confirmed by the survey, although this too has been substantially altered. The dove holes, which are visible from the inside of the chapel have been blocked up from the outside and

a window has been added at a later stage. Several brickwork repairs are also evident, and the wall is supported by two concrete buttresses (Breslin 2010).

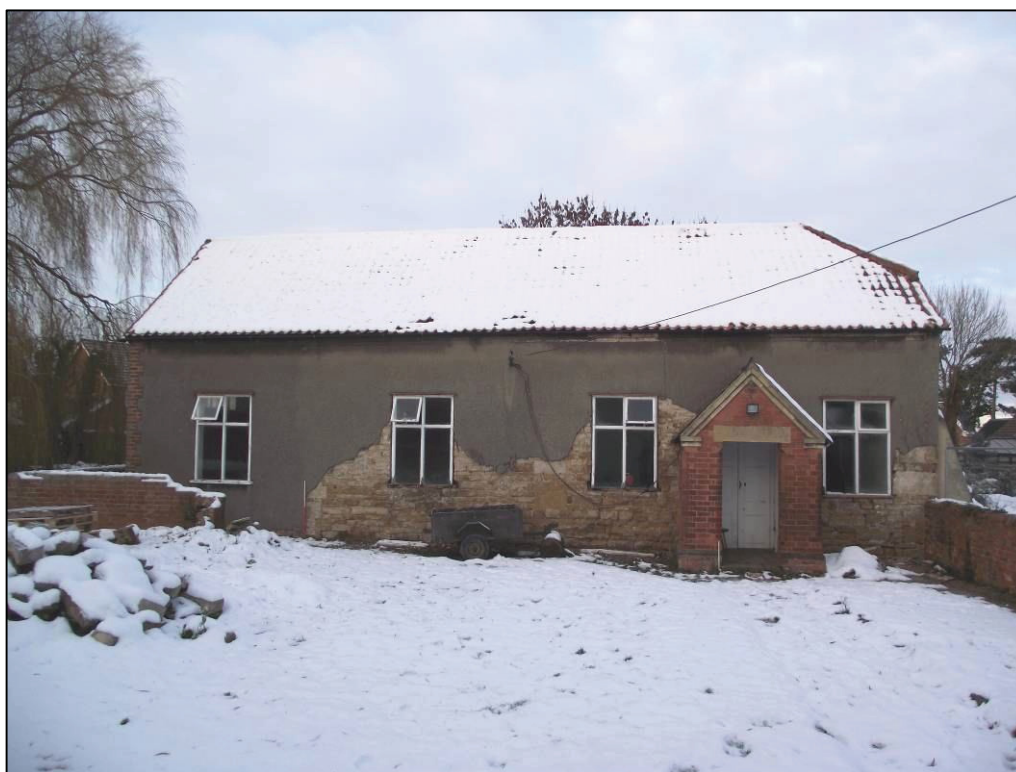
- 6.1 The former chapel is a single storey building. It has a double pitched gable roof, half-hipped at the north end, with a coverage of S-shaped ceramic pantiles. Brick coping runs along the roof line (Plates 1 and 2).

- 6.3 The east elevation is partially covered in a concrete render, and where it has been removed an underlying steel mesh is visible, originally held in place with metal pegs. Where the render has been removed the elevation displays evidence for three phases of development. The majority of the elevation is built in regular coursed limestone, representing the earliest two phases. A noticeable joint indicates where the later extension from 1832 abuts the earlier 1825 chapel to the north (Plate 3). Large dressed quoins to the right of this joint indicate the original south-eastern corner of the early chapel (Plate 3). Further to the south is the rendered brickwork of the 1956 extension, with rusticated brick quoins (Plate 2).

- 6.5 Also in the east elevation are four tall windows in wooden frames, each with three fixed lights and one top opening casement window (Plates 2 and 4).

Plate 2 (Shot 1): East elevation of the chapel, looking east

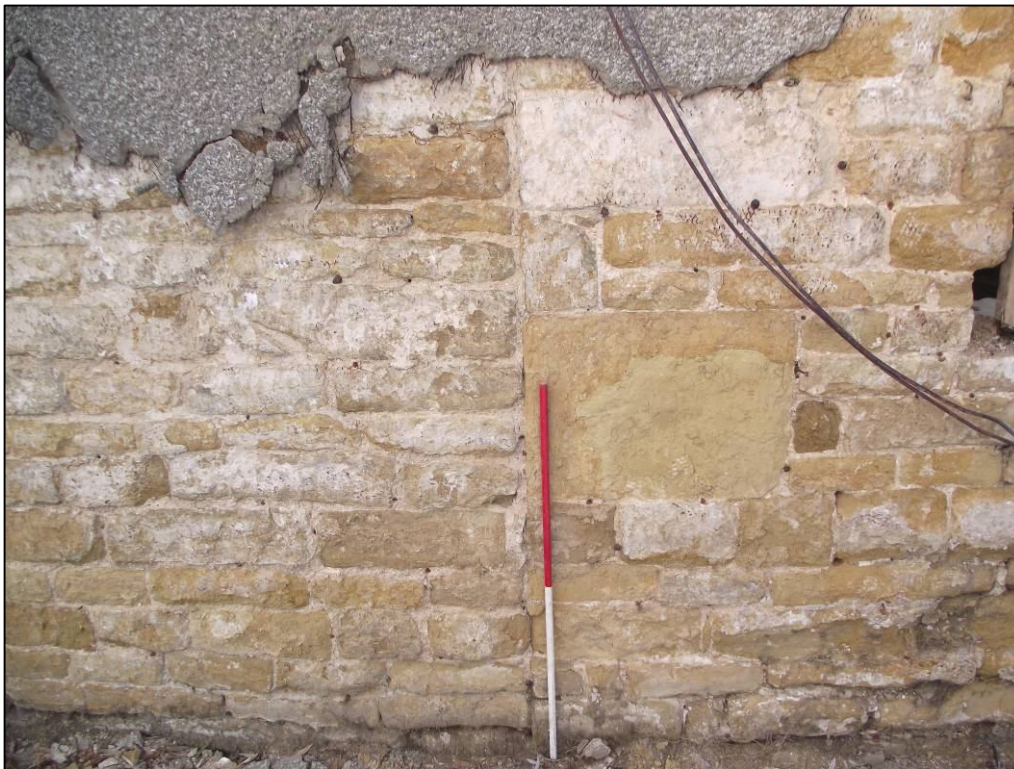
- 7.4 The chapel was then extended to the south and west seven years later (Phase 3), and the join in the two phases of construction are evident on the east elevation (Plate 3). It is possible that the coal shed attached to the west elevation and the adjacent outbuilding are also of this date, as the brickwork is very similar to that exposed in the south elevation of the chapel.

Plate 3 (Shot 14): Detail of east elevation showing joint between two early building phases of the chapel. Notice the large quoins to the right representing the corner of the early chapel

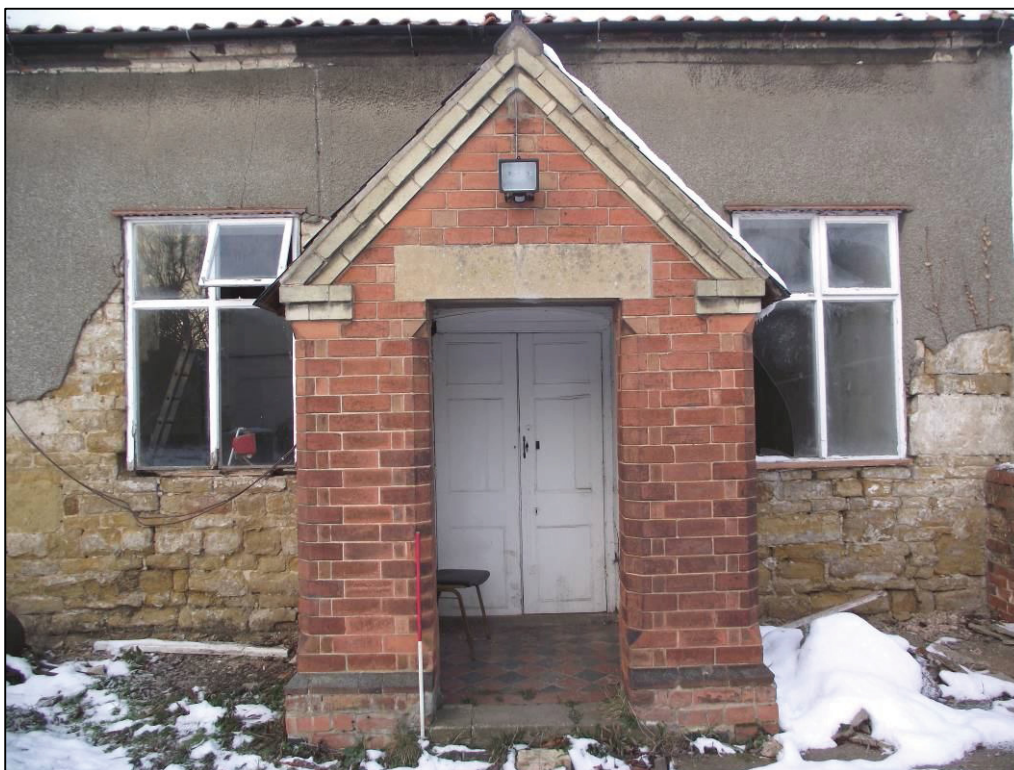
- 6.4 The eastern elevation also includes the later addition of a brick porch, with a brick plinth, an open pediment gable and a stone lintel. Angle bricks have been used on the corners of the porch and red and black quarry tiles cover the porch floor, leading up to a six-panelled wooden door which forms the entrance to the chapel. The roof of the porch is a double pitched pantile roof (Plate 4). The porch is stylistically too late to be associated with the 1825 or 1832 building phases, and may be a late 19th or early 20th century addition.

- 7.5 The next phase identified, Phase 4, relates to the addition of a brick porch on the east elevation. The porch uses better quality machine made bricks with a much finer fabric than the coarser slightly irregular bricks used for the outbuildings and the south elevation of the kitchen. Although undated, it is stylistically of a late 19th or early 20th century form, and therefore does not belong to any of the documented phases of development in 1825, 1832 or 1956.

Plate 4 (Shot 3): Detail of brick porch on east elevation, looking west

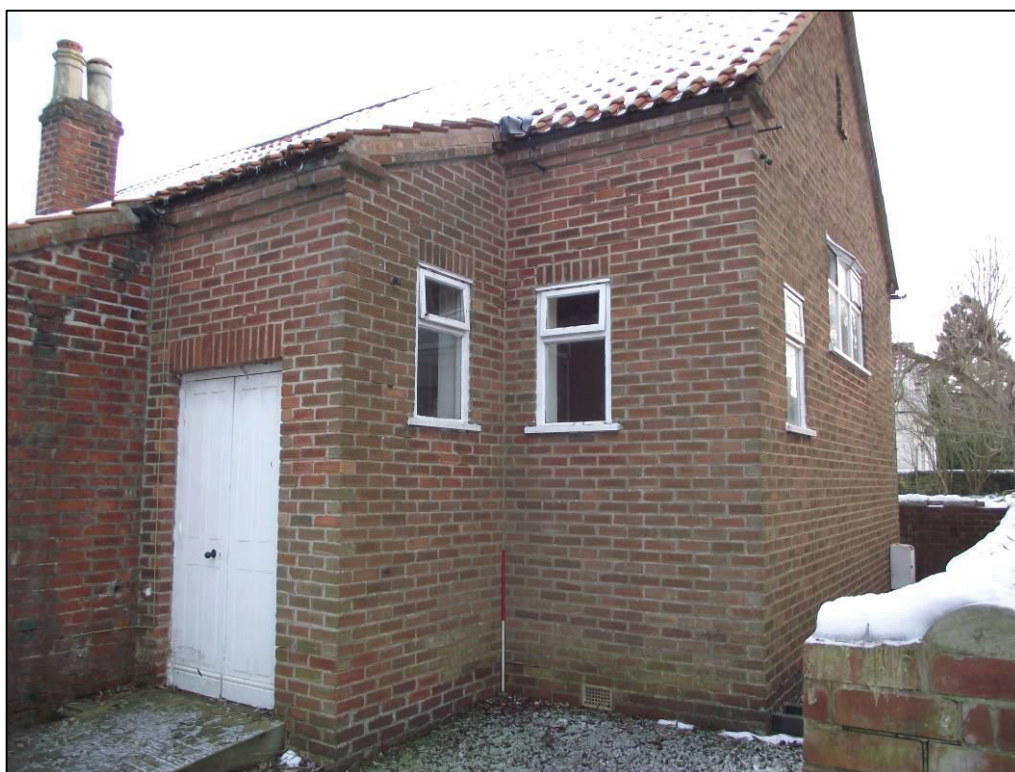
- 6.6 The latest additions of 1956 are at the south end of the building, built in stretcher bond brickwork. This component of the building has three two-light windows, each with a single top opening casement, as well as a six-light window with two top opening casements. Within the eaves on the south elevation there is a small rectangular opening, perhaps being a decorative feature reflecting the former use of part of the chapel as a dovecote. All the openings in this part of the building have flat brick soldier arches (Plate 5).

- 7.6 The final phase of construction (Phase 5) is represented by the 1956 brick extension at the south end of the chapel. The concrete render is likely to be an addition of this date, as well as the windows in the east and west elevations of the earlier chapel phases. It seems likely that the kitchen area was subject to internal alterations at this time as well.

Plate 5 (Shot 6): Latest phase of extensions at south end of chapel, looking north-east. Note south elevation of earlier extension to left of shot

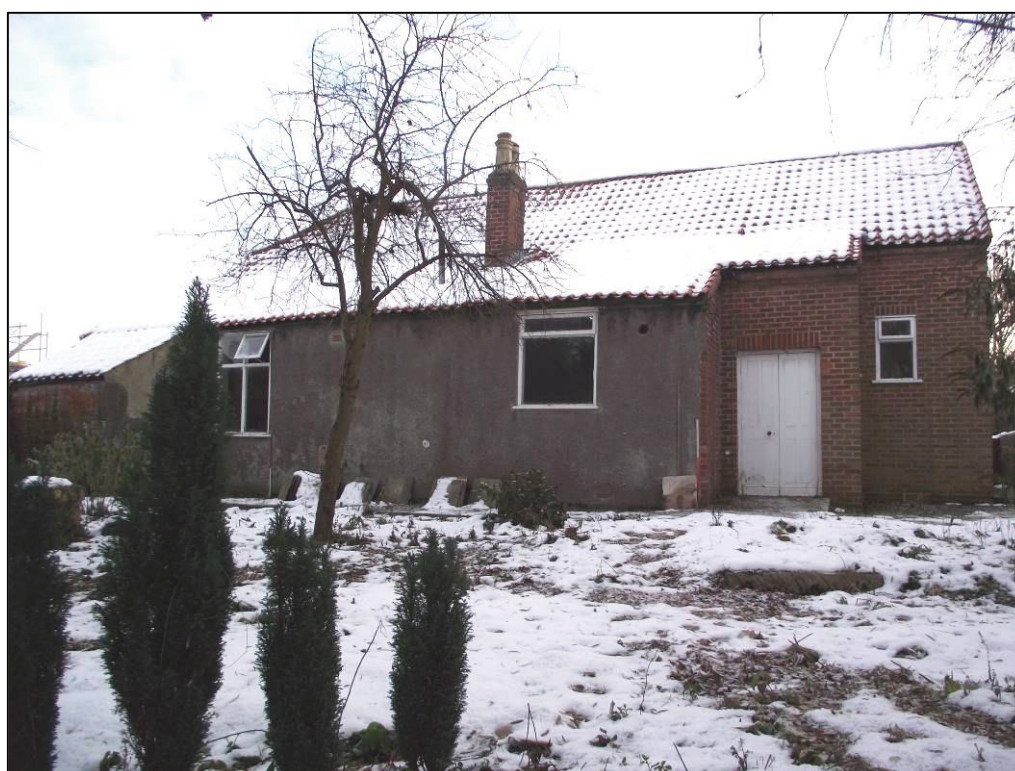
- 6.7 The remainder of the west elevation is covered in concrete render, except for the south elevation of the kitchen block, which is built of a brickwork that is noticeably older than the adjacent extensions. It seems likely that this part of the building was converted into a kitchen during the latest phase of extension in 1956.

- 6.8 There are two further windows in the west elevation; a two light window in the kitchen with a single large fixed light below and a top opening casement above, with a four light window with a small top opening casement further to the north looking into the chapel itself, which is identical to the windows in the east elevation.

Plate 6 (Shot 8): West elevation of chapel, looking east-north-east

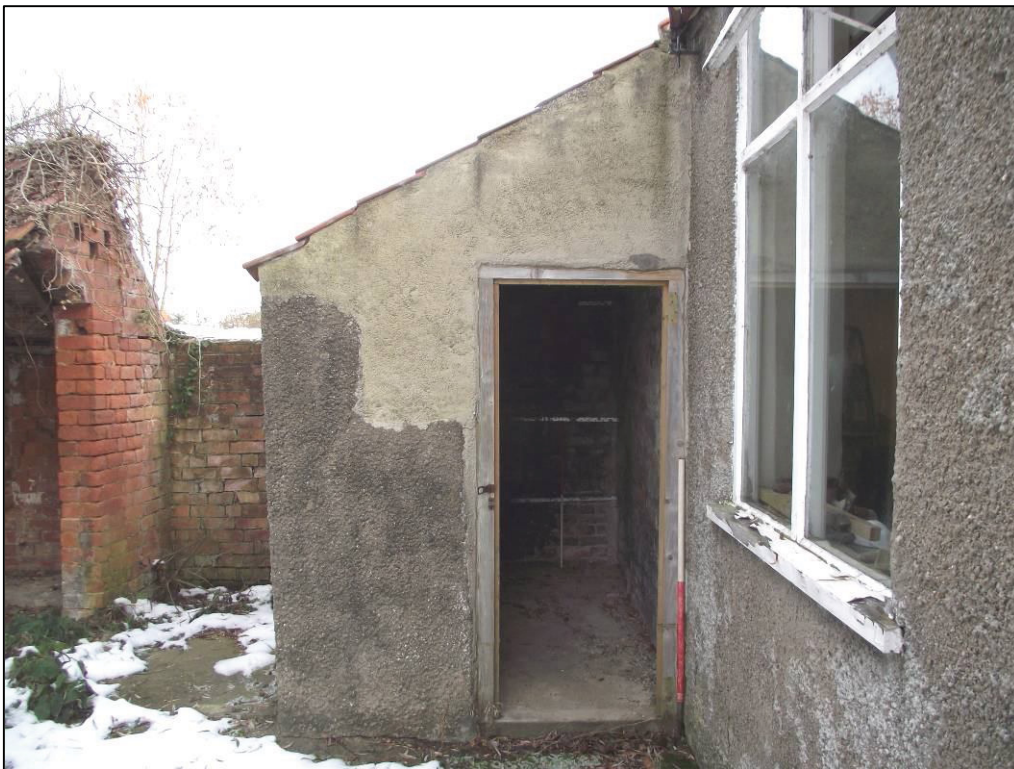
- 6.9 There is a brick built coal store on the north-west corner of the structure, covered by a pitched roof and rendered on its south elevation (Plate 7). There is a single opening on the south elevation. There is another derelict brick outbuilding to the west with a double pitched pantile roof (Plate 8).

Plate 7 (Shot 9): General view of the concrete rendered coal shed on the north-west corner of the building. Looking north.

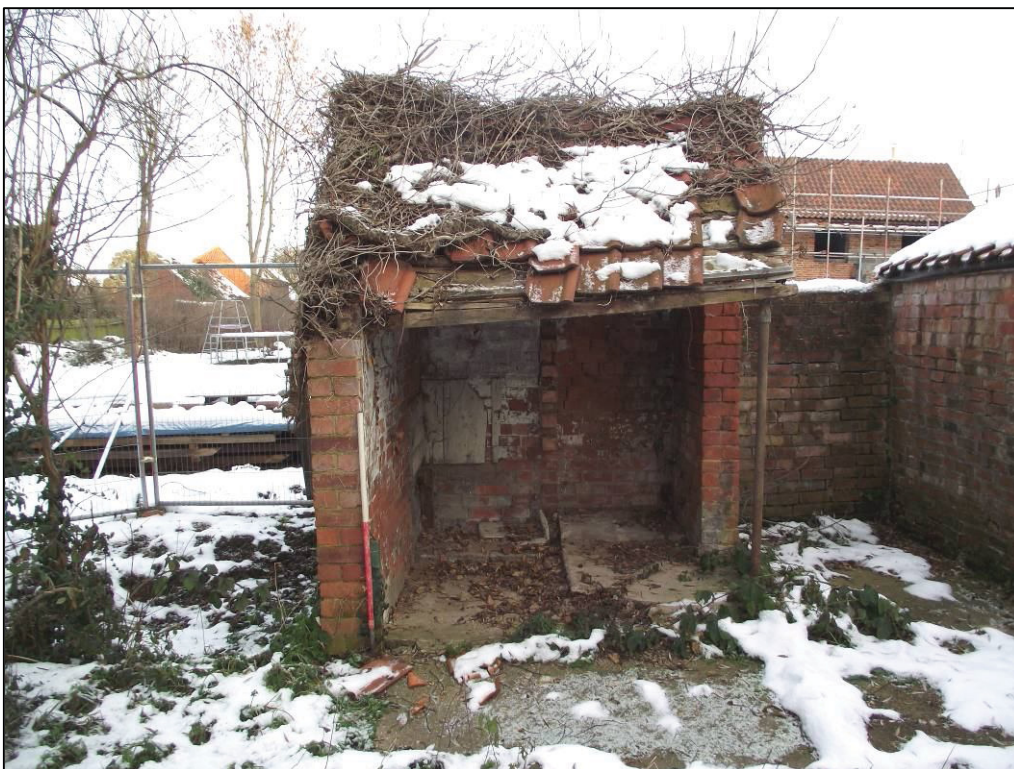
Plate 8 (Shot 11): Derelict brick outbuilding adjacent to the coal store. Looking north

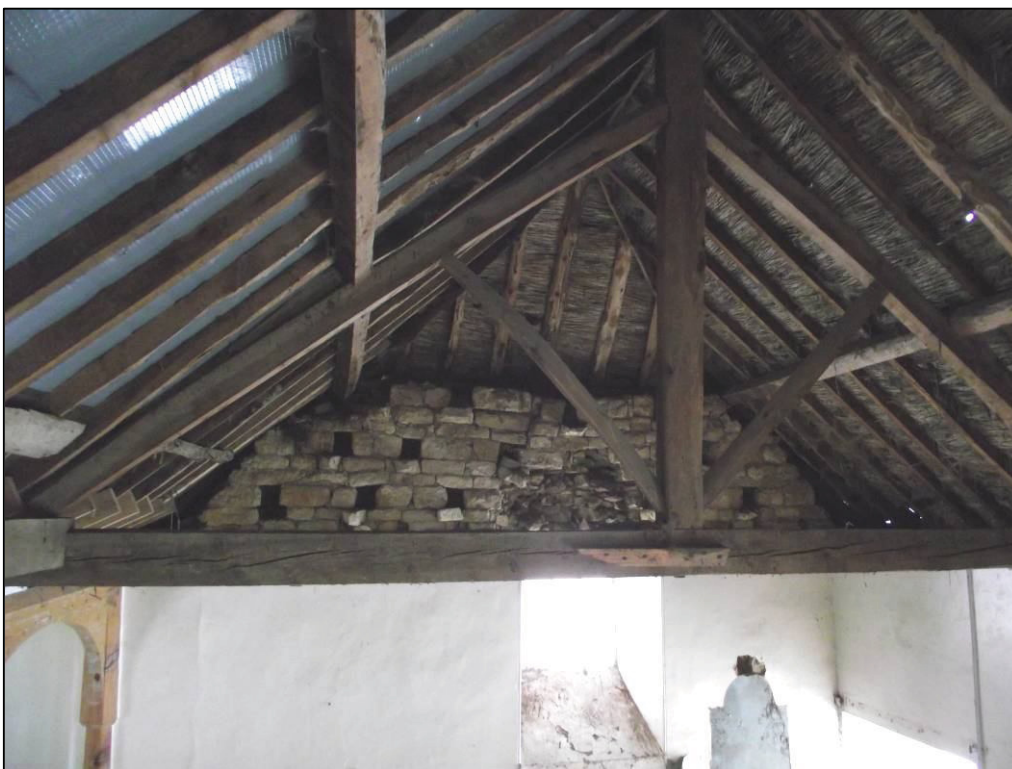
- 6.10 The internal roof structure of the building comprises kingpost roof trusses, supporting principal rafters with through purlins. Straw insulation is visible below the roof tiles throughout most of the structure with plastic sheeting covering part of the western half of the roof. At the north end of the building above the roof line are a number of square dove holes which have been blocked off from the outside, probably when the structure was converted into a chapel. Traces of a possible psalm plate can also be seen on the northern wall (Plate 9).

Plate 9 (Shot 20): Interior roof structure of the converted dovecote, also showing dove holes and the traces of a psalm plate to the right of the window, looking north

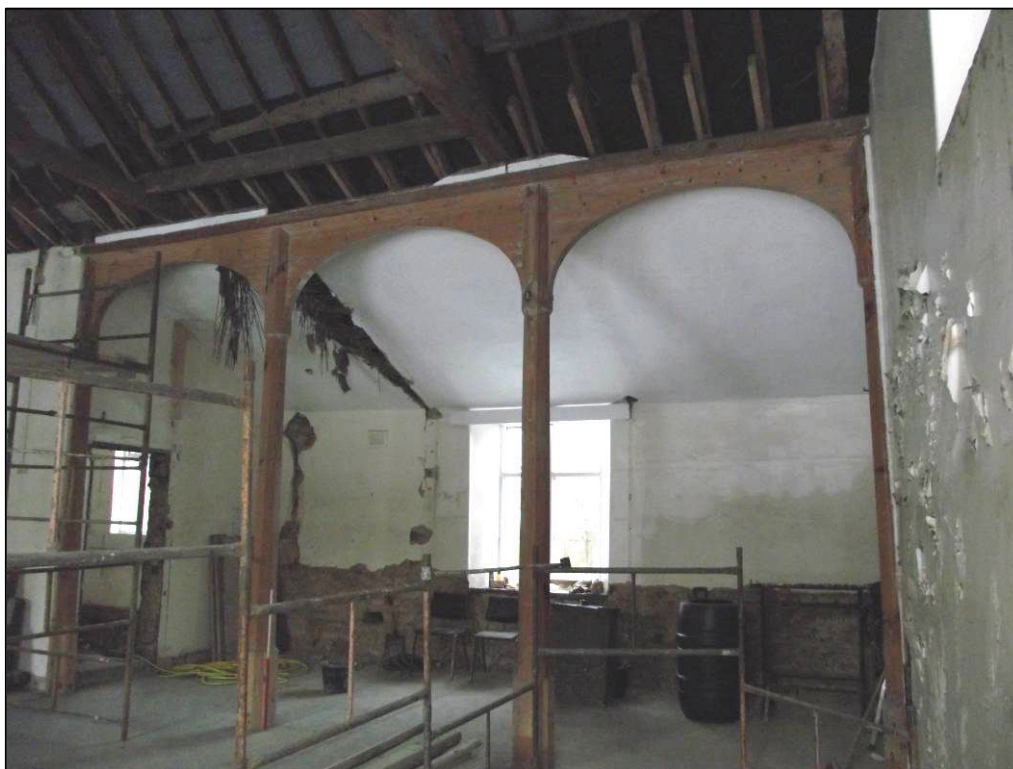
Plate 11 (Shot 25): Wooden arcade dividing the north-west corner of the chapel. Doorway to the left of shot leads to the kitchen. Looking west-south-west
