## Appendix 2: Photographic Archive List

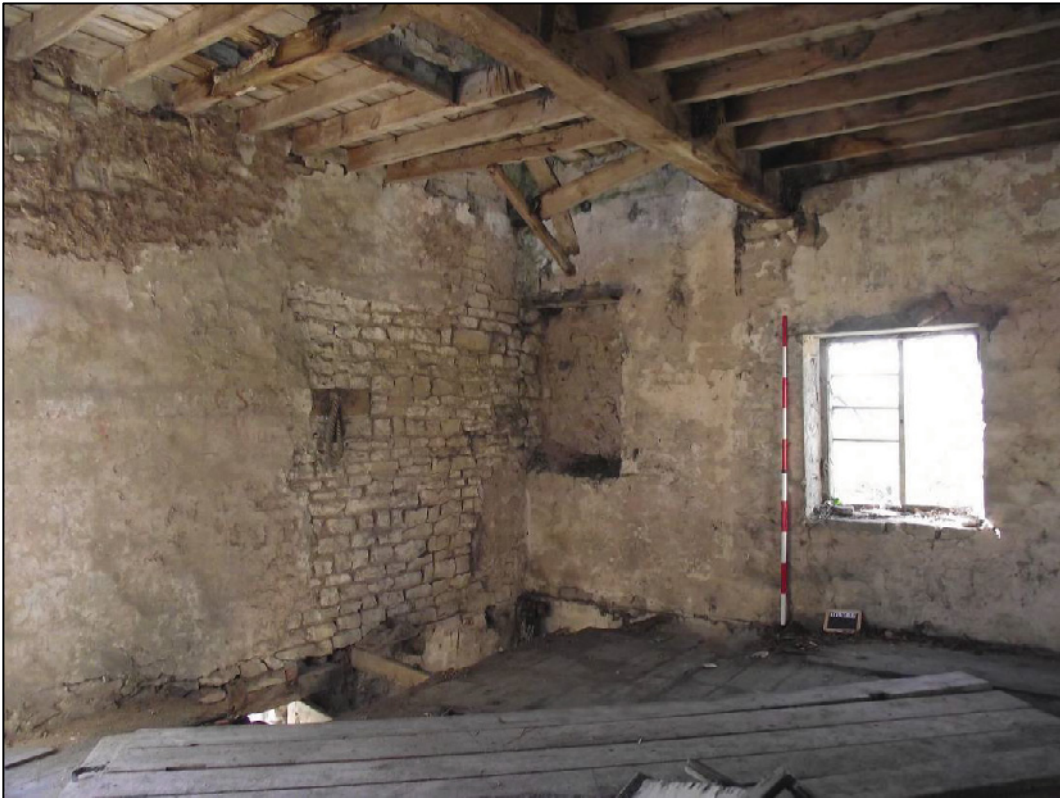
**Plate 29 (Shot 57):** General shot of first floor south and west elevations, showing holes in the floor, the recess in the west elevation and exposed limestone walls where the plaster has fallen off. Looking south-west

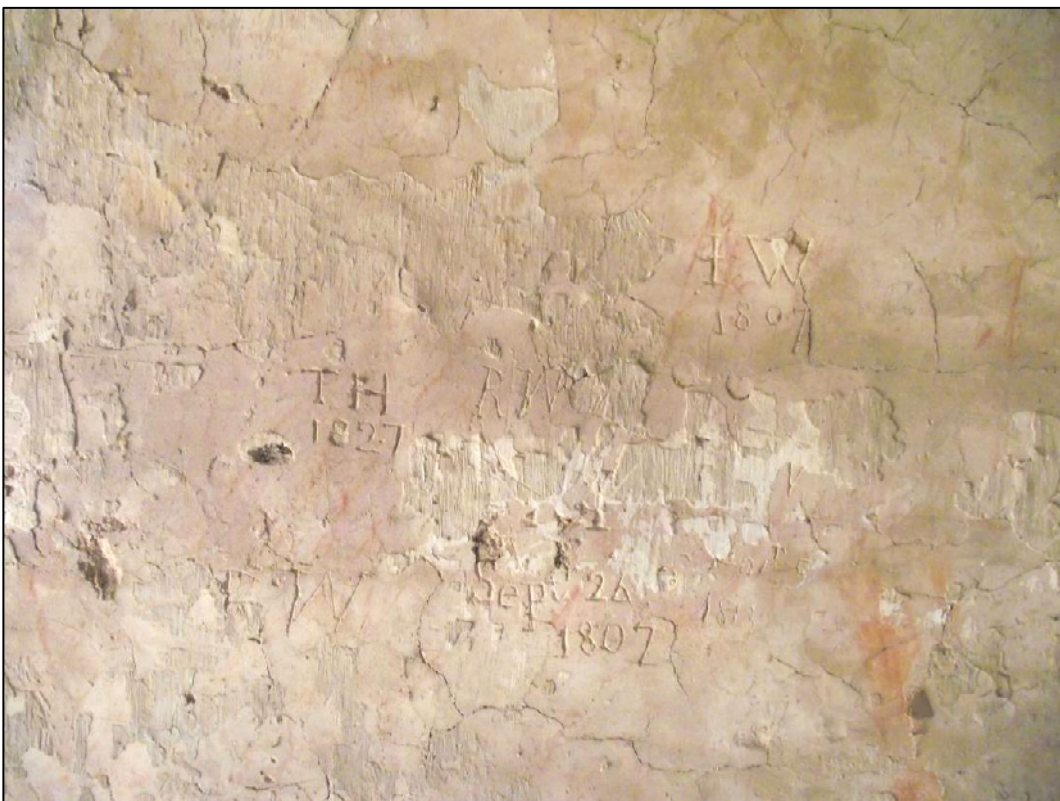
**Plate 30 (Shot 69):** Detail of graffiti on first floor south elevation ('graffiti reads 'IW 1807', 'TH 1827', 'RW', 'F(?) W', 'Sept 26 1807', '01', '5', '1813'). Looking south

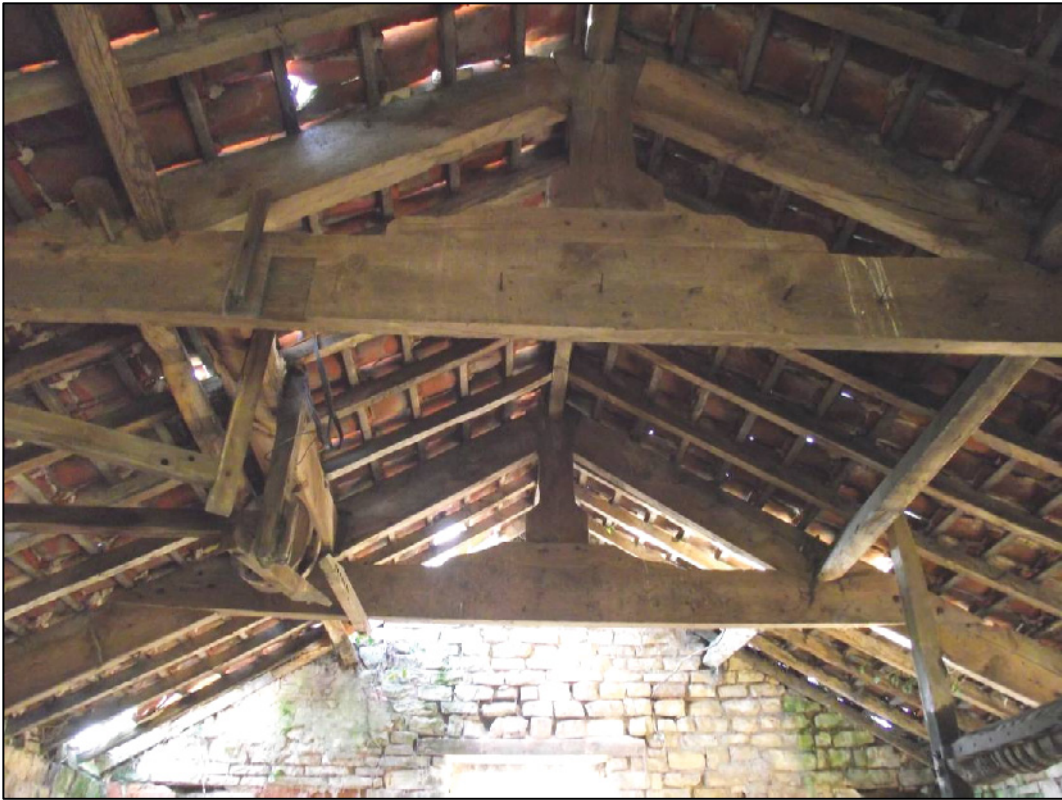
**Plate 31 (Shot 58):** General shot of roof structure, also showing pulley to the left. Looking west

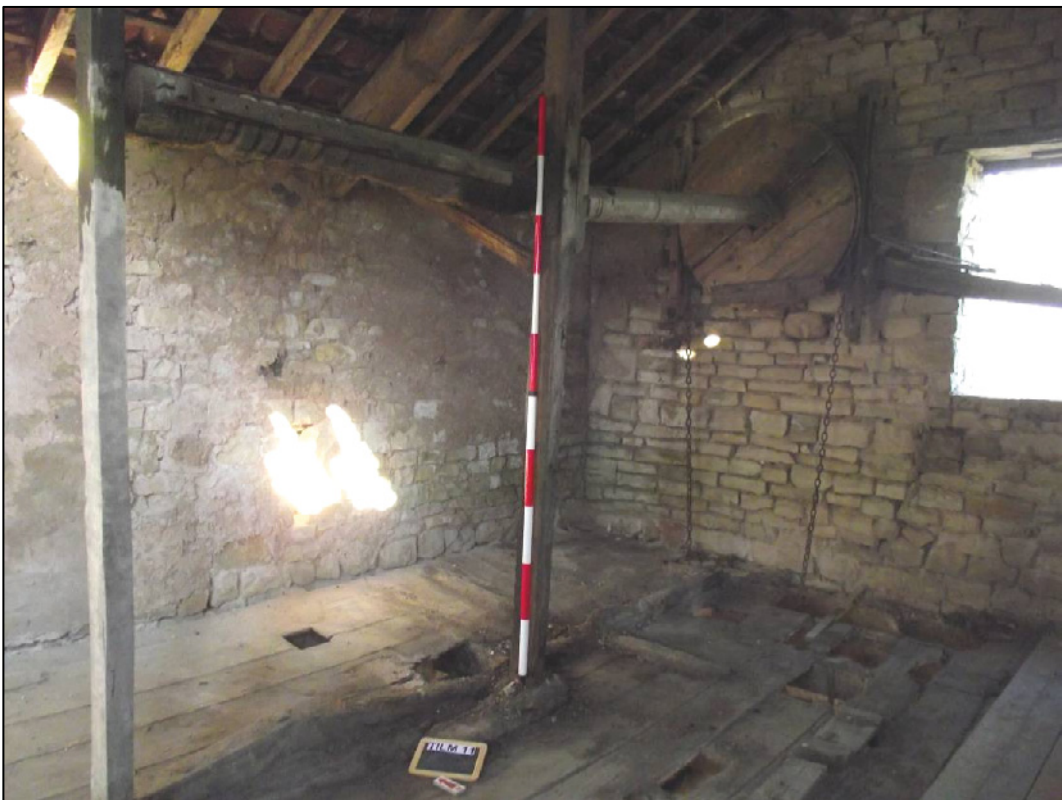
**Plate 32 (Shot 62):** General shot of sack hoist machinery on second floor. Looking north-east

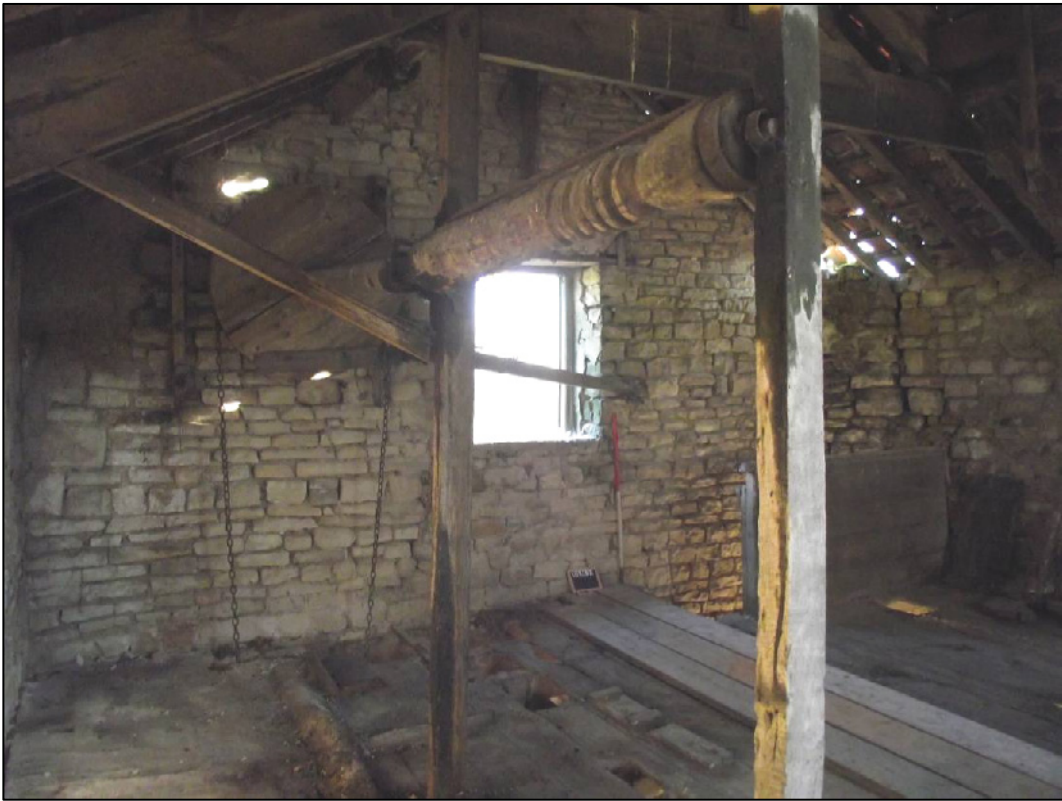
**Plate 33 (Shot 54):** General shot of sack hoist machinery and staircase in the south-east corner leading down to first floor. Looking east-south-east

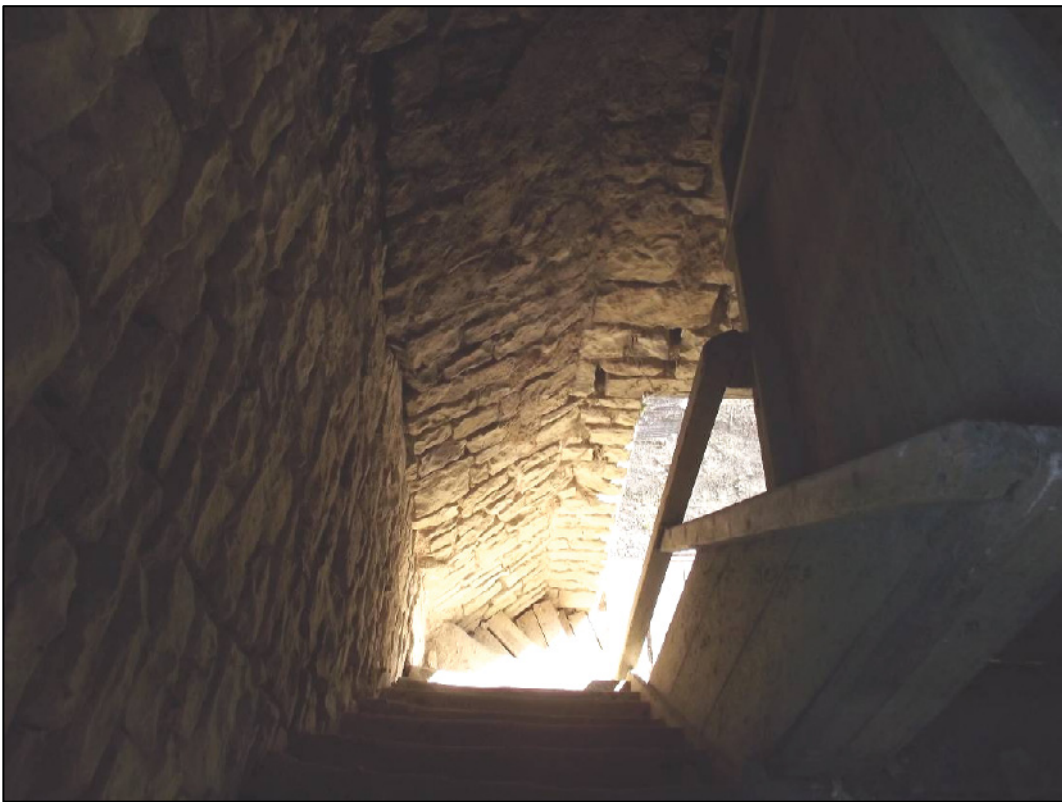
**Plate 34 (Shot 67):** General shot looking down the staircase to first floor. Looking south. Note internal buttressing in the angle of the two walls

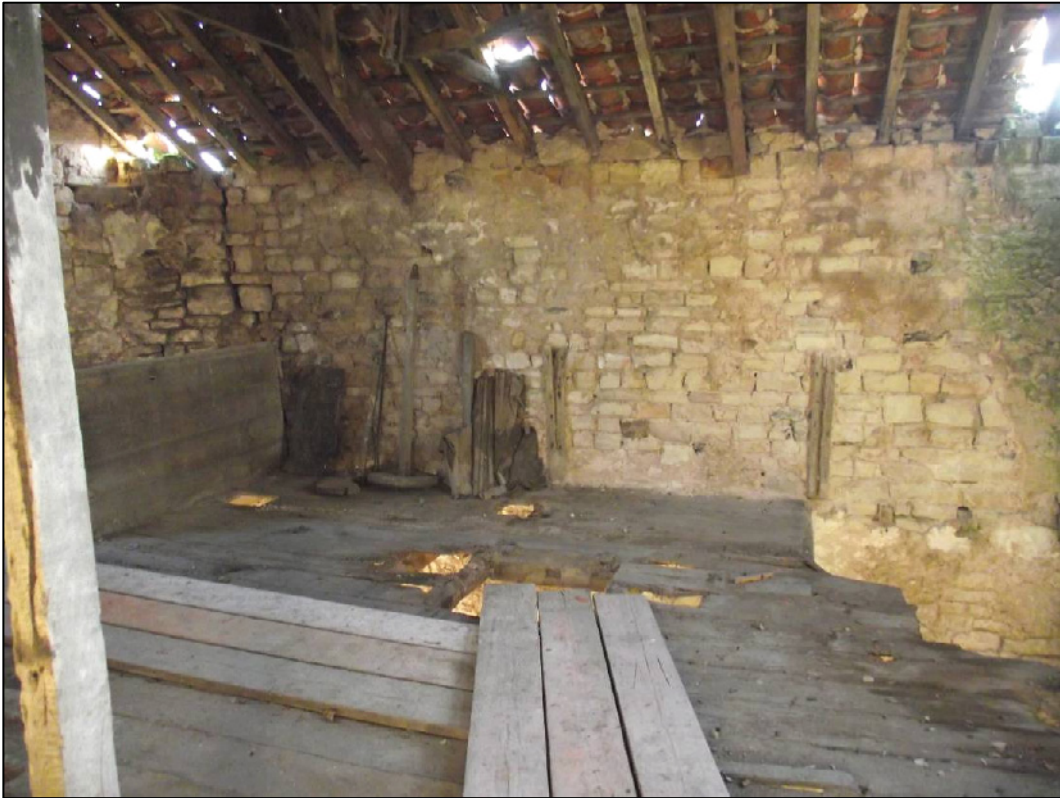
**Plate 35 (Shot 64):** Second floor, looking south-south-east showing tools and fittings against south wall and voids in the floor

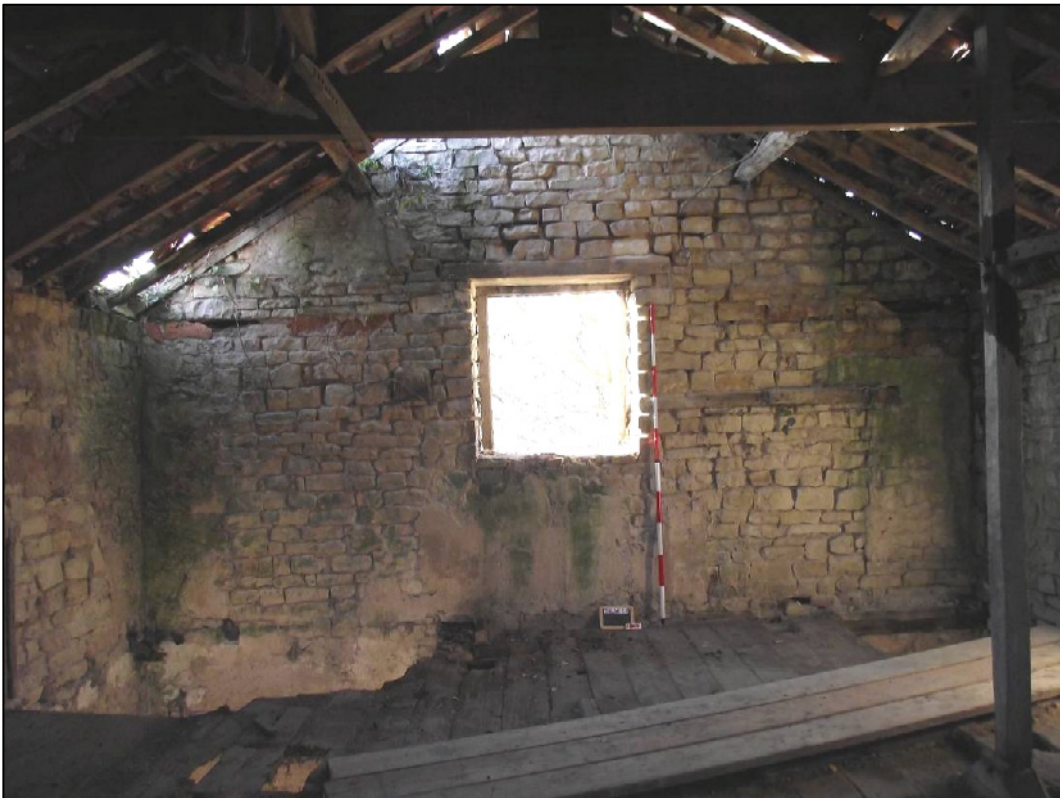
**Plate 36 (Shot 66):** General shot of west elevation on second floor. Looking west
