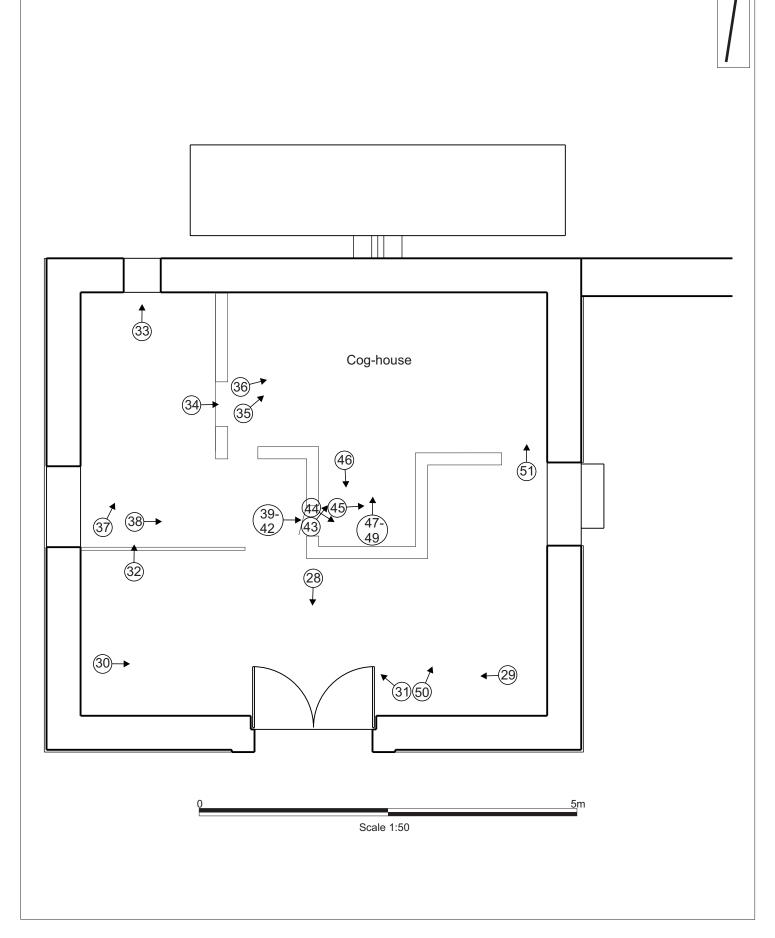
**Figure 3:** Plan showing location and orientation of photographs taken on ground floor at scale 1:50 (Survey drawings provided by Scorer and Hawkins)

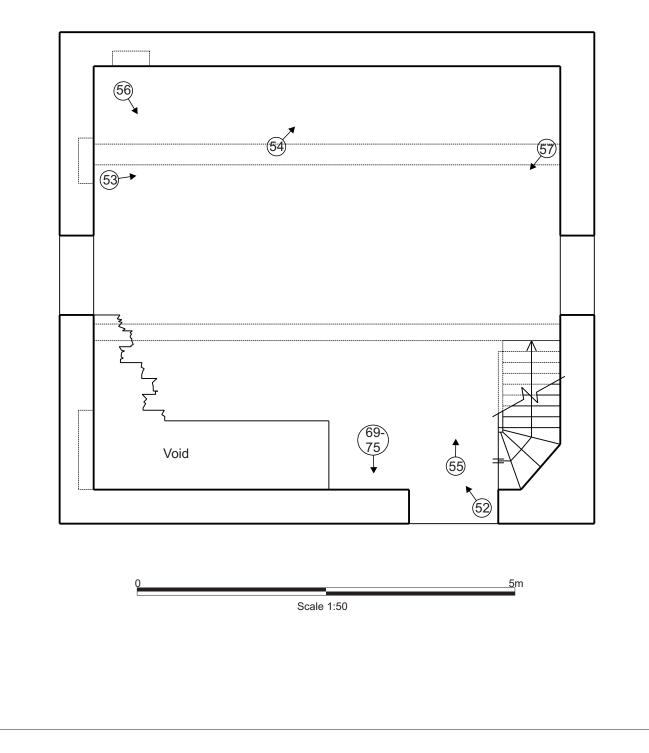
Figure 4: Plan showing location and orientation of photographs taken on first floor at scale 1:50 (Survey drawings provided by Scorer and Hawkins)

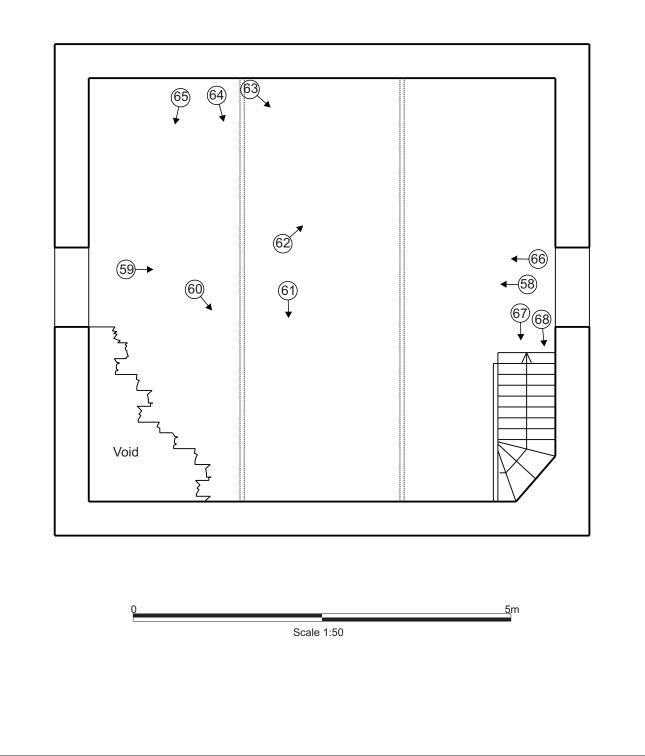
**Figure 5:** Plan showing location and orientation of photographs taken on second floor at scale 1:50 (Survey drawings provided by Scorer and Hawkins)

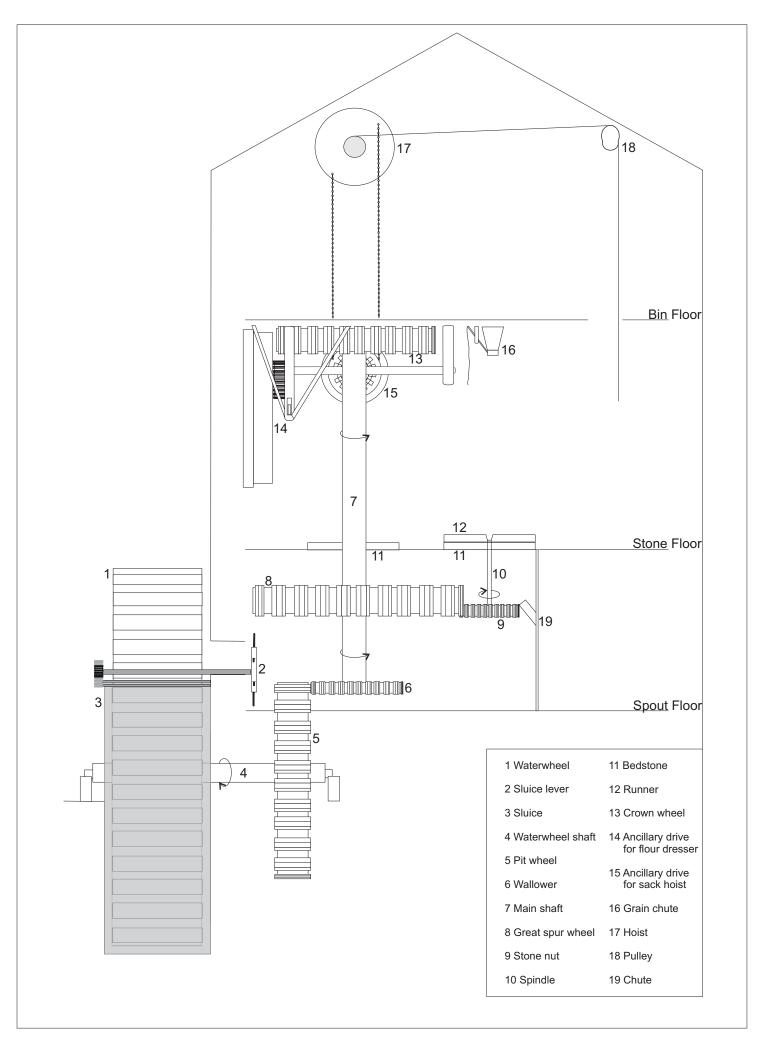
**Figure 8:** Schematic diagram of ancillary machinery for flour dresser and sack hoist, looking north (not to scale). For diagram of machinery below see Figure 7.
