**REPORT ON AN HISTORIC BUILDING SURVEY AND
ARCHAEOLOGICAL WATCHING BRIEF: THE SWILL, LEICESTER ROAD,
THORNHAUGH, PETERBOROUGH, CAMBRIDGESHIRE**

Planning Application Reference: 09/01464/FUL

By
Allen Archaeology Limited
Report Number 2011032

May 2011

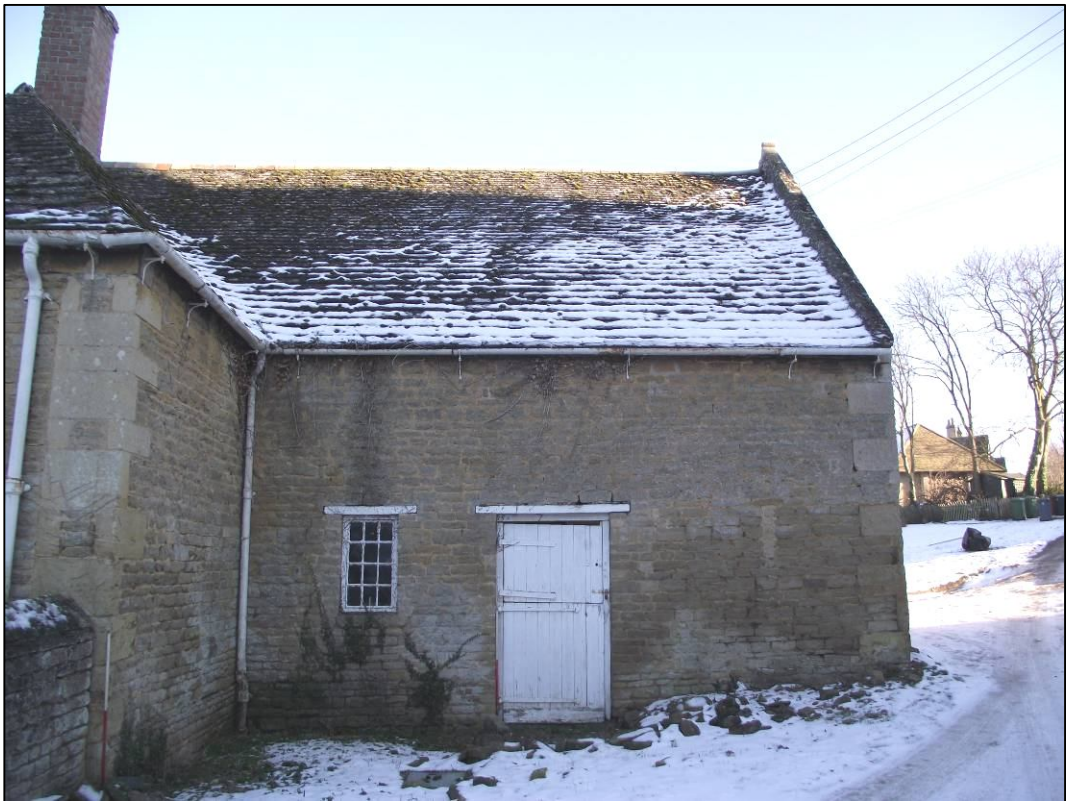
Plate 1 (Shot 1): South-west elevation of eastern range also showing the corner of the possible later extension to the left, looking north-east

- 6.2 It is constructed in coursed irregular squared limestone bonded with lime mortar with large stone quoins on the corners. The roof is double pitched apart from a block extending from the south-west elevation with a hipped roof. Collyweston slate tiles cover the entire roof, with stone coping on the south-eastern gable (Plates 1, 2 and 4).

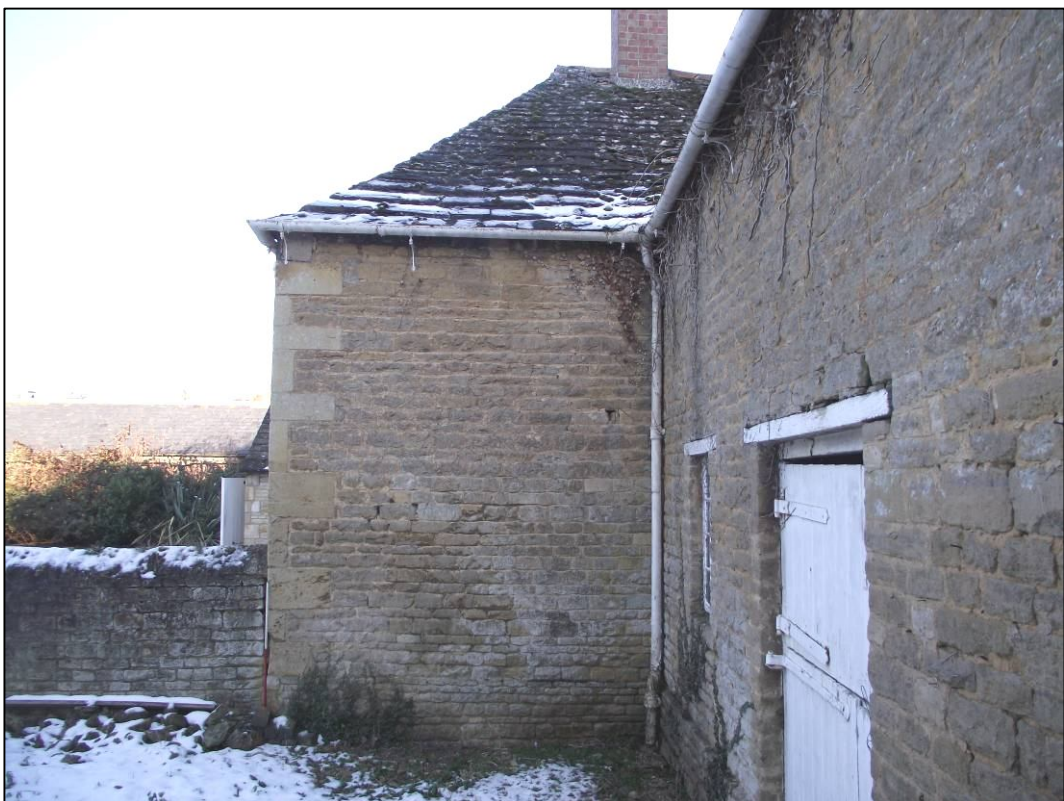
Plate 2 (Shot 3): South-east elevation of the tack room showing half-hipped roof. The brick chimney is a later addition. Looking north-west

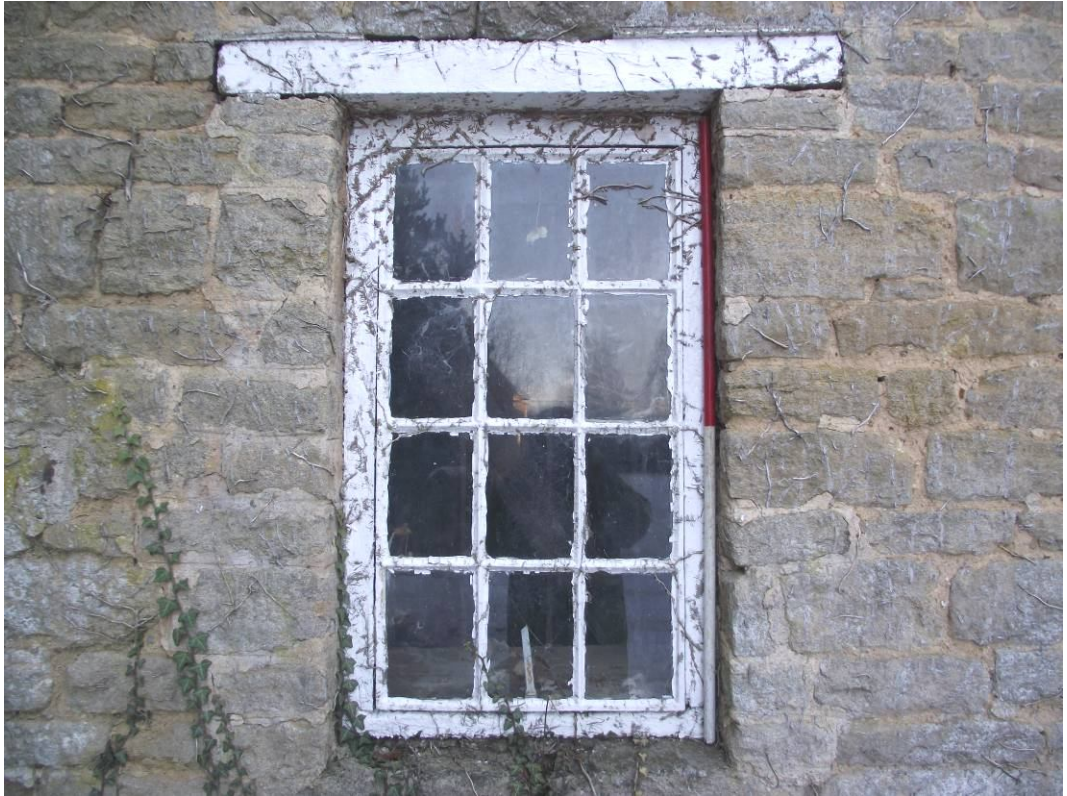
Plate 3 (Shot 4): Detail of window on south-west elevation, looking north-east

- 6.3 The south-west elevation has a single wooden door opening with a wooden lintel above. All ventilation holes on the building have been blocked up, one can be seen on this elevation close to the south-west corner. A window with twelve glass panes, with wooden muntins and lintel is situated north-west of the door (Plate 3).

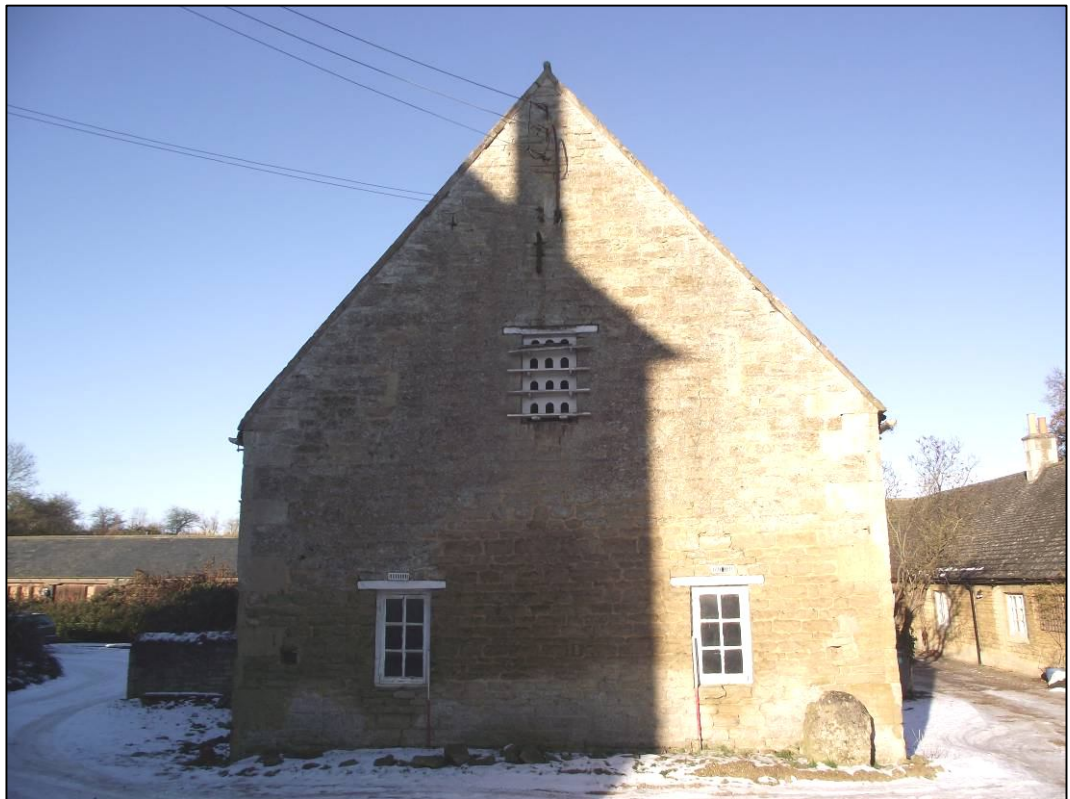
Plate 4 (Shot 5): South-east elevation showing nesting holes on the gable, looking north-west

- 6.4 The south-east elevation has two windows with six panes each with wooden muntins and lintels. On the gable there is a four tier wooden nesting box, each tier has a ledge with three nesting holes. Two blocked up ventilation holes are visible either side of the nesting box (Plate 4).

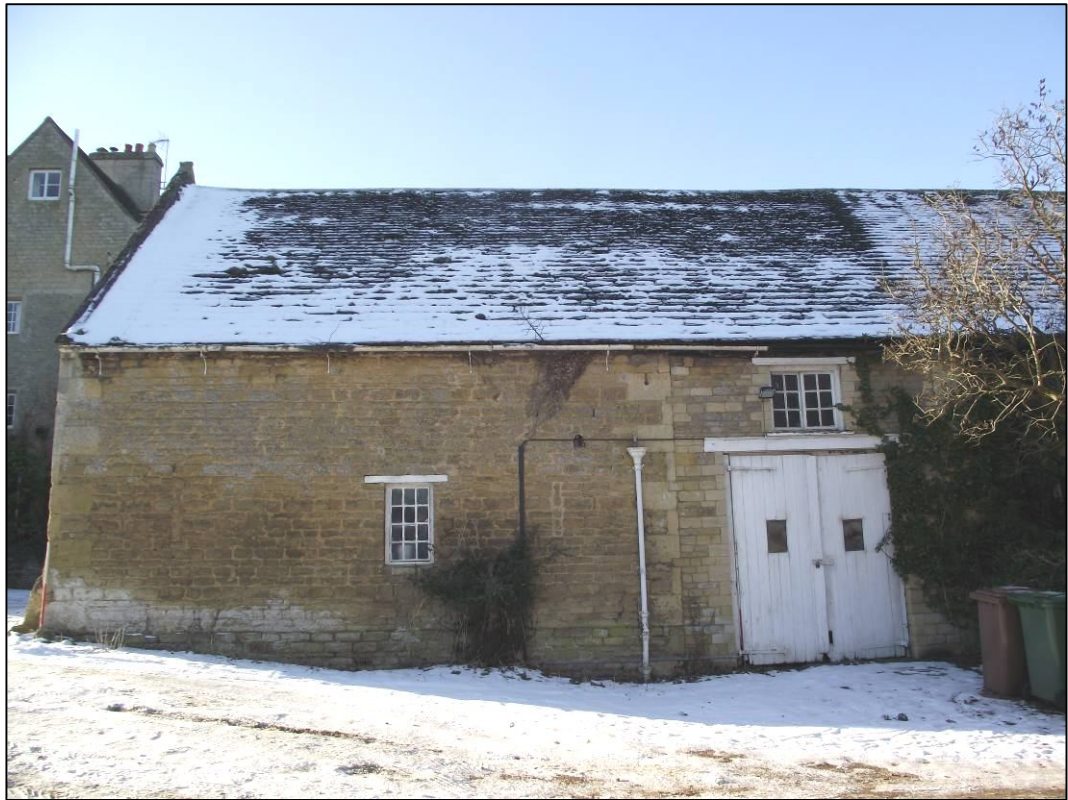
Plate 5 (Shot 8): North-east elevation, looking south-west

- 6.5 The north-east elevation of the stable block has a twelve pane window in the centre, two blocked up ventilation holes and dressed quoins on each corner (Plate 5).

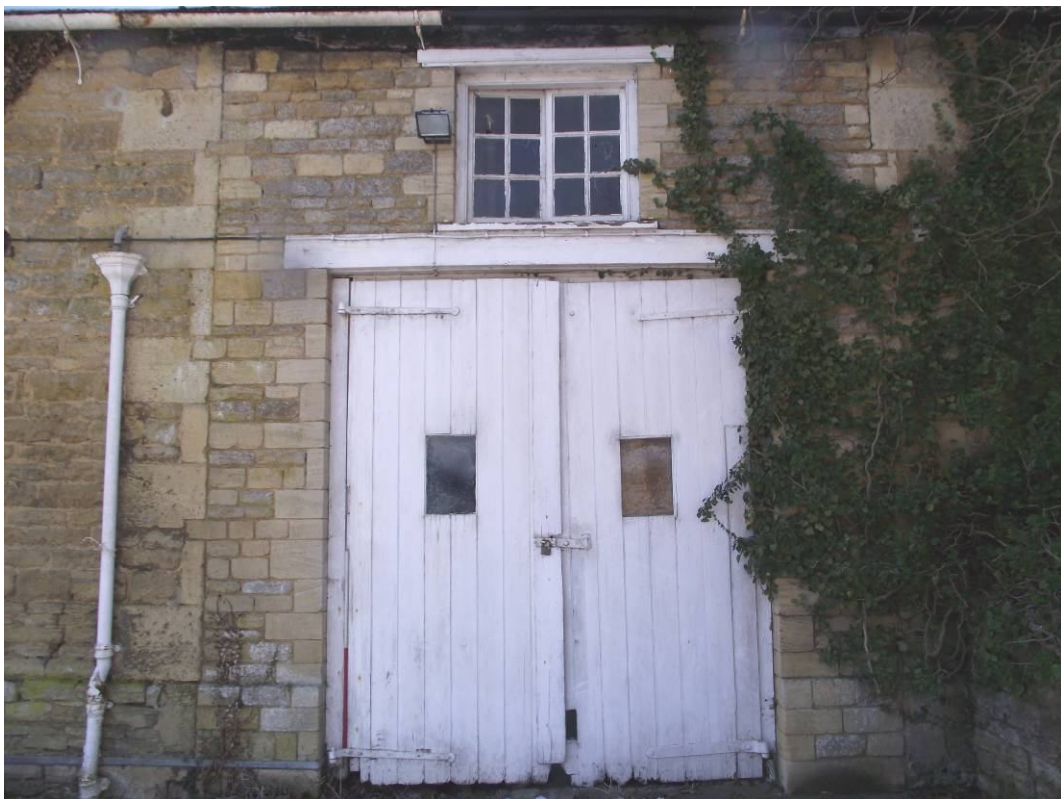
Plate 6 (Shot 9): Detail of quoins on the early stable block and wooden double doors and first floor window on the later extension. Also notice the quoins on the right hand side of the shot, suggesting a space may have only been blocked up rather than it being an added extension, looking south-west

- 6.6 The northern end of the elevation has a wooden double door leading into the store, above is an opening with a wooden lintel and sill containing an inward opening casement window (Plate 6).

- 7.3 The presence of the large quoins on the north-east end of the north-east elevation of the stable block suggests that this was originally the end of the elevation, and that the north-east elevation of the adjacent store represents a later infilling. In support of this, the adjacent building to the north-east also has quoins on its adjacent corner. It is possible that this was originally a covered opening that allowed the loading of feed into the hayloft over the stables, which was subsequently blocked in line with the changing fashions in the design of farm buildings.

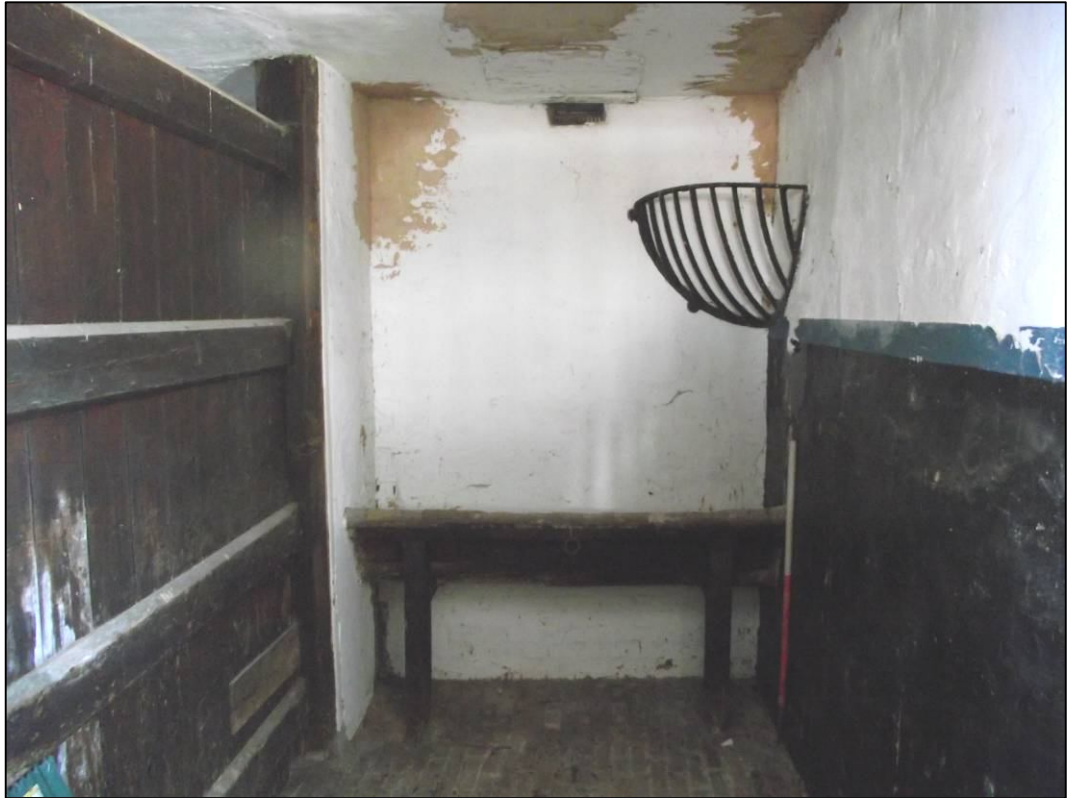
Plate 7 (Shot 10): Detail of stable with a feeding trough and a metal hayrack. Also notice the hatch from the hayloft above, looking south-west

- 6.7 The stable is divided by wooden partitions into four stalls (with the possibility of a fifth stall at the north-west corner under the hayloft hatch). Only one metal and one wooden hayrack remain and a feeding trough is also present within the north-east stall. The two stalls on the north-western side each have a hatch in the ceiling; this is to allow hay to be dropped from the hayloft above. The stable still has its original brick floor. Metal bars in front of the window openings are probably a security measure and may suggest that the current windows are a later addition, replacing the original wooden shutters as there would be little need for glazed windows in a stable block (Plates 9 and 10). Possibly contemporary with this change is the insertion of a number of single brick sized metal ventilators visible above the stalls to improve ventilation (Plates 7, 8 and 10).

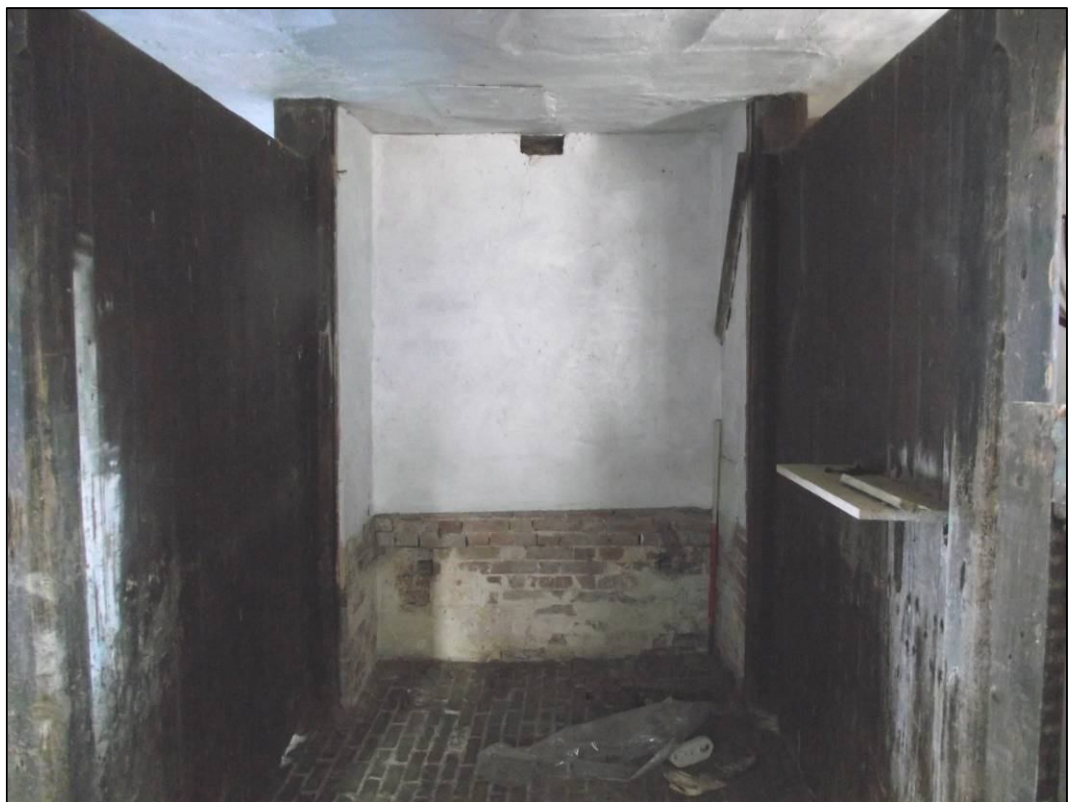
Plate 8 (Shot 11): Close-up of stable with hatch in the ceiling, looking south-west. The wooden partitions about the brick roof supports visible on the first floor (see Plate 16)

- 6.10 The hayloft is accessible from the stables via a ladder through a hatch in the ceiling. The original roof structure is visible from this floor and consists of a tie beam collar and struts, supporting purlins and common rafters. Two brick pillars have been put in place to support a tie beam and give extra strength to the structure (Plate 16). On the ground floor these are abutted by the wooden stable partitions (Plate 8).

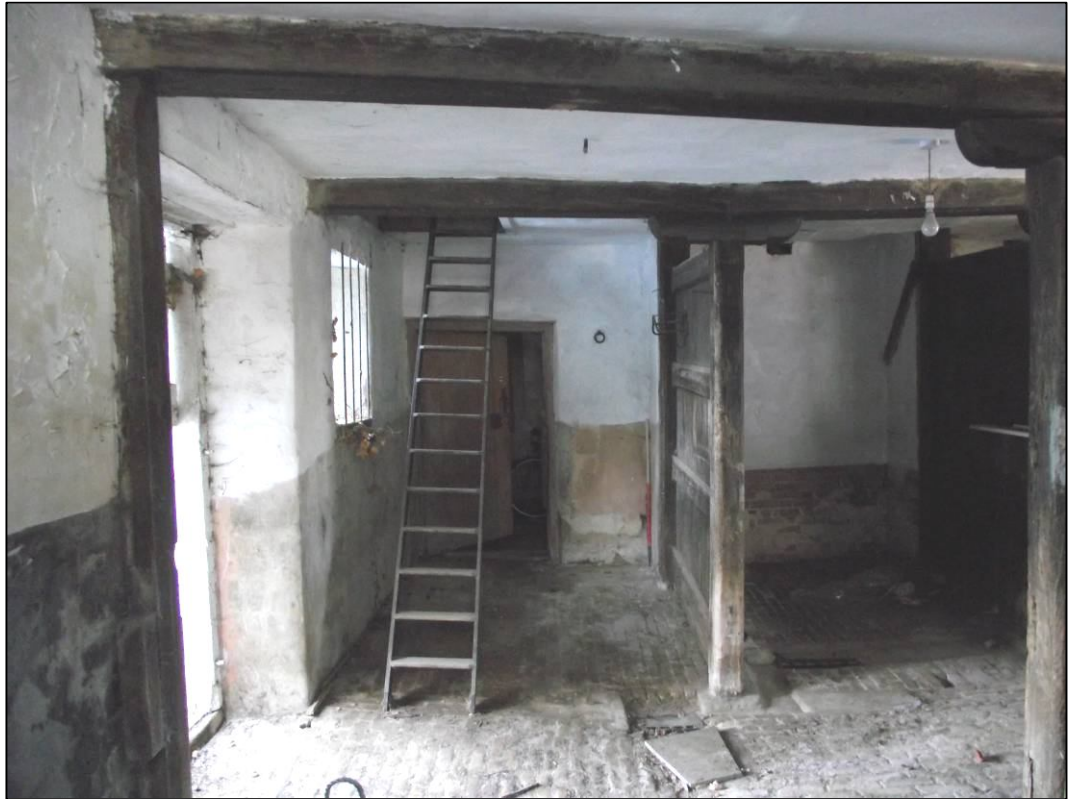
Plate 9 (Shot 12): General view of stable interior with hatch and ladder leading up to the hayloft. Notice the steel bars in front of the opening to the left of shot, there is also a metal fitting on the wooden partition wall for hanging a tack or harness, looking south-west

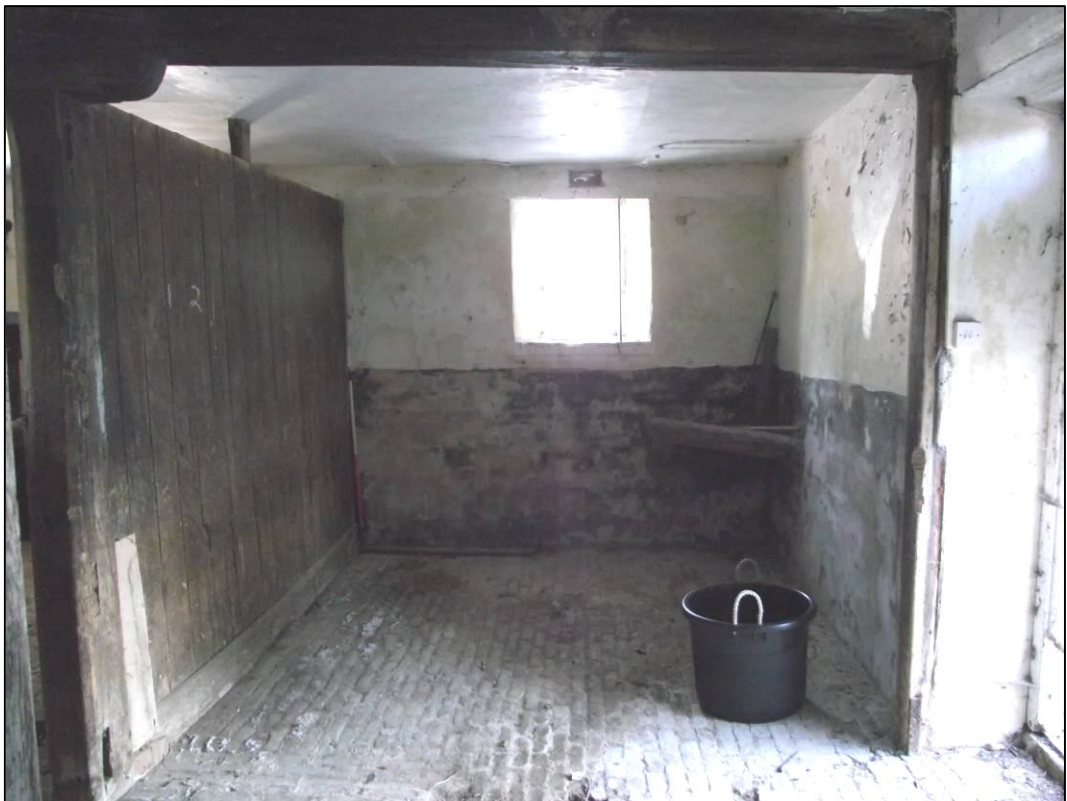
Plate 10 (Shot 13): Close-up of south stall in stable block, looking south-east

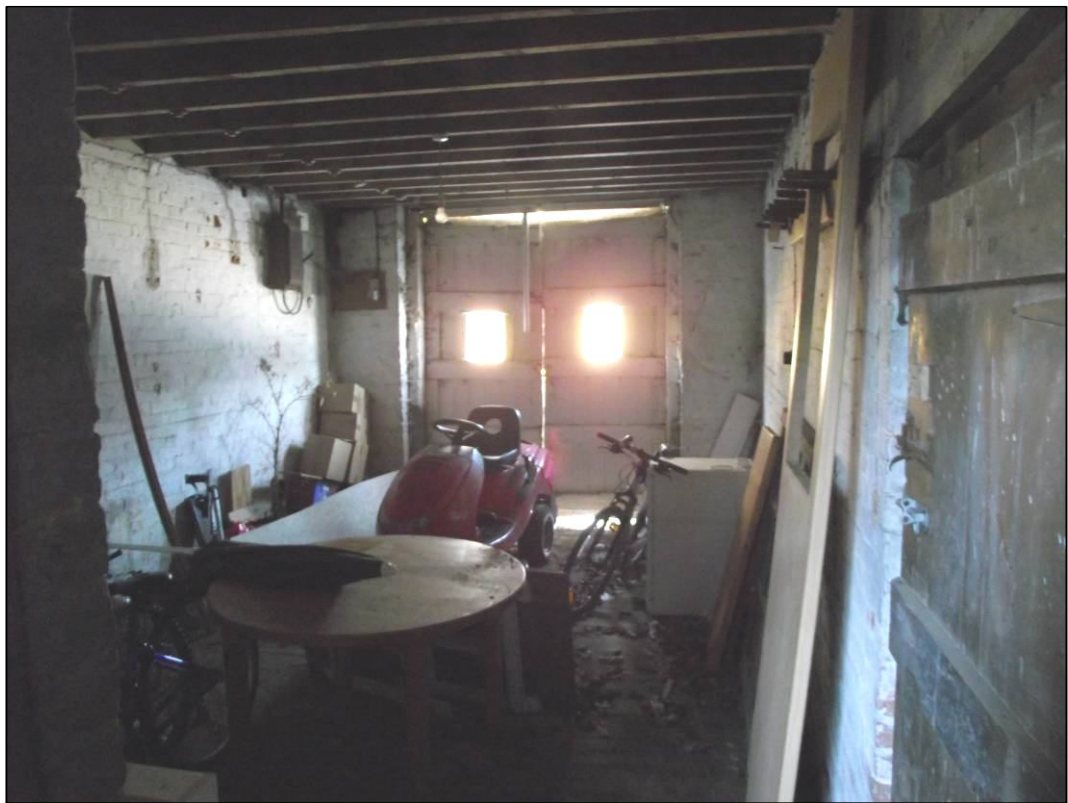
Plate 11 (Shot 14): General shot of garage/store interior, looking north-east

- 6.8 A wooden door in the north-west corner of the stable block leads to a room currently used as a general store. The floor is made up of a wooden planks sitting on top of an earlier brick floor which was exposed during the archaeological watching brief (Plates 11 and 12, and see section 8.2 below).

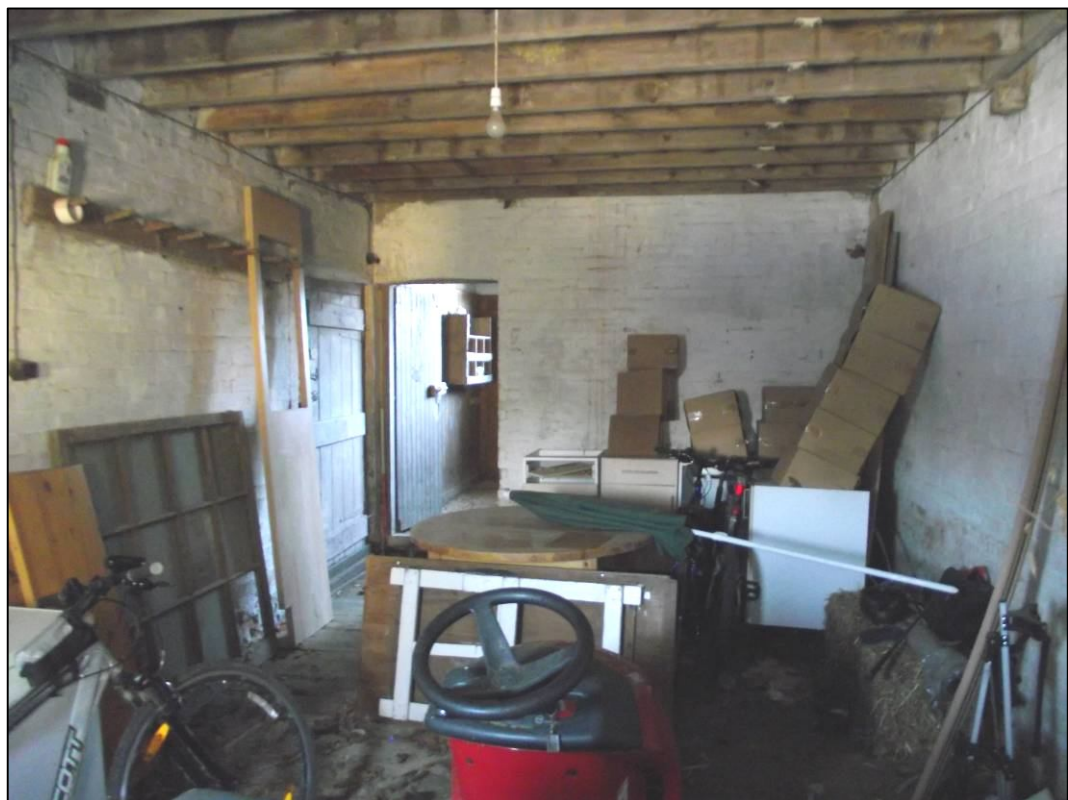
Plate 12 (Shot 15): General shot of garage/store interior, looking south-west

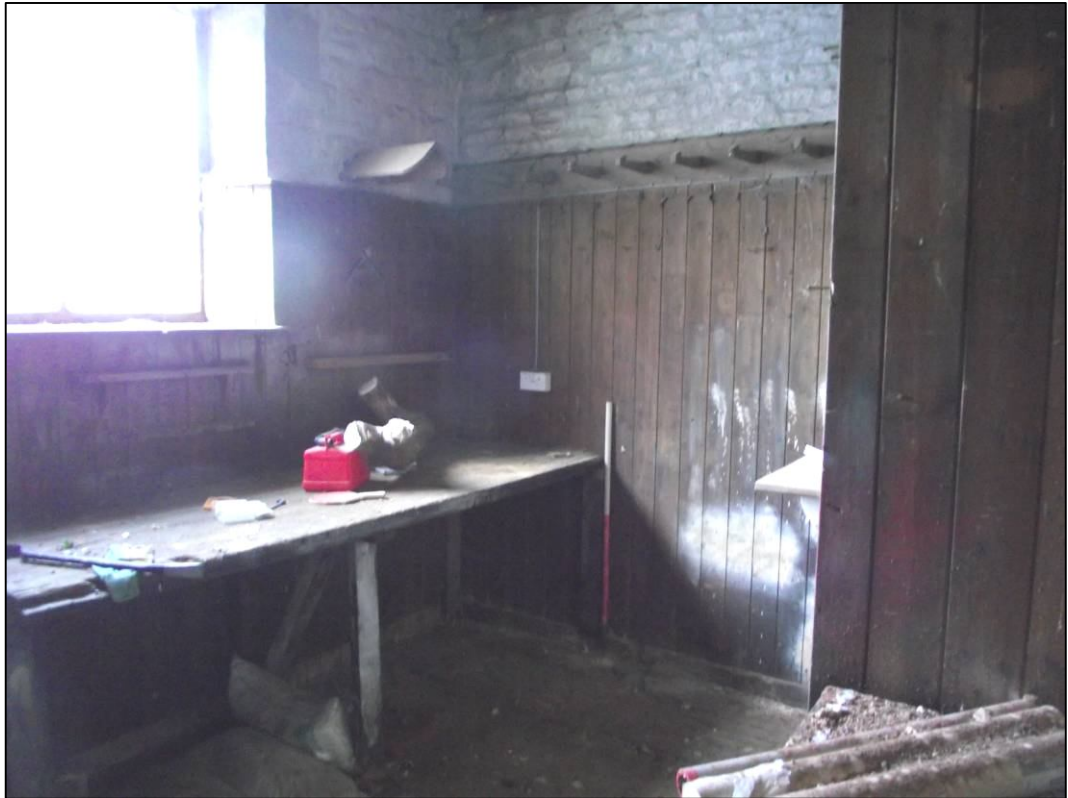
Plate 13 (Shot 16): General shot of tack room, looking north-west

- 6.9 To the south-west there is another doorway into a third room, a tack room with features such as wooden pegs for hanging up harnesses and racks for placing saddles (Plate 13). The room has wooden panelling on all four walls, and also has a brick fireplace and chimney on the north-east wall and workbenches on the south-west wall (Plates 14 and 15).

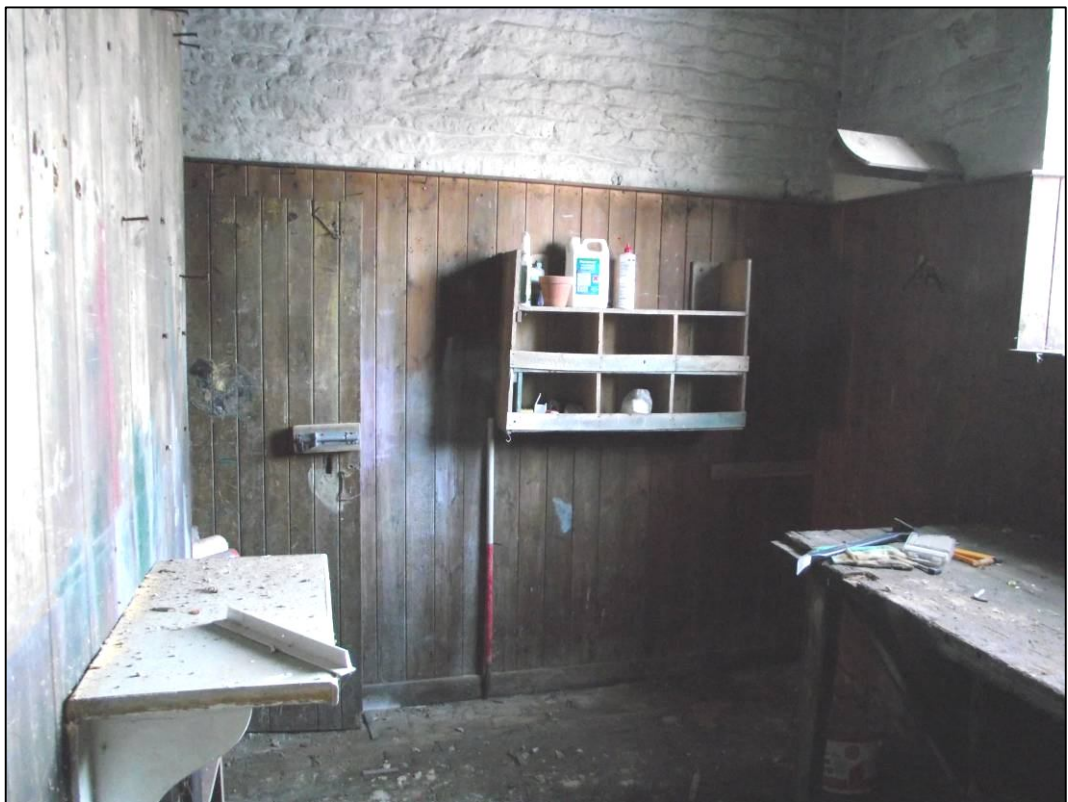
Plate 14 (Shot 18): General shot of tack room, looking east-south-east

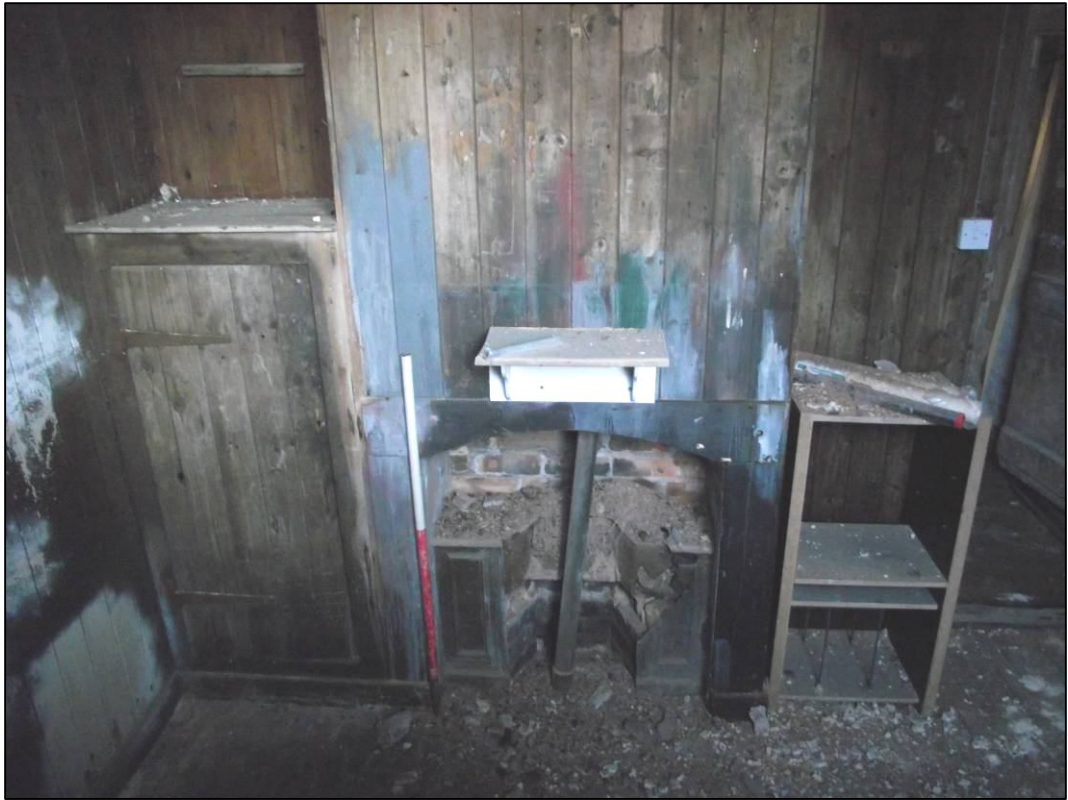
Plate 15 (Shot 17): Detail of fireplace in tack room, looking east-north-east

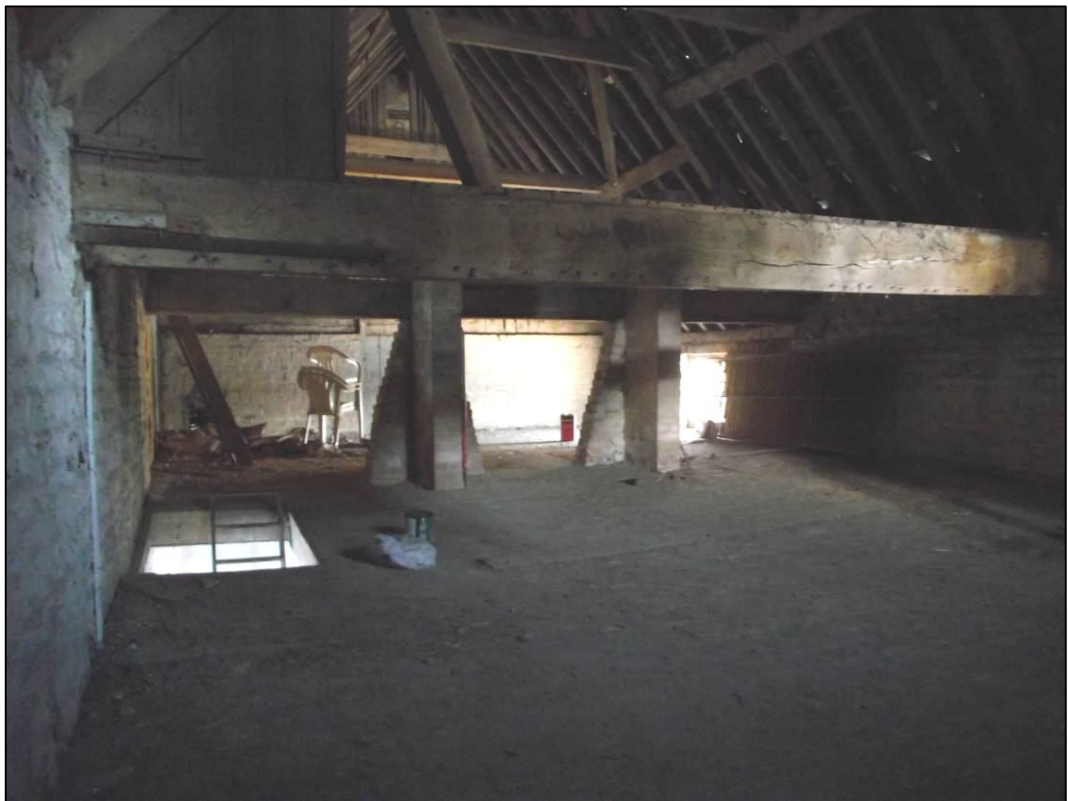
Plate 16 (Shot 19): General shot of hayloft, looking north-north-east

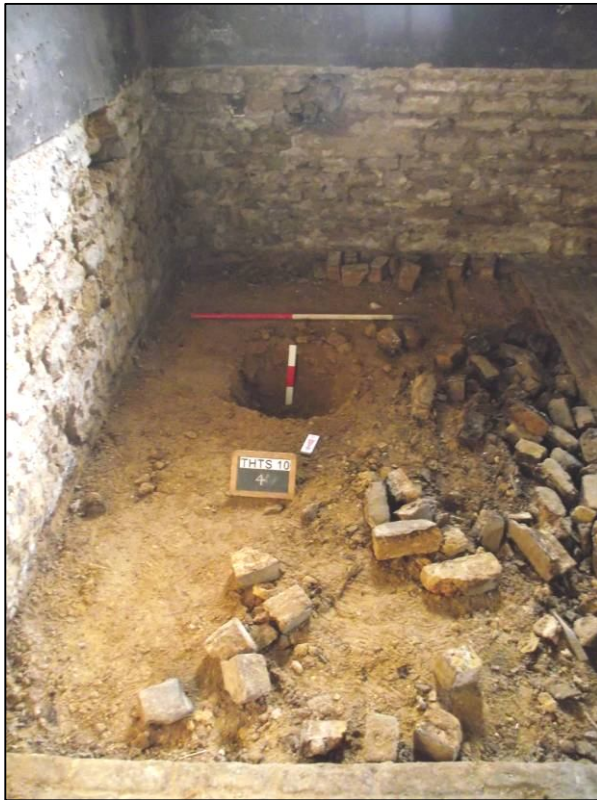
Plate 17: General shot of the stable, showing sondage through the sand bedding, looking south-south-east.

- 8.1.1 The uppermost layer in the stables consisted of a brick floor 101 bonded with lime mortar. It sealed a compact sand bedding layer 102 which overlaid make-up layer 103, a very compact yellow sand with limestone rubble.

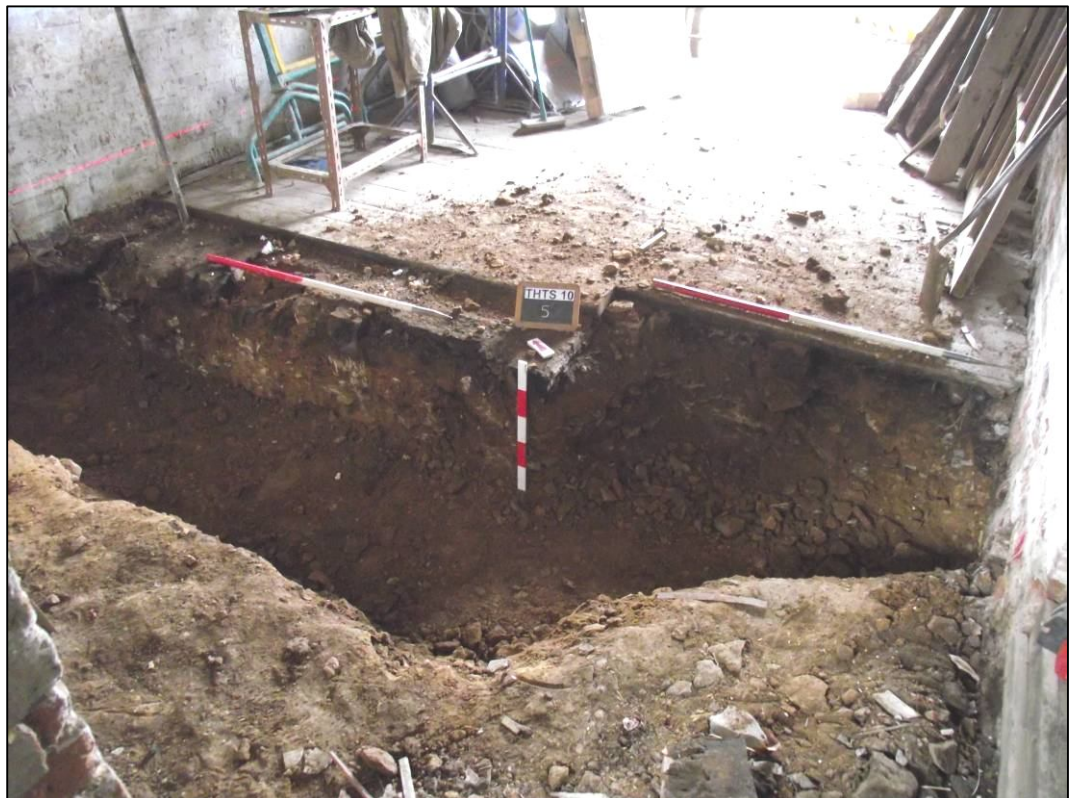
Plate 18: General shot of ground reduction inside the garage, showing south-west facing section, looking north-east

- 8.2.1 A planked wooden floor 201 was the first surface encountered. It sealed the original brick surface 202 which overlaid a compact bedding layer of sand, 203. The earliest layer recorded comprised a very compact yellow sand with limestone rubble 204, representing another probable bedding layer.
