Butlers Farm, Broomfield, Essex.

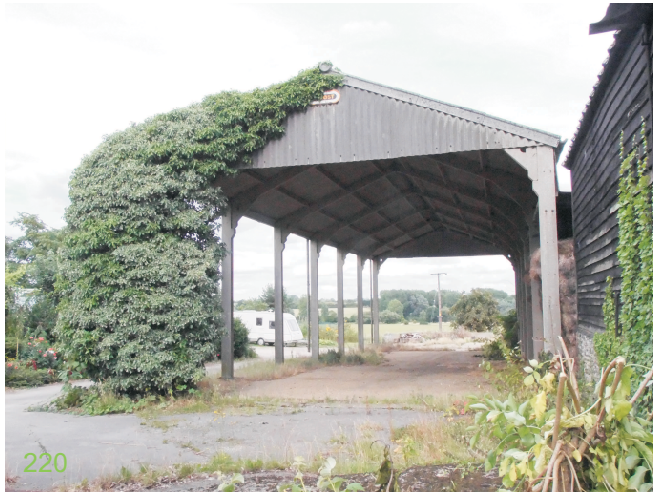
Building 5. This is a modern Atcost precast concrete framed Dutch barn originally open through to the adjoining building. Now with a bale wall.

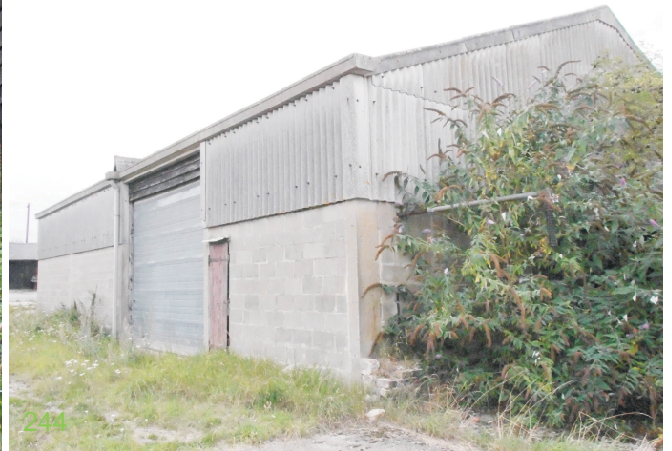
Building 7. Another precast concrete framed storage building. Lower block walls with asbestos cladding above.

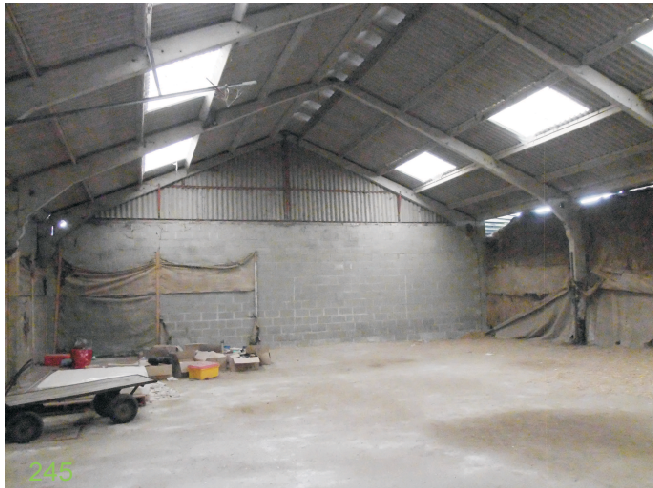
Inside it shows the large area used for bulk grain storage. The gable wall adjacent to the barn has block-work to eaves as it would be impossible to attach the cladding.

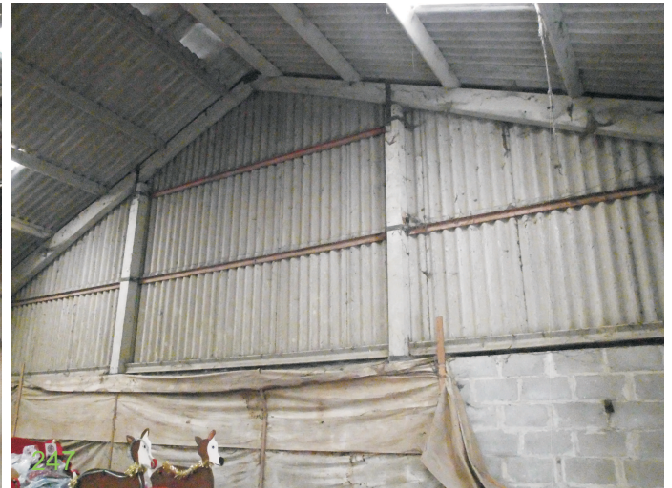
The east wall has the lower height of blockwork as to the south. These walls had been cloth lined as the earlier lined buildings on the site which it replaced.

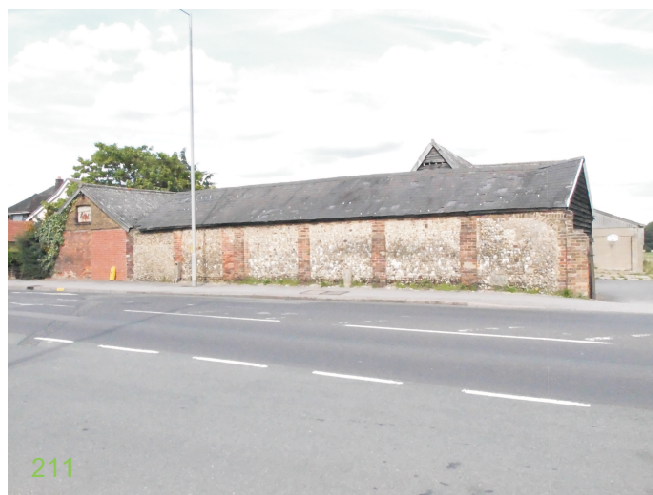
A general view of the farmyard as it would be seen from the main road. The carriage shed, Building 3 to the left with the stable range building 4 framing the road boundary and showing differences in the walling.

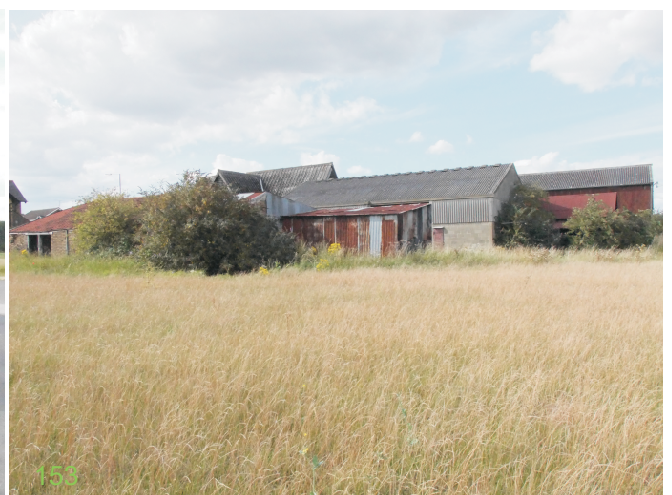
The view of the farmyard from southwest in the Chelmer valley shows other buildings with building 2 in the foreground. The barn and later buildings behind.
