Butlers Farm, Broomfield, Essex.

Surveyed & drawn by B&E Watkin August 2011. CNV.BF5/5

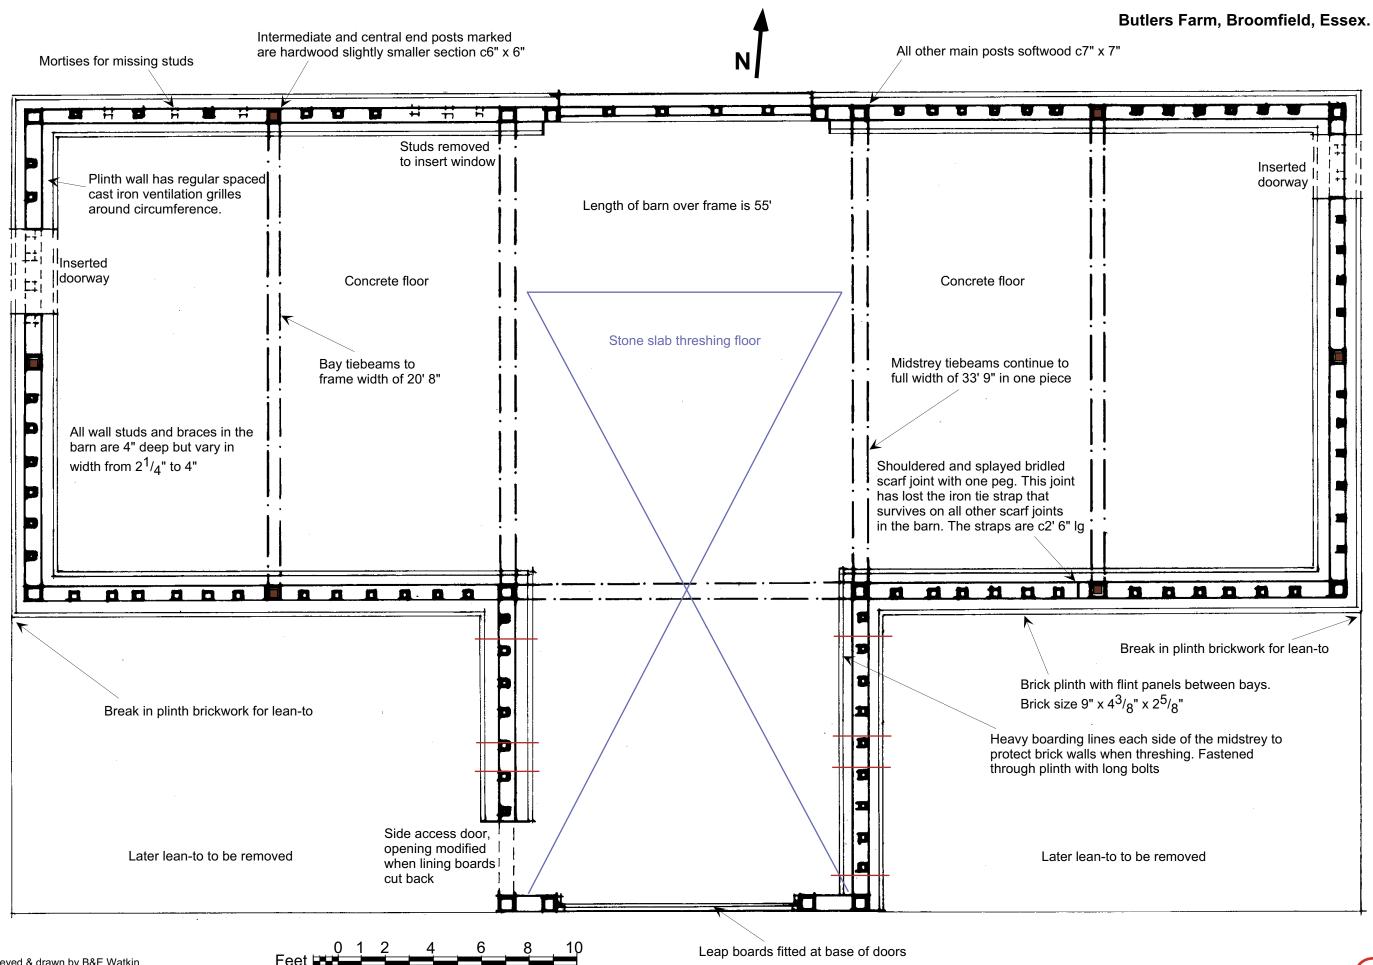
Common rafters and principles same depth but principles wider to accommodate trenched collars Ridge board Saddles under ridge board Purlin Wind brace Tiebeam Collars Top plate Solid cracket bracing bolted through posts and plate for doorway Sill scarf joint with iron strap. This was standard for all scarf joints in the barn Primary braced walls Plinth has two courses with plinth brick. Brick pillared plinth with flint panels between bays Cast iron vents with unpegged studs Above between pillars is flint infill. One fitted at intervals course of flint bricks above Later window around plinth High doors removed now later infill with concrete replacing leap boards below

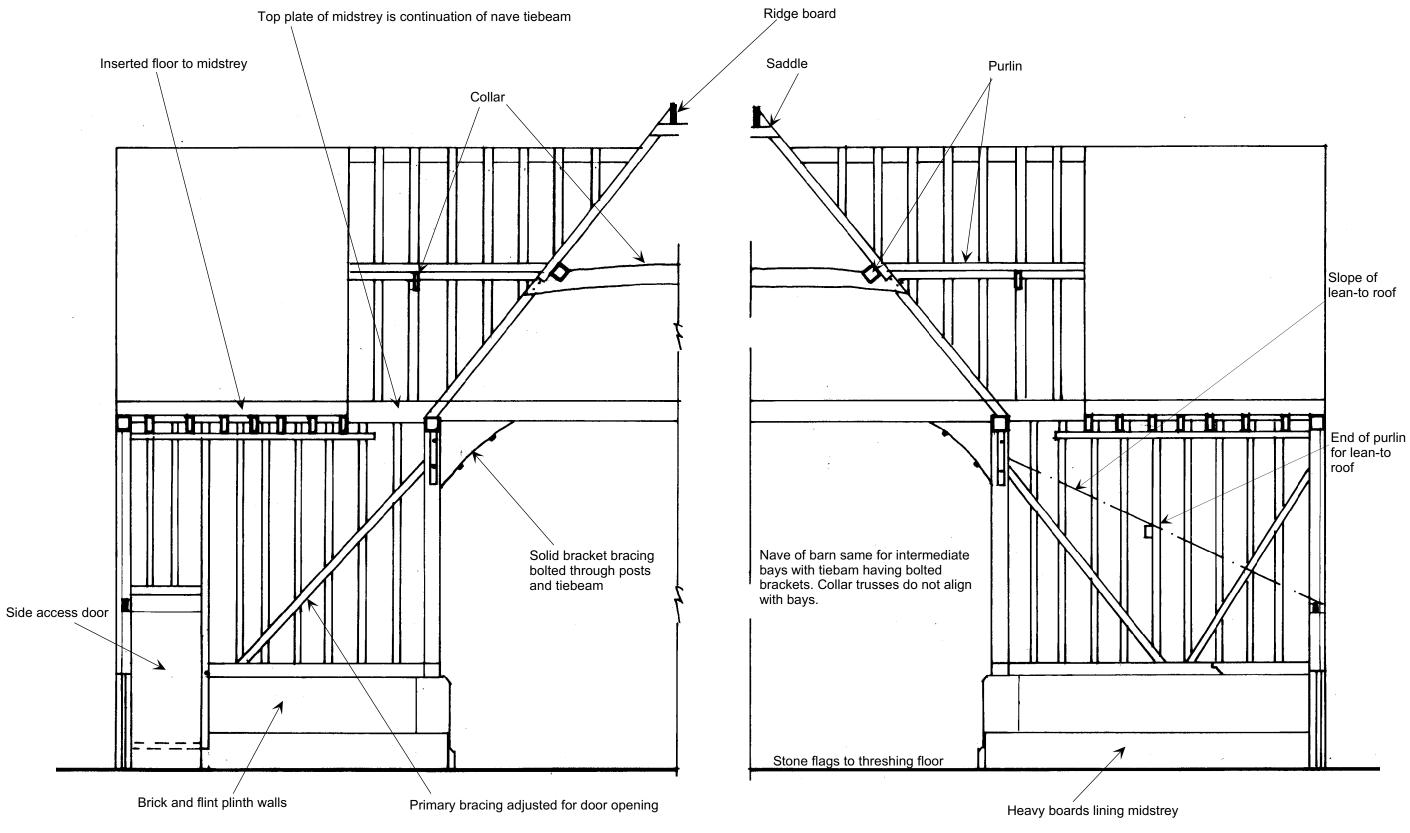
SECTION C - C OF BARN 1 INTO MIDSTREY TO WEST

SECTION D - D OF BARN 1 INTO MIDSTREY TO EAST
