Stone Hall Barn, Matching, Essex.

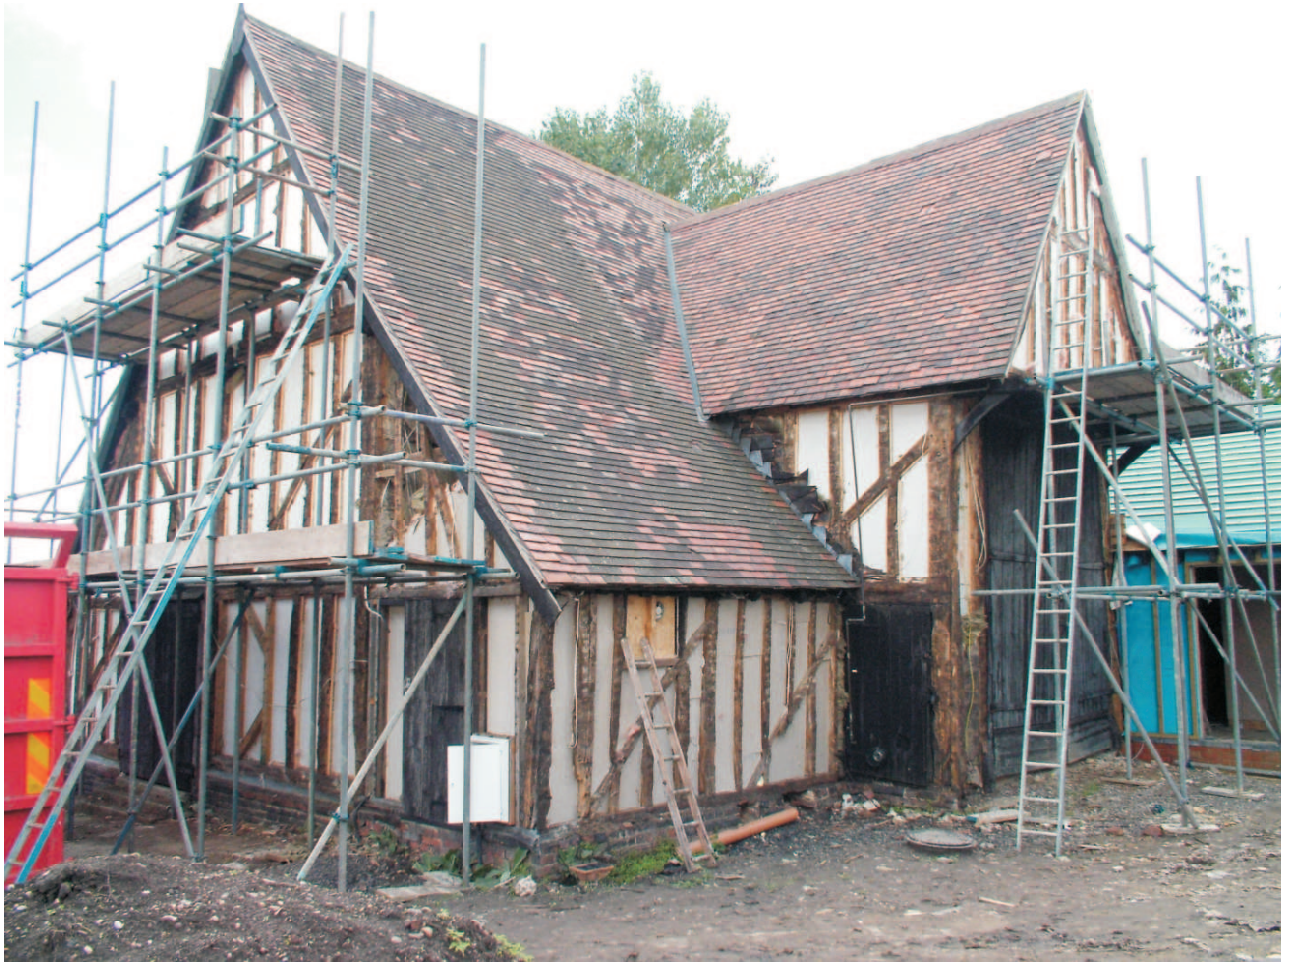
From survey digitals, LUH02, this view of the south west corner of the barn shows the lean-to extension, the projecting gable to the midstre with brackets and the primary braced wall structure to the barn.

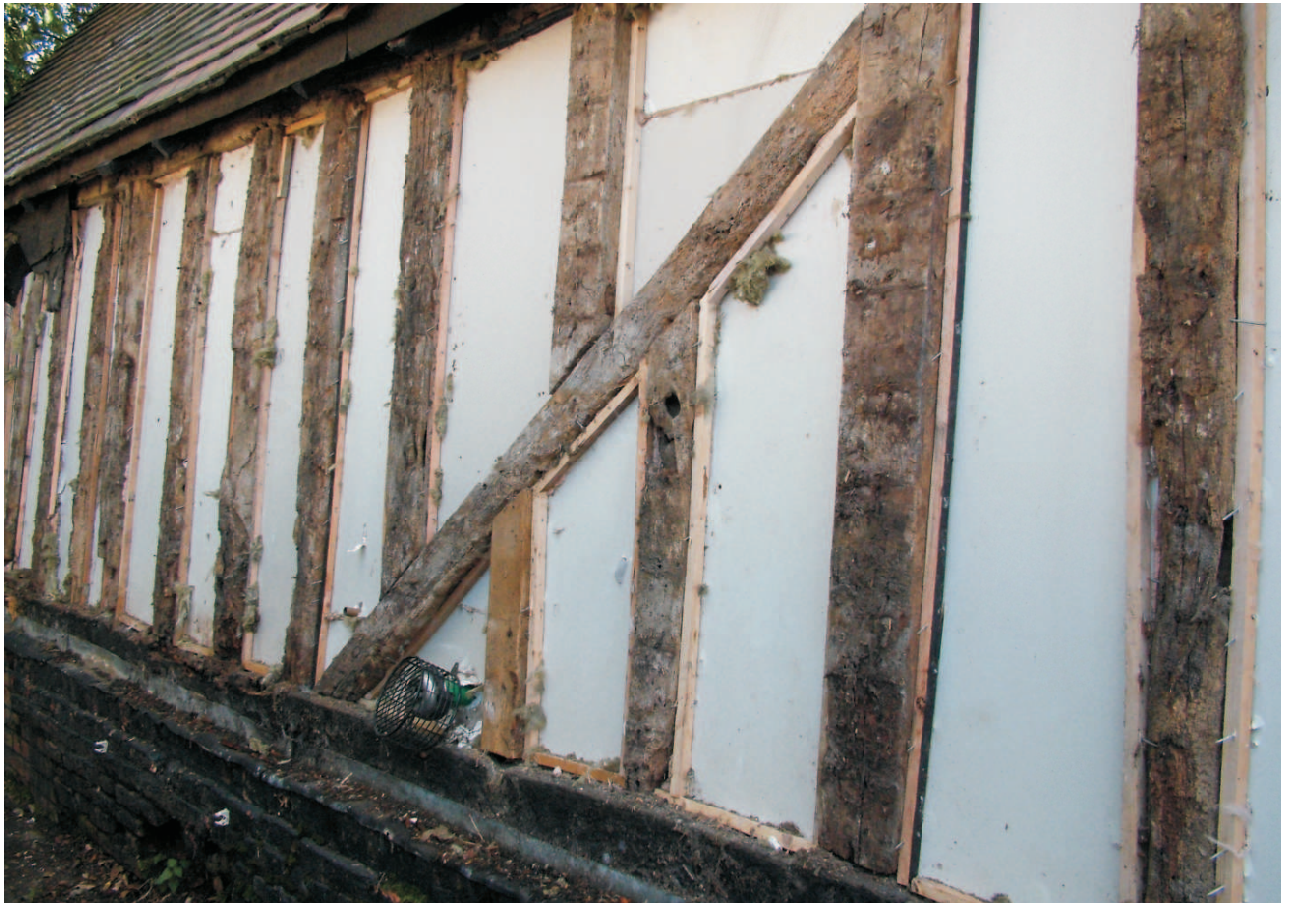
L23 shows the typical wall structure of the northerly aisle, set onto a good brick plinth the lower bricks of which are early but the top courses are later showing that a sill change has taken place.
