Stone Hall Barn, Matching, Essex.

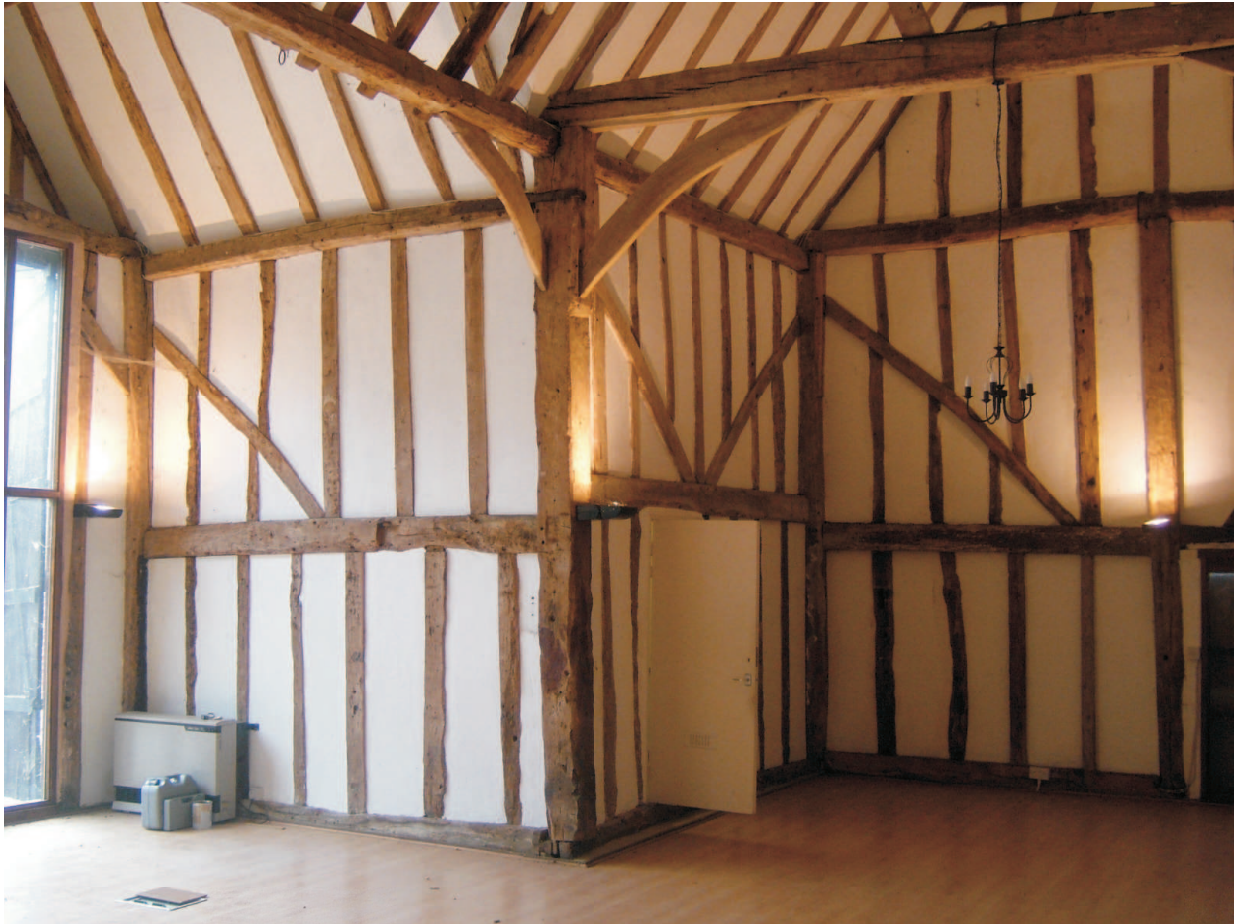
Owners digital 97 - to E showing midstrey wall and the single bay beyond. New access to lean-to and front side entry door into midstrey has been filled in. Framing also shows midstrey to be original.

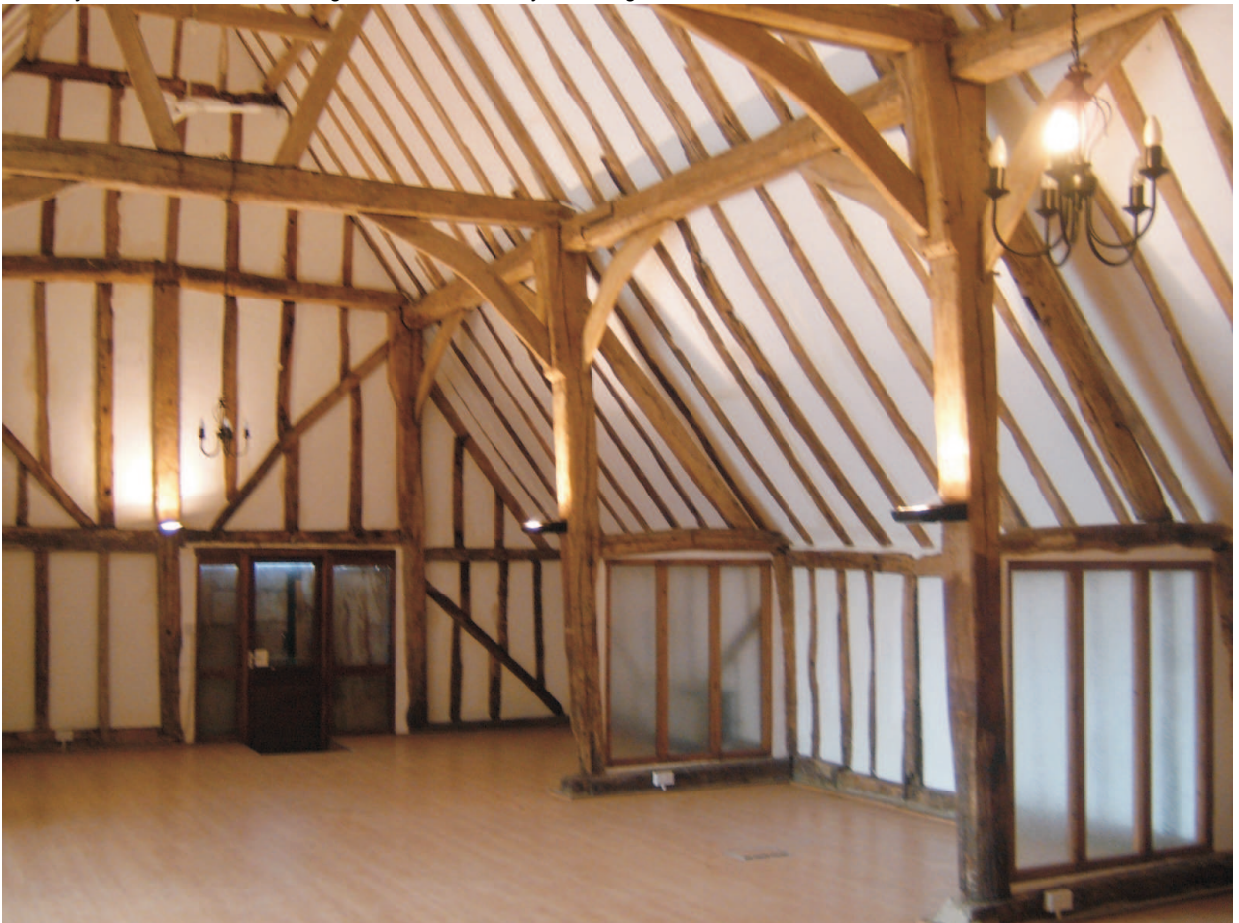
Owners digital 98 - to W showing bay beyond midstrey and the midstrey bay with arcade posts and aisle. Note the shores to the aisle ties and different infill to the end wall in the aisle. Double doors added for office conversion in previous change.
