Enlarged and lined-in extract from the 1840 Tithe map for Matching.

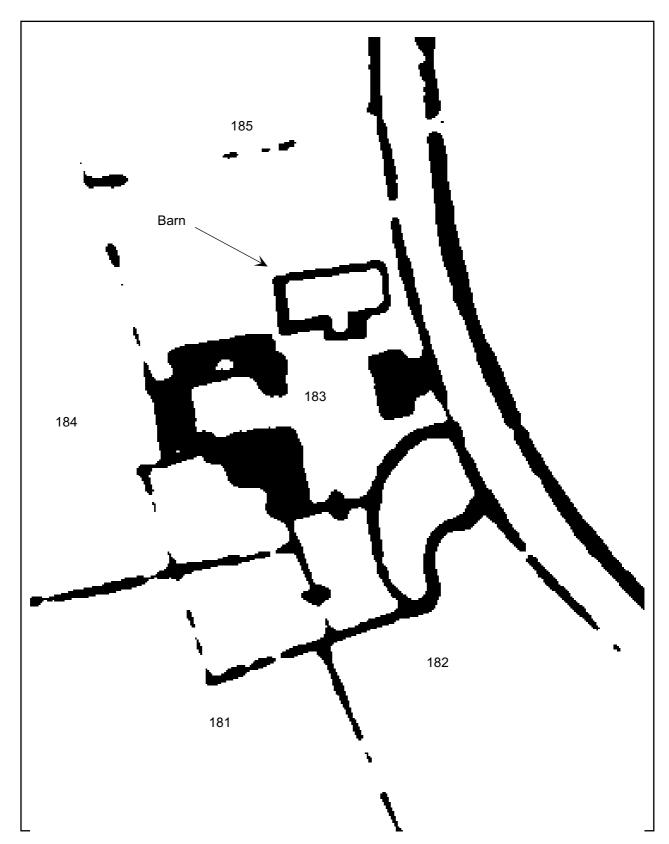
The barn is shown clearly within the farmyard with possibly another barn below it against the road and the block to the left possibly contains the remaining stable with the house below it. The area to the right of the midstrey may be a previous attachment but the barn does suggest the lean-to is extant at that time to the left of the midstrey.
