**Boars Tye Barn, Silver End, Rivenhall, Essex.**

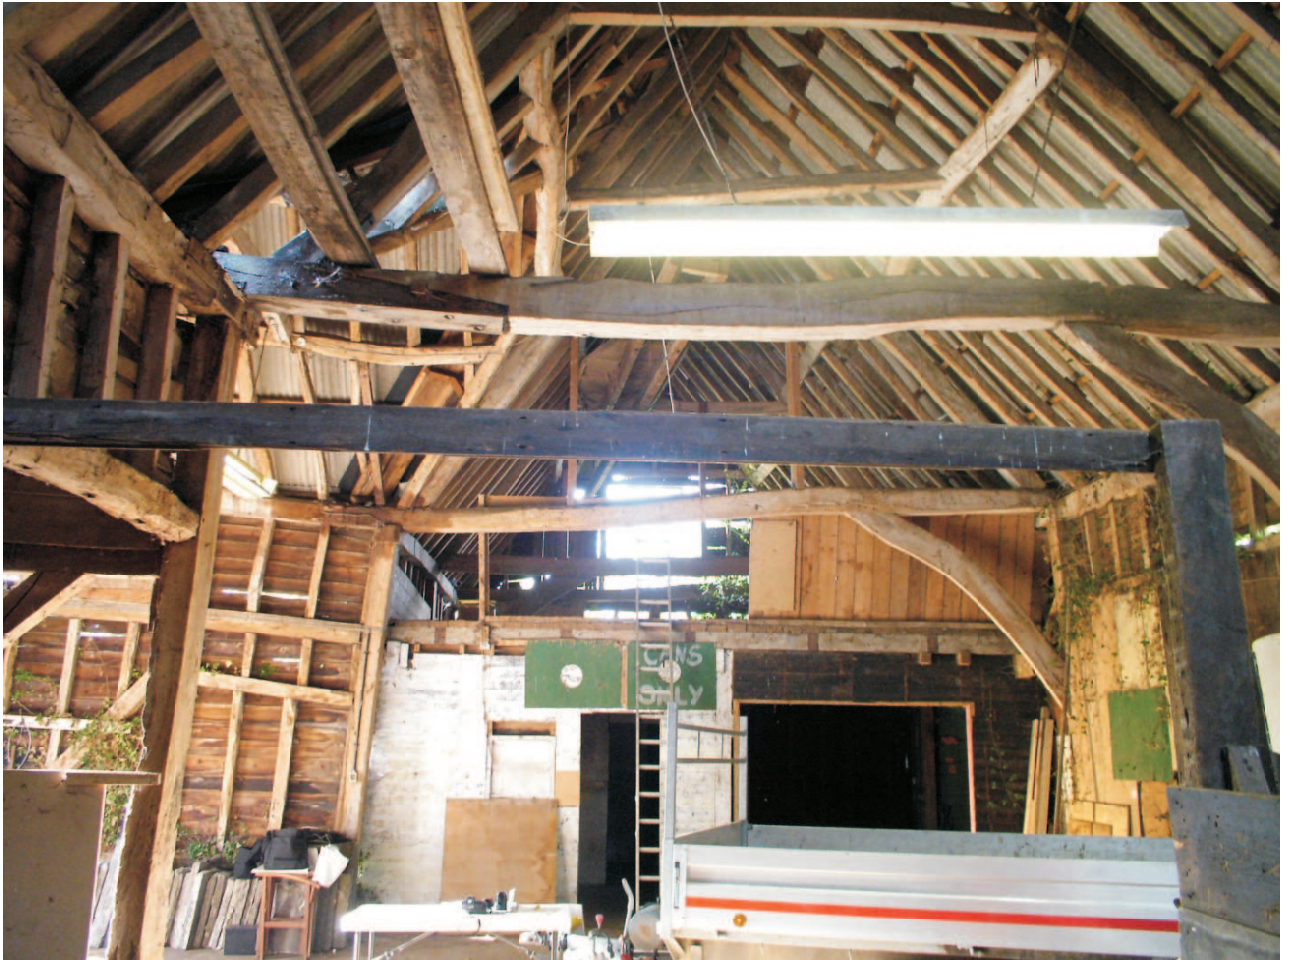
General view looking west to inserted floor beyond the midstrey opening. Under the floor divided into two rooms with no natural light. Note large serpentine bracing to rear wall.

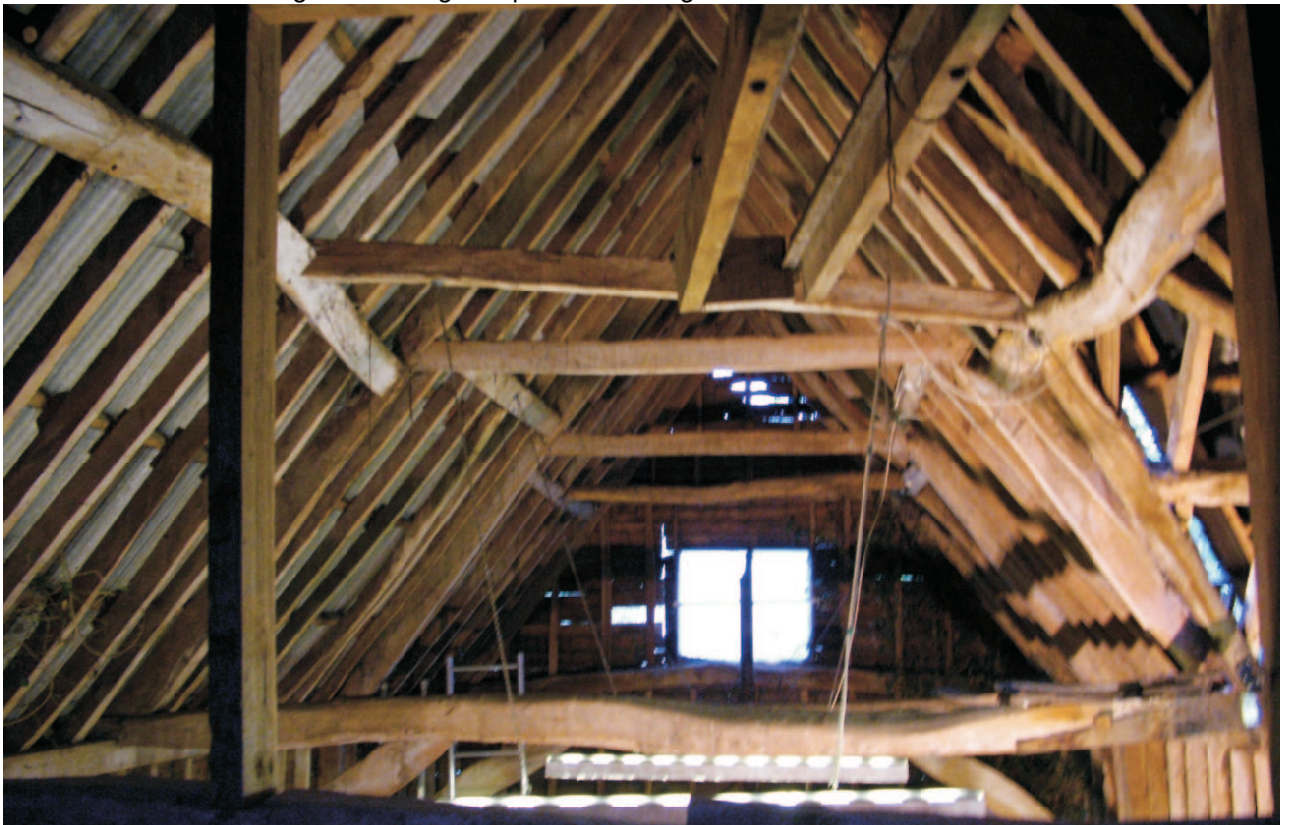
View at tiebeam level looking east. Joggled framed side purlin roof collars mortised into principle rafters and birds mouth intermediate collar above the midstrey bay. End of Crittall installed trackway at top of photograph.
