Shenfield Hall Barn, Shenfield, Essex.

LIST DESCRIPTION

IoE number: 373450
Location: BARN AT SHENFIELD HALL, HALL LANE (east side)
BRENTWOOD, BRENTWOOD, ESSEX
Photographer: Mr James Sears
Date Photographed: 30 June 2002
Date listed: 09 December 1994
Date of last amendment: 09 December 1994
Grade II

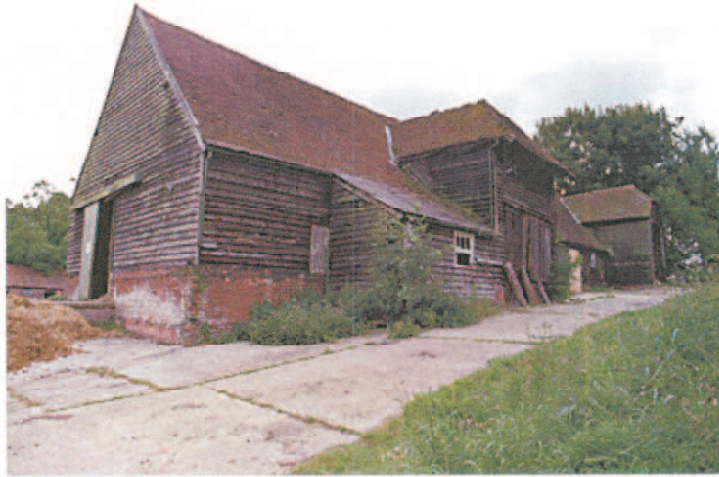
BRENTWOOD TQ69NW HALL LANE, Shenfield 723-1/6/275 (East side) Barn at Shenfield Hall GV II Barn, now used as a stable. Early C16, late C16, mid C17, C18. Timber-framed on red brick walling, weatherboarded, peg-tiled roof. Aligned N-S on sloping ground and walling deepest at N end to retain level base for timberwork. Rectangular plan of 7 bays, 2 waggon porches on W side. EXTERIOR: E elevation somewhat irregular as a result of alteration, one C20 top-opening casement window with glazing bars at each end, N 4x2 panes, S 3x2 panes. 2 iron-framed fixed lights with segment heads and glazing bars, 6x4 panes in S end with 2-sectioned stable door between, second stable door with fixed window of 5 panes above in centre of range. W elevation has hipped roofed waggon porch towards N end, roof eaves project with 2 bracket struts. Another porch at the extreme S end with half hipped roof. Both porches have C20 2-leaved upper doors with lower closed sections, a remnant of arrangements for threshing. Central C20 2-leaved door with, to S C20 top-opening casement window as on E elevation, 3x2 panes, to N, C20 2-sectioned stable door with 5 panes fixed light above. To N of N porch is a lean-to, slated, weatherboarded addition with C20 3x2 paned, top-opening casement window. S end elevation plain. N end has C20 sliding door. INTERIOR: the 7 bays are of progressively later build from S to N in 3 phases. Bay one early C16, heavy construction, jowled post, end tie-beam has slight camber, curved tie-beam and arcade braces, arcade plate has edge halved and bridled scarf, raking queen stuts, upper roof renewed, side aisle walling renewed in C19 or C20. Waggon porch added to earlier structure in mid-C17, jowled posts, primary wall bracing. Bays 2 and 3 added in late C16 similar to phase one but now with face-halved and bladed scarf joint on arcade plates and aisle wall plates and generally of lighter scantling: tie-beam and supporting braces are straight. Side aisled with straight post/tie triangular bracing. Roof has trapped side purlins, collars supported by raking queen struts, also intermediate unsupported collars. Side aisle walling unusual with primary arched braces and secondary studding. N end of bay 3, weatherboarded and originally a closed frame - quite clearly once the N end of the barn. Bays 4-7 C17, simply attached to older barn end with way cut through. Slender face-halved and bladed scarfs, arcade posts and braces some reworking - original system has jowled post, straight tie-beams with slightly curved braces, some now removed and replaced by C18 solid knee braces; jowls cut away to accommodate arcade bracing, square section, well curved, accompanying carpenters' marks in Roman numerals. Aisles have rear in-sloping braces between sills and ties. Roof of simple form, side purlins with collars (no support struts), outer side walling slender, of oak and elm, C18 or C19. Waggon porch to W of bay 5 built as one with main structure, E side of this bay has original barn doorway blocked. A date of 1757 with a cyma and bead moulding below is cut into the jowl of the W arcade post of the S side of bay 5 and if it dates anything it is contemporary with the substitution of knee braces for normal tie-beam braces in bays 4 and 7. Shenfield Hall (qv) and the barn form a group.
