Shenfield Hall Barn, Shenfield, Essex.

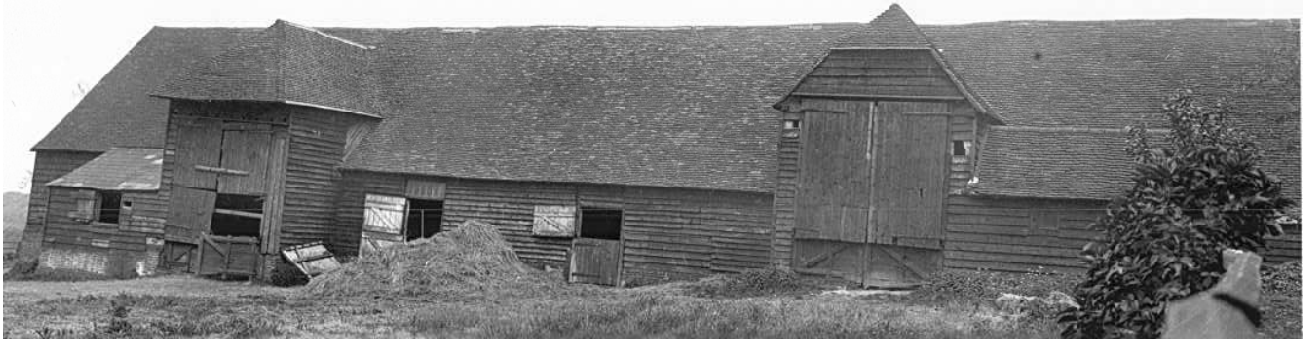
Extract from 1920 RC photograph showing barn with the two bays now removed at the south. A lean-to also existed for at least one of the bays. Also note that stable doors had already been inserted into the bays of the barn to the north of the older section of the barn.

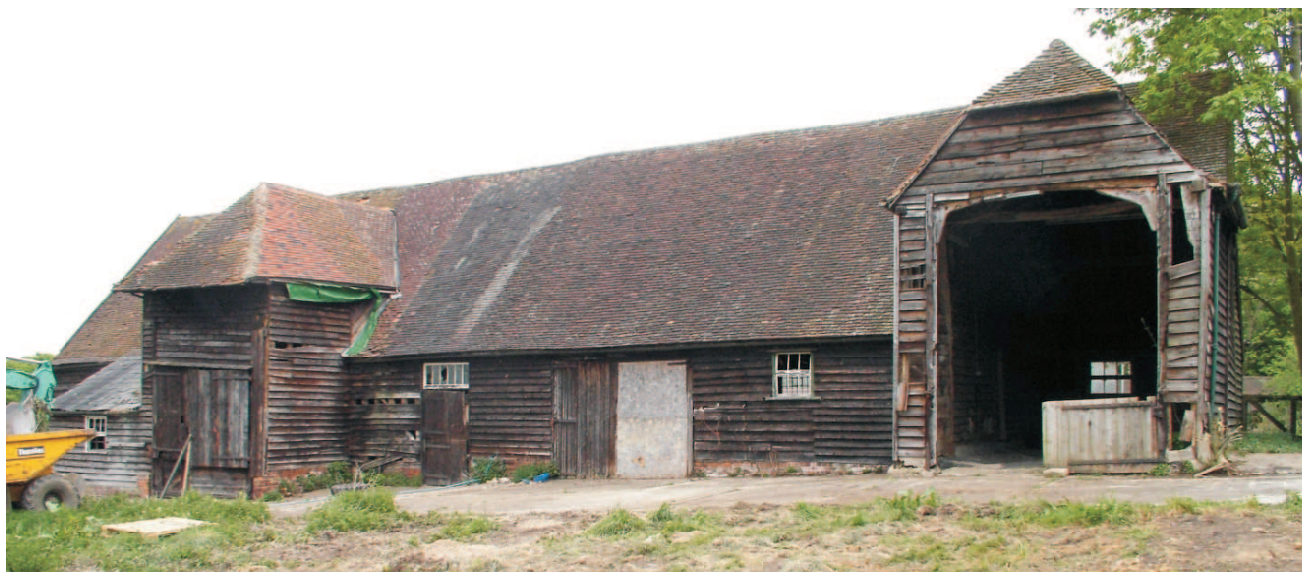
The barn in 2007. Note the doors to the north midstrey have been reduced in height. The northern stable door is similar but with a glass light above. The other door has changed completely and a window has been added between it and the south midstrey, now devoid of doors.

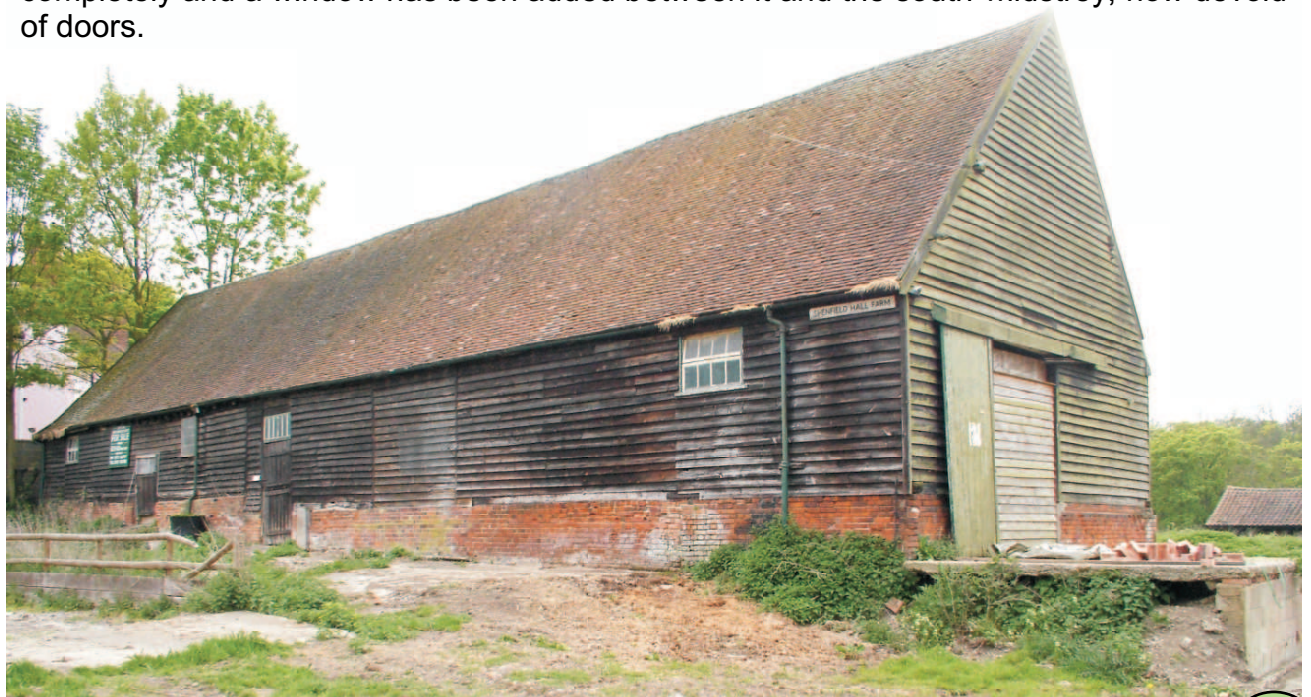
The barn in 2007 viewed from the north-east. The building has lost buildings from this corner in the period since 1937.
