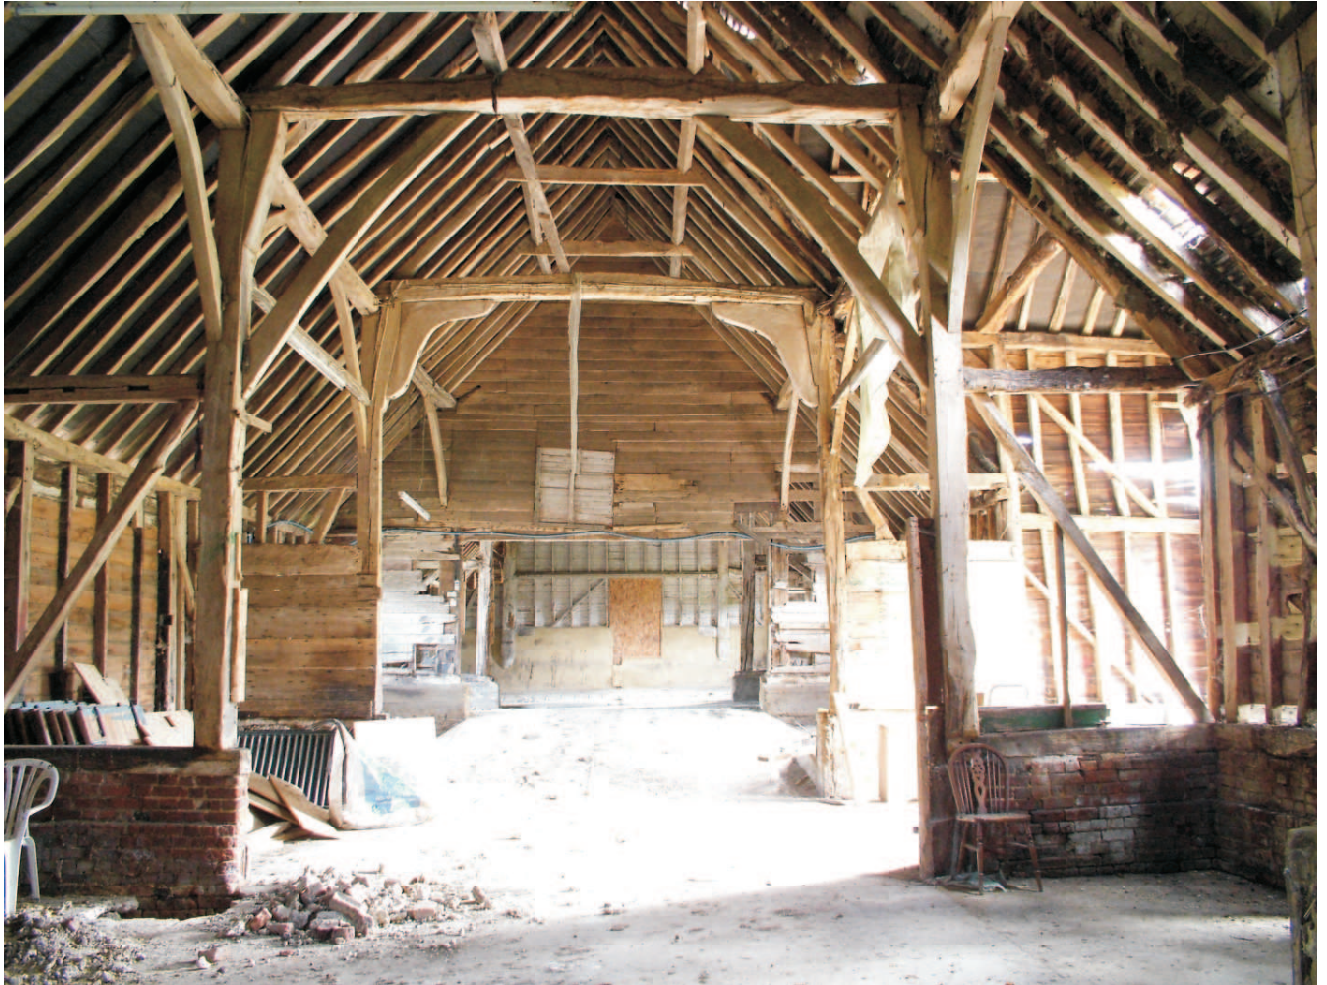
(277) Long view from south in bay 7-8 to infill on trusses 4 end of seventeenth century rebuild and truss 2 closing off bay 1-2

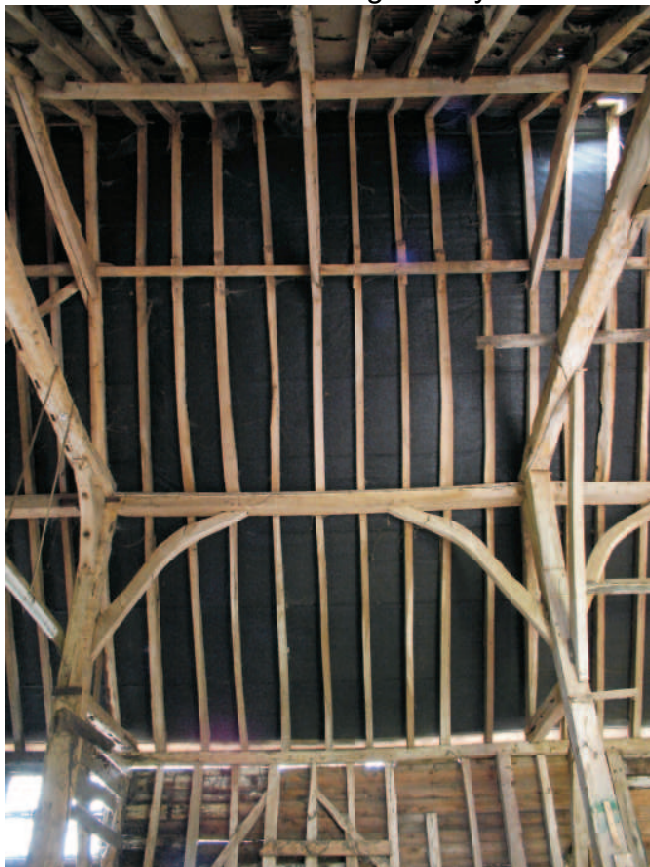
(266) Roof form in eighteenth century bay 6-7 east with simple clasped purlin roof

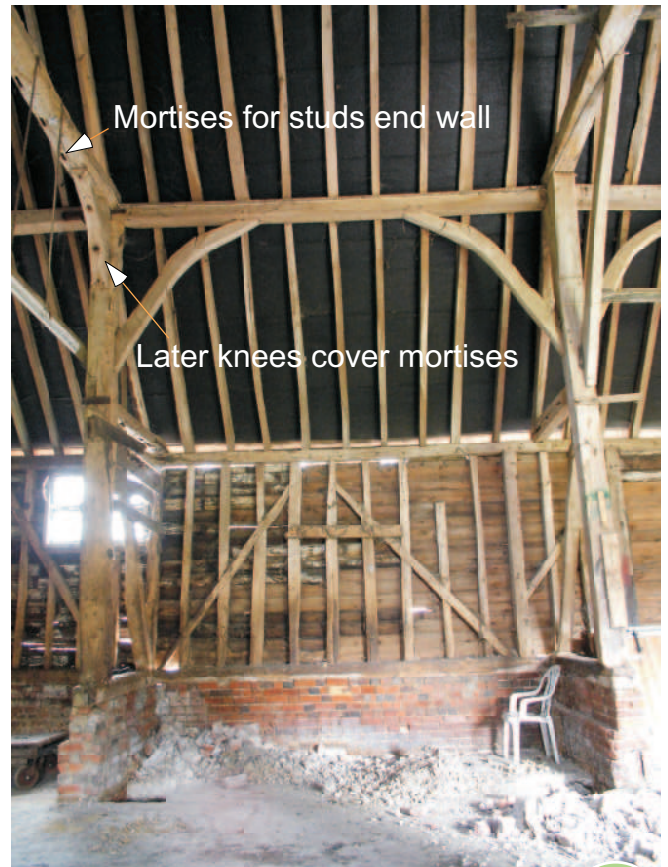
(267) Aisle wall structure bay 6-7. Truss 7 (left) was end this build
