Shenfield Hall Barn, Shenfield, Essex.

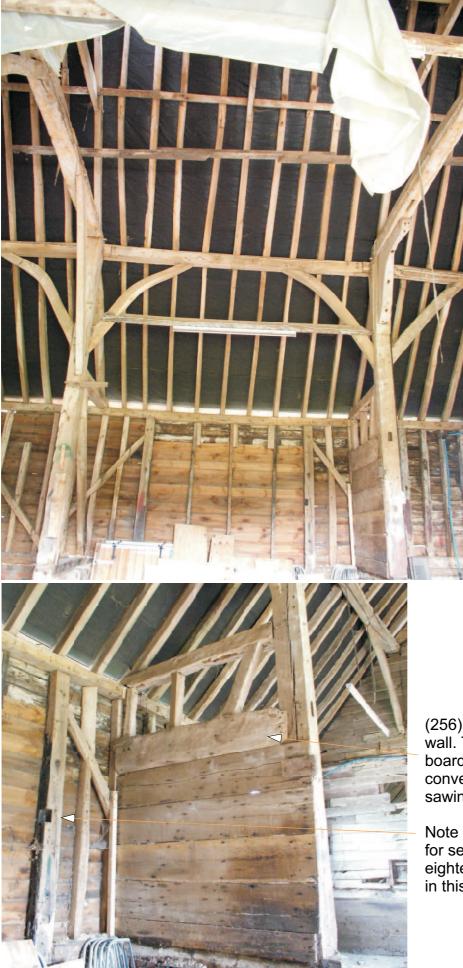
(255) Bay 5-6 east showing framing for opposing door to porch in eighteenth century build. Note that the primary bracing to the wall frame runs through to the next bay, The aisle wall frames do not relate to the main trusses but are built as independent units

(256) Elm board infill to aisle wall. Top board was outer board of tree and axe converted before through sawing the other boards.

Note stepped mortise entry for security bar for the eighteenth doors originally in this opening.
