Shenfield Hall Barn, Shenfield, Essex.

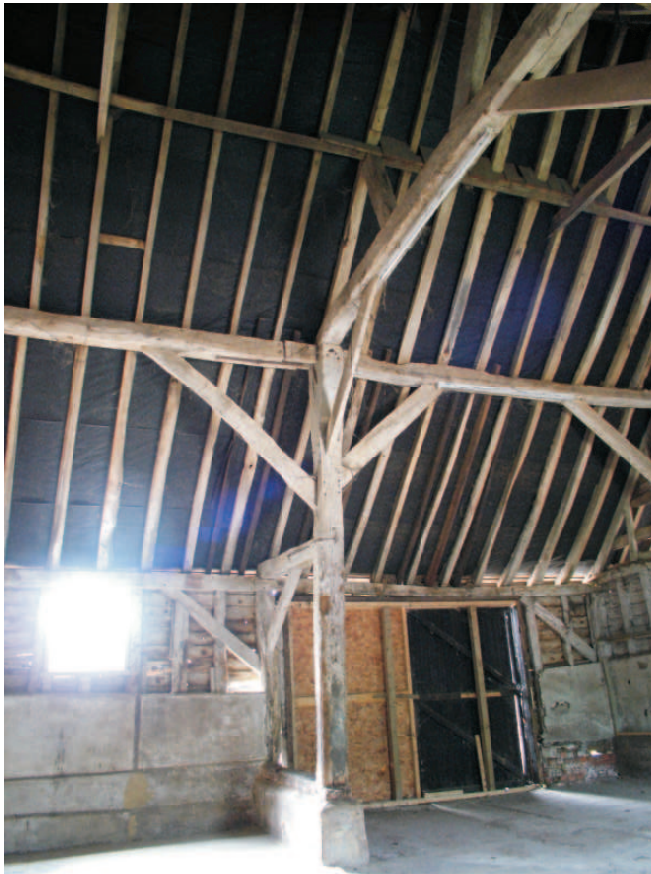
(241) View to post 3D the intermediate of the seventeenth century rebuild. note the face halved bladed scarf to the arcade plate.

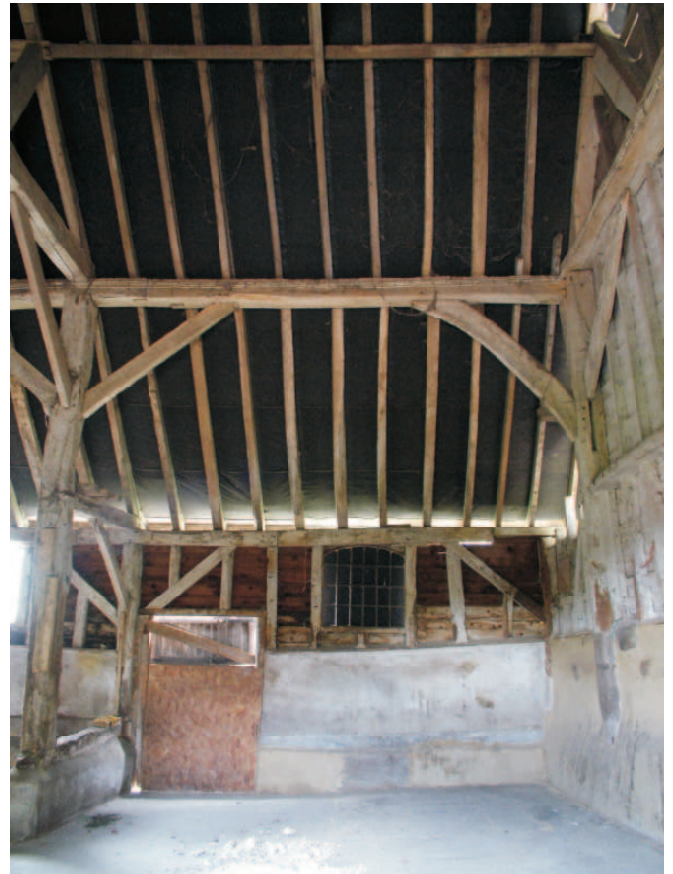
(238) Bay 2-3 to the east showing aisle wall framing for seventeenth century rebuild. note the arch bracing to the outer walls

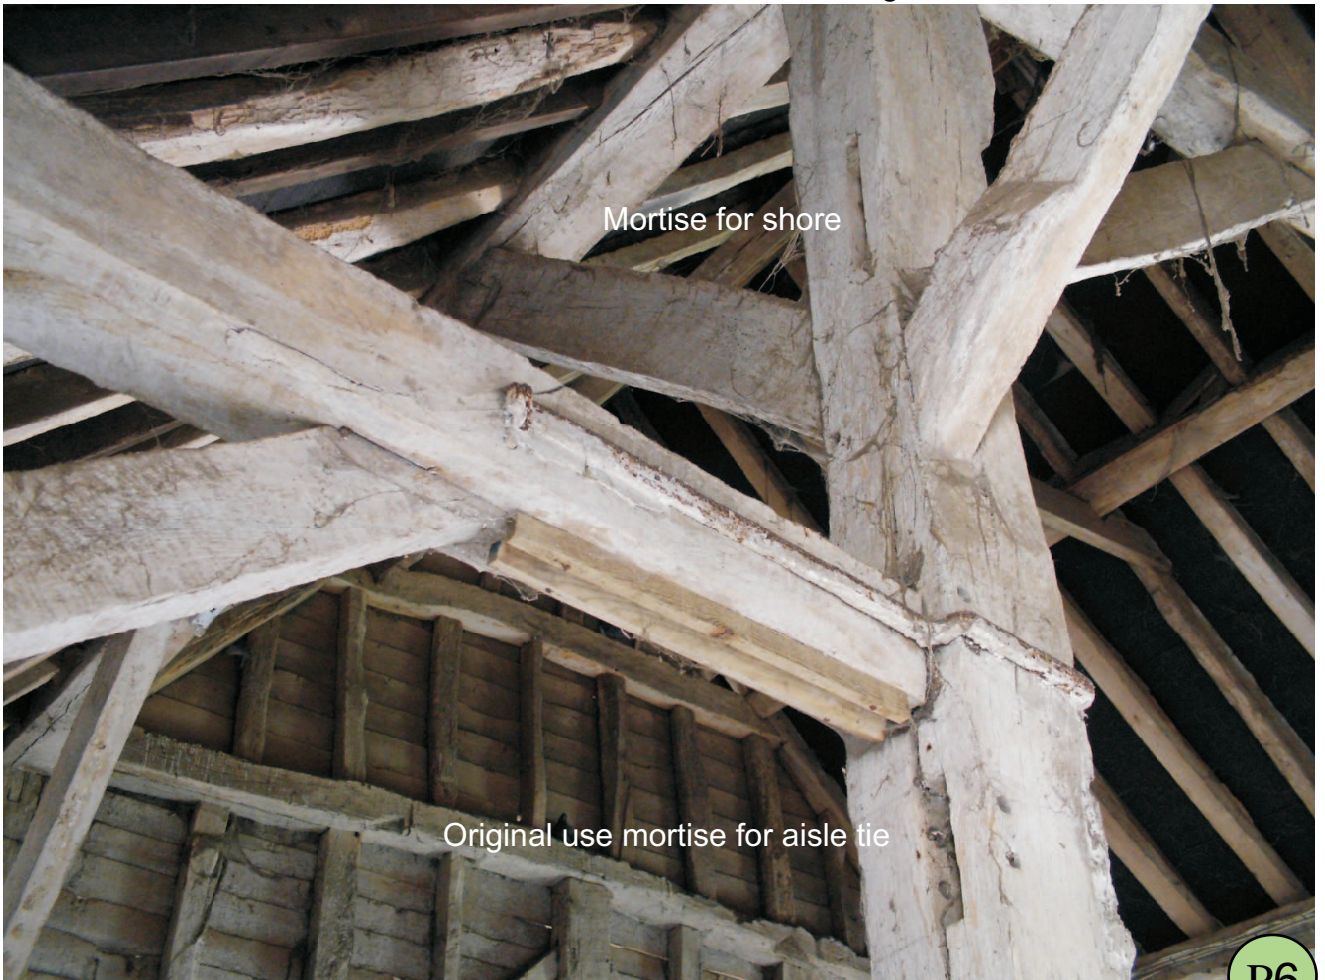
(248) View from aisle to post 3D showing in previous use had aisle shores.
