Feeringbury Barn, Feering, Essex.

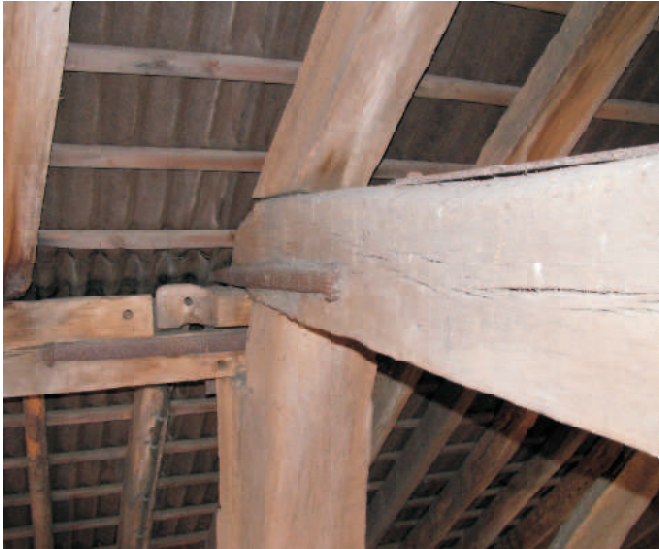
Photo 54. Typical detail to top of jowled arcade post with halved and bridled scarf joint in arcade plate and principal rafter above. Many joints have wrought iron ties.

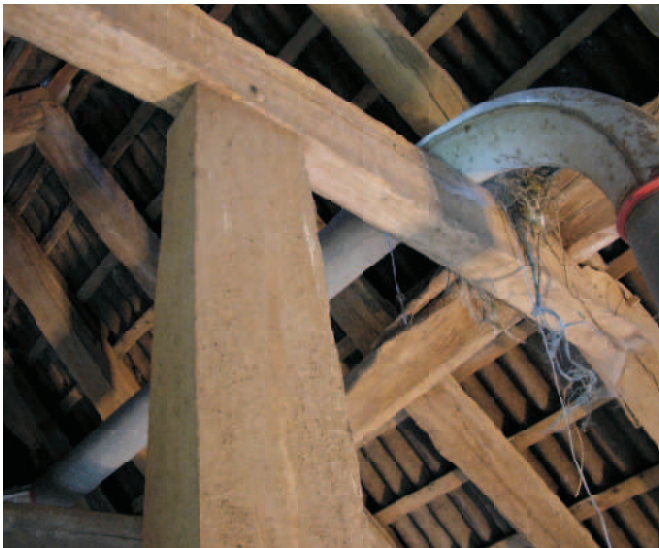
Photo 52. Typical crown strut to collar detail. The use of the crown strut suggests a transitional roof between the earlier crown post and the later side purlin roofs. The final change in Essex appears to come at about 1580.

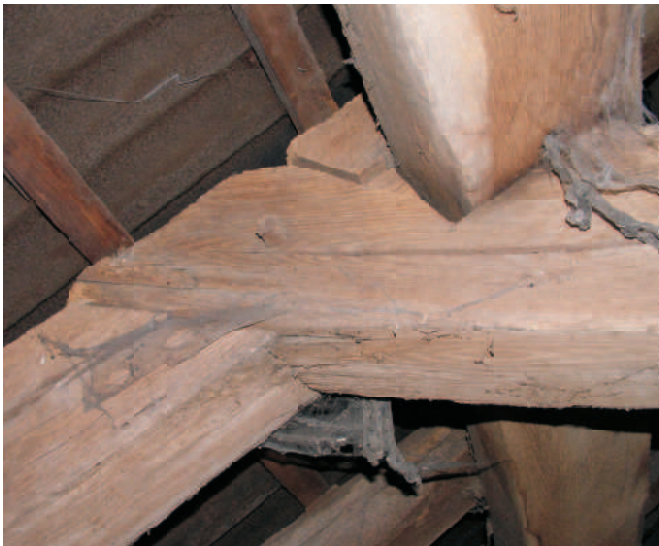
Photo 49. Typical detail of the collar with bare faced dovetail clasp the purlin to the principal rafter which reduces section through the joint.

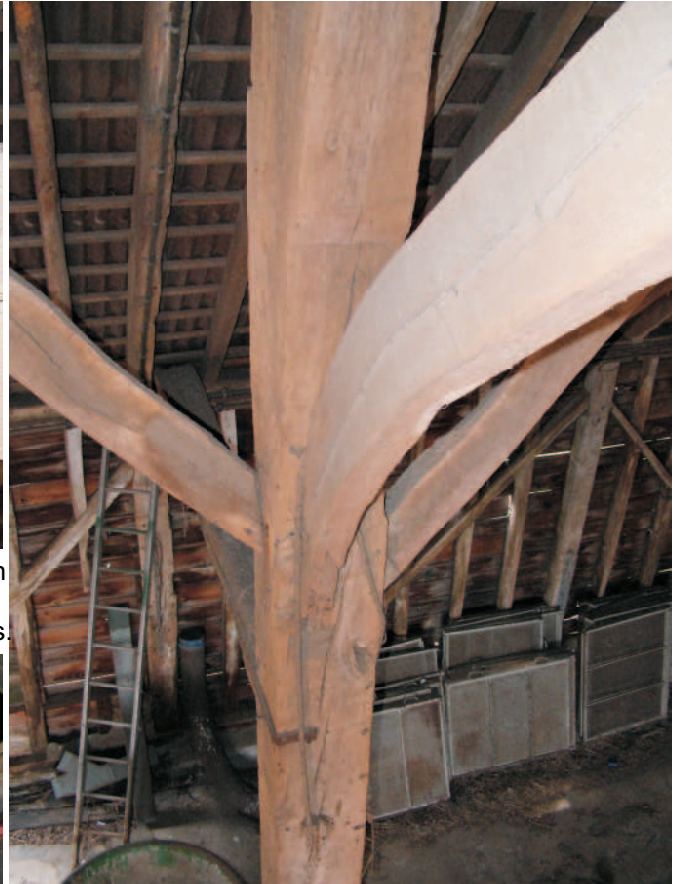
Photo 56. Arcade post bracing to plate & tiebeam.

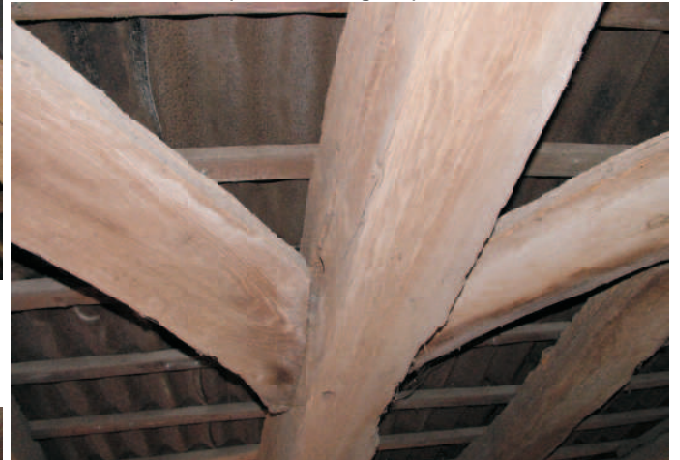
Photo 50. Wind braces in roof where they survive.

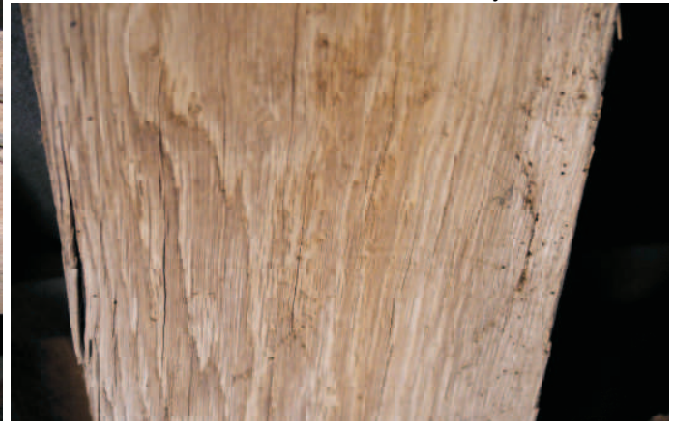
Photo 65. Apotropaic circle just visible on principal rafter facing to main doors in midstrete. Has partially completed radii to form the daisy pattern. Protection symbols are common in barns.
