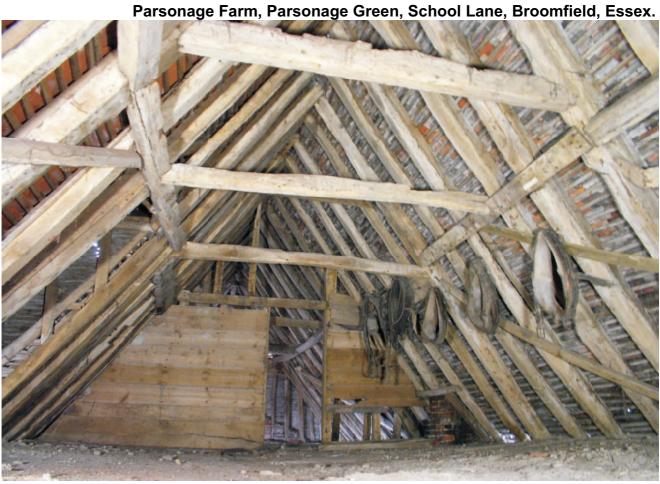
Building B. Hay Loft with view to west and access to gallery above Carthorse stable. Framed side purlin in area where stack goes through roof.

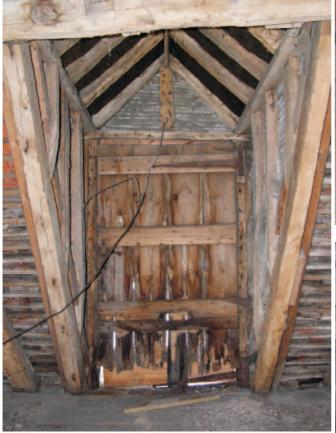
Gabled roofed timber framed dormered loading door to the farmyard. Good wide boarded unbraced door suggests eighteenth century as do the long fine hinges.
