Parsonage Farm, Parsonage Green, School Lane, Broomfield, Essex.

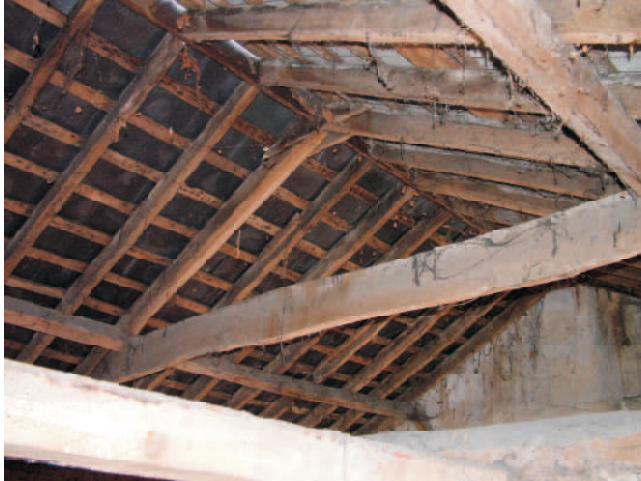
Building B, Granary. Detail of side purlin roof with collars to principle trusses and consistent size rafters. The raised ridge board was for a lead formed ridge.

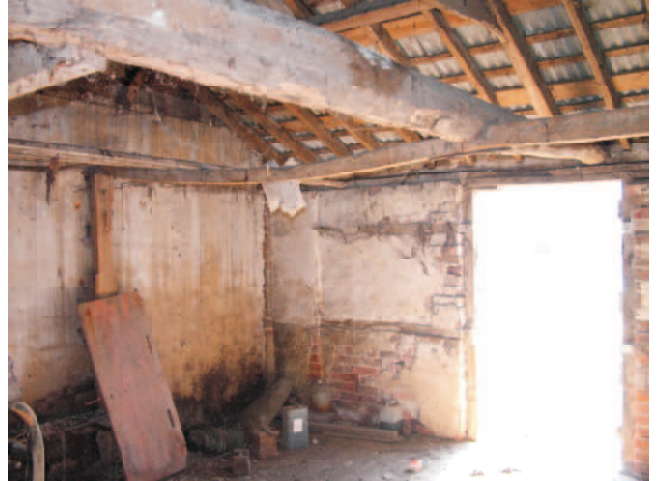
View to front wall showing plastered finish most likely boarded below lacing pieces.

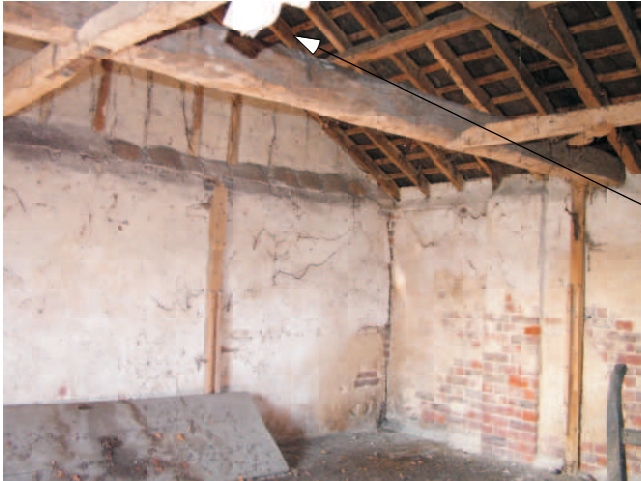
View to north west corner showing plastered walls and infilled eaves against rodent entry. Vertical timbers to walls with fillets for division boards.

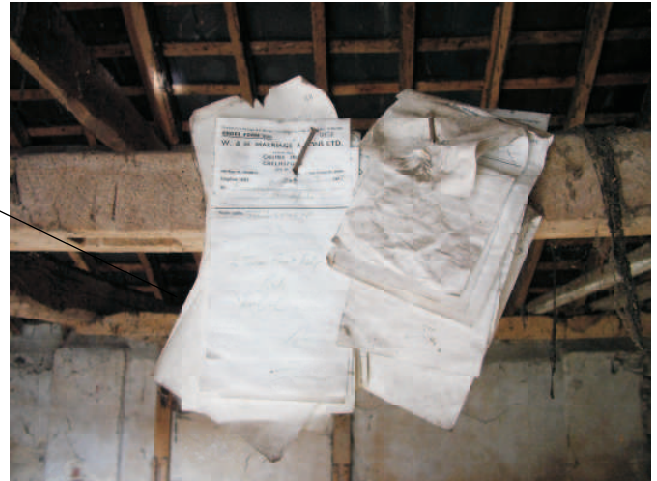
Quantity slips pinned to beam showing last materials stored.

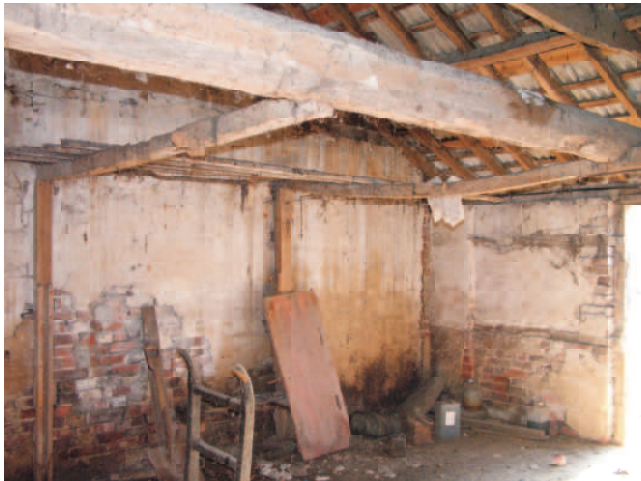
View to front south east corner showing broken brick joint suggesting Carthorse stable was originally longer. The large detail shows the same area on the outside with broken brick forming the end of the stable wall.

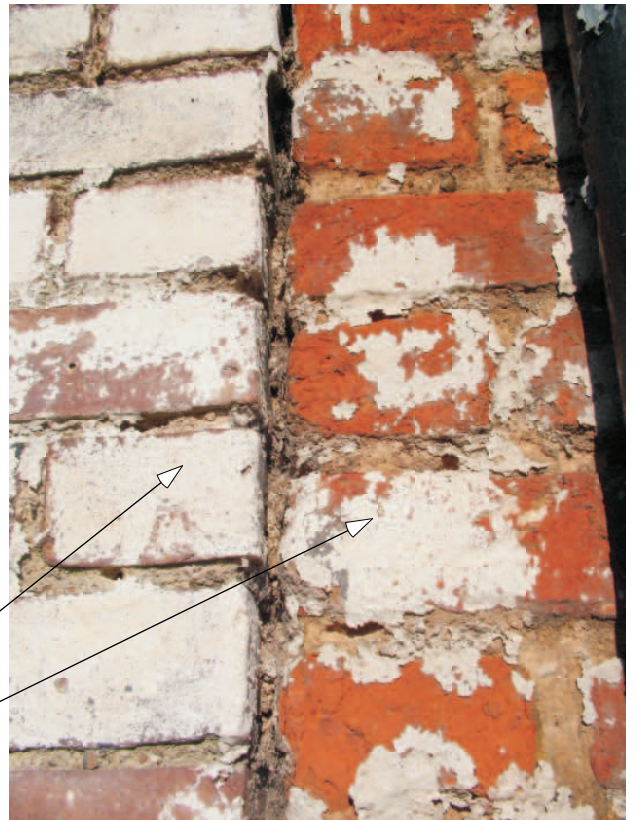
Granary wall

Stable wall
