EDGE END FARM, EDGE END LANE, NELSON LANCASHIRE

Archaeological Building Investigation

Oxford Archaeology North

April 2006

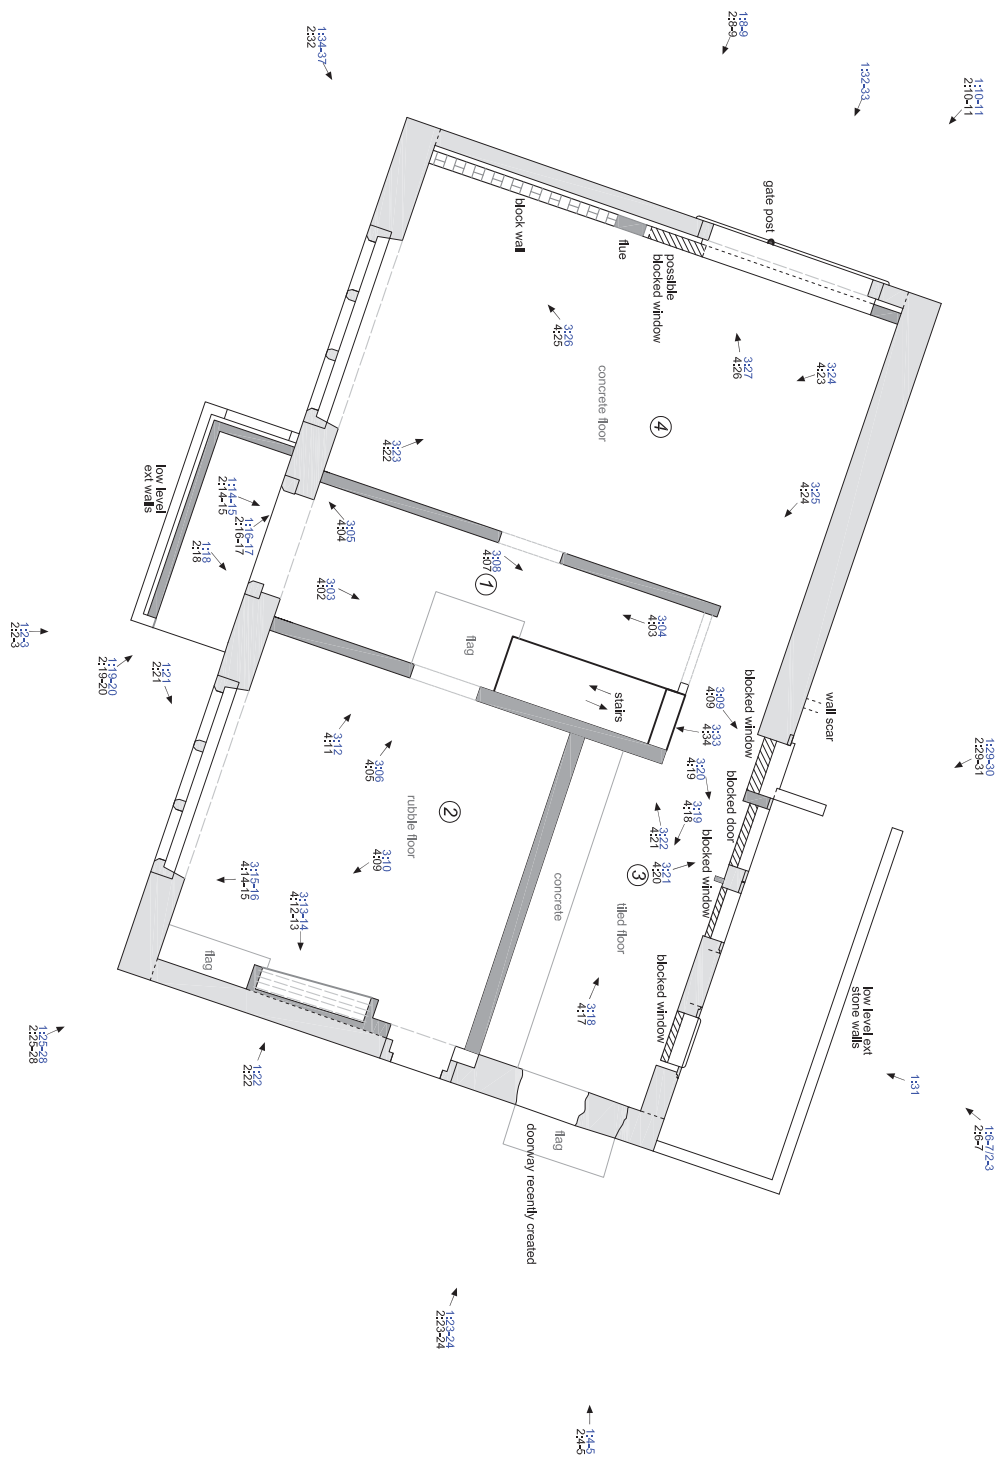
Figure 4: Ground floor plan

4.3.1 The house measures approximately 12m by 7.5m, is rectangular in plan and its long axis lies on a general east west orientation (Fig 4). Its appearance is typical of many Pennine vernacular double-pile small houses of the region (Brunskill 1997a; 1997b). The house is roughly symmetrical and has a central

hallway flanked originally by a single ground floor room on either side and two first floor rooms on either side (from wall scar evidence – see *Section 4.5.14*). The east ground floor room has been divided to create Rooms 2 and 3 (Fig 5). The hallway contained the stairs (now removed) allowing access to the upper floor and the step leading down into the basement which is limited in extent to the area below Rooms 2 and 3. All the rooms appear to have been accessed only via the hallway (except Room 3 which could also be accessed from outside – see *Section 4.5.10*). There are two chimneys flush with each gable, each of which contain two flues, which allowed fireplaces in all rooms.

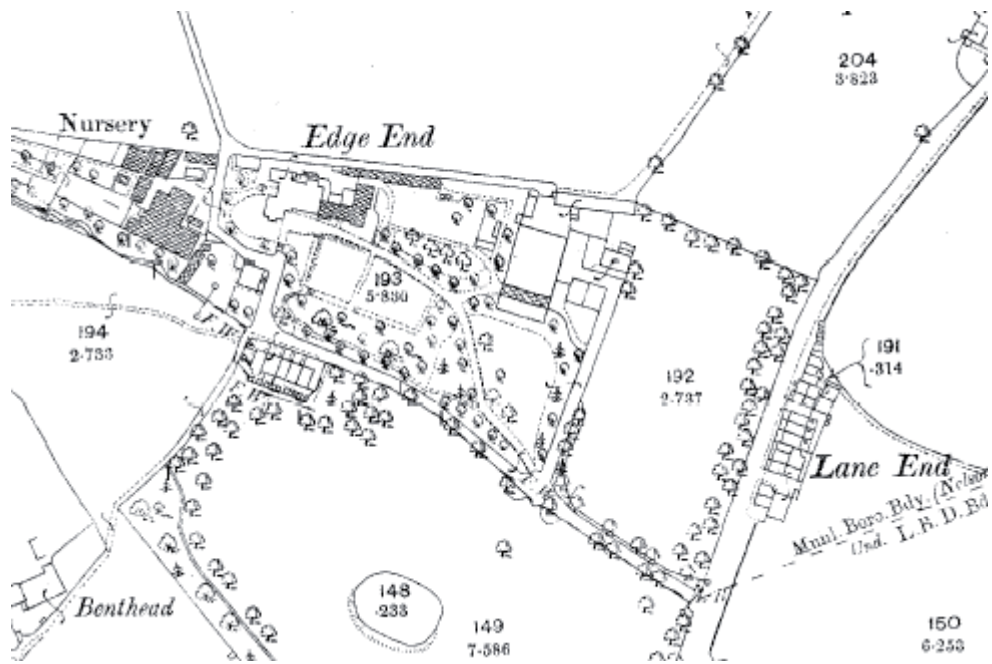
- 3.1.5 ***Ordnance Survey 1893***: by this date the settlement at Edge End has changed dramatically (Plate 1). Edge End Hall is still present and takes essentially the same form, but there are a large number of glasshouses associated with it situated to the east and west. The buildings at Clare Green have changed considerably more, what is now Edge End Farm has been built replacing the building at Clare Green and this comprises a much larger rectangular block, also with a glasshouse making up part of the south end. Additional outbuildings have also been constructed to the north and south. The building

under investigation appears for the first time at the north end of a track to the west of a field labelled 192.

Plate 1: Part of the Ordnance Survey map of 1893 showing Edge End and Edge End Farm

- 5.2.3 The final phase of exterior modification is that of the patio and retaining wall which surrounds the south and west sides of the building. These probably date to the late twentieth century, although it is possible that they are illustrated on the 1893 OS map (Plate 1) and the current patio replaces an earlier feature.

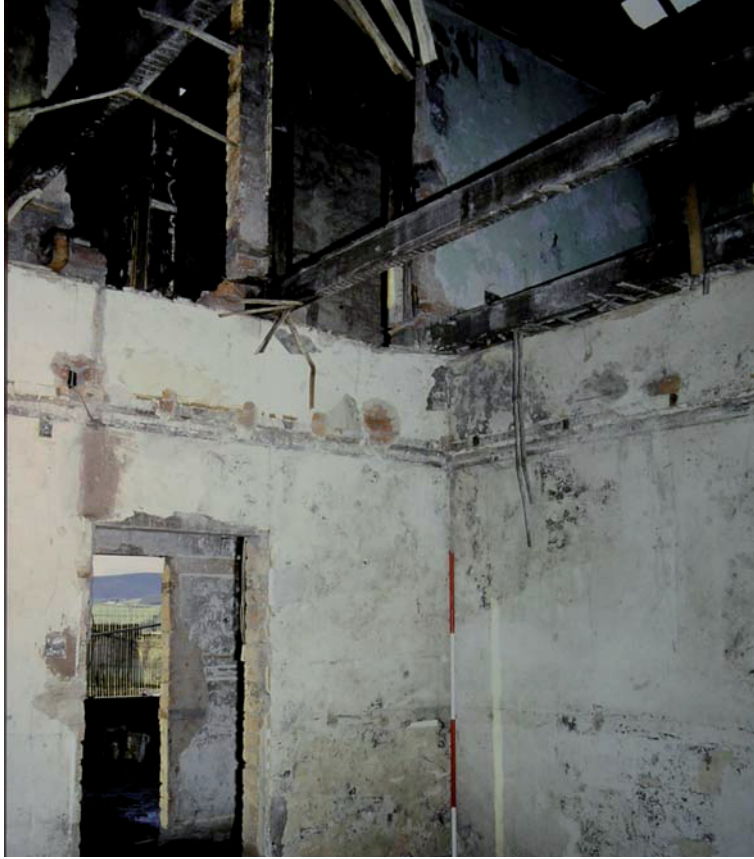
- 4.5.5 **Room 2:** this room lies in the front of the building and is roughly square (Plate 12). It can only be accessed from Room 1 through a single doorway and no obvious function for this room is discernible. The west and north walls are of brick construction, while the south and east are of rubble. The east wall contains areas of rebuilding, which are of modern grey brick. The north wall, which separates this room from Room 3, rests upon a substantial timber baulk and only extends up to ceiling height. This wall is of similar construction to the other brick walls and may be contemporary. The floor comprises loose sand/gravel and may have originally been flagged. The ceiling is the same as that described for Room 1 with evidence for inserted joists (Plate 13).

Plate 12: Room 2 facing north-west

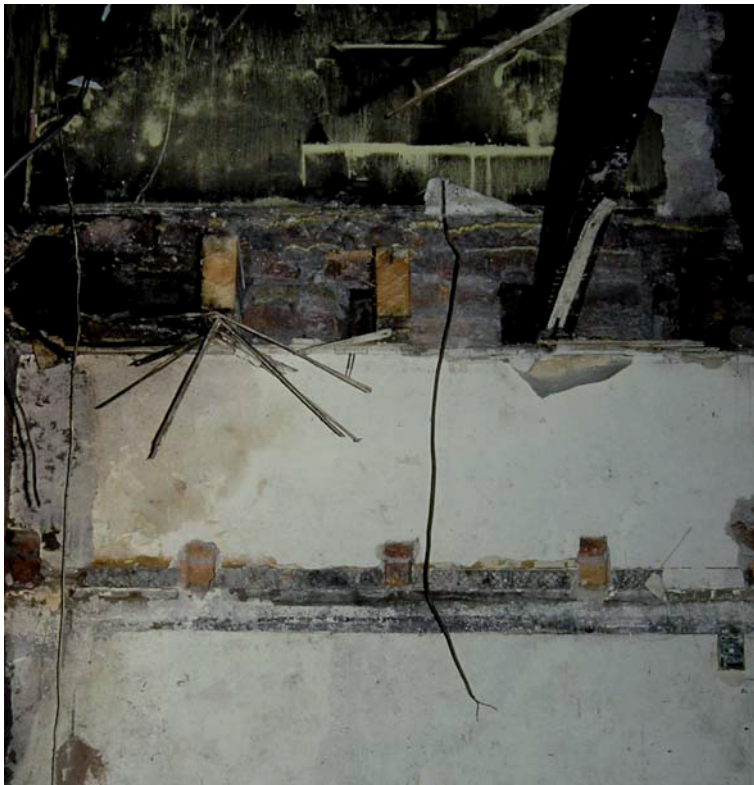
Plate 13: Inserted later joists

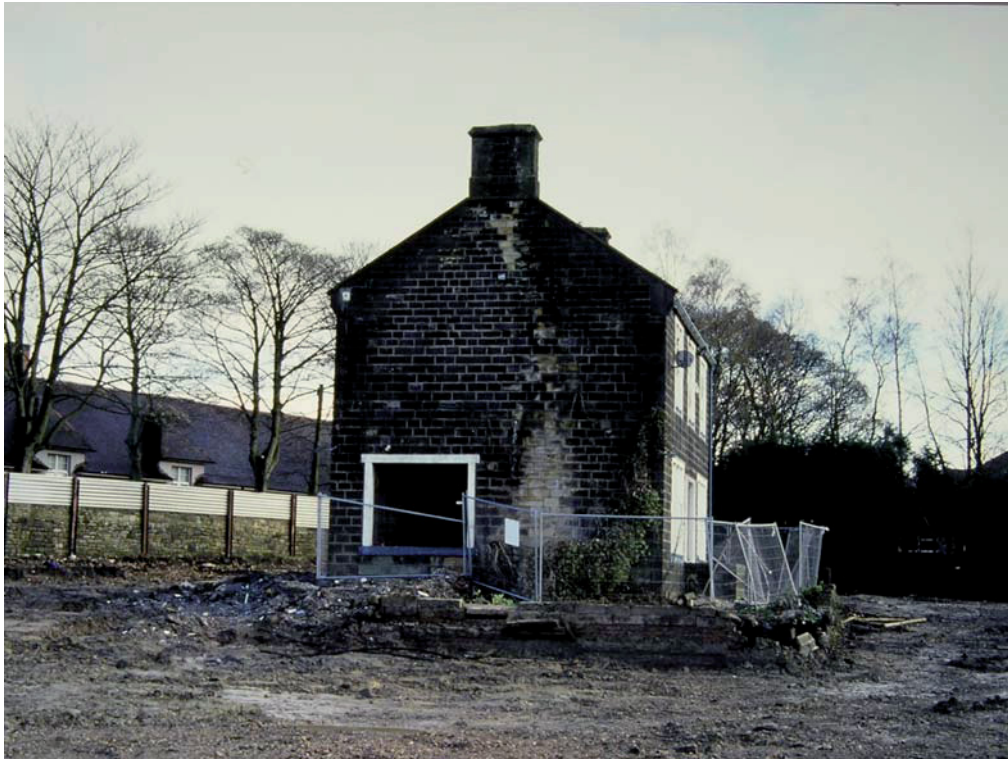
- 4.4.7 ***The West Elevation:*** this is constructed in exactly the same manner as the east elevation. Visible deterioration betrays the line of the flue (Plate 10). A large 'picture window' with a massive sandstone surround and projecting sill has been inserted into the northern side of the elevation. A patio area extends around this side of the building.

Plate 10: West Elevation

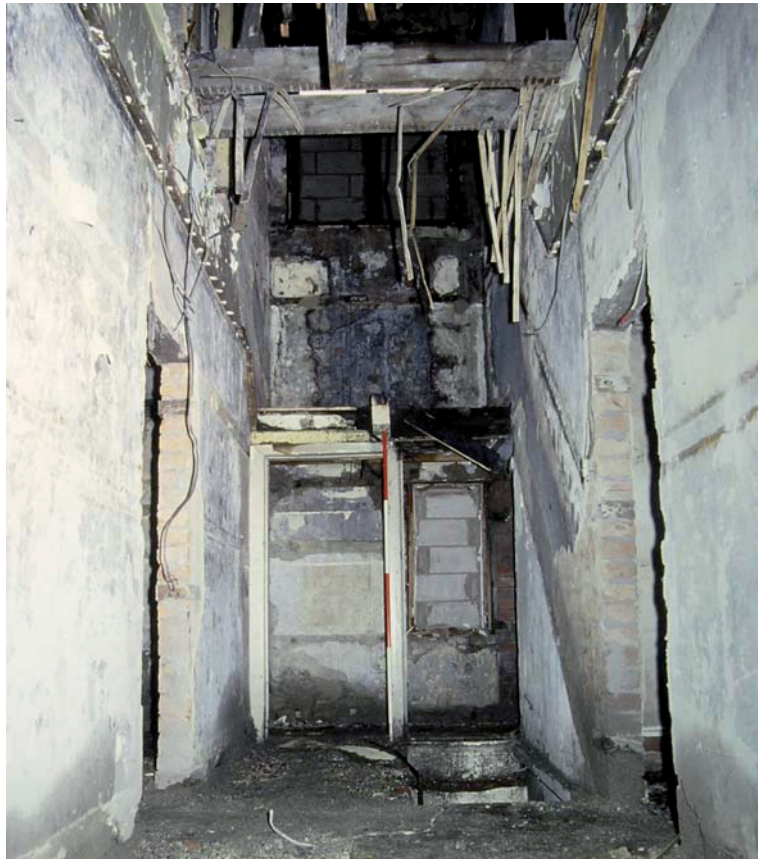
- 4.5.1 ***Room 1 (and 6):*** this room forms the main entrance lobby and originally housed the main staircase and first floor landing (Plate 11). The stairs appear to have been of half-turn construction, below which was access to the basement. Some beaded matchboard is still present and the stairs are fire damaged. All the rooms of the house lead off the lobby. The first floor landing (Room 6) was inaccessible at the time of survey.

Plate 11: Room 1

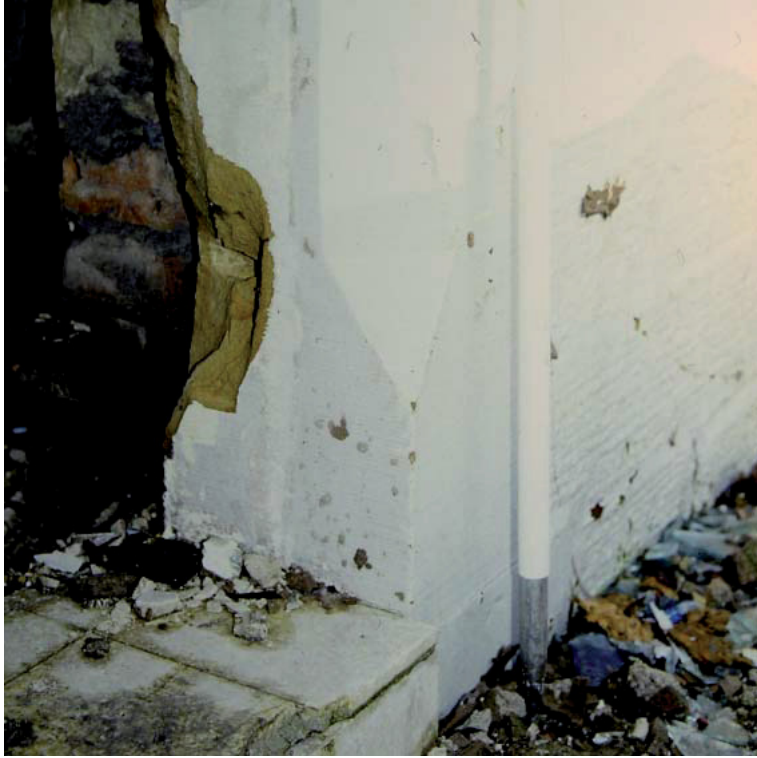
Plate 8: Detail of base of front door

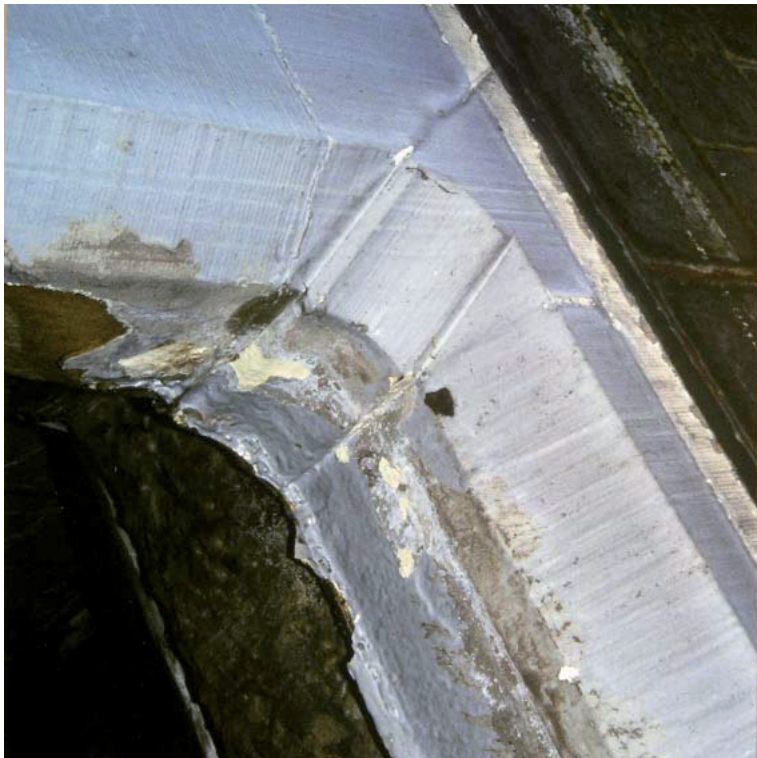
Plate 9: Shoulder detail of front door

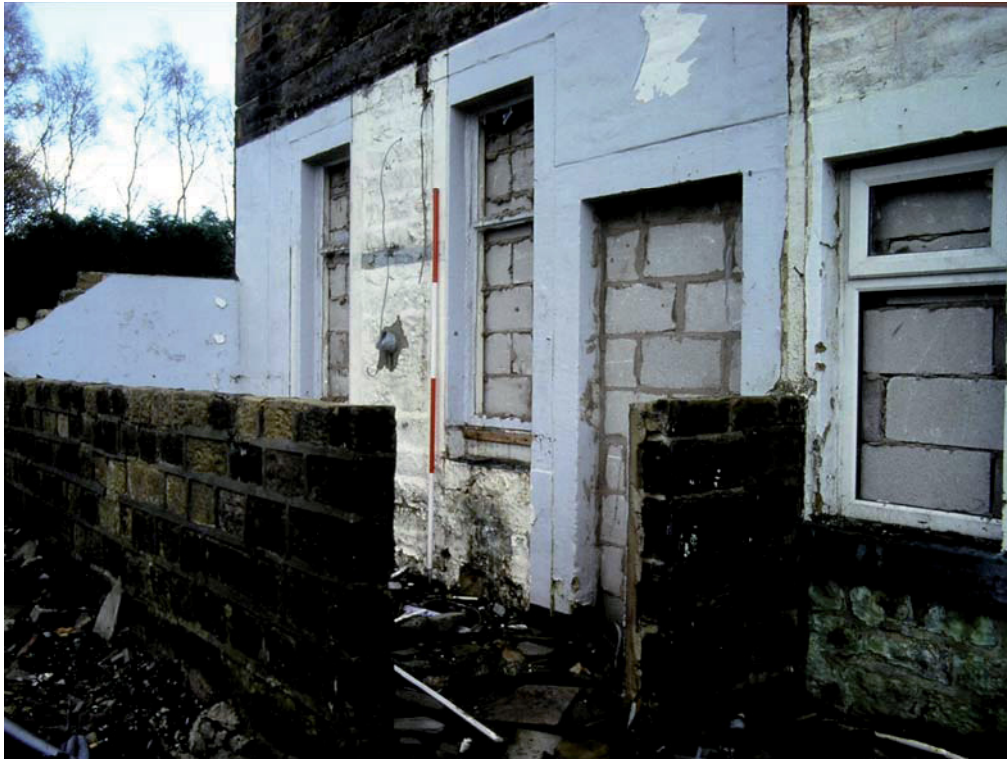
- 4.4.4 Within the outshut are three windows and a door, all of which have been blocked from the inside with cinder blocks (Plate 6). They all have square furrow tooled sandstone surrounds and the sill of one window projects slightly. The first floor windows are effectively a mirror image of those on the front

Plate 6: Detail of rear outshut

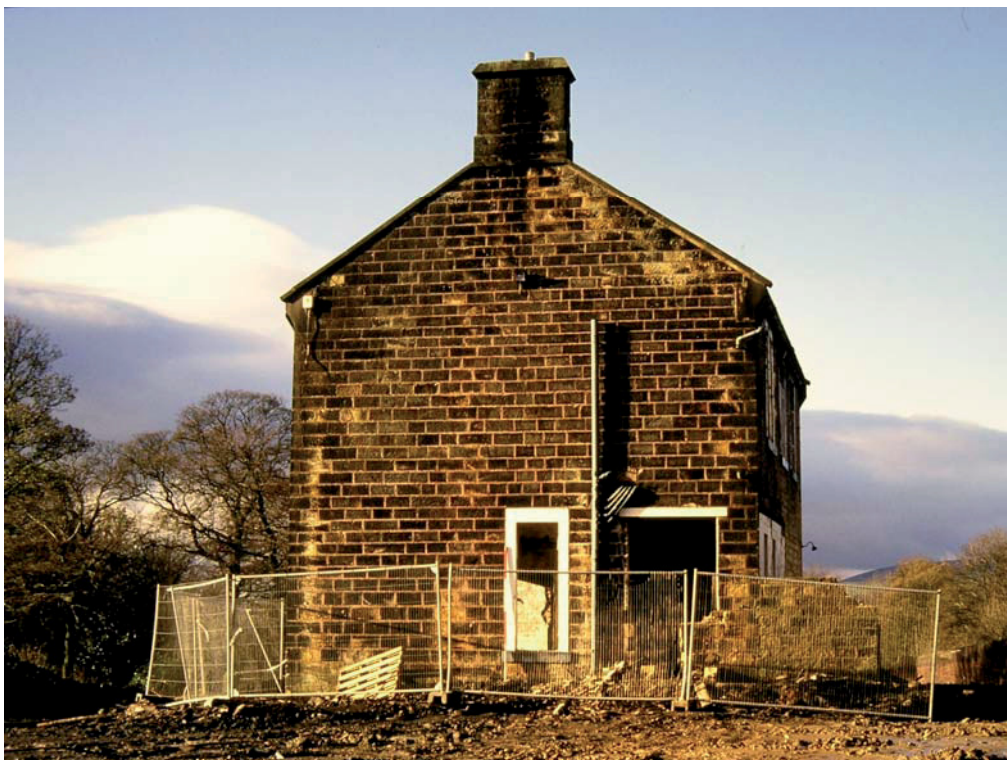
- 4.4.5 ***The East Elevation:*** this elevation is constructed in the same manner as the west and front elevations (Plate 7) and forms the gable. The verge is flush and exhibits a sandstone coping with moulded sandstone kneelers at each side. A chimneystack of the same construction as the main wall is flush with the wall and straddles the roof ridge. This has a plinth, together with moulded sandstone oversailing course. There is a plastic downpipe into which the outlet pipes from Room 7 flow.

Plate 7: East elevation

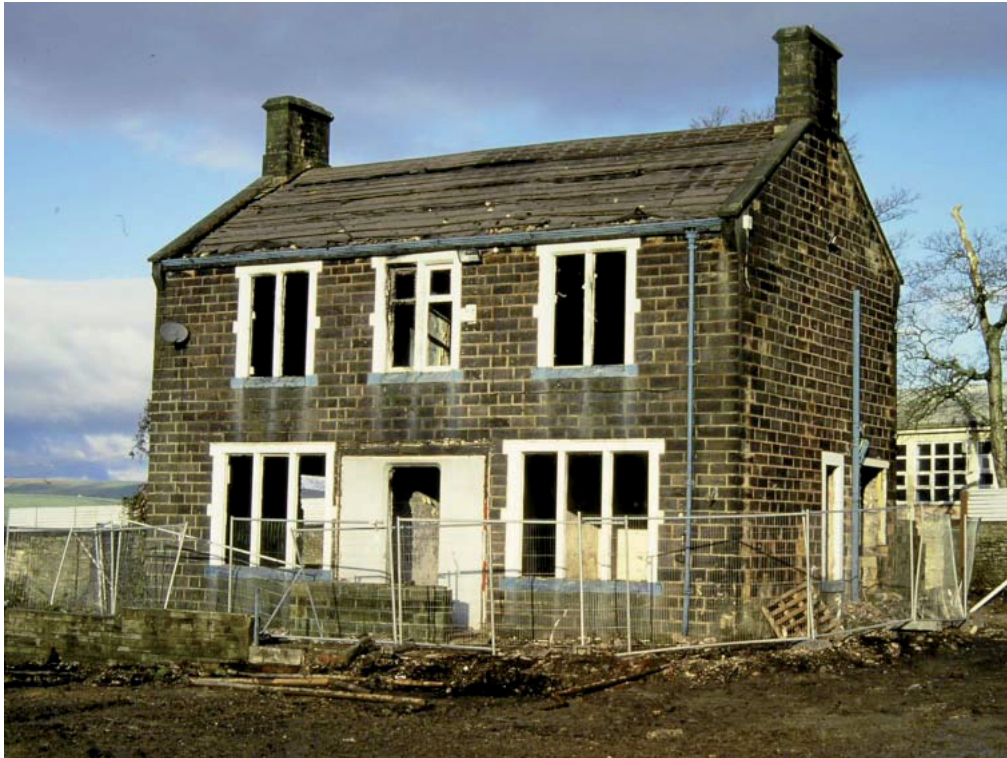
- 4.4.2 There are five large windows present in this elevation, two on the ground floor and three on the first (Plate 2). The ground floor windows contain three lights separated by simple splay moulded flush mullions and have splayed sills. Each window has tails that are keyed into the surrounding stonework. The first floor windows are identical but have just two lights. It appears that all the windows were glazed with PVCu windows. There is an ogee gutter, which rests on projecting sandstone, and a single cast-iron down spout.

Plate 2: General view of front of house

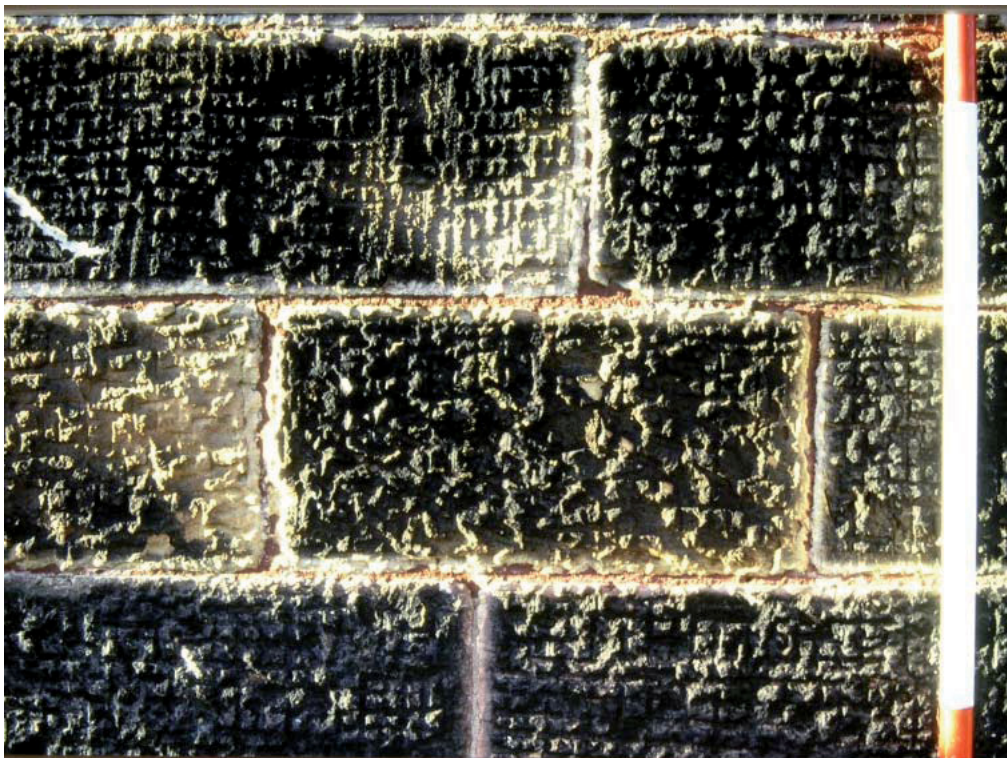
4.2.1 The main elevations of the house are constructed from compound walls with regular, tooled (Plate 3), coursed blackened gritstone facing, the largest block measuring 0.59m (1 foot 11 inches) by 0.18m (7 inches), with red mortar and rubblestone (brick near the front door) backing (Plate 3). The rear of the house is constructed from coursed random rubblestone with smeared lime mortar. There is a partially demolished outshut/extension at the rear of the property, which is constructed from a single skin of rock-faced yellowish sandstone with cement mortar. A partly demolished porch at the front door is of similar stonework to the house but is lined with a skin of brickwork. All of the window and door surrounds are of tooled sandstone, most of which have been painted. The windows, although removed, appear to have been most recently PVCu replacements.

- 4.4.1 ***The Front (South) Elevation:*** this contains the main entrance and is composed of well-finished stonework with narrow joints, which exhibit deep crosshatched tooling (Plate 3), some of which is in poor condition. The doorway has a substantial gloss painted stone surround, which exhibits very fine horizontal furrow tooling chamfers with straight-cut stops and carved shoulders (Plates 8 and 9). A porch once stood here and was probably of dwarf wall construction with a glazed upper section.

Plate 3: Tooling on main elevations

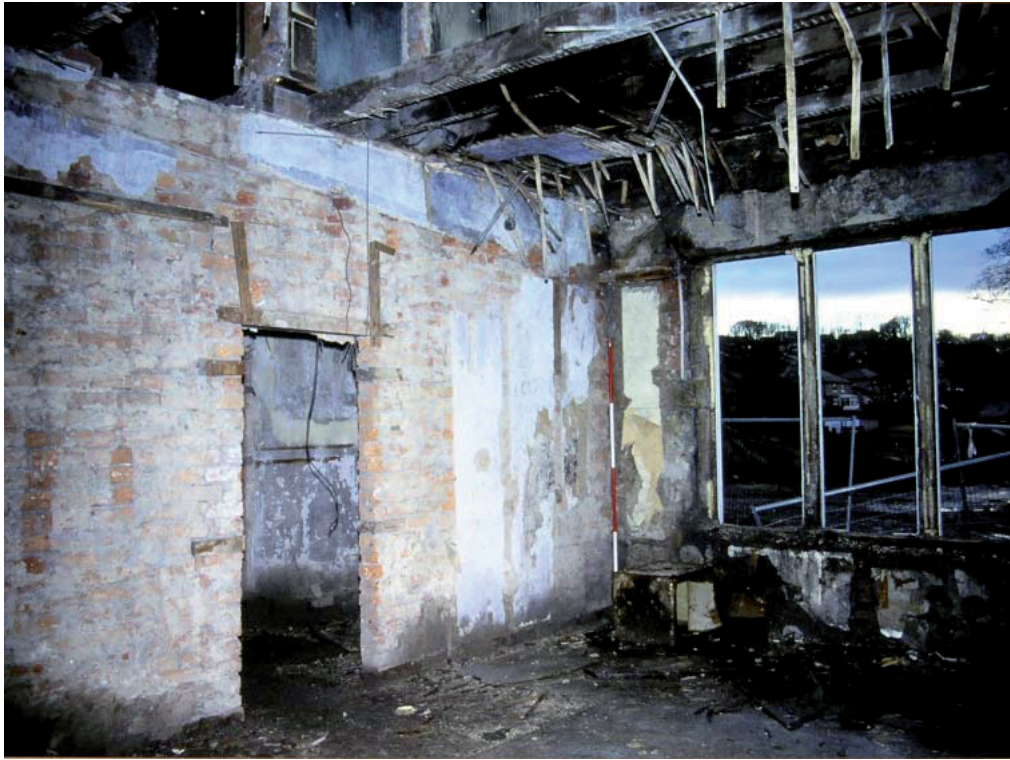
4.2.3 Internally, the dividing walls are of brick construction, mostly measuring 8³/₄ x 6 x 3 inches (Plate 4). Mortar is mainly lime but there are areas of cement patching and rebuilding/infilling (particularly the fireplaces) with later brick. There is also some infilling with cinder block present. All the walls appear to have been plastered (probably with lime plaster) but are now mostly bare. The remaining ceilings are lath and plaster with traces of lime still visible. The basement walls are all plastered. Some of the floors are concrete but it would appear that they were originally of flagged construction.

- 4.5.12 **Room 4:** this is the largest room in the building and occupies the whole of the ground floor to the west of Room 1 (Plate 4). The east wall is constructed from brick while all the rest are of rubblestone. Most of the walls exhibit some patching and repair in modern brick but the southern side of the gable wall has been entirely reconstructed in cinder block. It contains a modern steel flue and the remains of a boiler are present. It would appear that a chimneybreast was once present here and later removed. The steel flue was probably inserted into the existing flue, which passes up to Room 5.

Plate 4: General view of Room 4

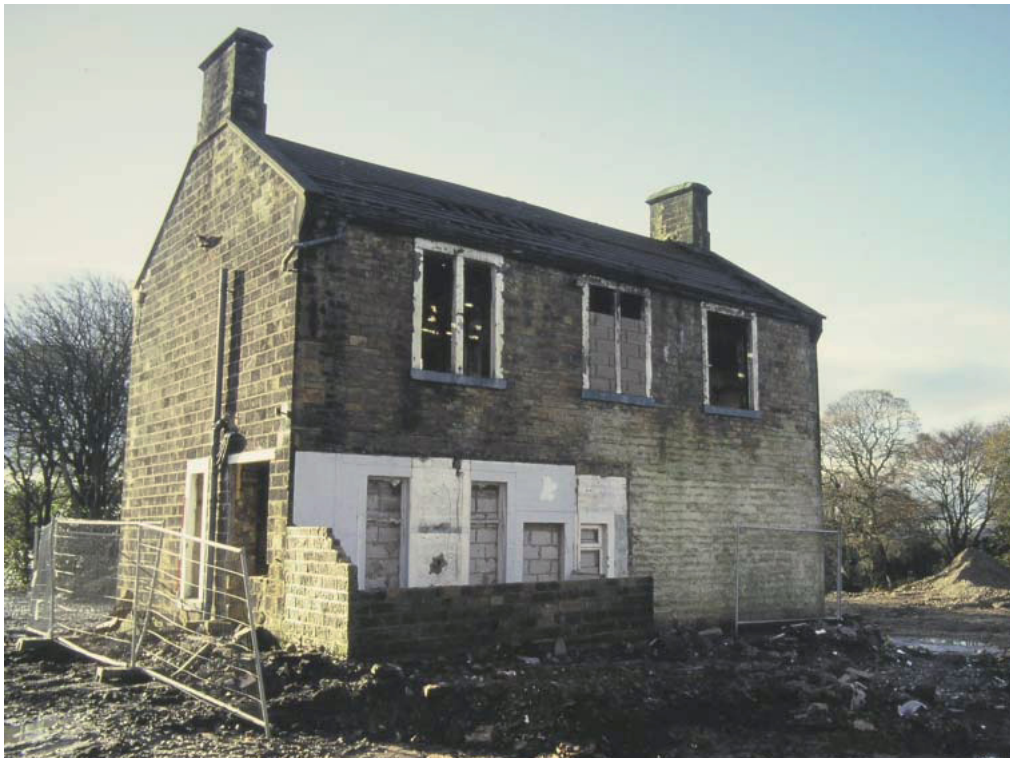
elevation except that they have different, square surrounds and mullions with projecting sills (Plate 5). The centre window has been partially blocked from inside with cinder block.

Plate 5: Rear view of house

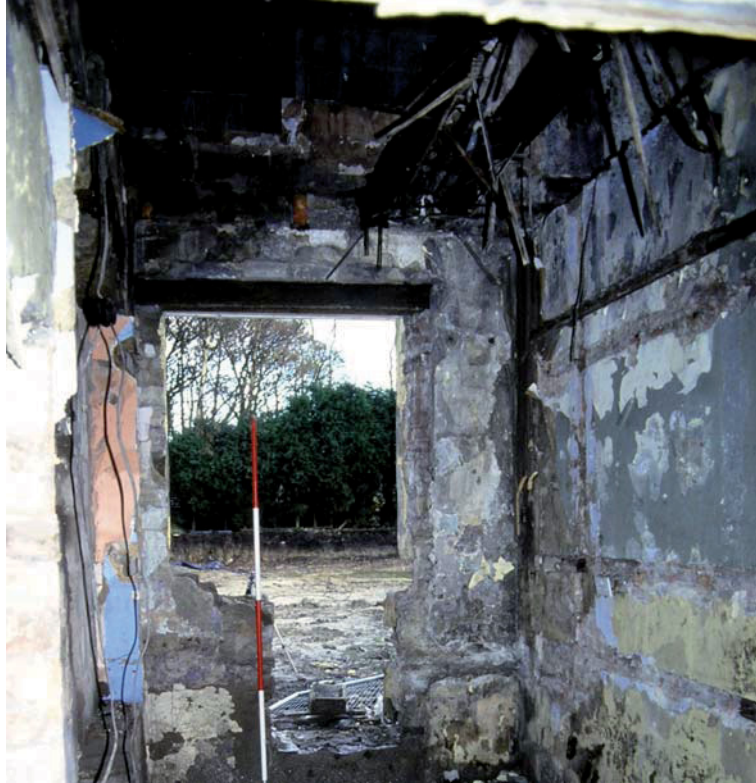
Plate 14: Room 3 facing east

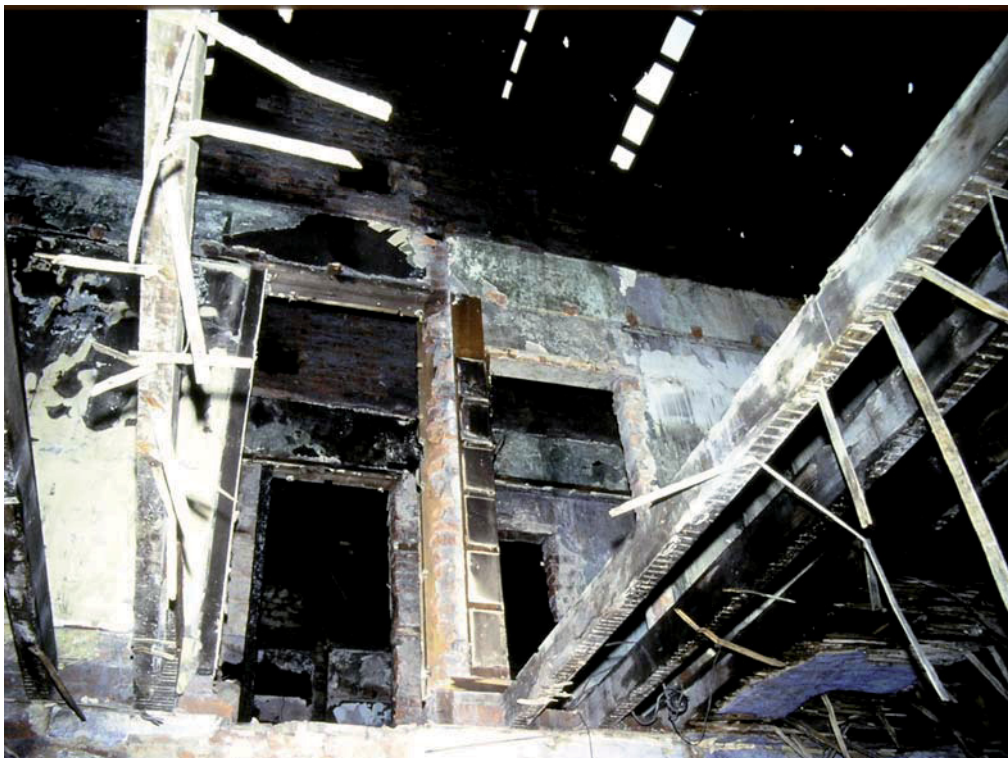
Plate 15: Doorways on first floor
