109 Church Street, Workington, Cumbria

Rapid Desk-based Research and Watching Brief

Oxford Archaeology North

January 2010

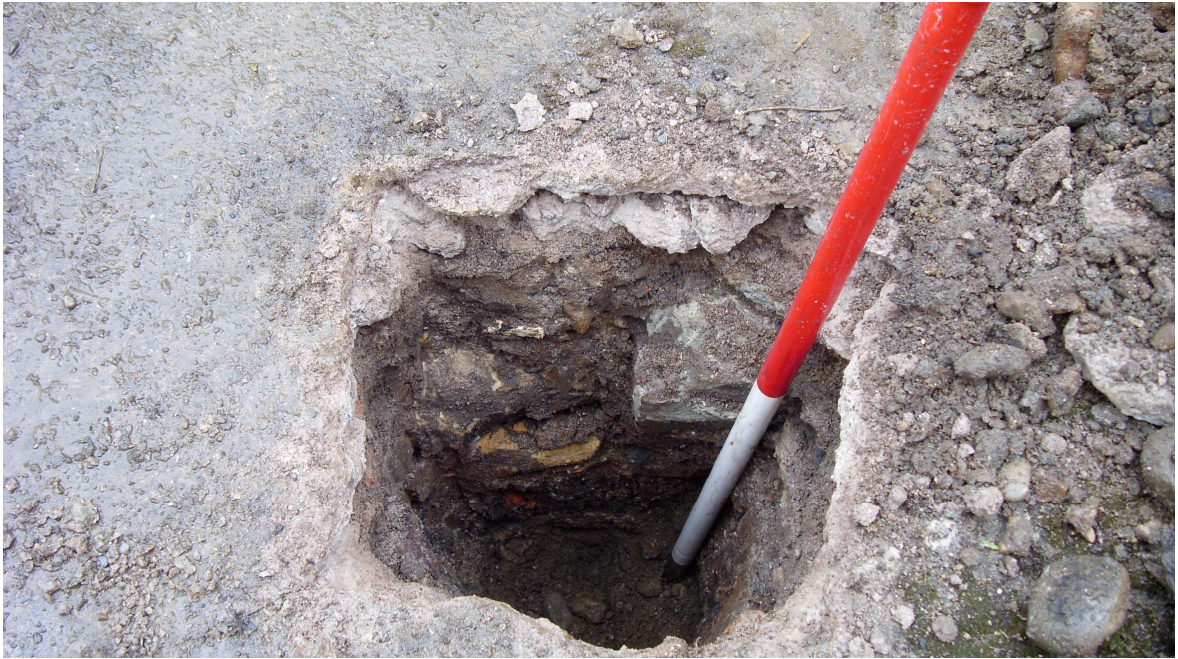
Plate 4: View of hand-inspection pit for borehole showing concrete surface *1029* with underlying rubble deposits *1030* and *1032*

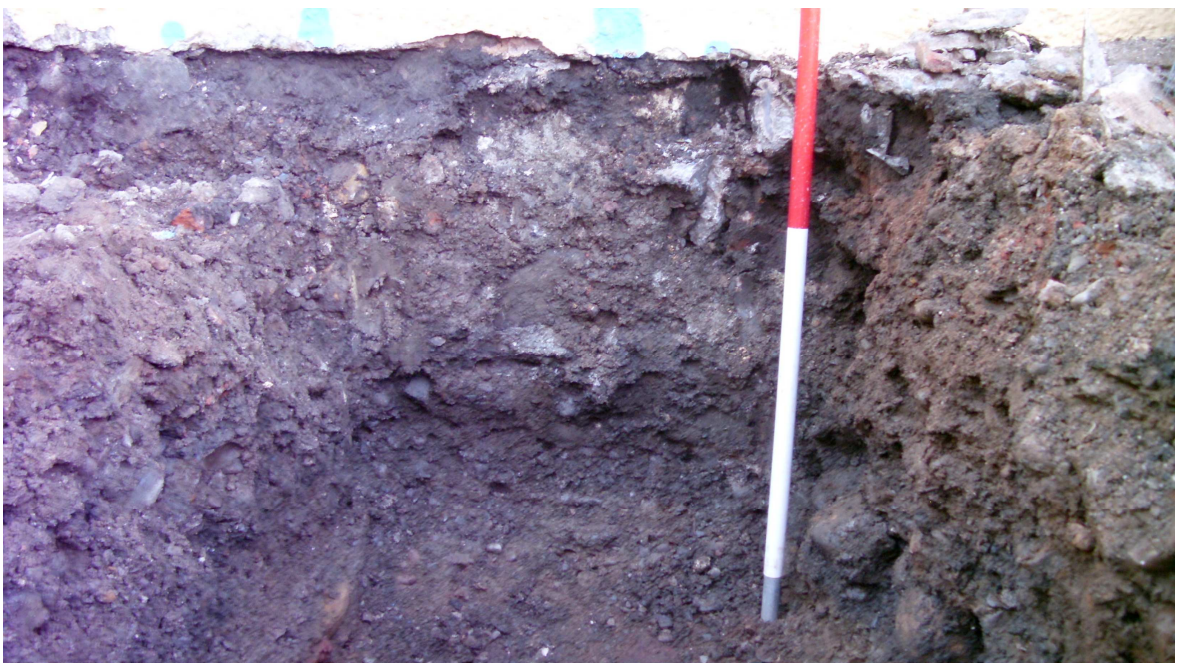
Plate 5: View to the west of the foundations of 111 Church Street and underlying made ground *1032* overlying natural *1001*

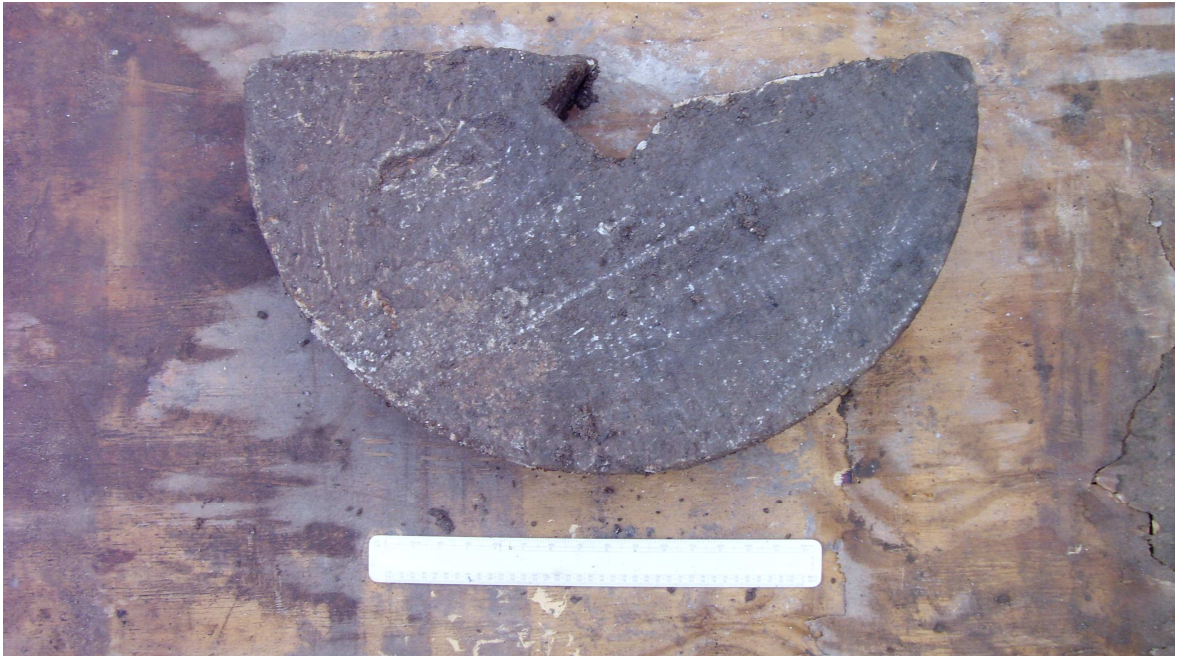
Plate 6: A large fragment of grindstone recovered from made ground **1032** in the north-west corner of the site

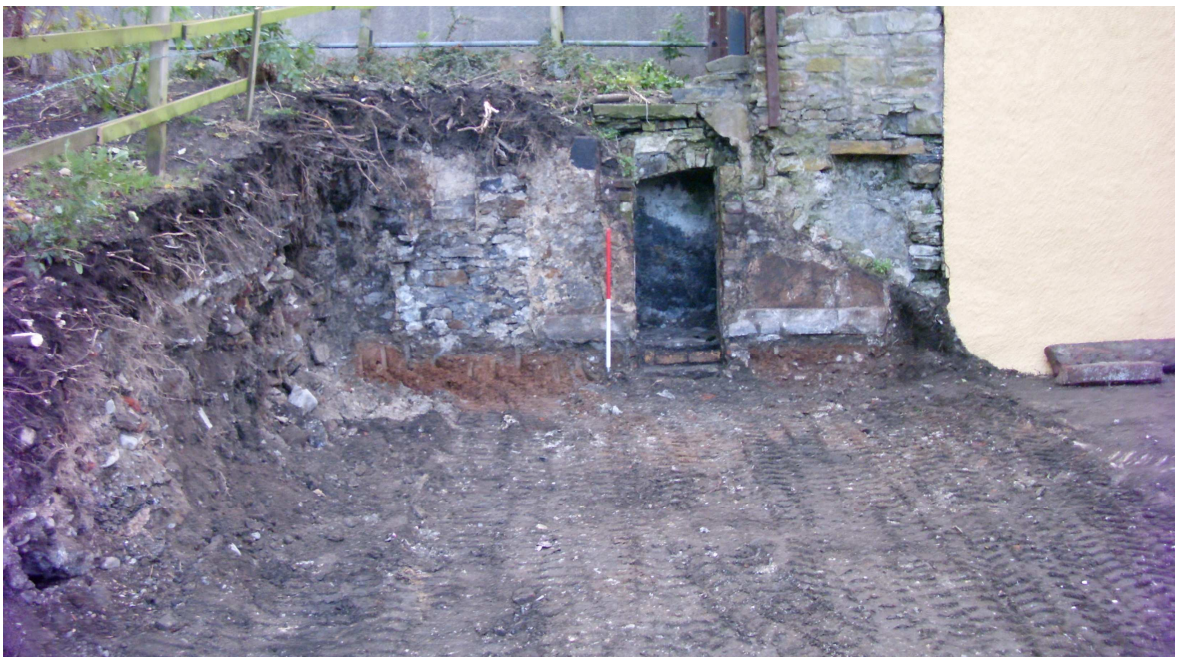
Plate 7: View to the south-east of landscaped bank **1035**, tenement wall **1034**, and coal cellar **1033**, exposed by ground reduction

- 5.2.5 The ground reduction exposed an extant standing section of the rear wall, **1024**, of the tenements, **1034**, formerly occupying the site (Fig 10, Plate 7). The upper part of the wall was partly visible prior to the ground reduction that exposed it to the foundations. The wall was built on a foundation layer of medium to large stones **1025** that were placed on a levelling deposit of clayey-sand **1027**. This clayey-sand could have been ships' ballast that was unloaded from vessels docked at the nearby quay and replaced with a cargo of coal (see *para 3.3.8*). The wall was built of mortar-bonded random stones, worked and water-rounded, of small to large size. A doorway in the rear wall (Plate 7) led to the extant coal cellar **1033**. A layer of mortar/plaster **1023** was applied to the wall, and a layer of brownish finishing plaster **1022** was then applied. (Plate 8). Moulded on the finishing plaster at ground level was a skirting board **1021** of similar material. The plaster on the wall showed evidence of having been painted, **1020** (Plate 11). A small section of an internal wall, **1037**, aligned north/south, joined the rear wall but was not bonded to it. The upper part of the rear wall, **1024**, has been rebuilt with reused random stones bonded with cement **1038**, and topped with a wooden fence, **1039**, that forms part of the yard wall at the rear of 111 Church Street. This yard was probably part of Church Lane in former times.

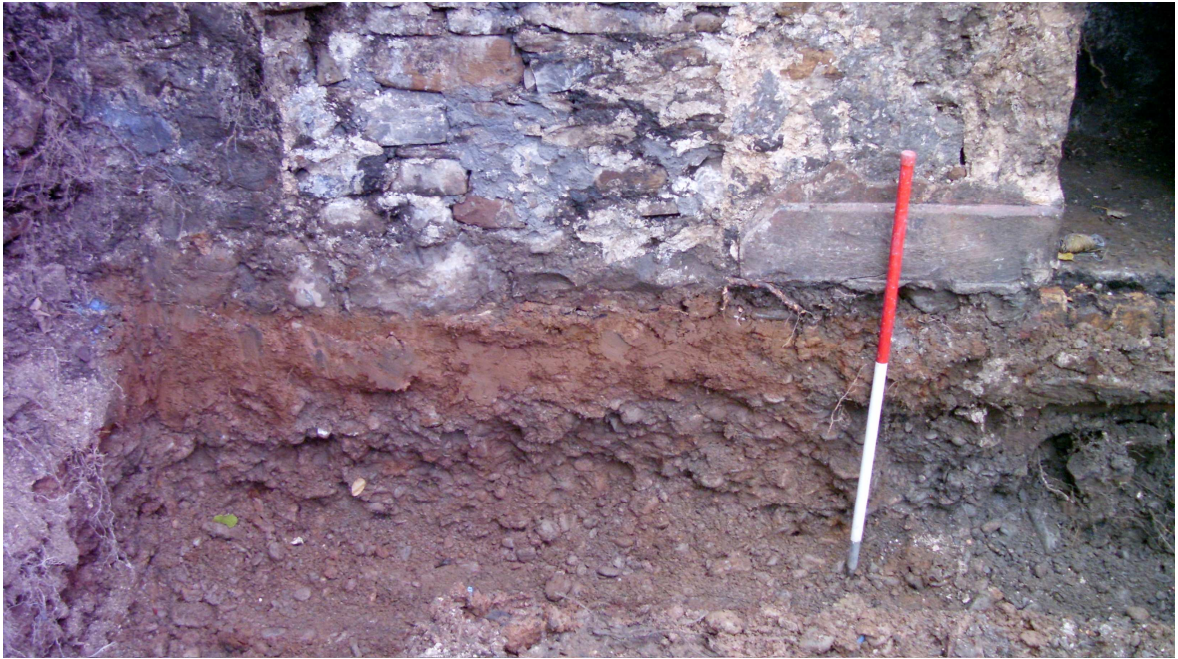
Plate 8: View to the south of the tenement wall *1024*, skirting board *1021*, foundation stones *1025*, and clayey sand levelling deposit *1027*, on natural ground *1001*

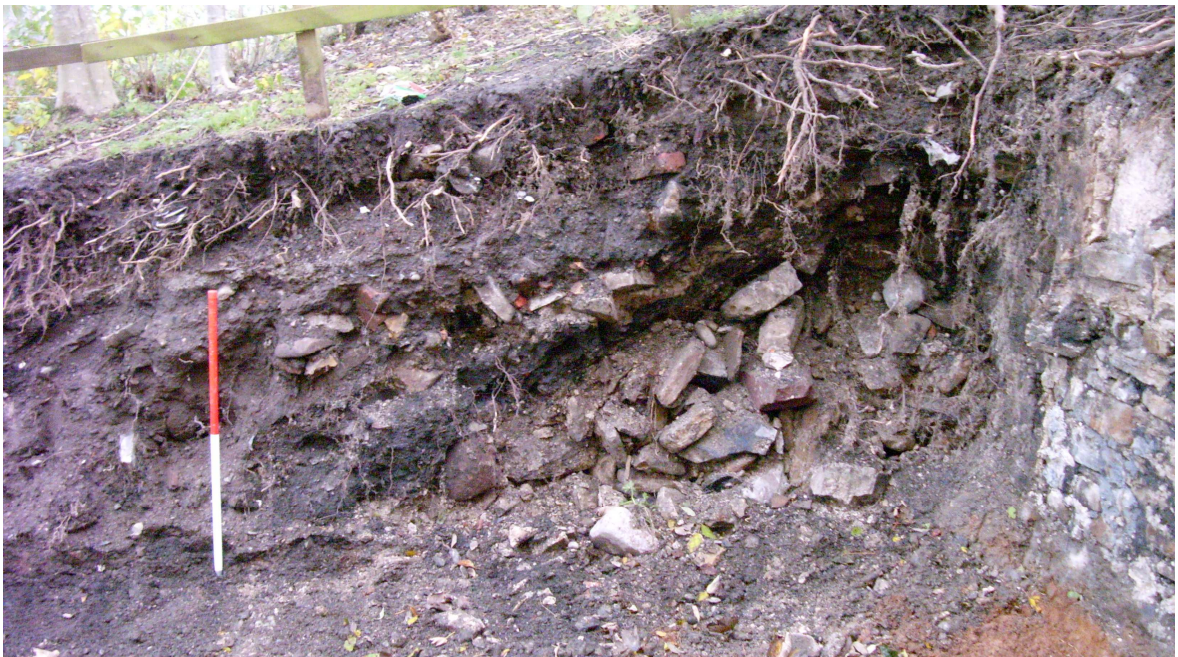
Plate 9: Demolition rubble deposit *1009* in the southern end of the landscaped bank section

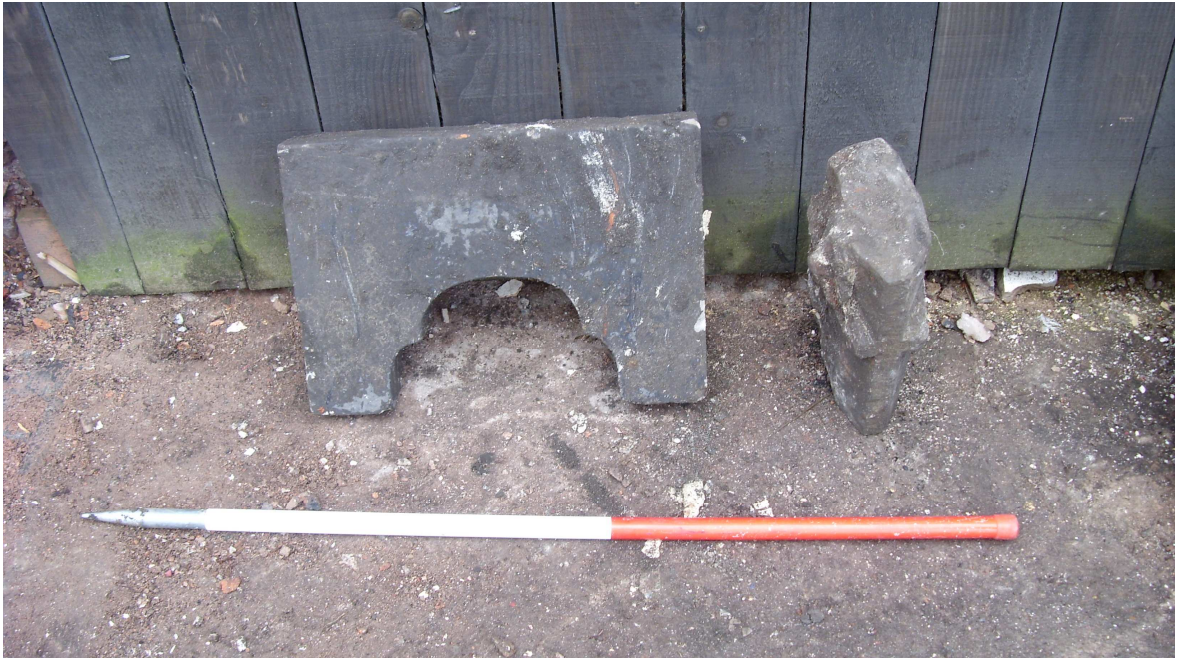
Plate 10: Two carved masonry remains recovered from demolition deposit *1009*

- 5.3.4 The medieval parish church was demolished and rebuilt in 1770 only to be burnt down in 1887. It is probable the two pieces of masonry came from either of these buildings and were reused in the buildings along Church Street.

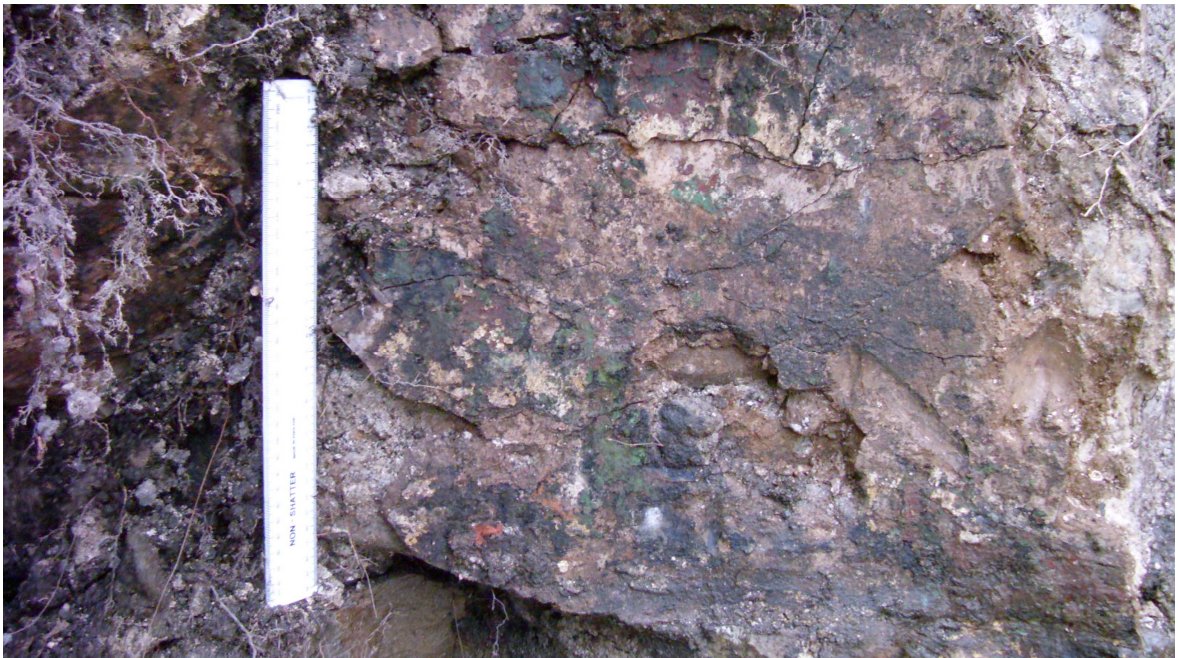
Plate 11: Remnants of green paint *1020* on plaster *1022*

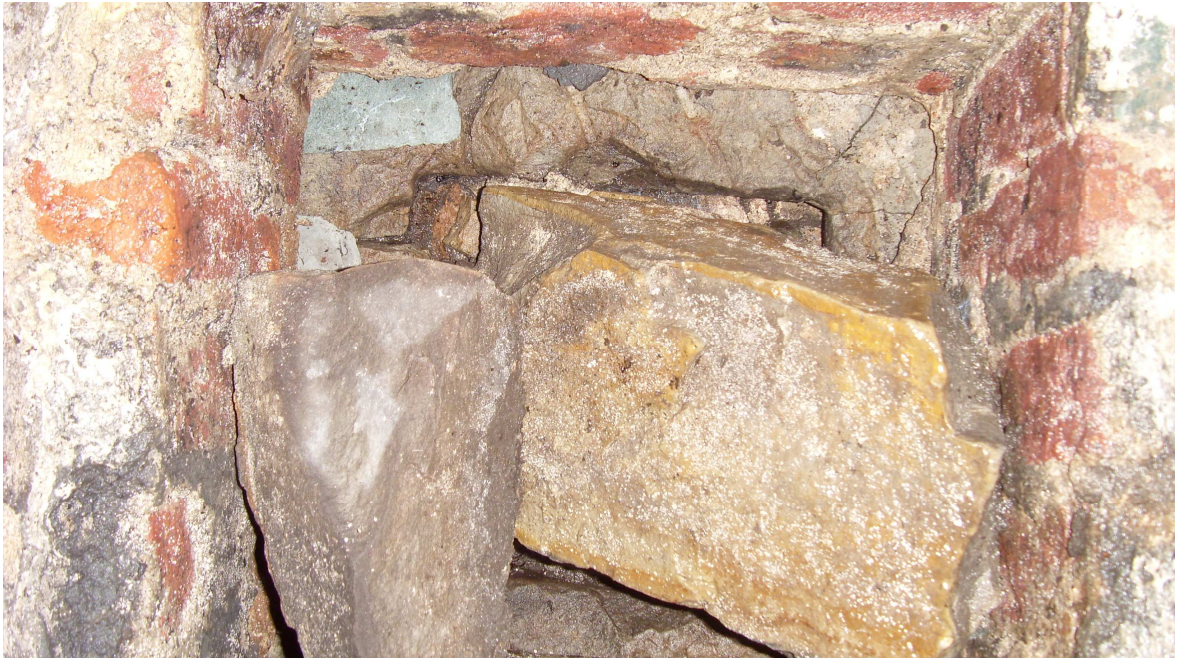
Plate 12: Blocked coalhole **1040** access to Church Lane, approximately 0.4m square

- 5.2.6 The interior of cellar **1033** measured 1.87m long by up to 1.01m wide and 1.3m high at the entrance (Fig 8). A coalhole **1040** in the ceiling was approximately 0.4m square (Plate 12). The cellar wall **1019** was of the same construction as the rear tenement wall **1024**, with whitewash **1013** remaining on the interior wall surface. A repair, or strengthening to the coalhole, the west internal wall, ceiling and doorway had been made in brick, **1015**. The floor of the cellar was concrete, **1014**, and this was possibly laid on an earlier floor of flagstones. The concrete floor formed a step at the entrance to the cellar, within which were four bricks of the same material as a brick-lined drain **1016** that was installed in front of the entrance to the cellar (Fig 10). Beneath the bricks part of a flagstone protruded and this maybe a former step or floor of the cellar. It was probably the installation of this drain after the construction of the building that led to the concrete floor, brick repairs and strengthening of the cellar.

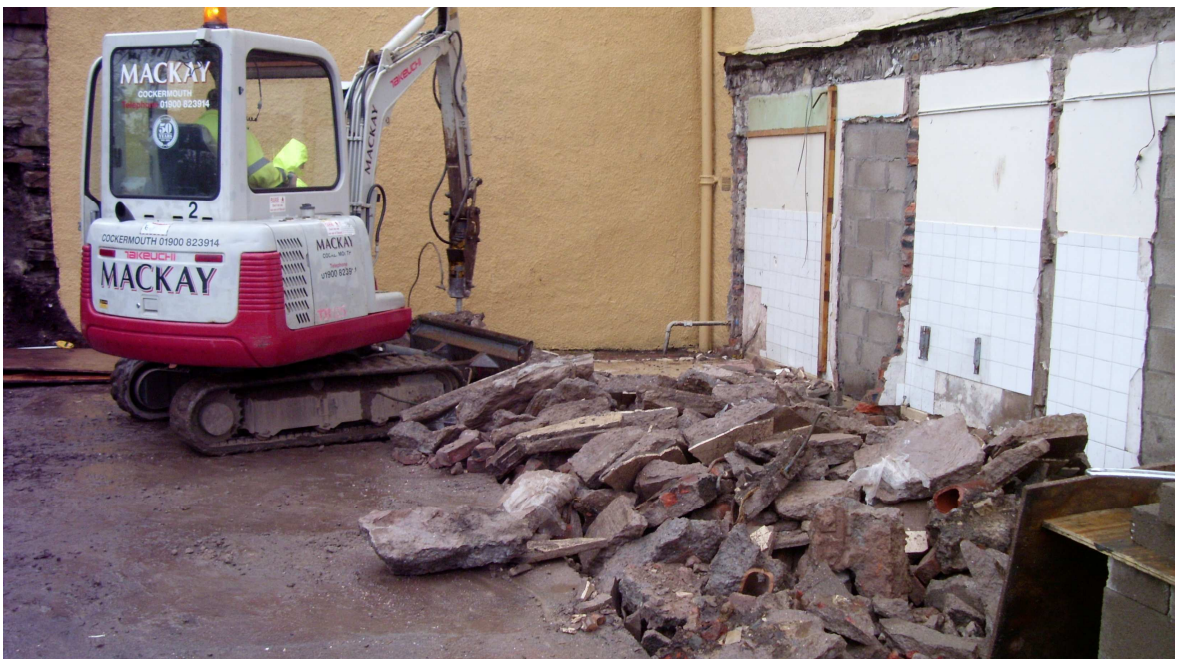
Plate 13: View to the south-west showing machine excavation of toilet extension, and concrete **1029**, drains **1031** and rubble levelling material **1030**

- 1.2.4 The proposed development site at 109 Church Street was occupied by a single storey building that was a toilet extension block for 111 Church Street, the former public house 'The Sailors' Return' (Plate 13, Fig 8). To the front and
