# **COBBLED SURFACE REPAIRS, BROUGH CASTLE, CHURCH BROUGH, CUMBRIA**

**Archaeological  
Recording and  
Watching Brief**

**Oxford Archaeology North**

September 2008

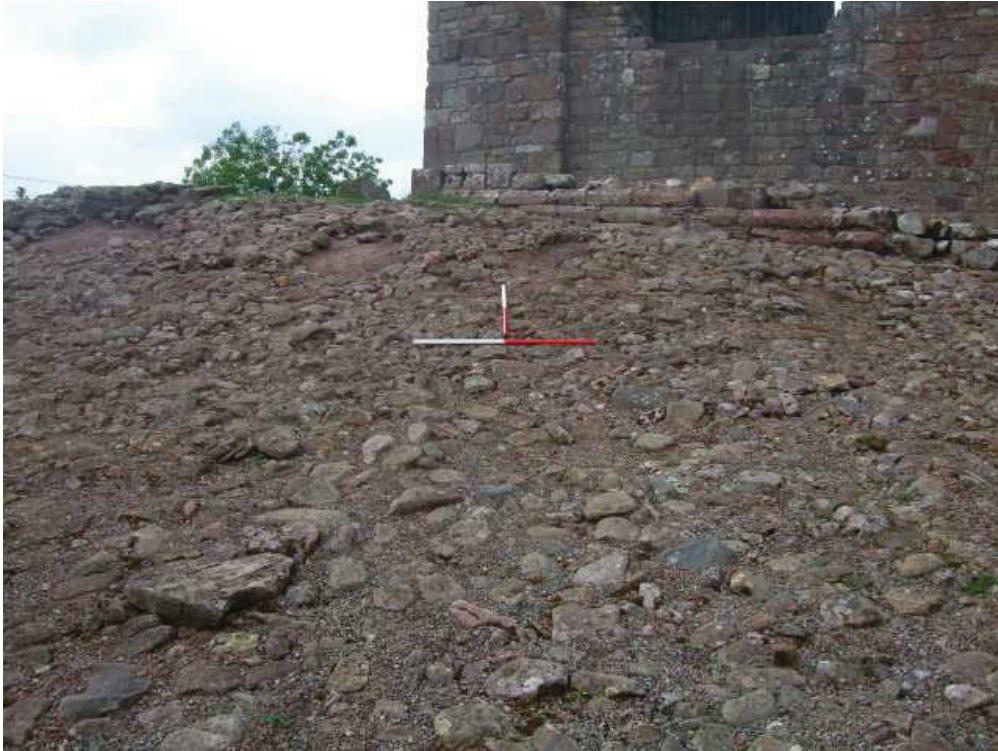
- 3.1.1 **Area 1:** Area 1 was located around the base of the eastern side of the keep, extending 8m from the south curtain wall and was up to 7.1m wide (Fig 3; Plate 1), bounded to the west by a small grassed area. The remaining cobbles of the surface, **7**, were in a generally good state of repair, although there were seven distinct bare patches of exposed bedding material where cobbles had been lost (**8-14**), the edges of which were starting to degrade and thus expand further. The surviving cobble surface consisted of rounded and sub-rounded large sandstone ‘cobbles’ ranging in size from 50mm to over 500mm in length, although the majority were approximately 100-200mm in length.

Plate 1: General shot of Area 1, facing south-west, prior to remedial works

- 3.2.1 **Area 1:** the repairs to cobbled surface **7** around the keep were focused around bare patches **10-12**, with those cobbles that were lifted and re-set shown on Figure 3. Each bare patch consisted of a dark reddish-brown friable silty sand without inclusions and, along with the matrices of similar bare patches **8, 9, 13** and **14**, are most likely the same cobble-bedding deposit, although it was impossible to demonstrate a direct relationship between them.

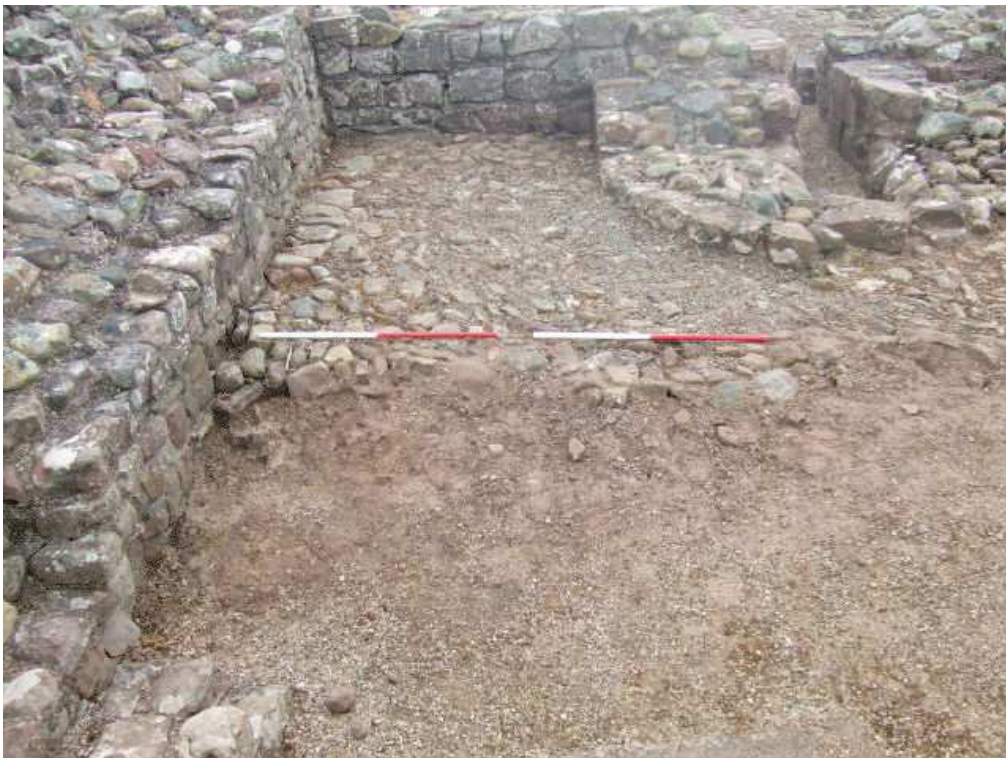
- 3.1.2 **Areas 2 and 3:** these areas were located within the north-east service range (Fig 4; Plates 2 and 3). Area 2, measuring *c* 11.5m east/west by 7.5m north/south, encompassed much of the contiguous bake house and brew house, together with part of the southern wall of that structure and an area of adjoining exterior cobbles. The cobbles in the area of the bake house (surfaces **1** and **2**) and brew house (surface **3**; Plate 2) were essentially similar in their dimensions and arrangement to those observed within Area 1. Of some interest was the fact that these cobbles, and those of the adjoining courtyard, appeared to have been laid within a series of north/south aligned linear cells, each about 4m wide and defined by strips of larger, more rectangular cobbles. Surfaces **1-3** were generally in a good state of repair; however, a large area (**4**) in the middle of these buildings was bare of cobbles and is likely to expand without remedial treatment as the edges, particularly to the east and west, had started to degrade. Bare patch **4** abutted the southern wall of the service range, **5**, and was thus planned in detail in the event of any changes associated with the repair works.

Plate 2: Cobbled surface 2 within the bake house (Area 2), facing east, prior to remedial works

- 3.2.2 **Area 2:** this area was assessed by the repair contractors, who concluded that, whilst the edge of the cobbles of the bake house surface (**2**) were stable enough to be left without remedial work, surface **3** within the brew house was in need of consolidation (Fig 4). A single piece of medieval pottery (*Section 3.4*) was recovered during the removal of loose stones from surface **3** although it may well have originated from underlying bedding layer **4**, a deposit of dark reddish-brown friable silty sand without inclusions.

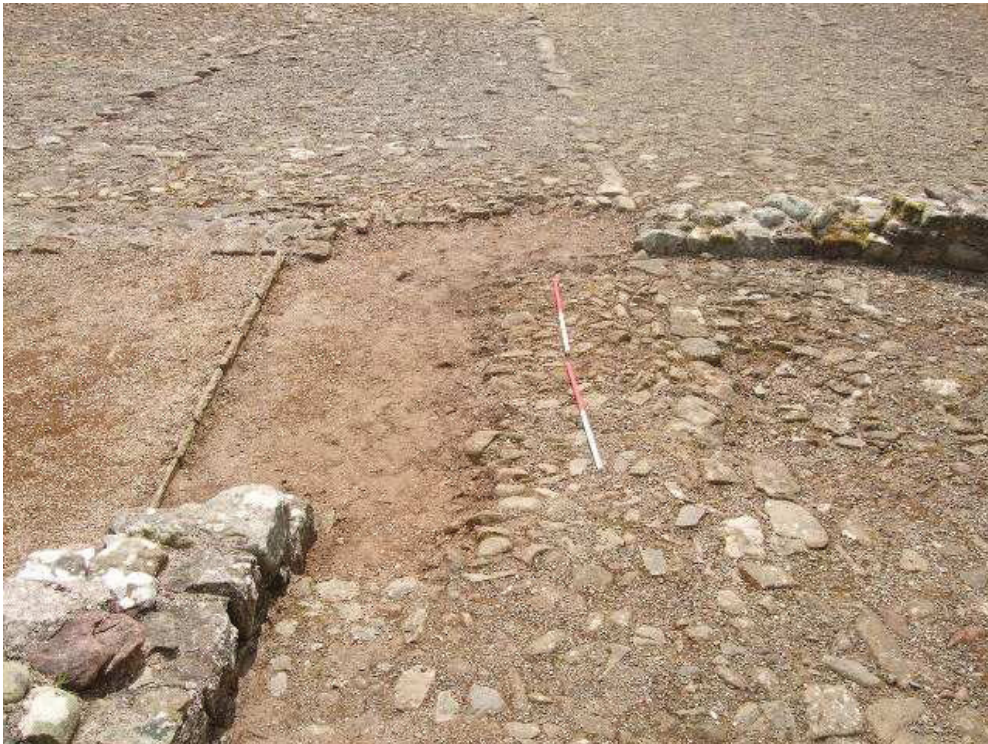
Plate 3: Cobbled surface **3** within the brew house (Area 2), facing south, prior to remedial works

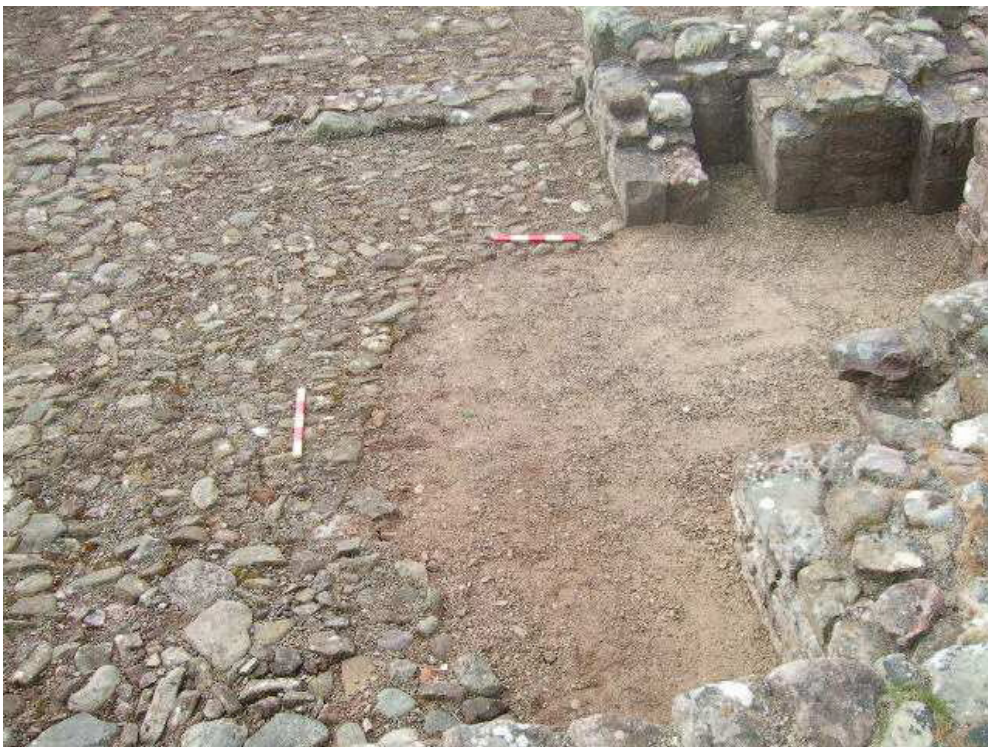
- 3.1.3 Area 3 (Plate 4) was located within the western part of the kitchen and measured 4m north/south by 2m east/west, bounded to the south by the remnants of service range wall **5** and to the west by an internal wall. Within the kitchen, the majority of cobbled surface **15**, which was similar in character to those in Areas 1 and 2, was generally in a good state of repair, although some of the cobbles along the western edge were loose as they skirted bare patch **16**.

Plate 4: Cobbled surface **15** within the kitchen (Area 3), facing south, prior to remedial works

- 3.2.3 **Area 3:** observations within Area 3 essentially matched those within Areas 1 and 2, with the exception that the exposed dark reddish-brown friable silty sand bedding layer **16** contained paler lenses.

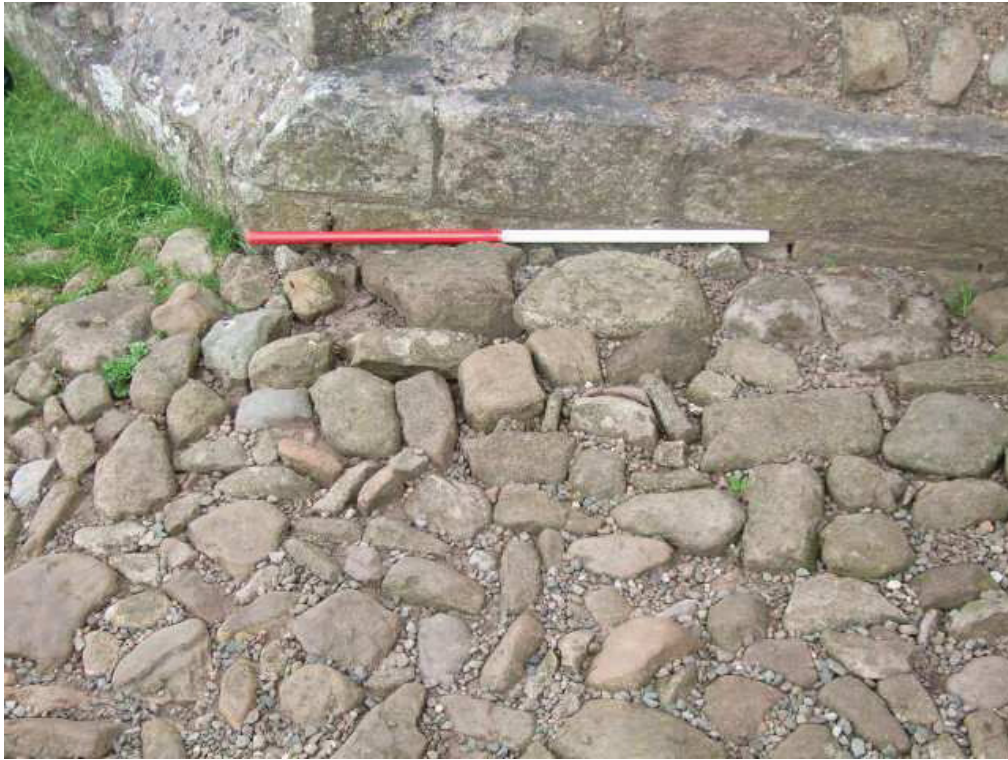
- 3.1.4 **Area 4:** Area 4 measured 2m north/south by 1m east/west, located just inside the western wall of the gatehouse (Fig 5; Plate 5). Cobbled surface **6** resembled each of the other recorded areas and, whilst in a better state of repair, there were a number of loose, but otherwise *in-situ*, cobbles.

Plate 5: Cobbled surface *06* within gateway (Area 4), facing west, prior to remedial works

- 3.2.4 **Area 4:** minimal work was carried out on cobbled surface **6**, within the area of the gatehouse. The loose *in-situ* stones were directly lifted and replaced in the same location with lime mortar to bed them in. No substrate or bedding material was exposed and it was therefore impossible to tell whether construction of this surface differed from any other of the recorded cobbled surfaces.

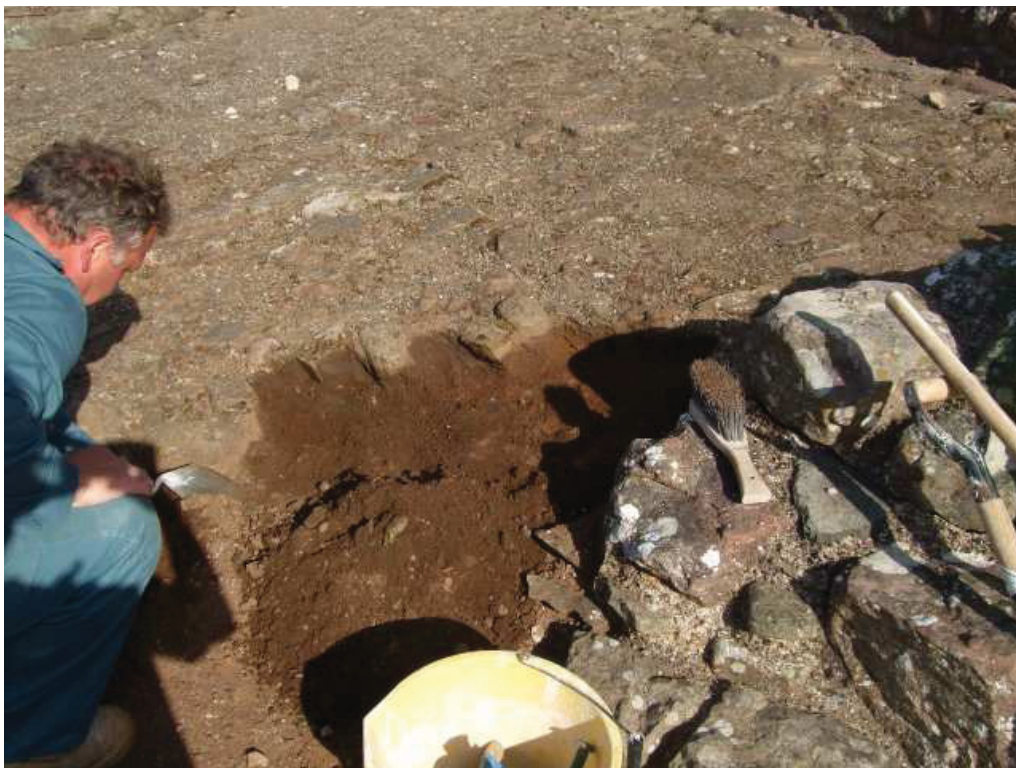
Plate 6: Working shot of remedial works

- 3.3.1 Those loose cobbles that were lifted as part of the repair works, together with additional cobbles (that no doubt originated from the surfaces), were re-set within a matrix of lime mortar mixed with some of the removed original silty sand bedding material (contexts **4, 10, 11, 12** and **15**; Plates 6 and 7). The areas of repair were then covered with further scraped-up bedding material to effectively restore the original appearance of the cobbles. As can be seen in Plate 8, the repairs are not obvious and match with the state of the cobbled surface prior to work commencing.

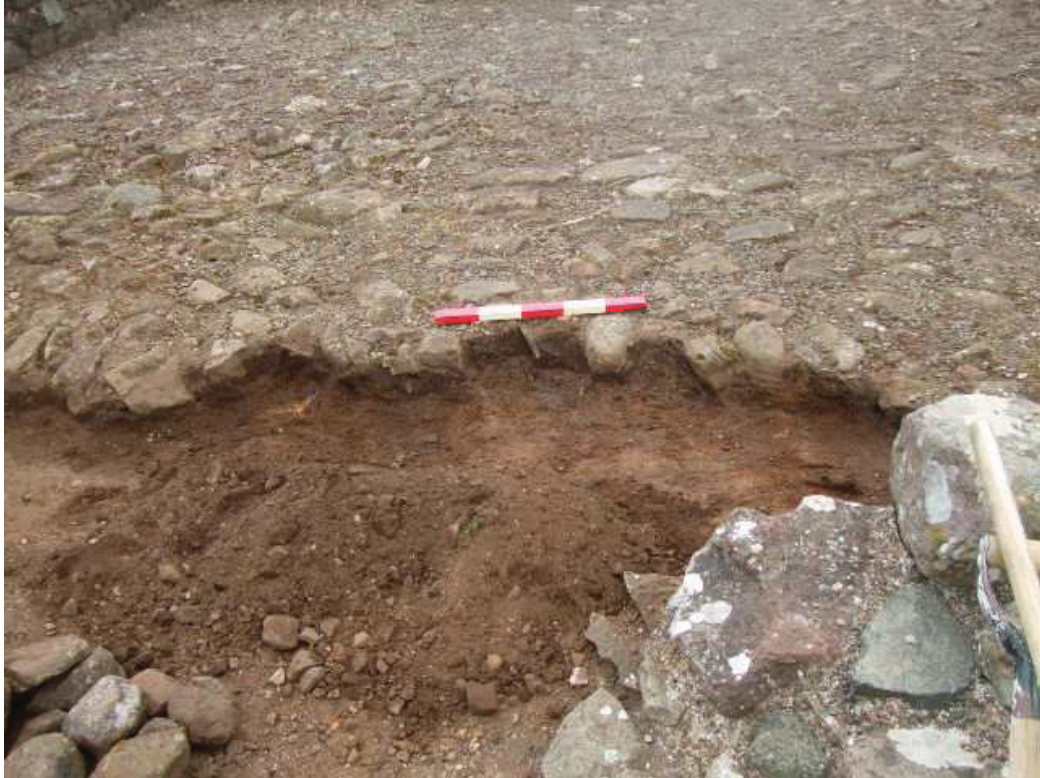
Plate 7: Surface 3 (Area 2), facing west, during repairs

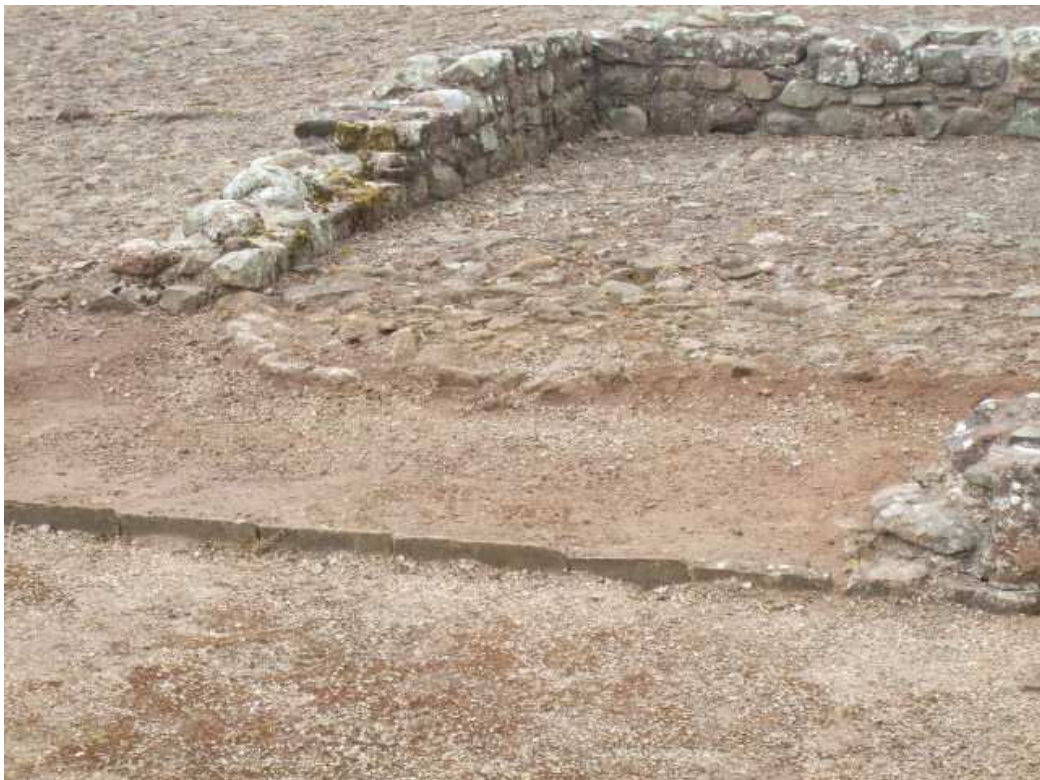
Plate 8: Surface 3 (Area 2), facing south-west, following repairs
